Structural Steel Repair Procedure

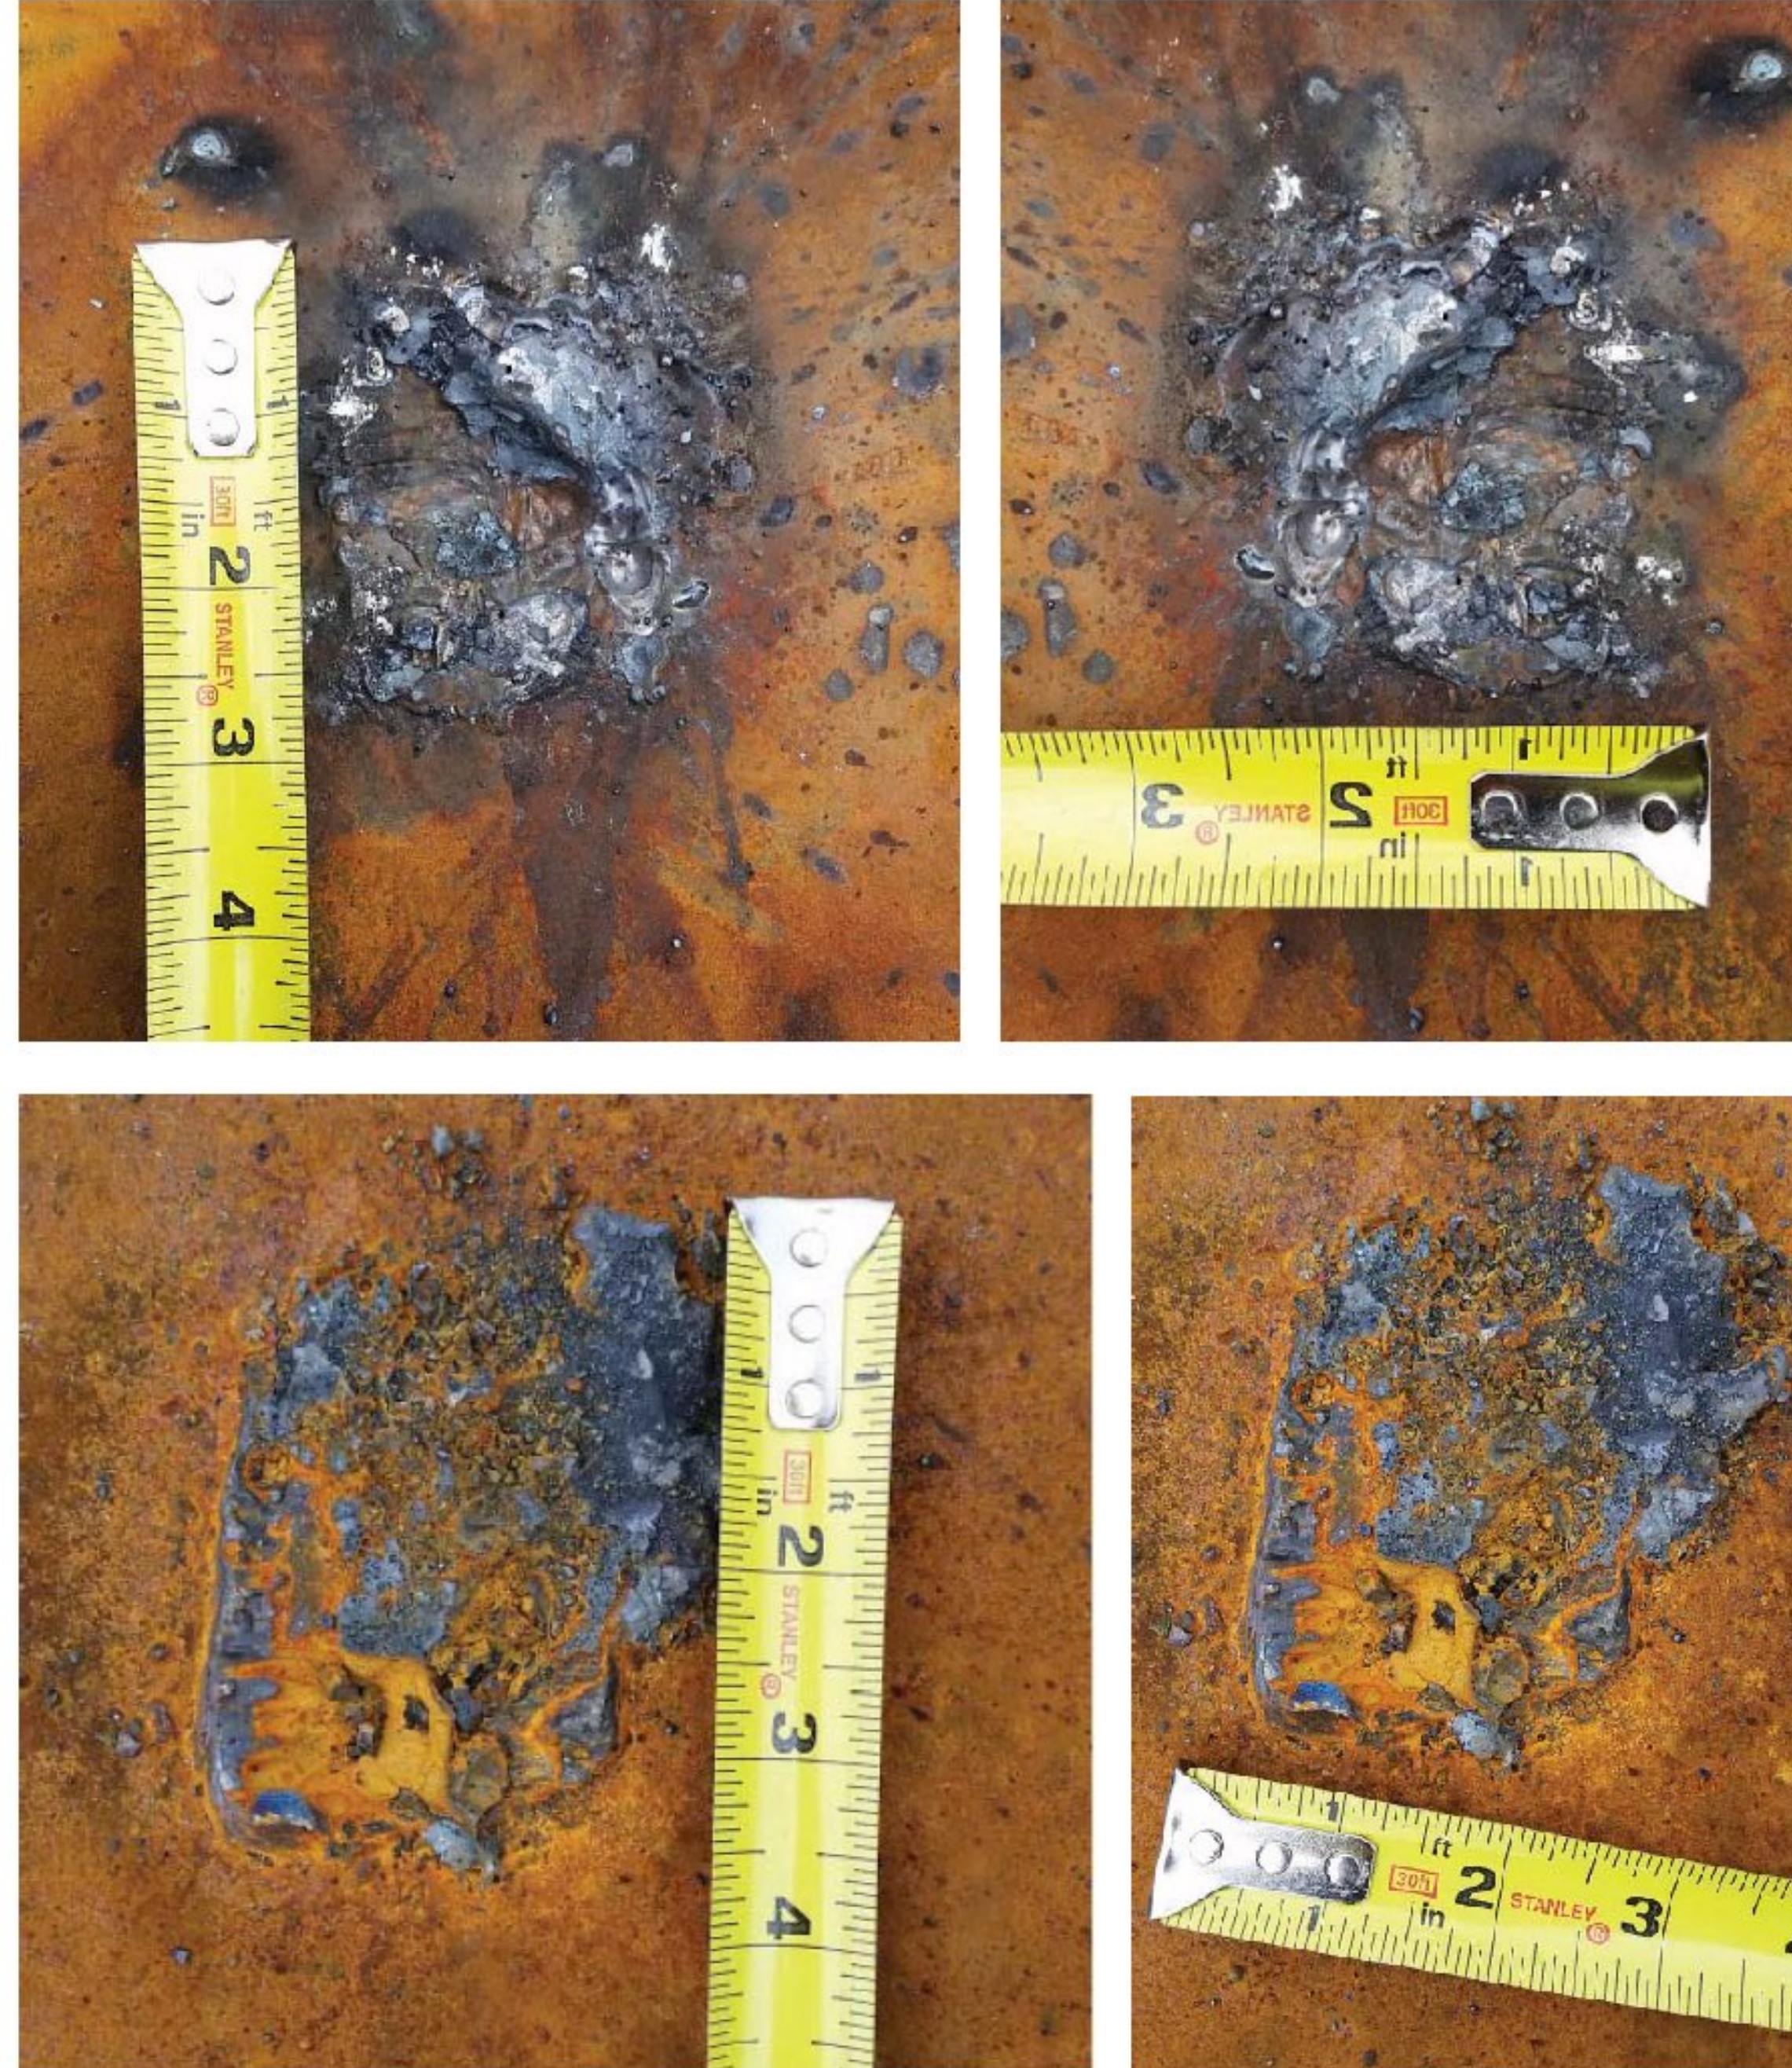
During inspection it was discovered that (2) small areas on I-91NB girder #6 were cut into with a torch. See pictures below for reference:

This happened when the welder cut and moved one of the legs for the fall protection. The welder has since been talked to as has the crew. If cutting of any temporary members is required grinders (not torches) are to be used. In no situation shall the permanent girders be damaged.

PCL proposes the following repair procedure:

1. Grind off all latent materials
2. Fill divots with weld (E70XX)
3. Grind area to be flush with flange
