NEW CRACK LOCATIONS

<b>STATE OF VERMONT AGENCY OF TRANSPORTATION</b>			
Town Of	MILTON	Bridge No.	81N & 81S
Highway No.	189	Log Sta.	MM 1066.30
		Surv. Sta.	---
<b>189 OVER THE LAMOILLE RIVER</b>			
<b>ADDITIONAL CRACK LOCATIONS</b>			
Designed By	P.M. THURBER	Drawn By	P.M. THURBER
Checked By	J.B. MCCARTHY	Bridge Design Supervisor	J.B. MCCARTHY
Date	04/1999	Date	04/1999
PROJECT	MILTON	PROJECT NO.	IM 089-3(31)
Bridge Sheet No.		Sheet	7 of 7

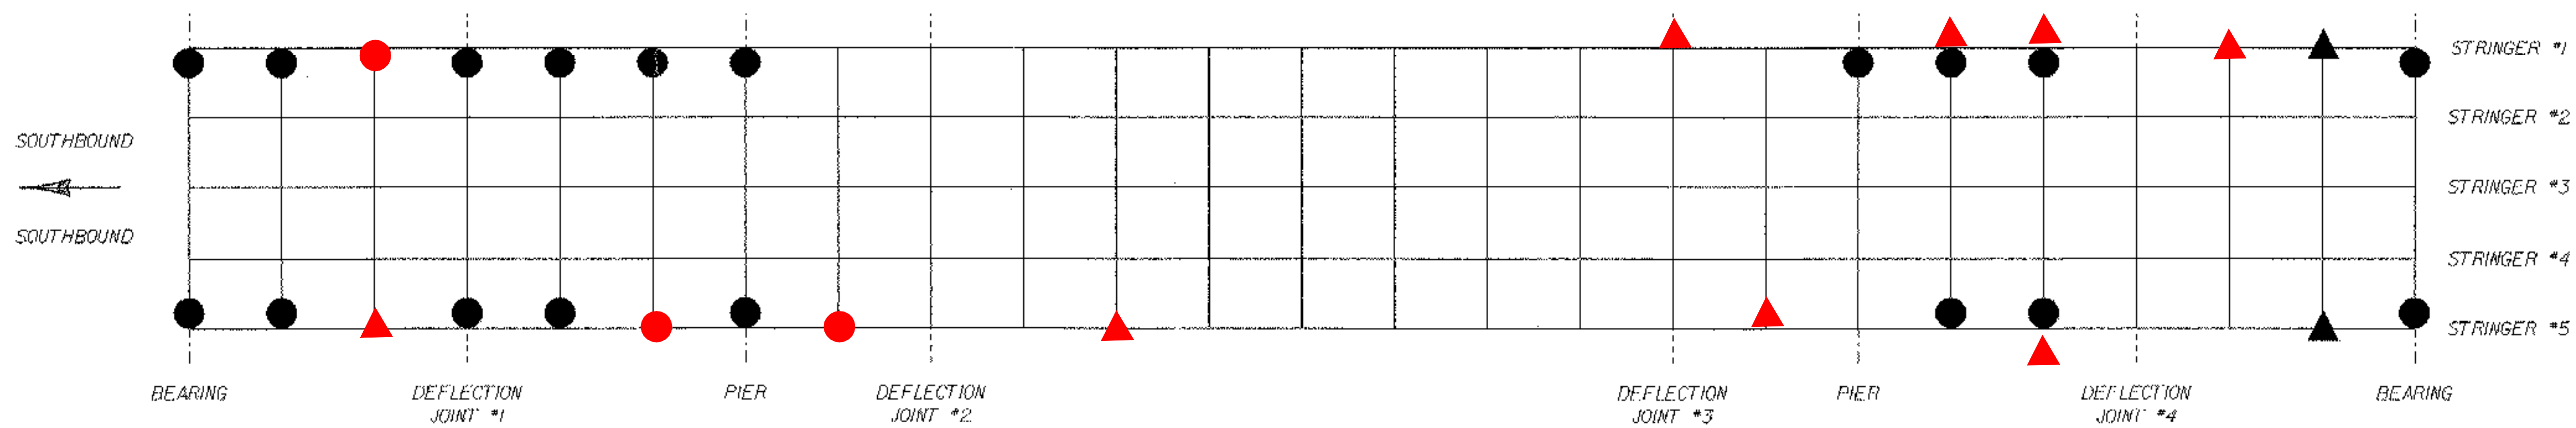
FRAMING PLAN SOUTHBOUND BRIDGE

CRACK LOCATIONS AS RECORDED ON SEPTEMBER 22, 1999	
●	END OF FLOOR BEAM CRACKED
■	HEAVY SECTION LOSS OR RUST HOLES THROUGH END OF STRINGER
▲	CRACKS THROUGH CONNECTION PLATE BELOW FLOOR BEAM

ALL CRACKS IN THE EXISTING STRUCTURAL STEEL AT LOCATIONS INDICATED IN THESE PLANS SHALL BE REPAIRED PRIOR TO ADDITION OF THE ANGLES AND CHANNEL DIAPHRAGMS. ALL CRACKS SHALL BE REPAIRED USING AN APPROVED GROOVE WELD PROCEDURE. PAYMENT FOR CRACK REPAIR SHALL BE MADE UNDER ITEM 506.75 "STRUCTURAL STEEL (MODIFIED)".
