Trench excavation for 36" culvert

Installed 92 LF of 36" PCCSP (079) PE & 1-36" Metal End Section
 R. Cerri 2-11-94

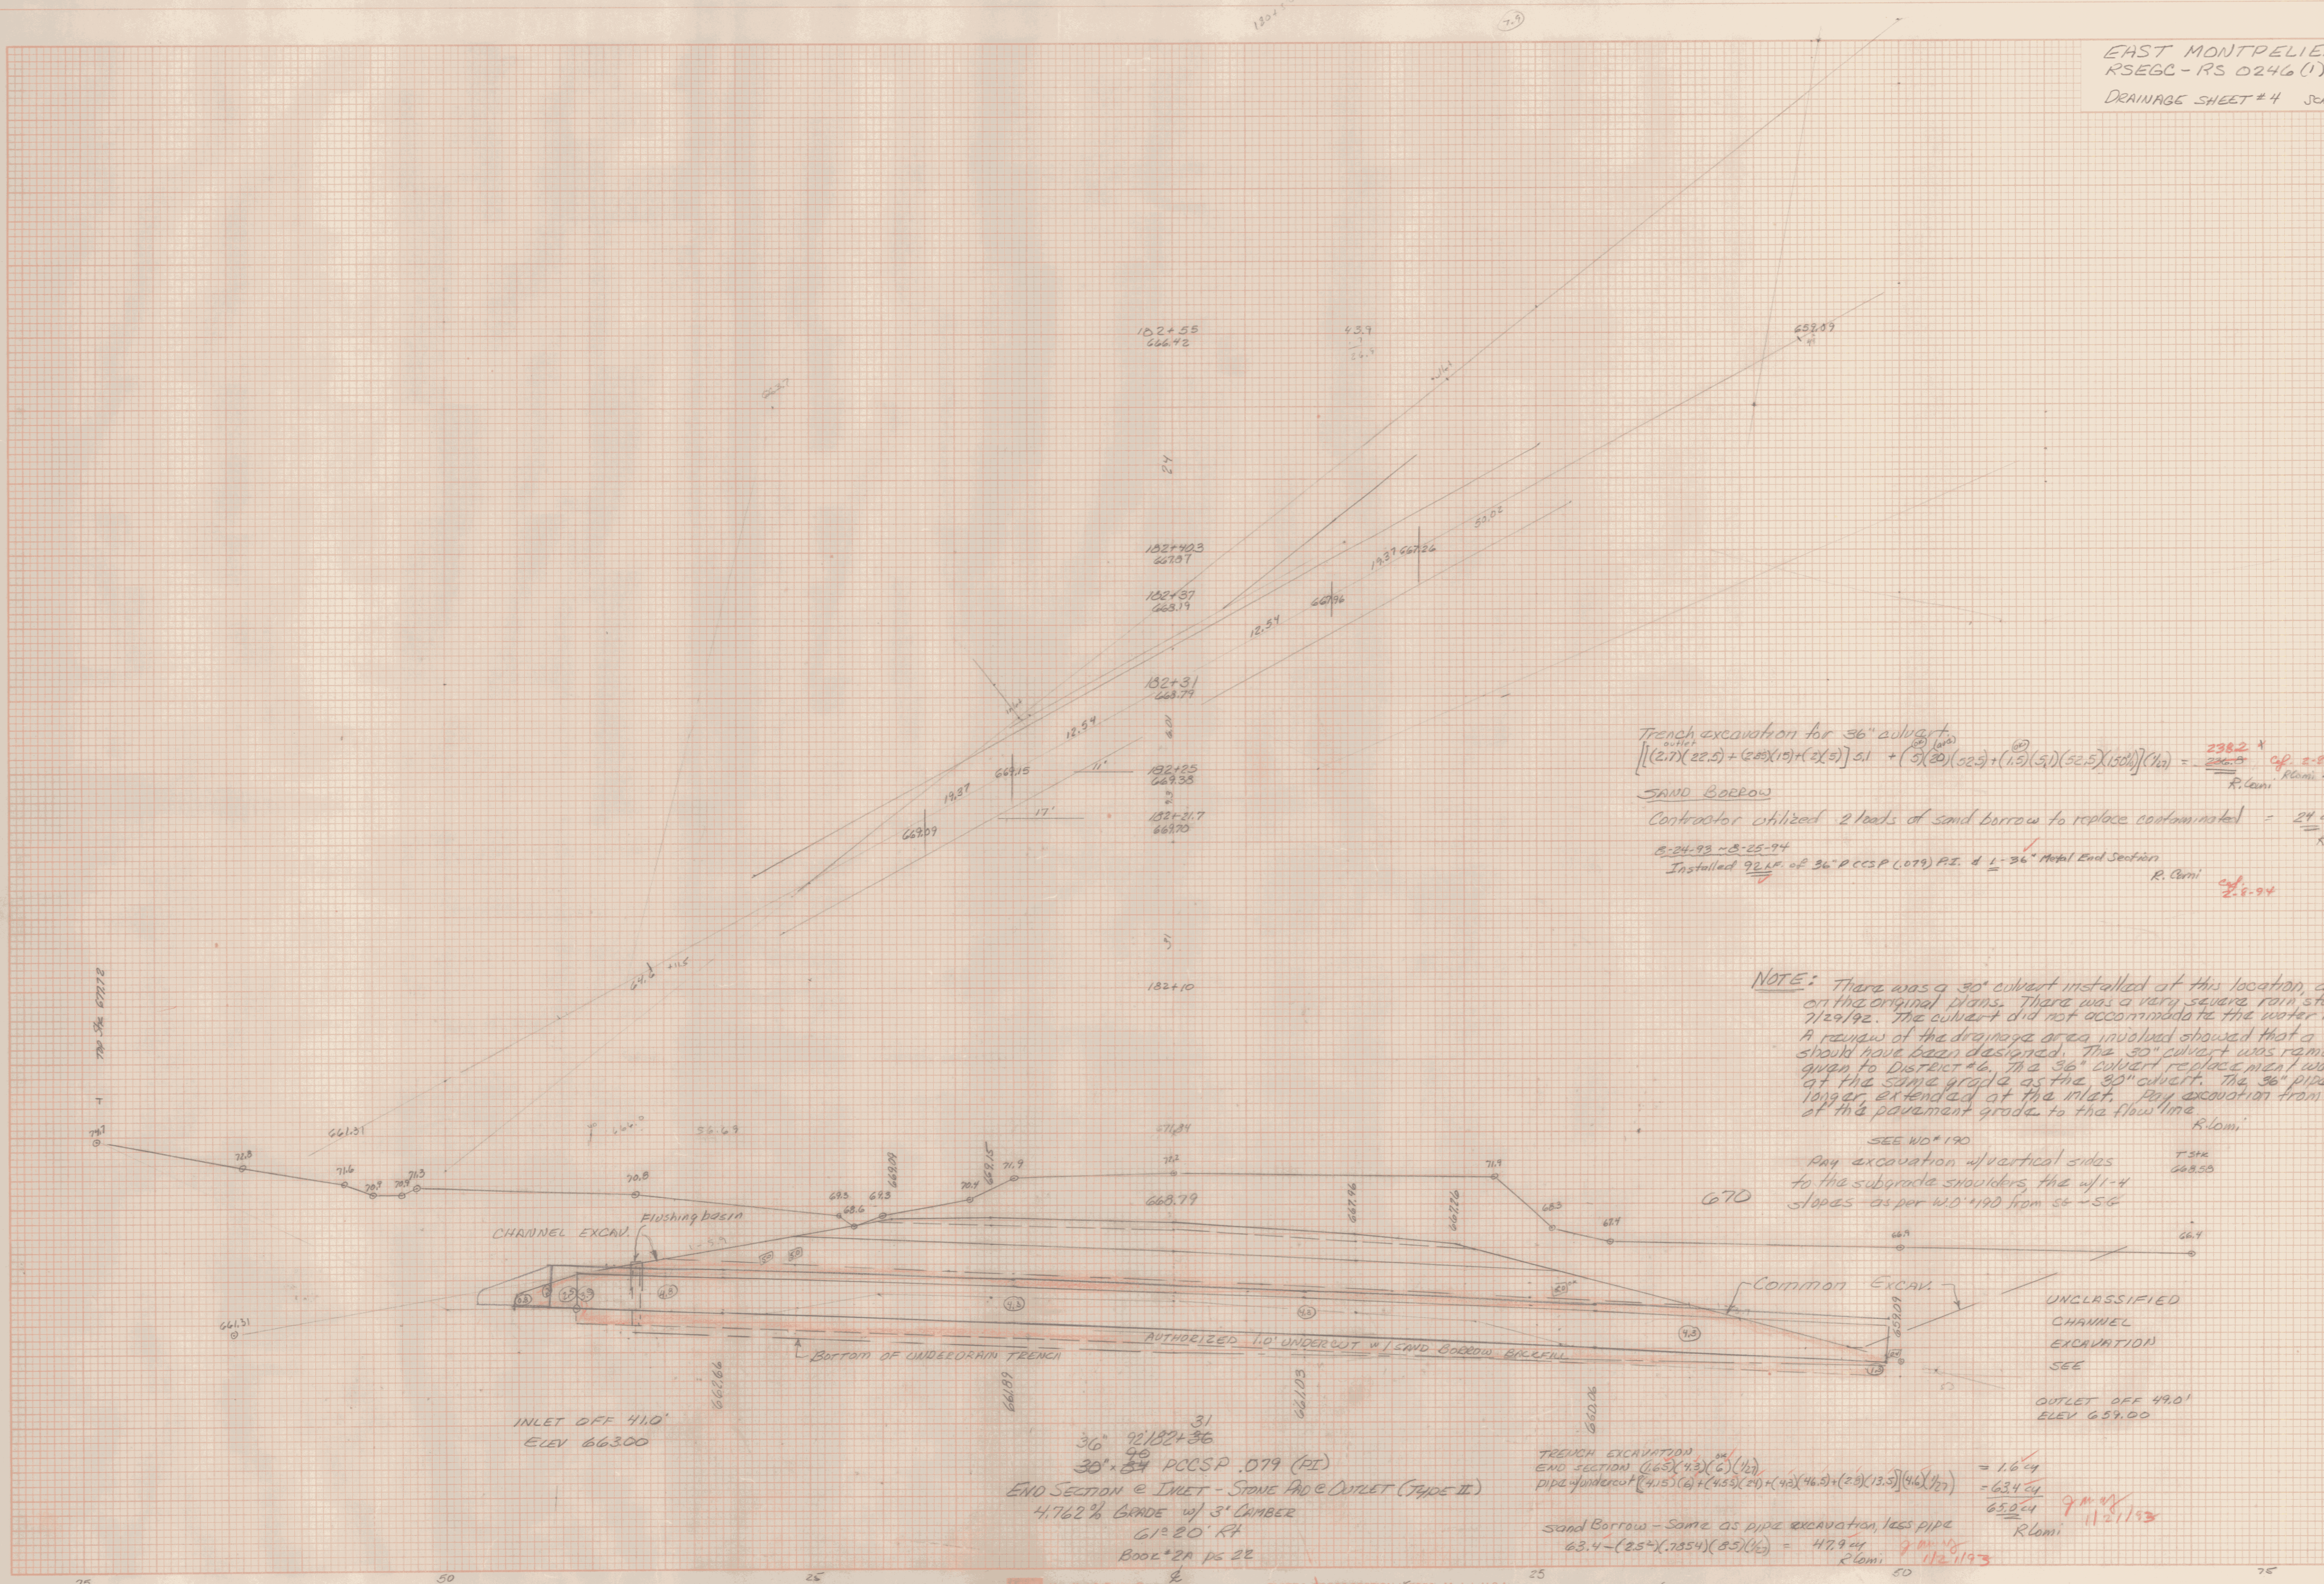
NOTE: There was a 30" culvert installed at this location, as indicated on the original plans. There was a very severe rain storm on 7/29/92. The culvert did not accommodate the water runoff. A review of the drainage area involved showed that a 36" culvert should have been designed. The 30" culvert was removed and given to District #6. The 36" culvert replacement was installed at the same grade as the 30" culvert. The 36" pipe was 2' longer, extended at the inlet. Pay excavation from the bottom of the pavement grade to the flowline.
 R. Cerri

36" PCCSP .079 (PI)
 END SECTION @ INLET - Stone Pad @ Outlet (Type II)
 4.762% GRADE w/ 3" CHAMBER
 61' 20" RT
 Book # 2A ps 22

$$\left[(2.7)(22.5) + (2.0)(19) + (2)(5) \right] 5.1 + \left[(3)(30)(52.5) + (1.5)(5.1)(52.5)(150)(1.2) \right] (1.2) = \frac{2382}{246.5} \times \frac{1.2}{1.2} = 29.2 \text{ cu yd}$$
 R. Cerri 2-11-94

SAND BORROW
 Contractor utilized 2 loads of sand borrow to replace contaminated = 24 cu yd
 R. Cerri 2-11-94

TRENCH EXCAVATION
 END SECTION $(1.5)(4.5)(6)(1.2) = 5.4 \text{ cu yd}$
 PIPE UNDERCUT $(4.5)(6) + (4.5)(24) + (4.5)(46.5) + (2.5)(13.5)(4.5)(1.2) = 63.4 \text{ cu yd}$
 SAND BORROW - Same as pipe excavation, less pipe
 $63.4 - (2.5^2)(.7854)(.85)(16) = 47.9 \text{ cu yd}$
 R. Cerri 11-21-93
