### Culvert Inspection Form

Railroad: <b>GMRC</b>	Town: <u>LUDLOW</u>
Valuation Sheet: <b>V 3 / 26</b>	Valuation Stationing: <u>1329 + 76</u>
Mile Post: <b>B 25.18</b>	GPS Coordinates: N: <u>43, 38 617</u> W: <u>72, 66 299</u>

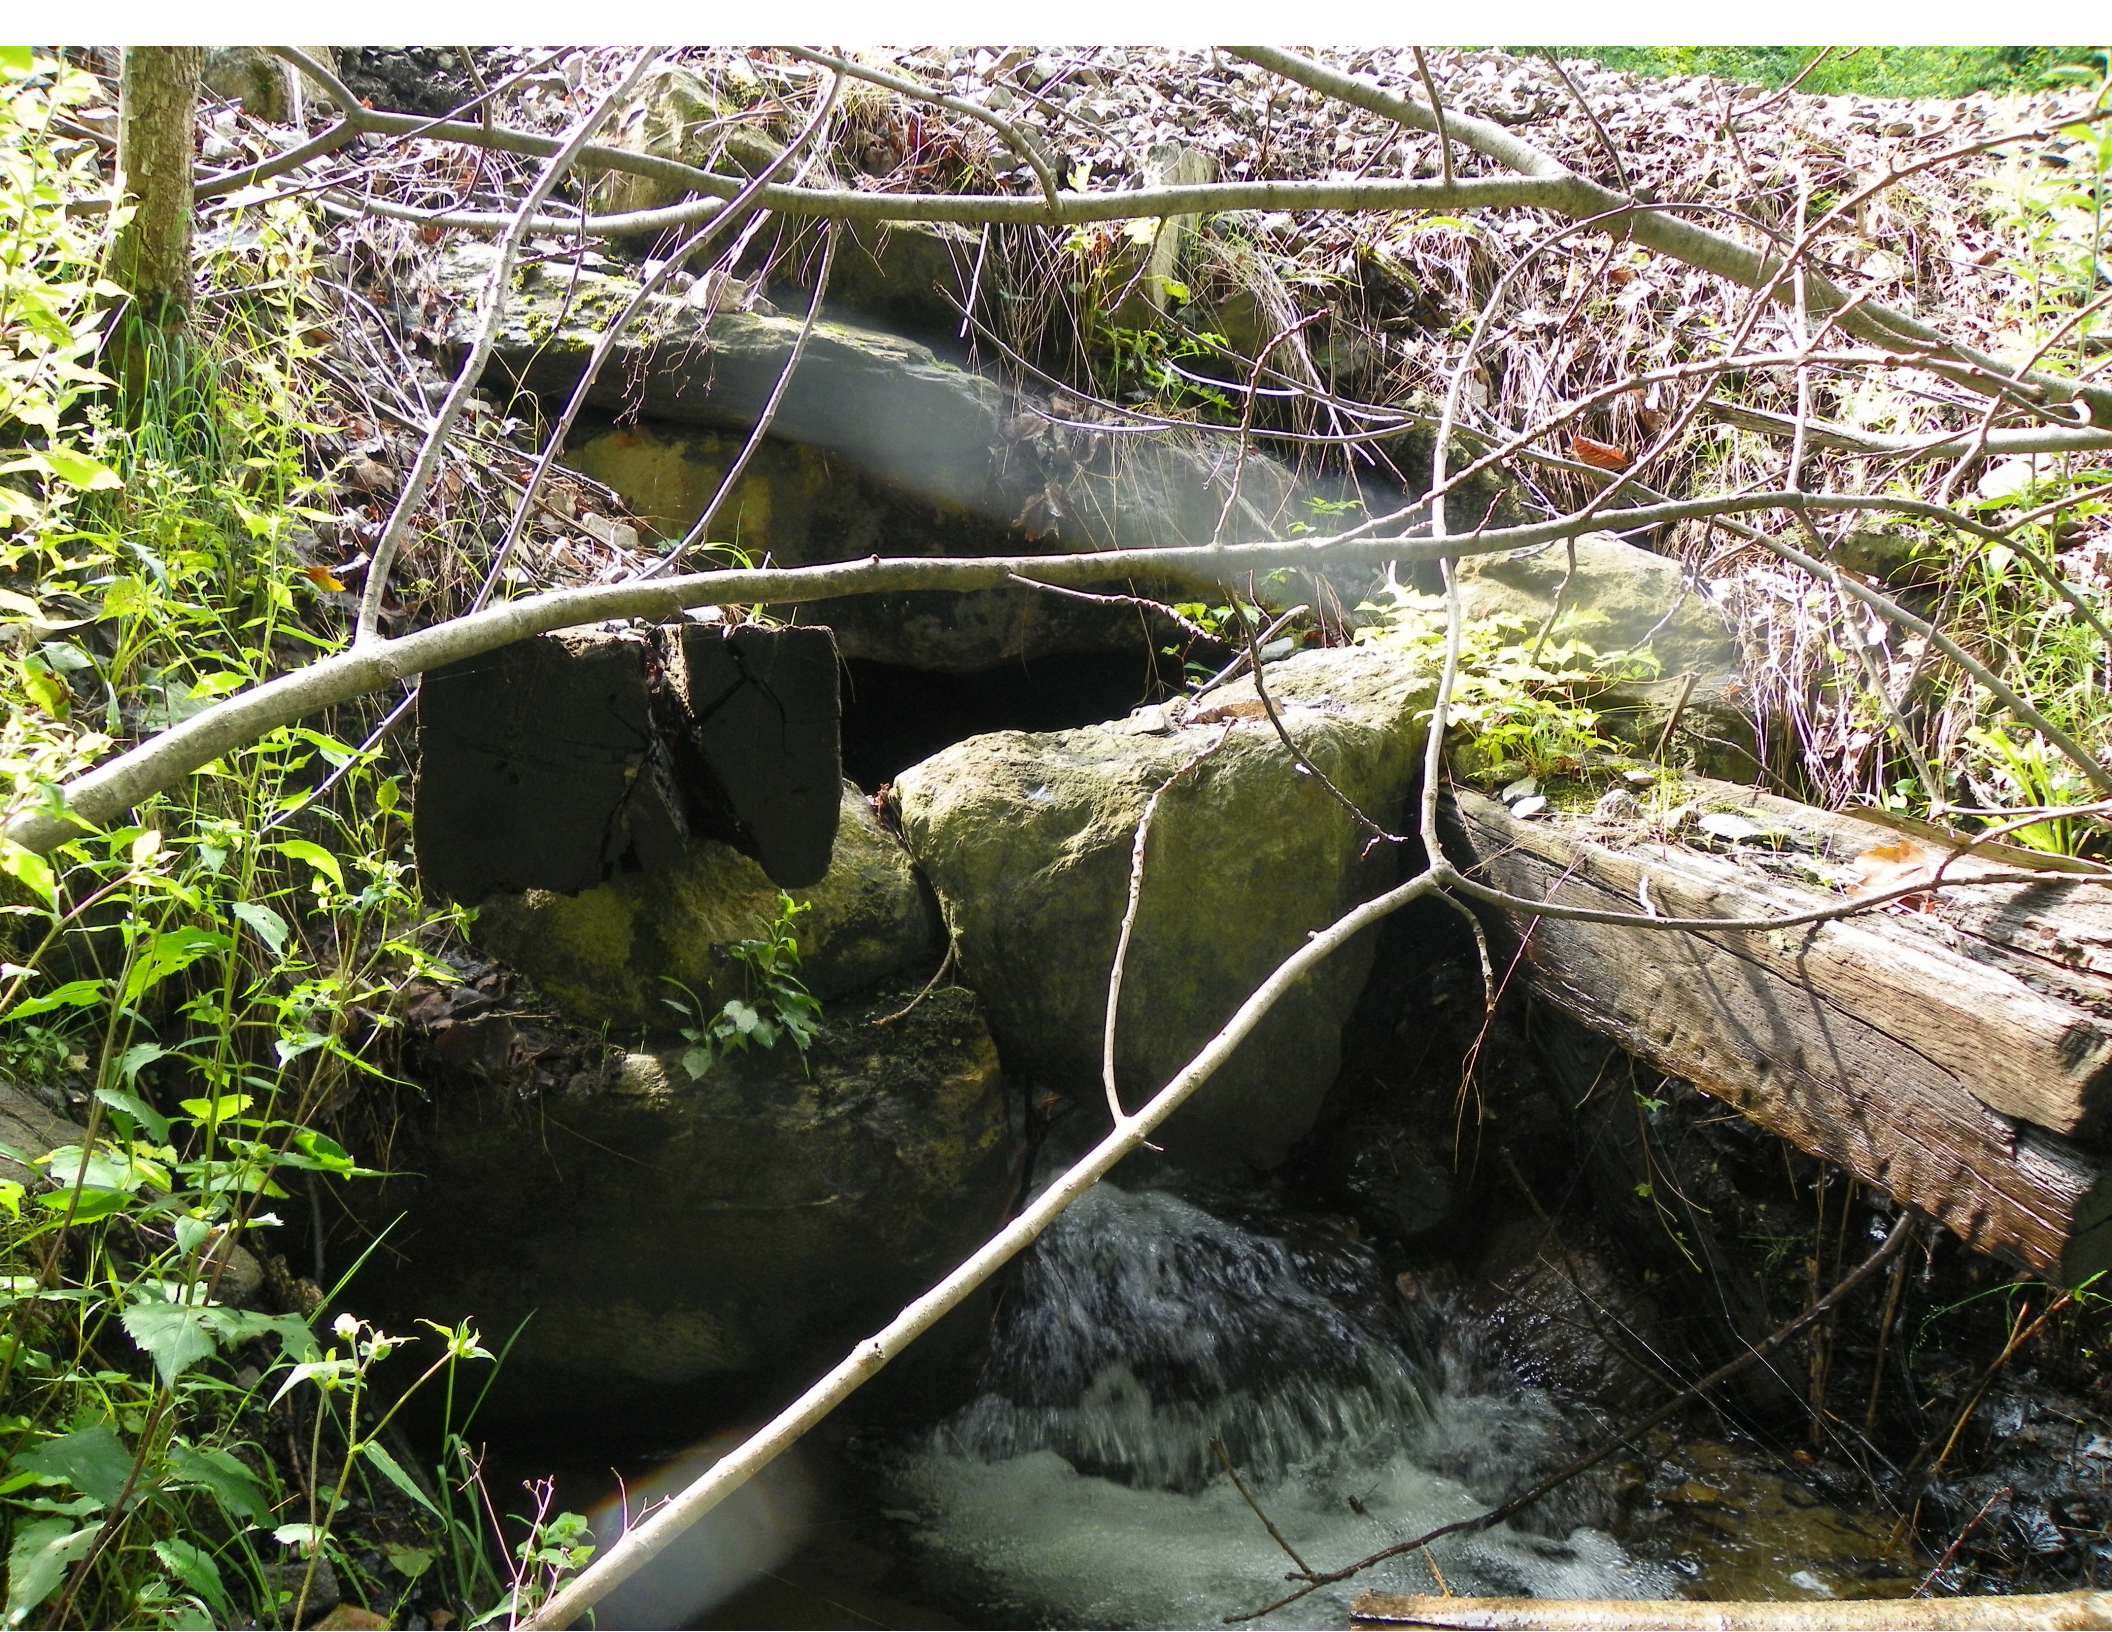
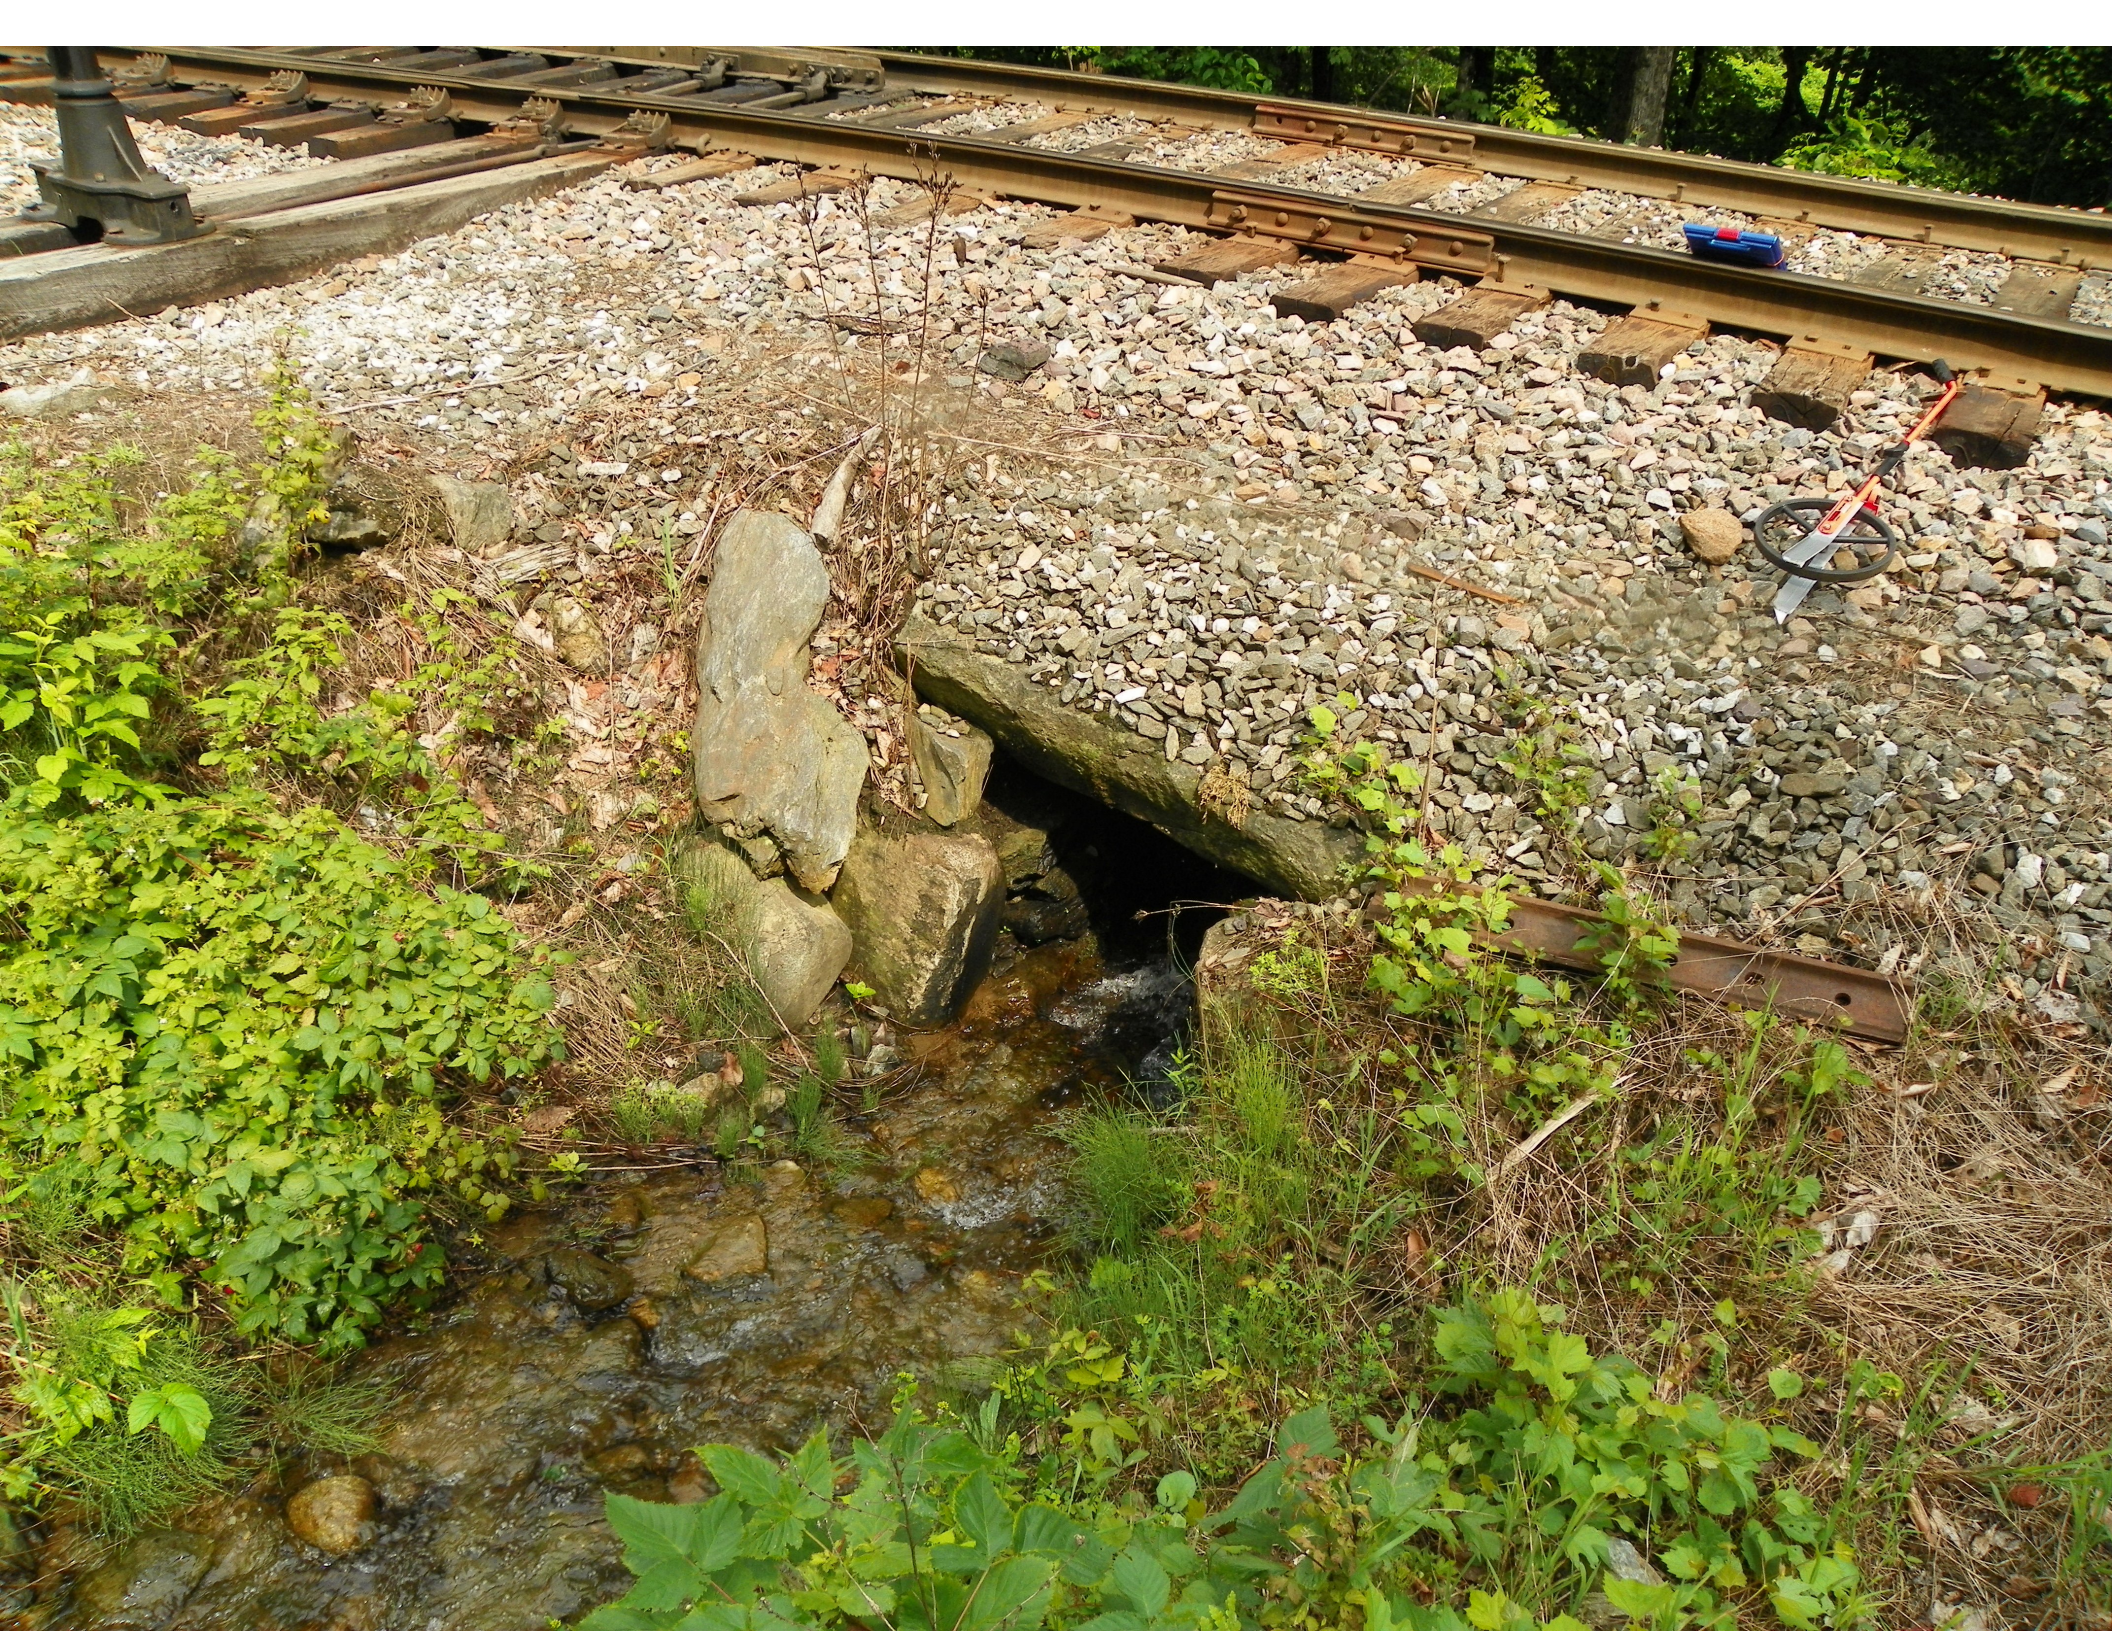
NORTH OUTLET STOPS SHIFTING  
\_\_\_\_\_  
\_\_\_\_\_

EAST SWITCH SMITHVILLE
