### Culvert Inspection Form

Railroad: <b>GMRC</b>	Town: <u>LUDLOW</u>
Valuation Sheet: <b>V 3 / 26</b>	Valuation Stationing: <u>1361 + 68</u>
Mile Post: <b>B 25.28</b>	GPS Coordinates: N: <u>43.38713</u> W: <u>72.67457</u>

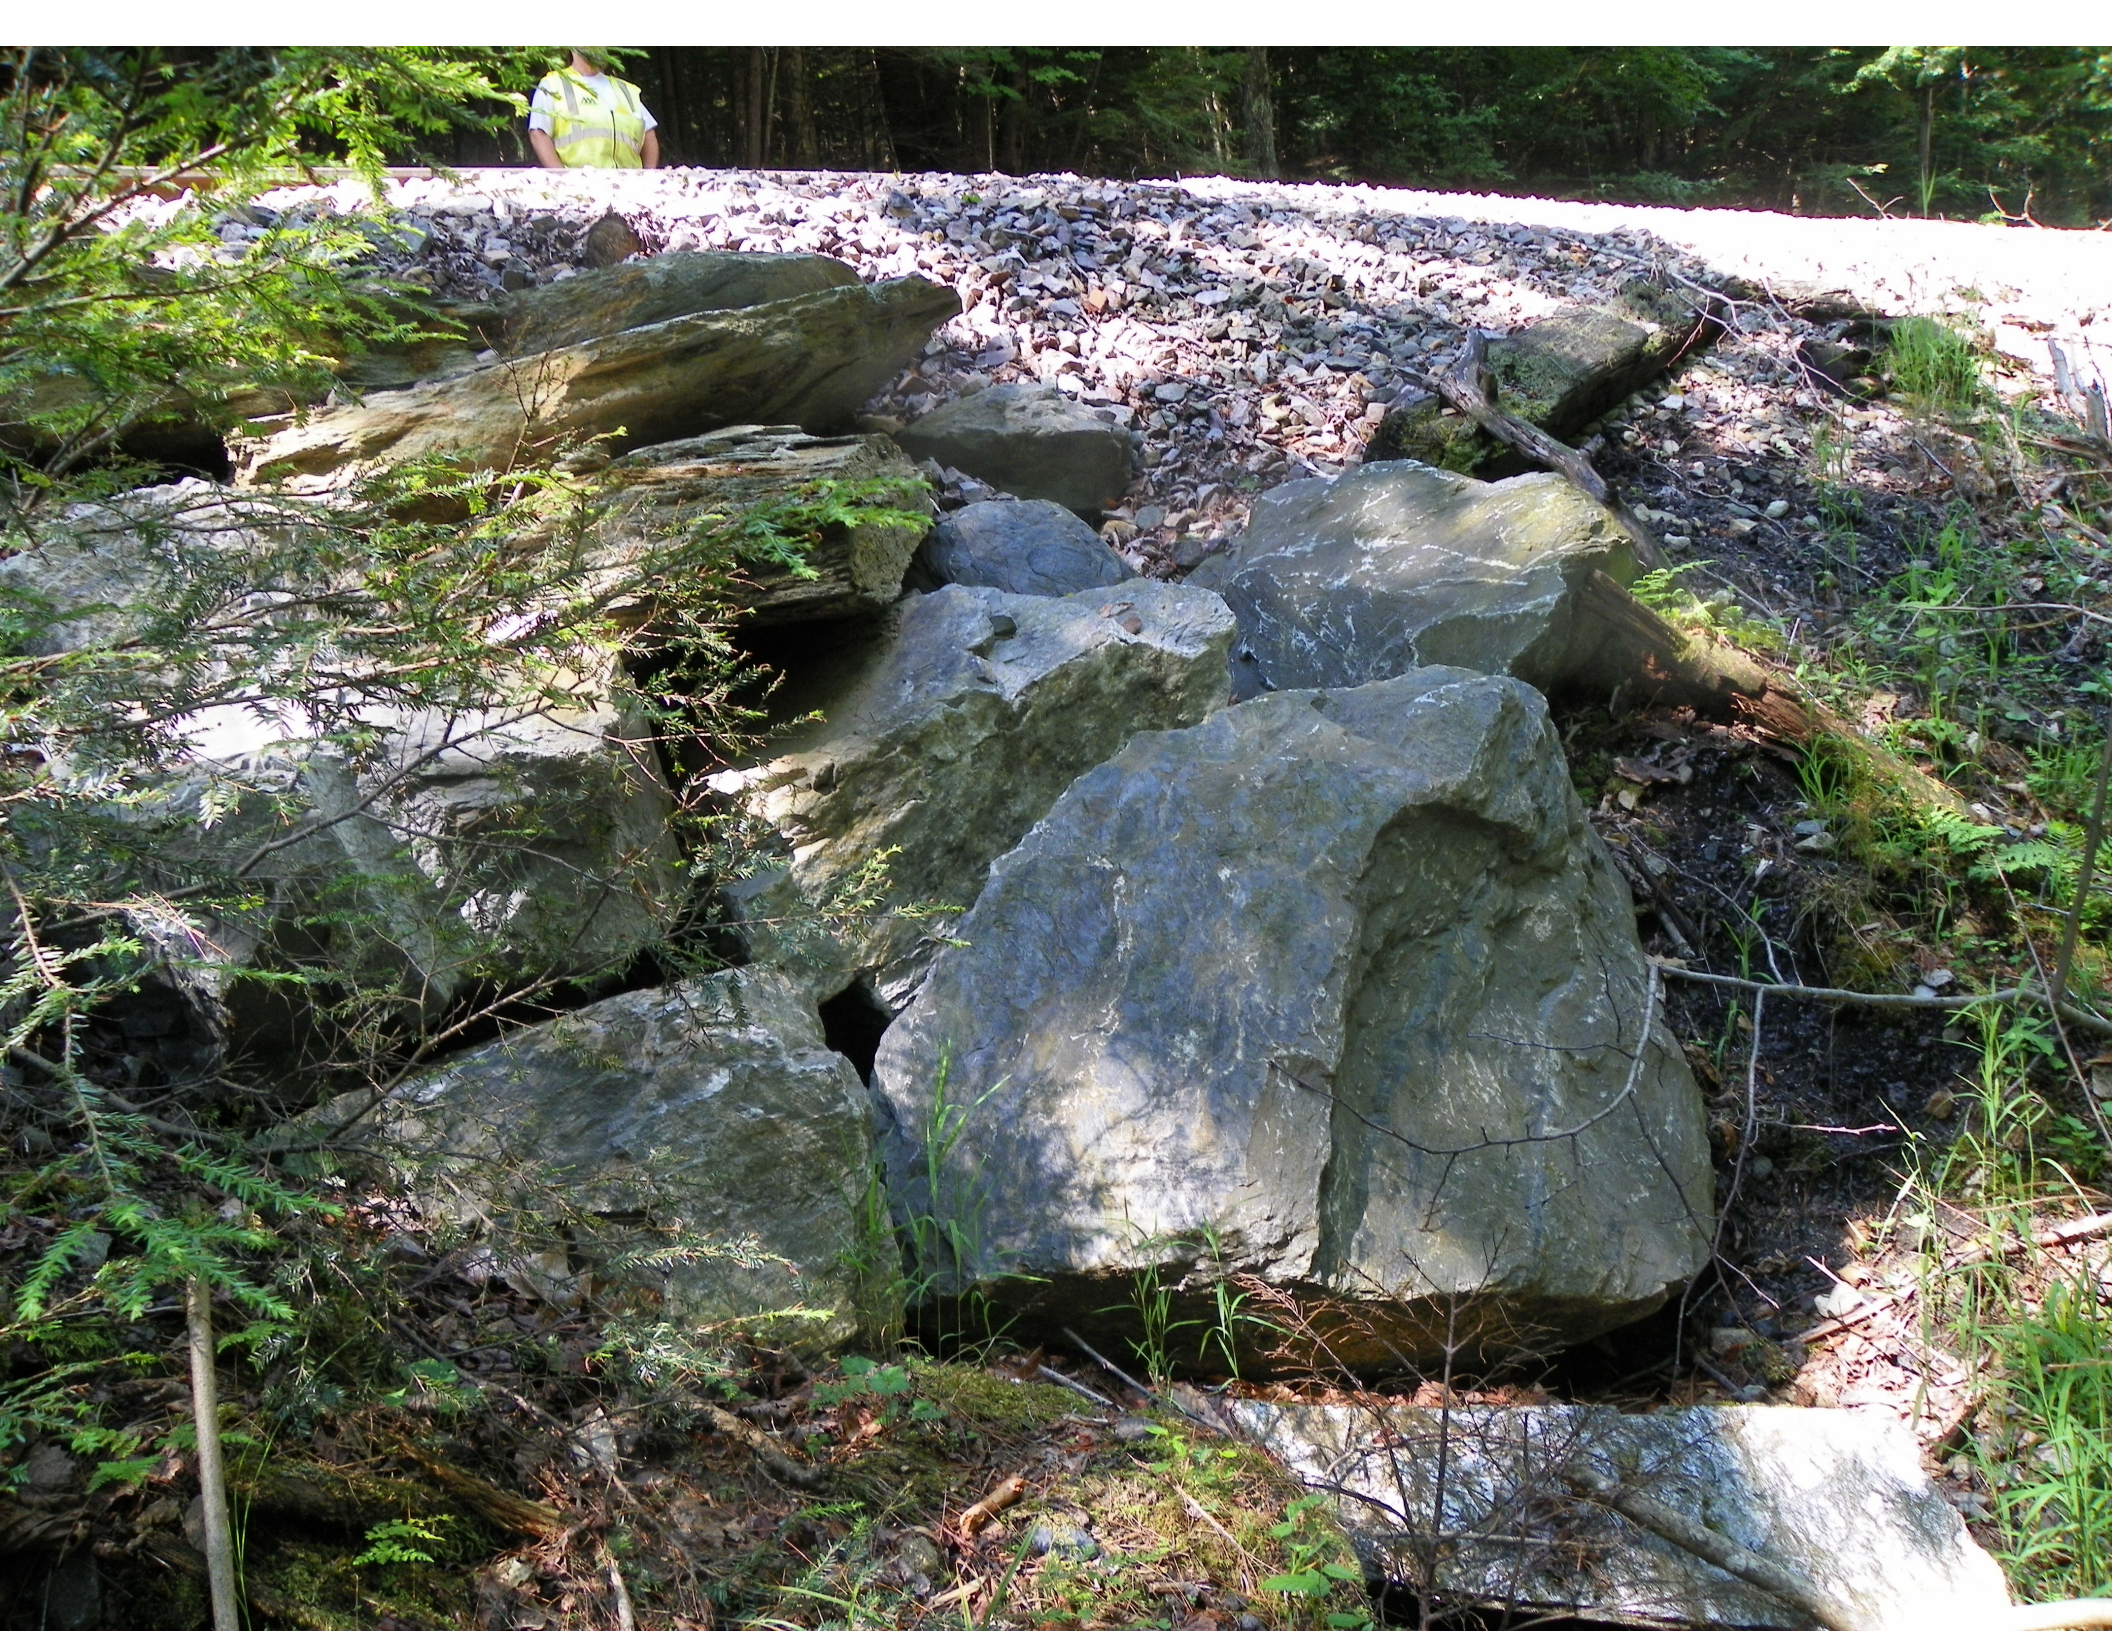
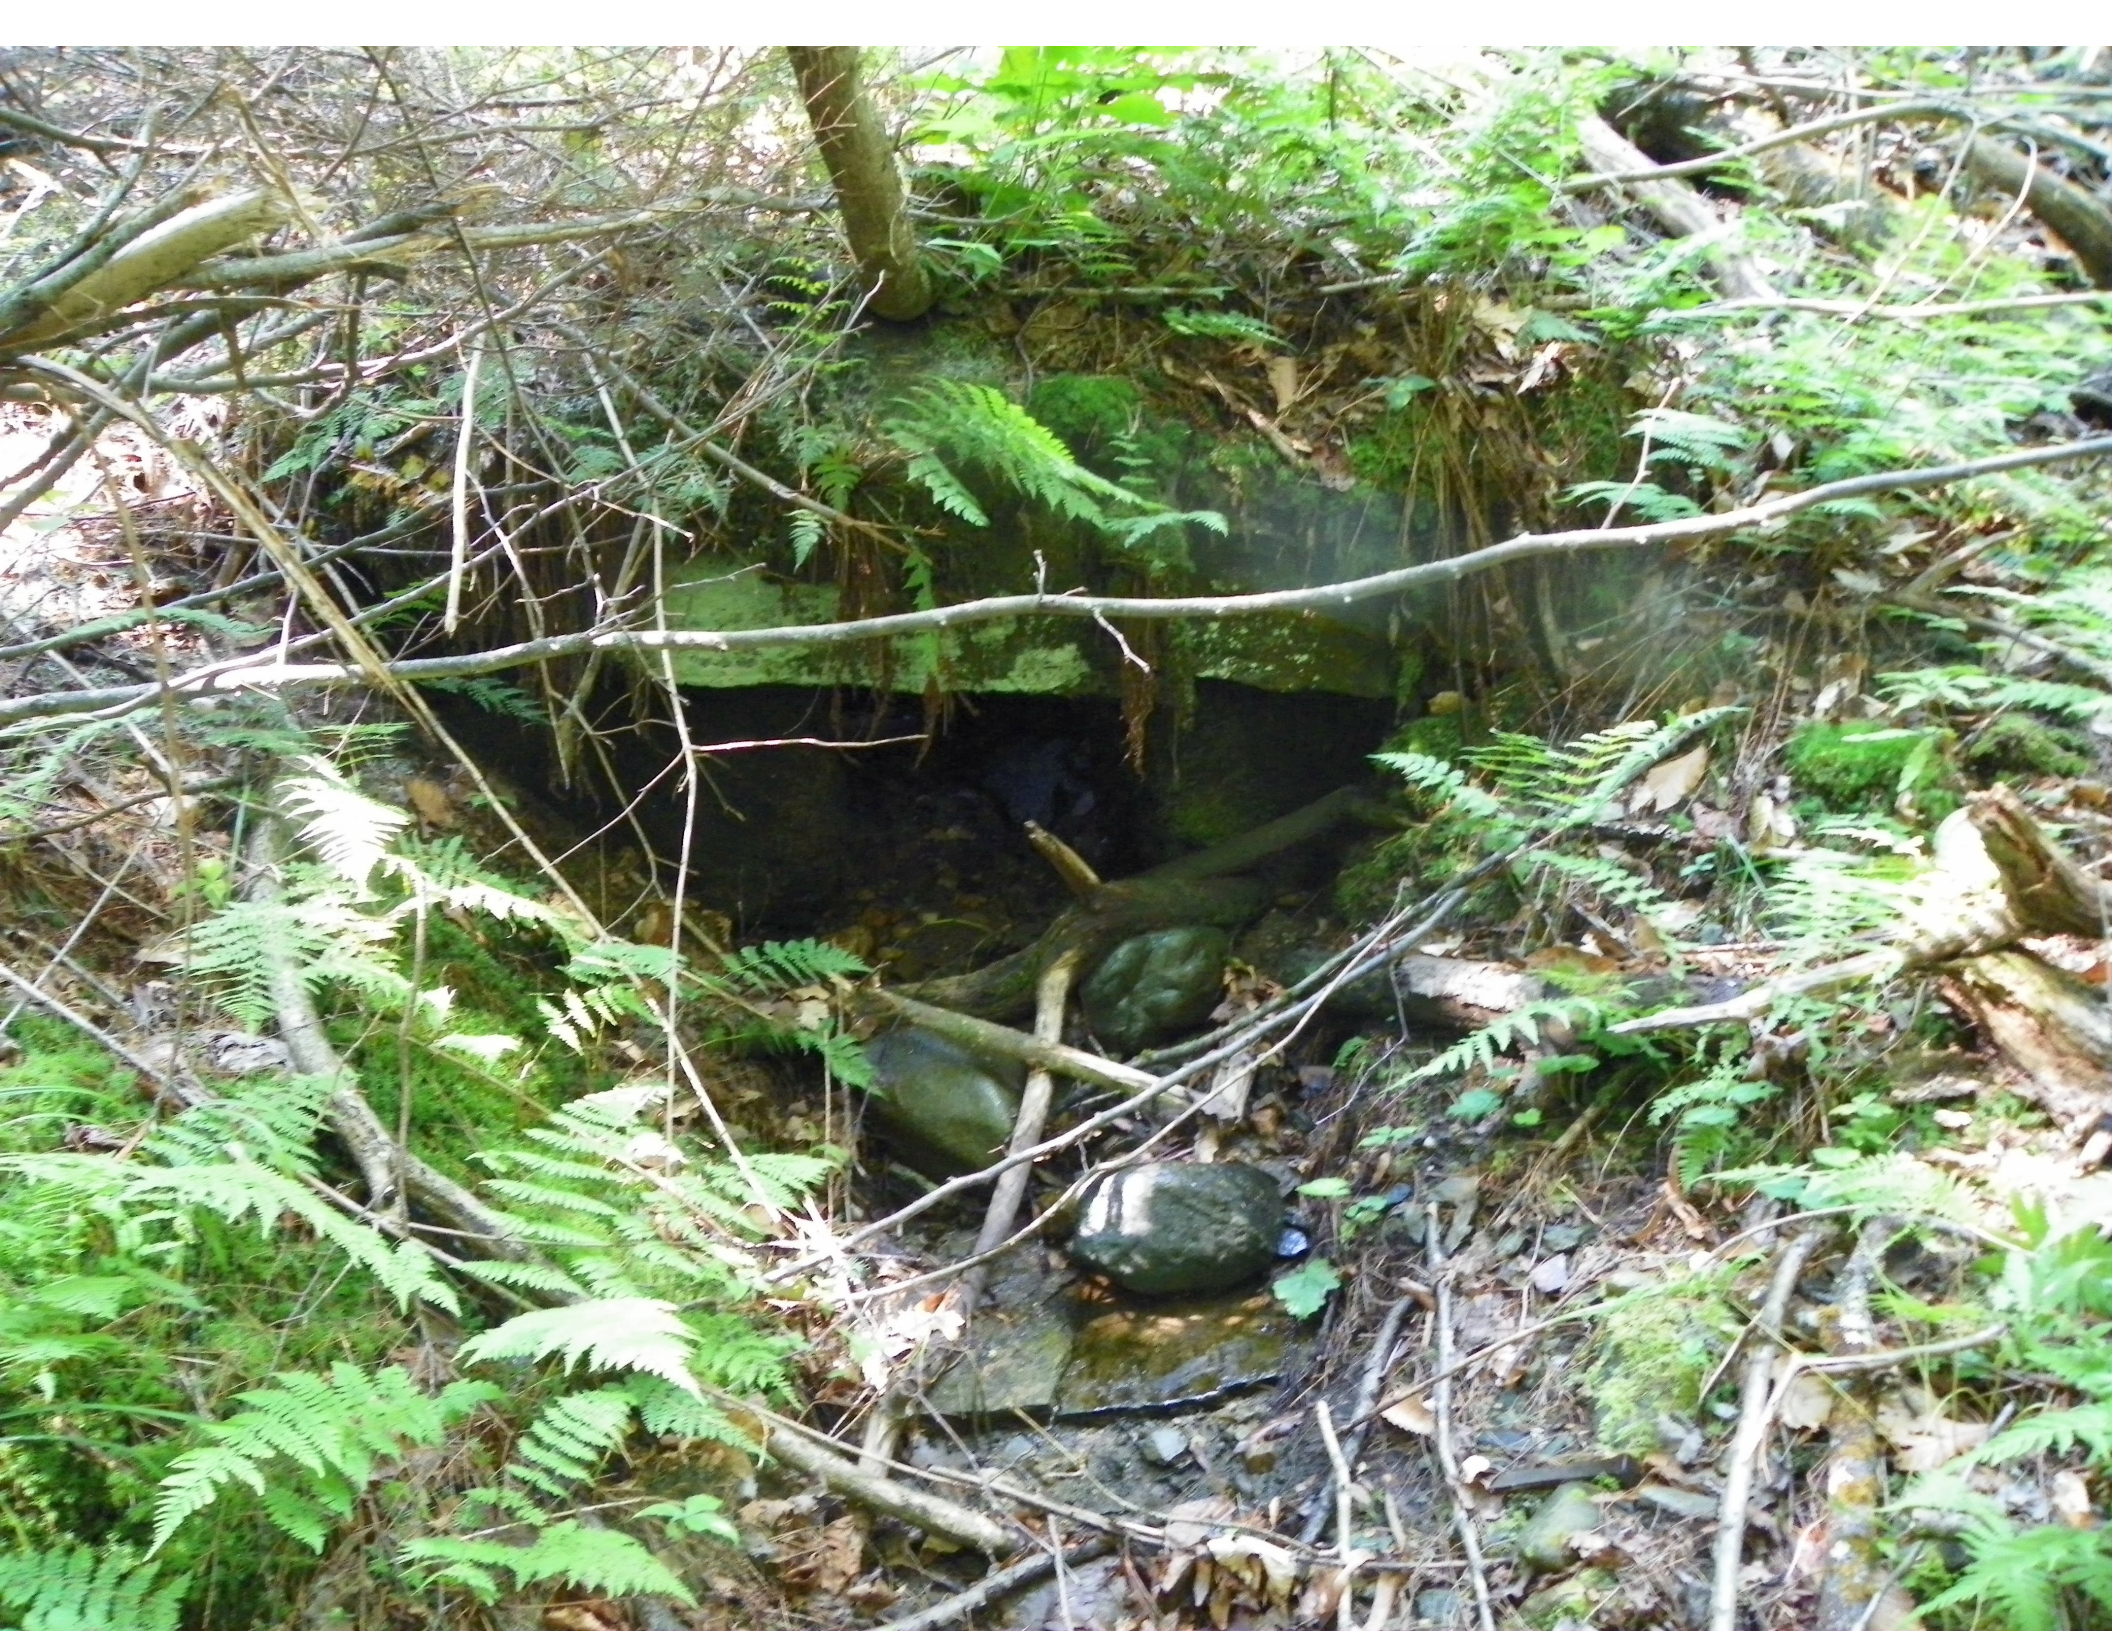
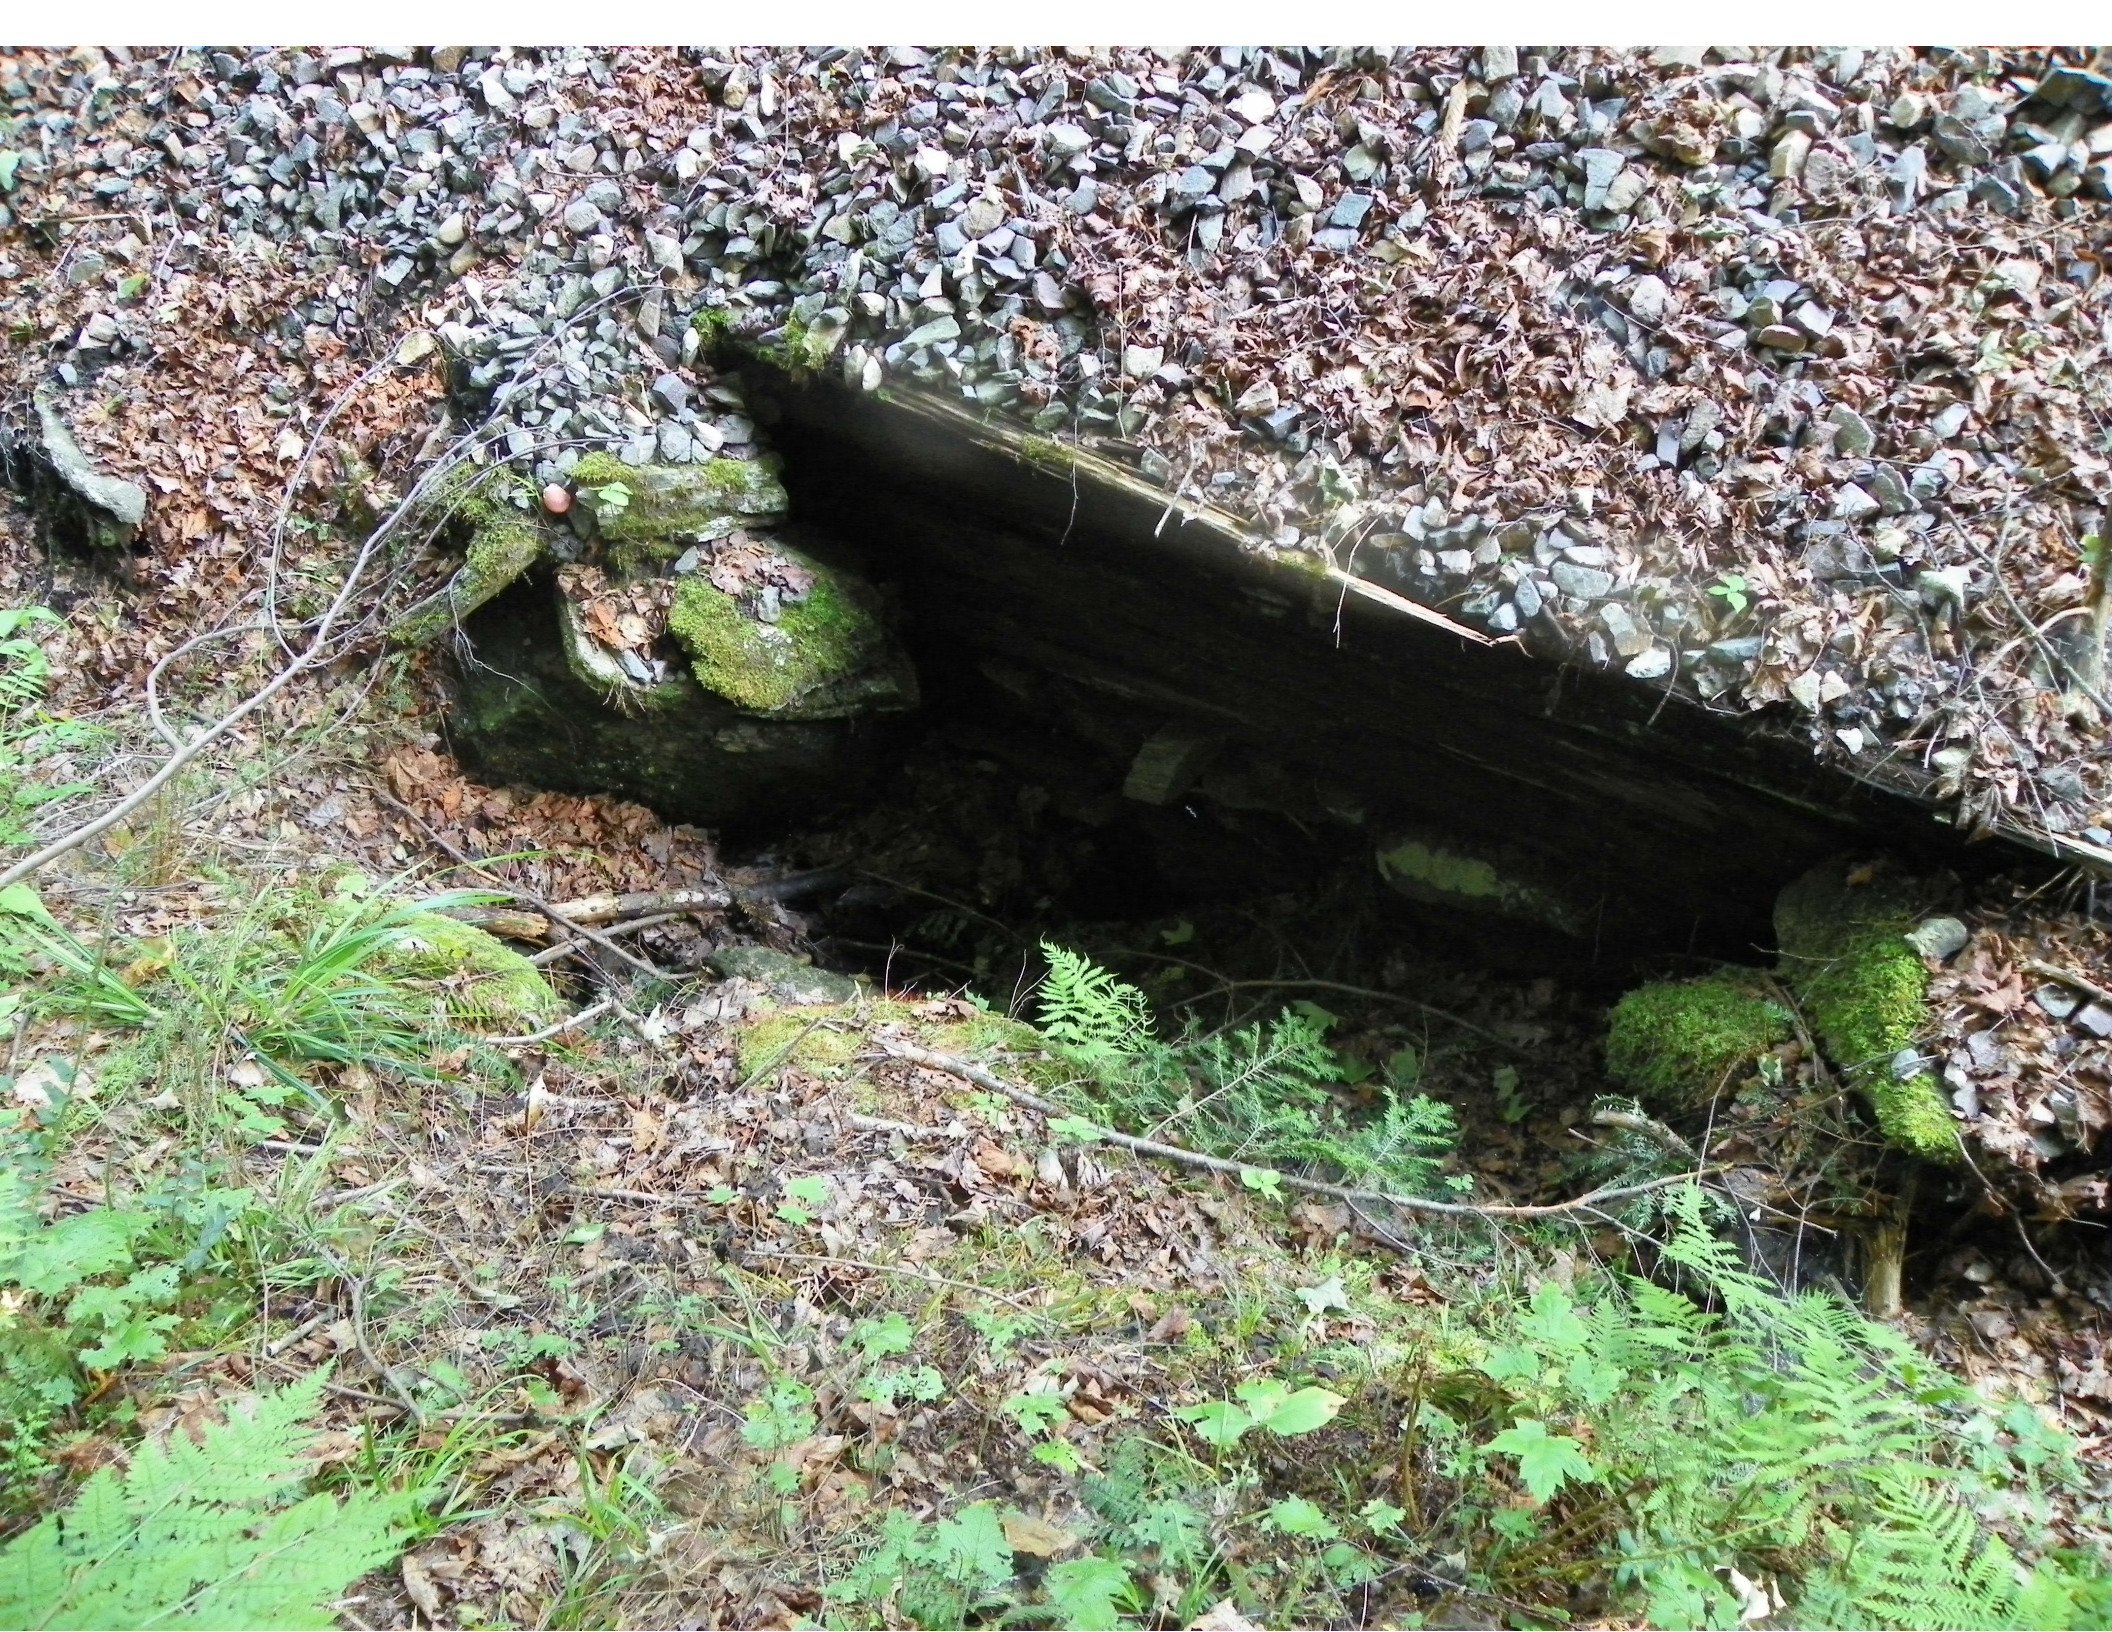
NORTH SIDE ROOF COLLAPSING
