### Culvert Inspection Form

Railroad: <b>GMRC</b>	Town: <u>LUDLOW</u>
Valuation Sheet: <b>V 3 / 28</b>	Valuation Stationing: <u>1459+18</u>
Mile Post: <b>B 27.62</b>	GPS Coordinates: N: <u>43.39532</u> W: <u>72.70714</u>

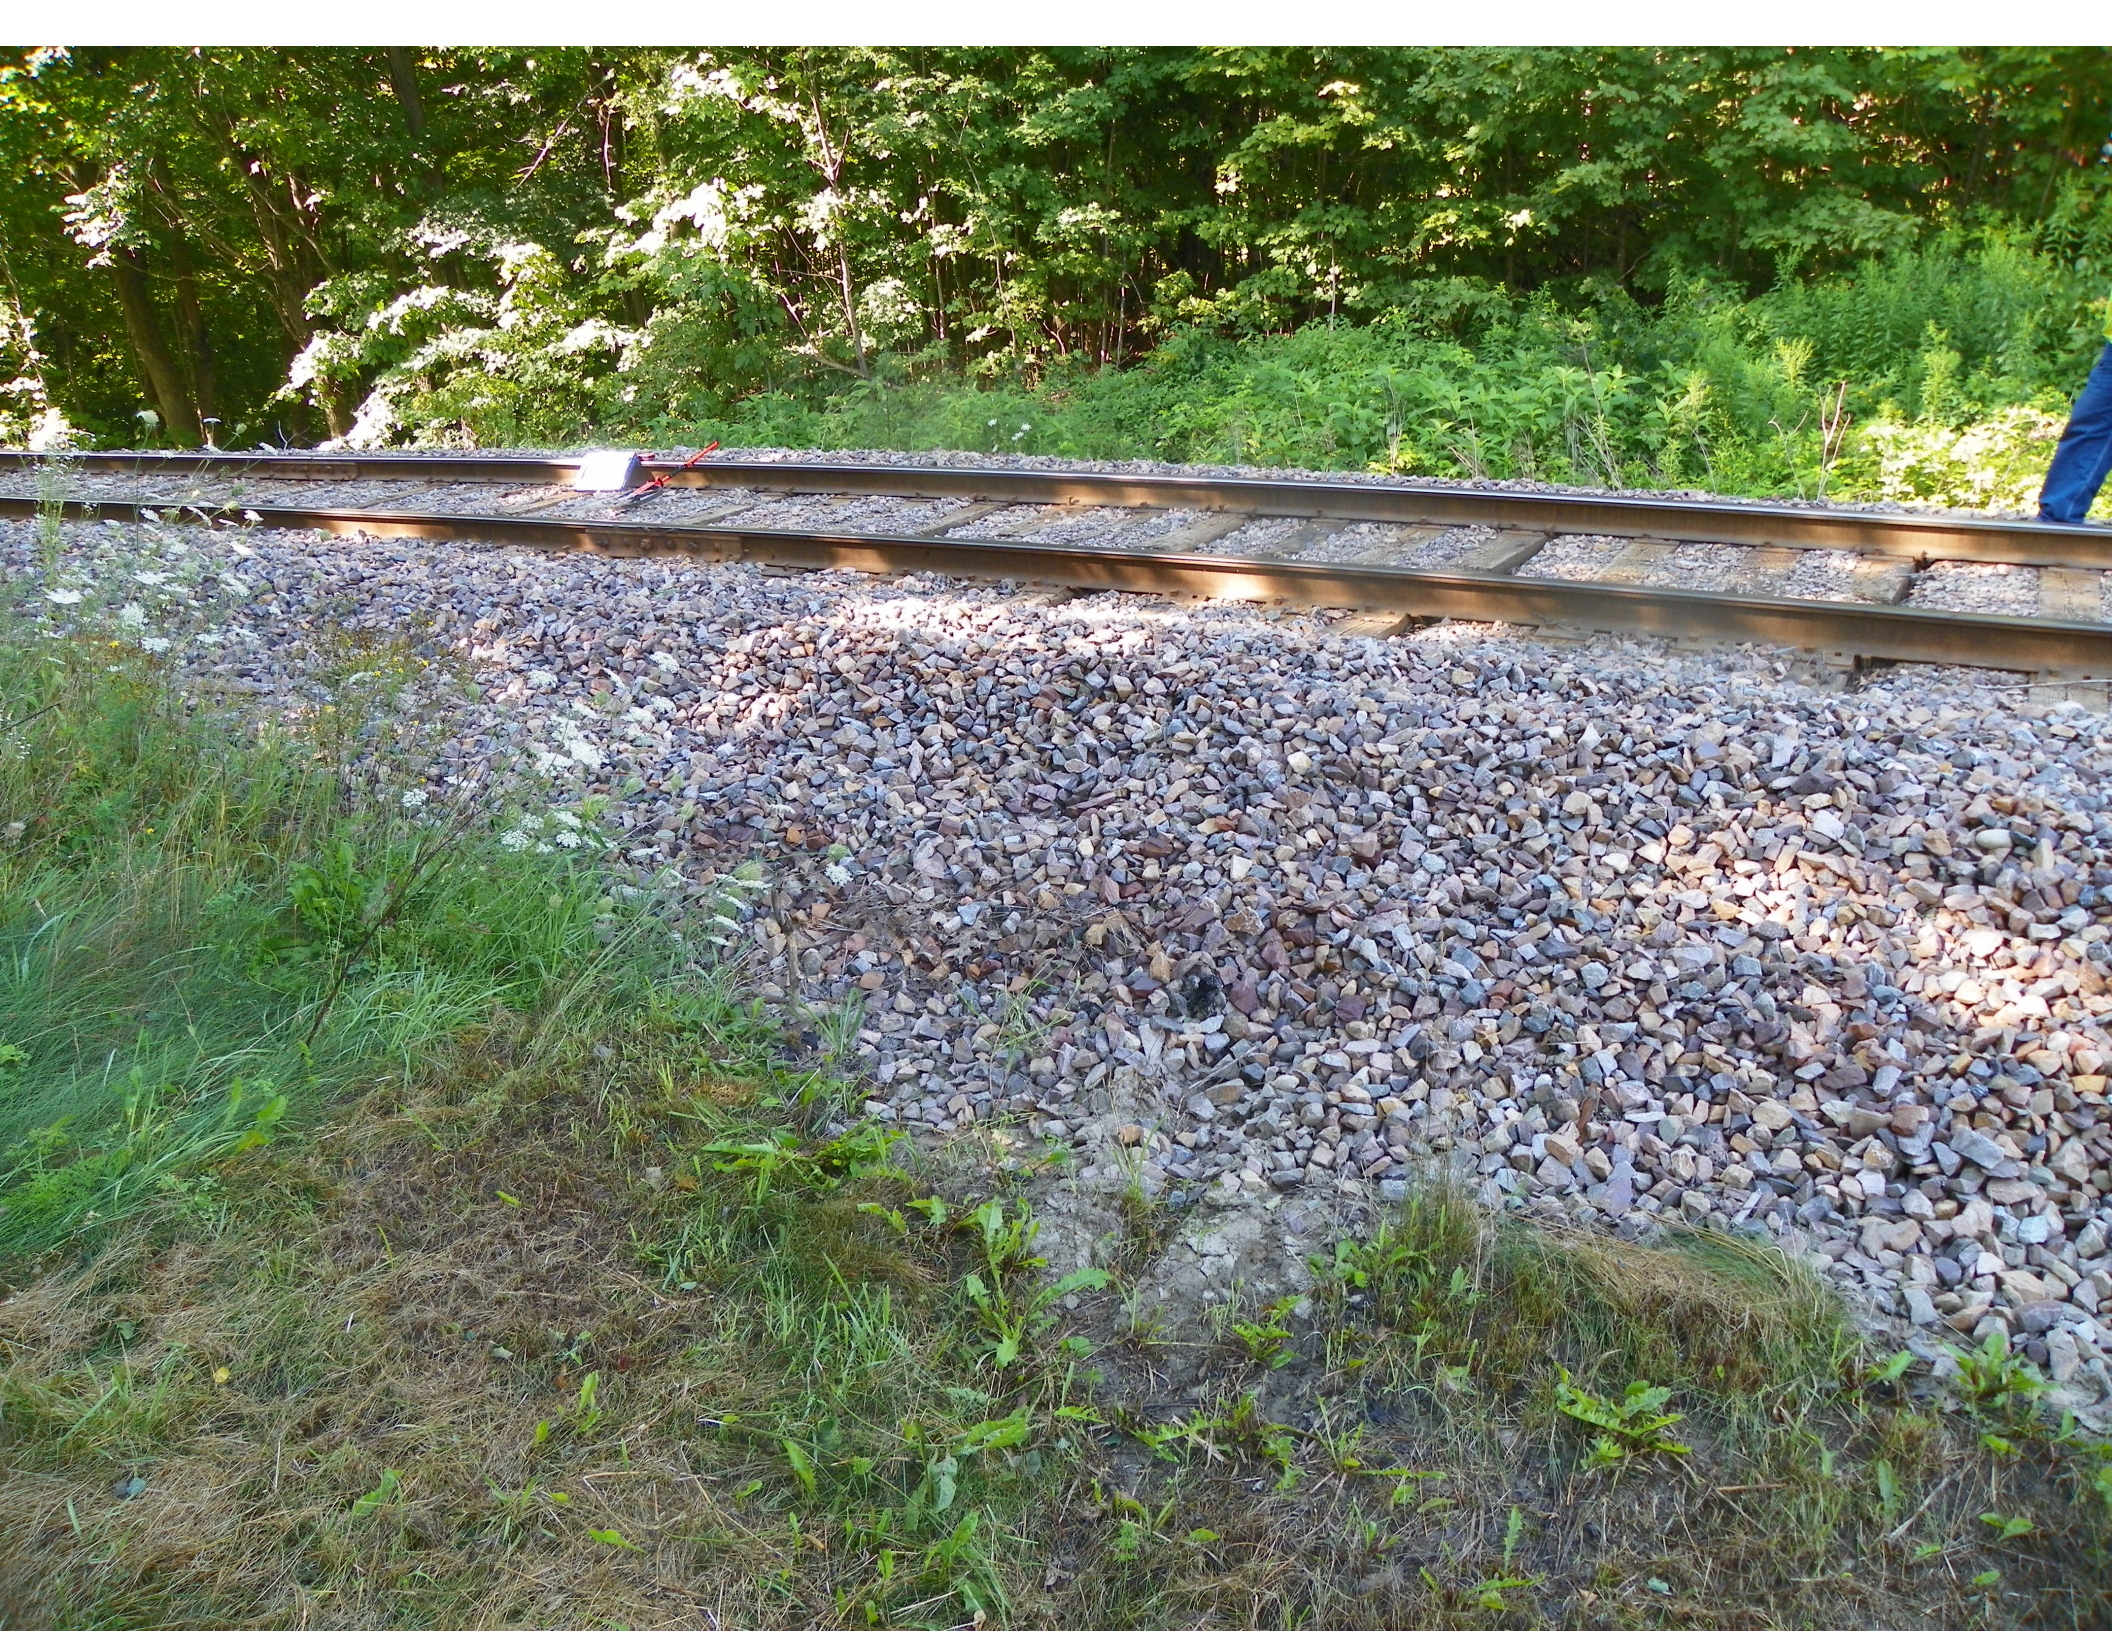
NORTH INLET NOT VISIBLE
