### Culvert Inspection Form

Railroad: <b>GMRC</b>	Town: <u>LUDLOW</u>
Valuation Sheet: <b>V 3 / 28</b>	Valuation Stationing: <u>1460 + 02</u>
Mile Post: <b>B 27.64 S</b>	GPS Coordinates: N: <u>43.39552</u> W: <u>72.70734</u>

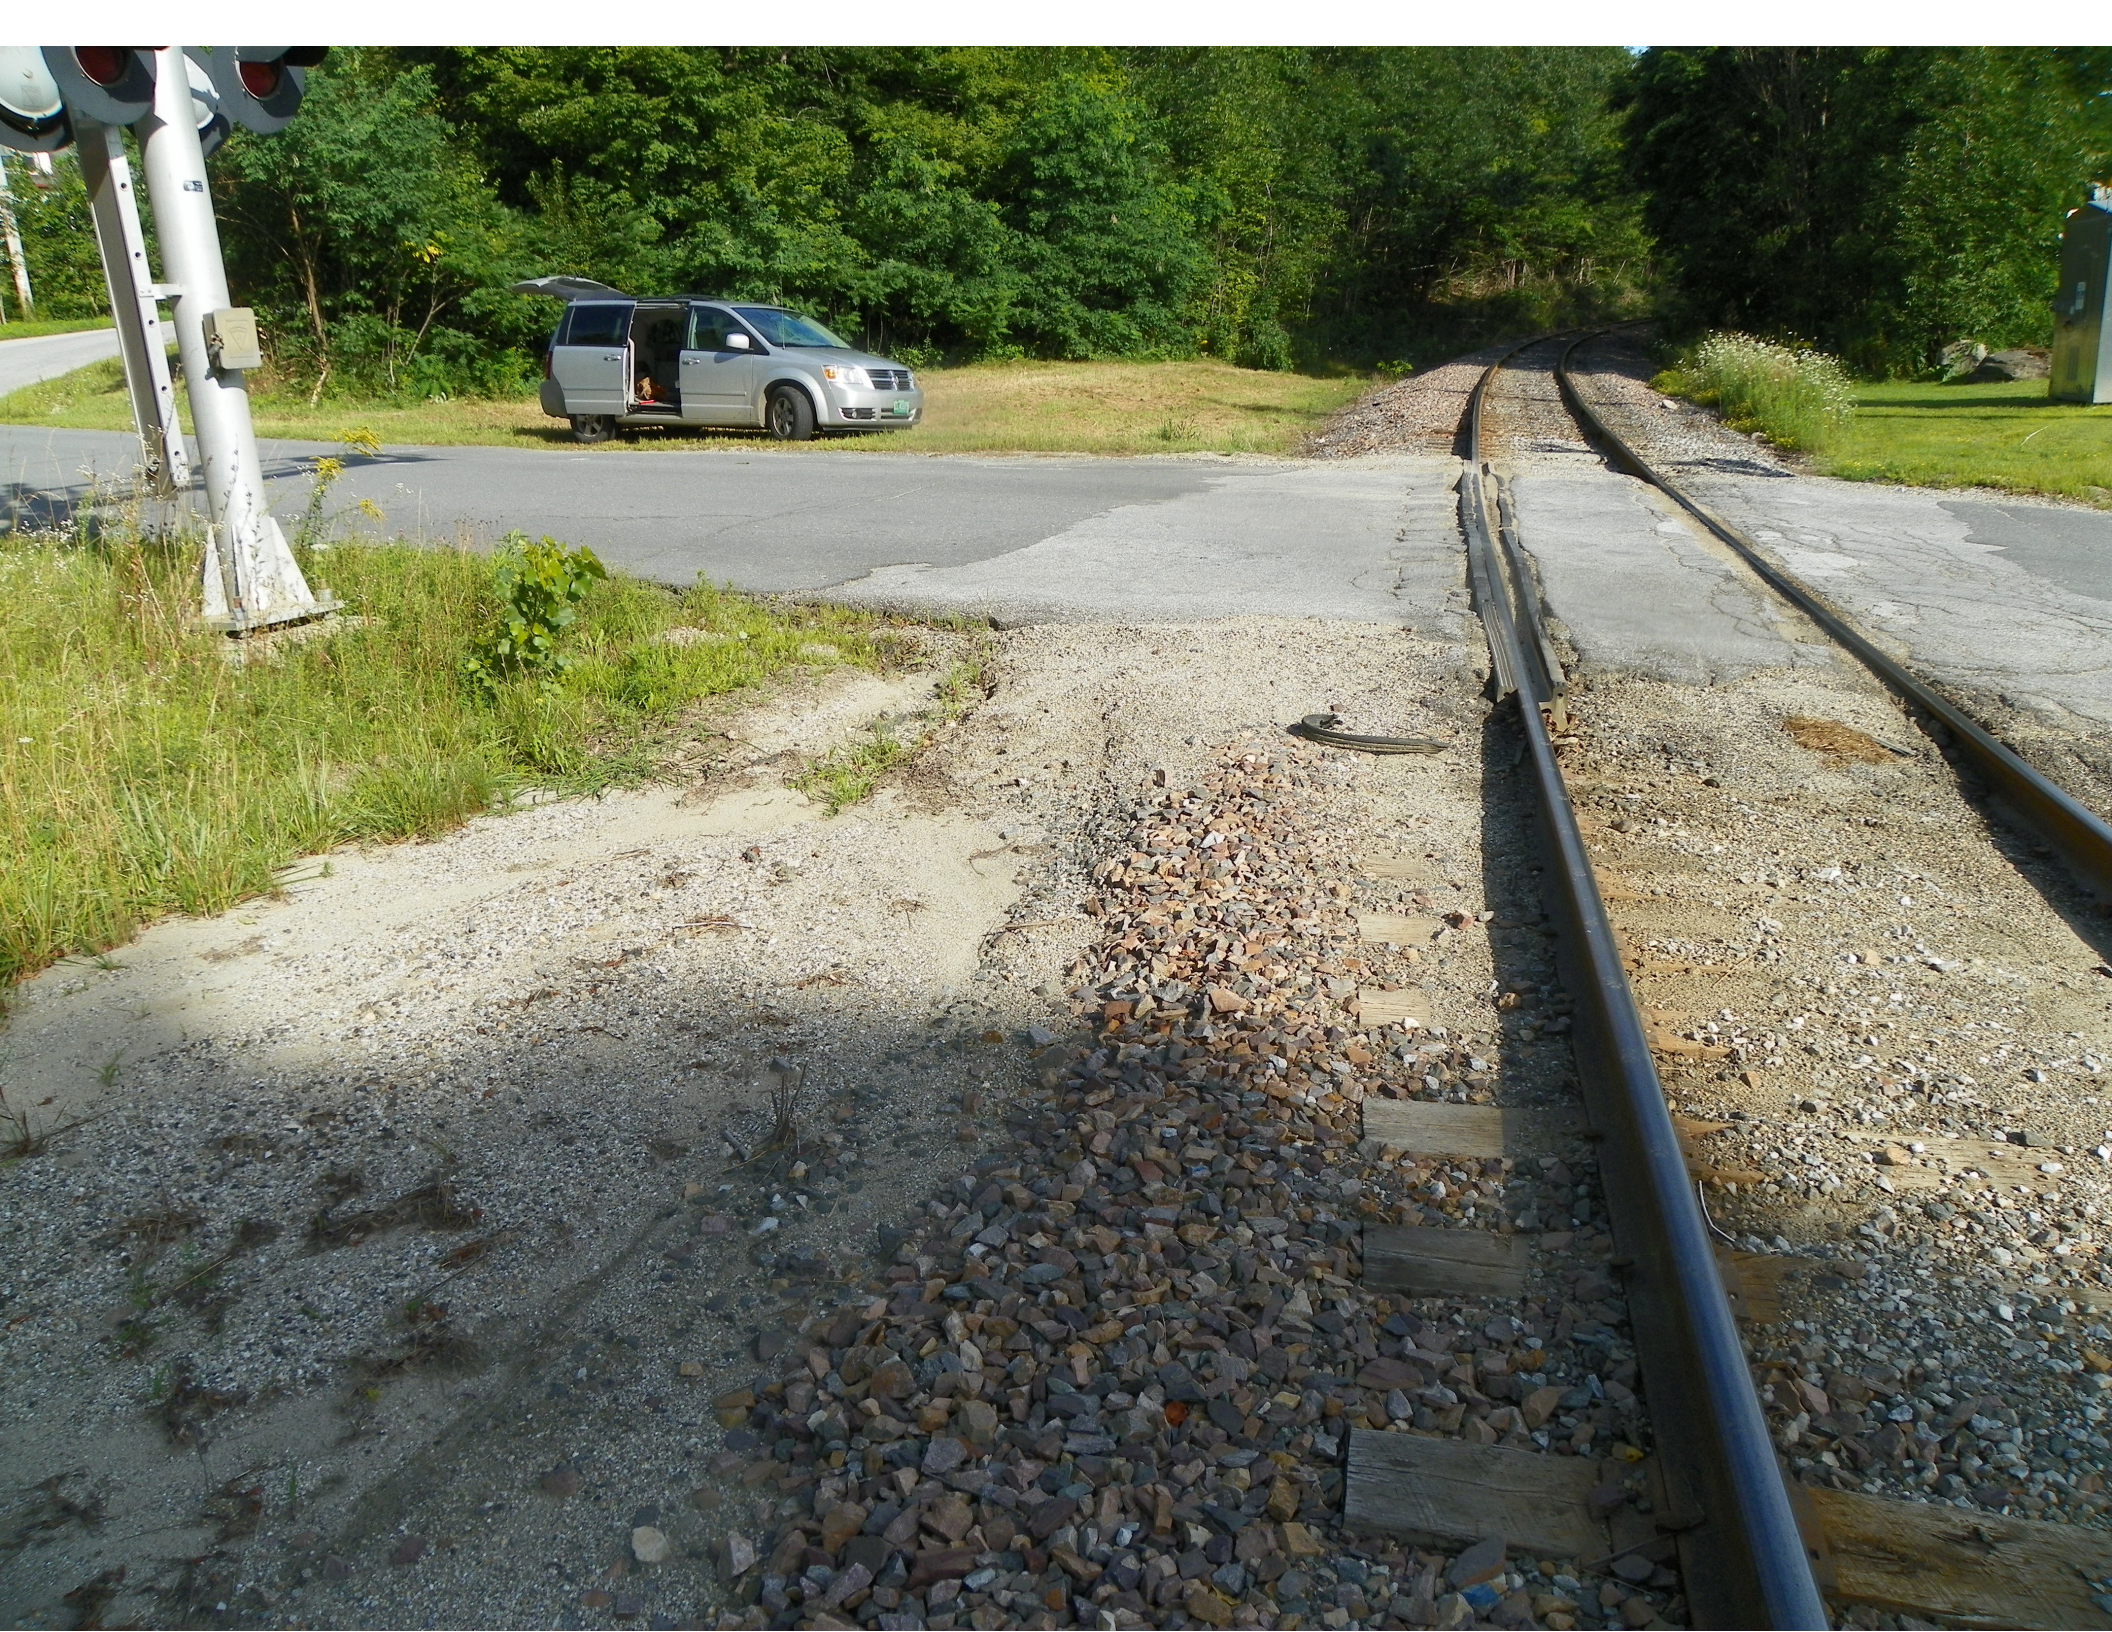
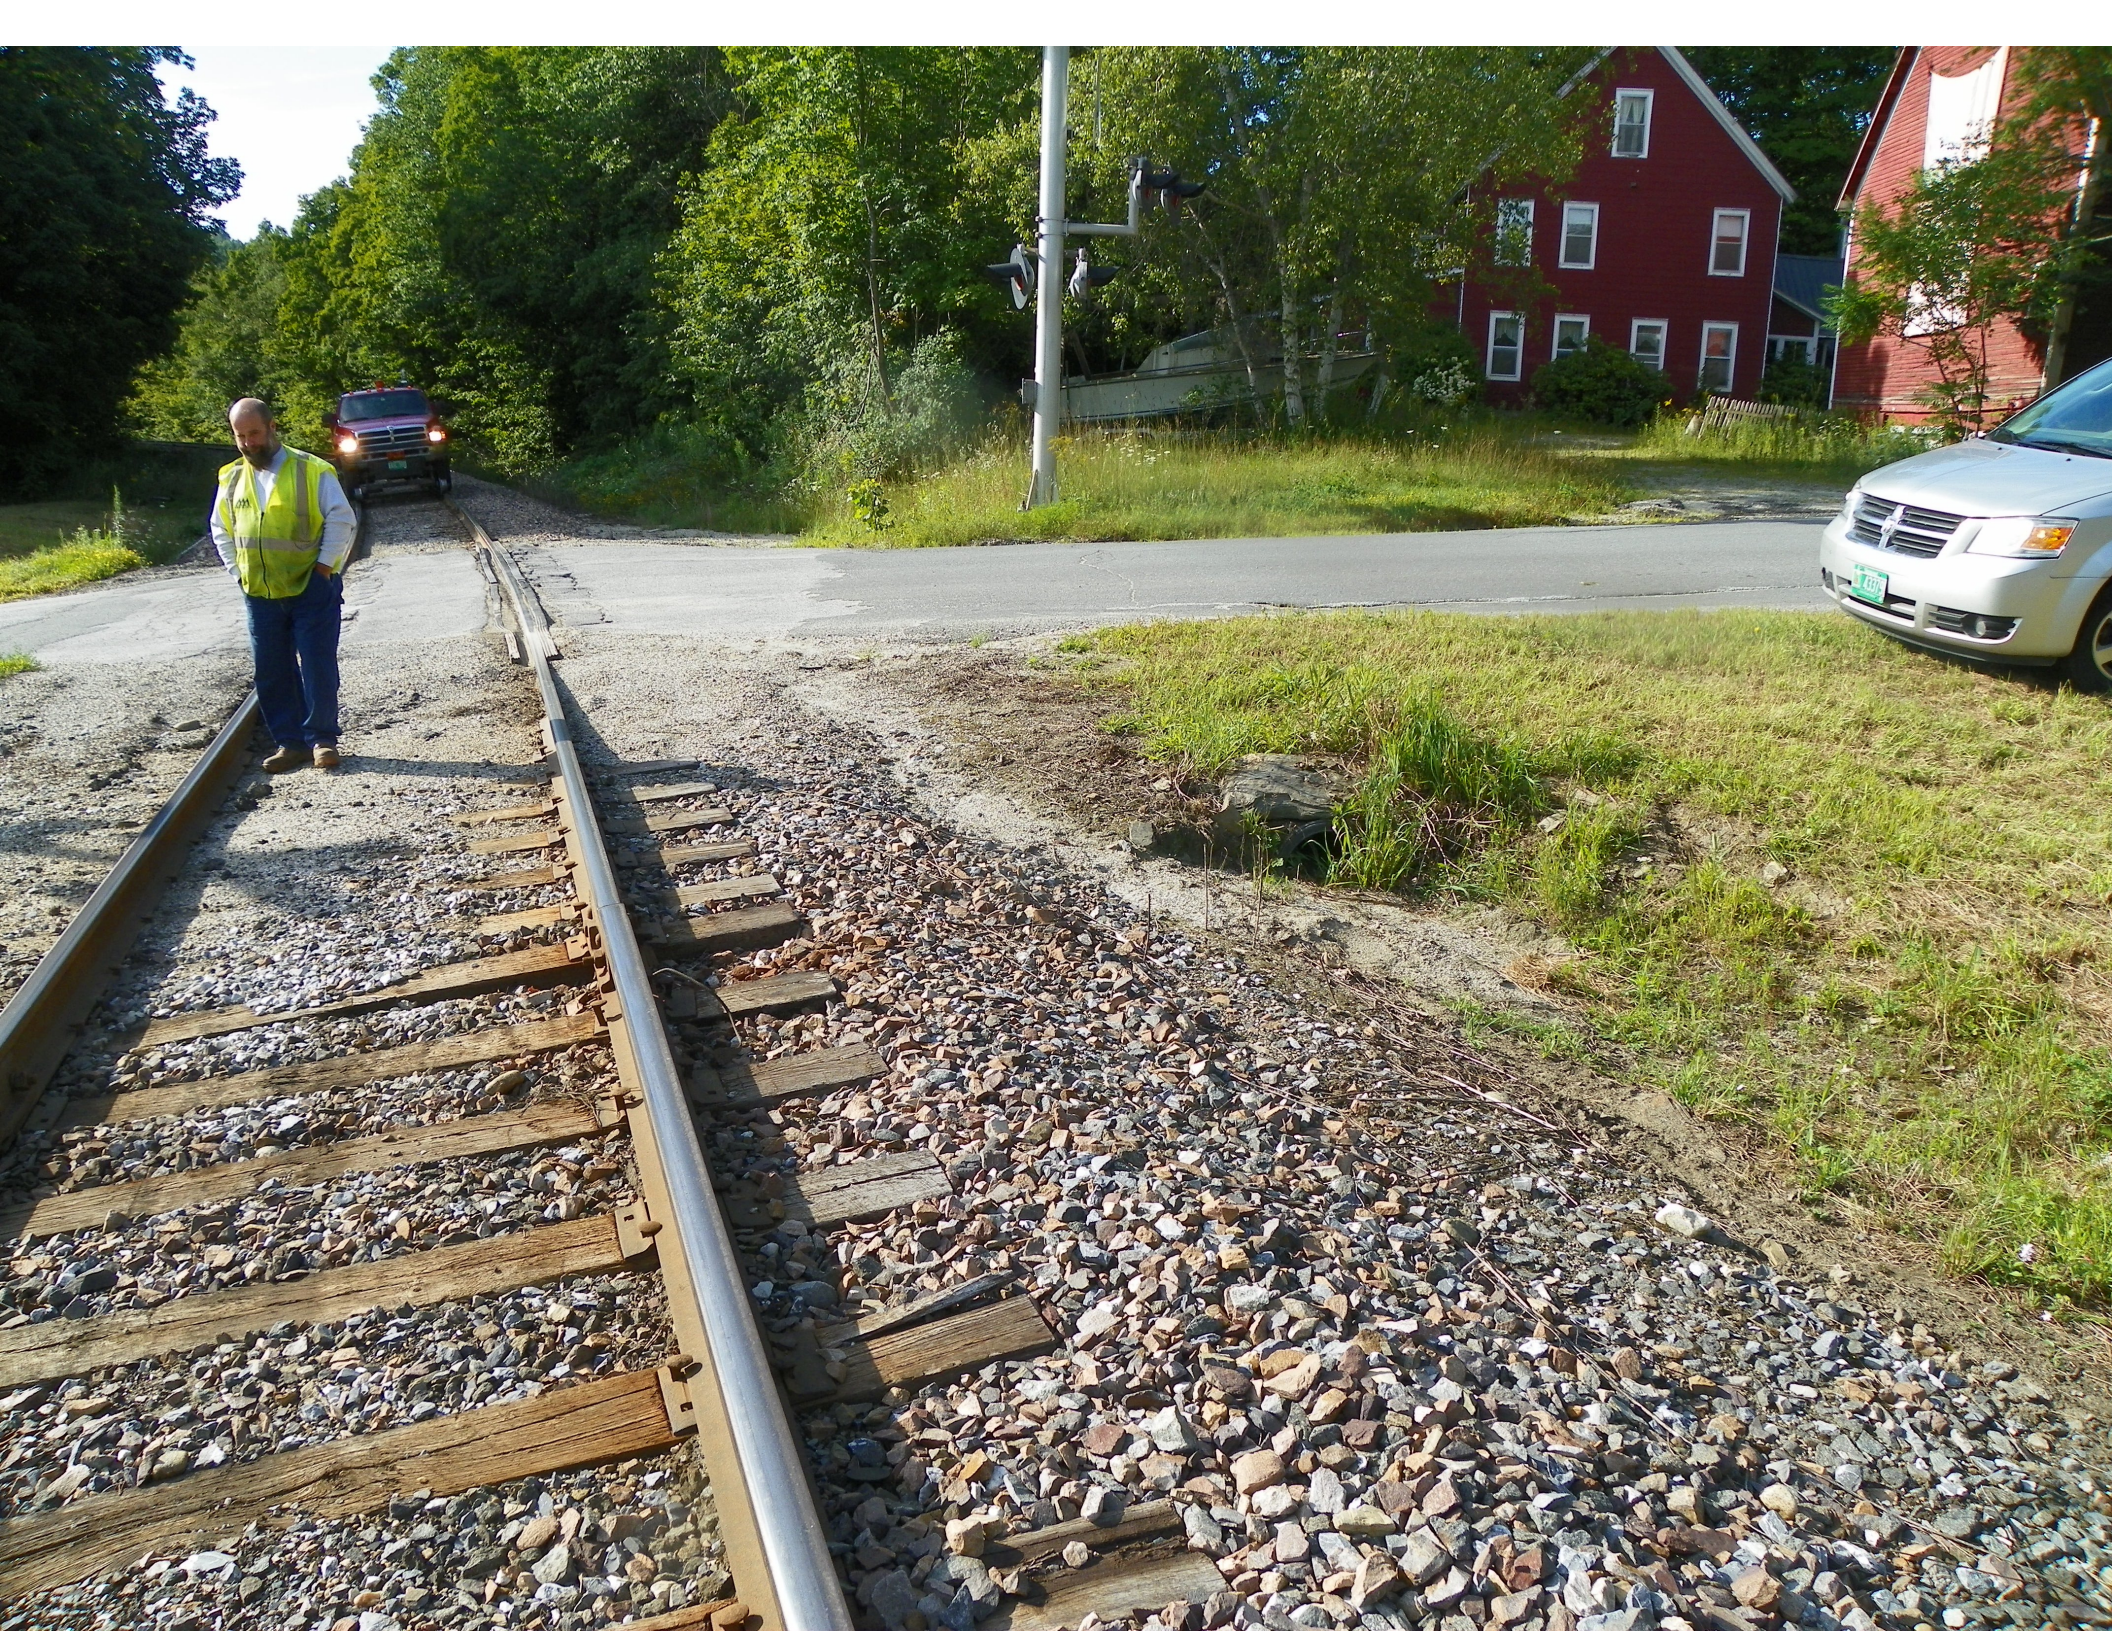
WEST OUTLET NOT VISIBLE

SOUTH SIDE PARALLEL TO TRACK
