### Culvert Inspection Form

| Railroad: <b>GMRC</b> | Town: <u>LUDLOW</u> |
| Valuation Sheet: <b>V 3 / 30</b> | Valuation Stationing:<br><u>1555 + 59</u> |
| Mile Post: <b>B 29.45</b> | GPS Coordinates:<br>N: <u>43.41899</u><br>W: <u>72.71667</u> |

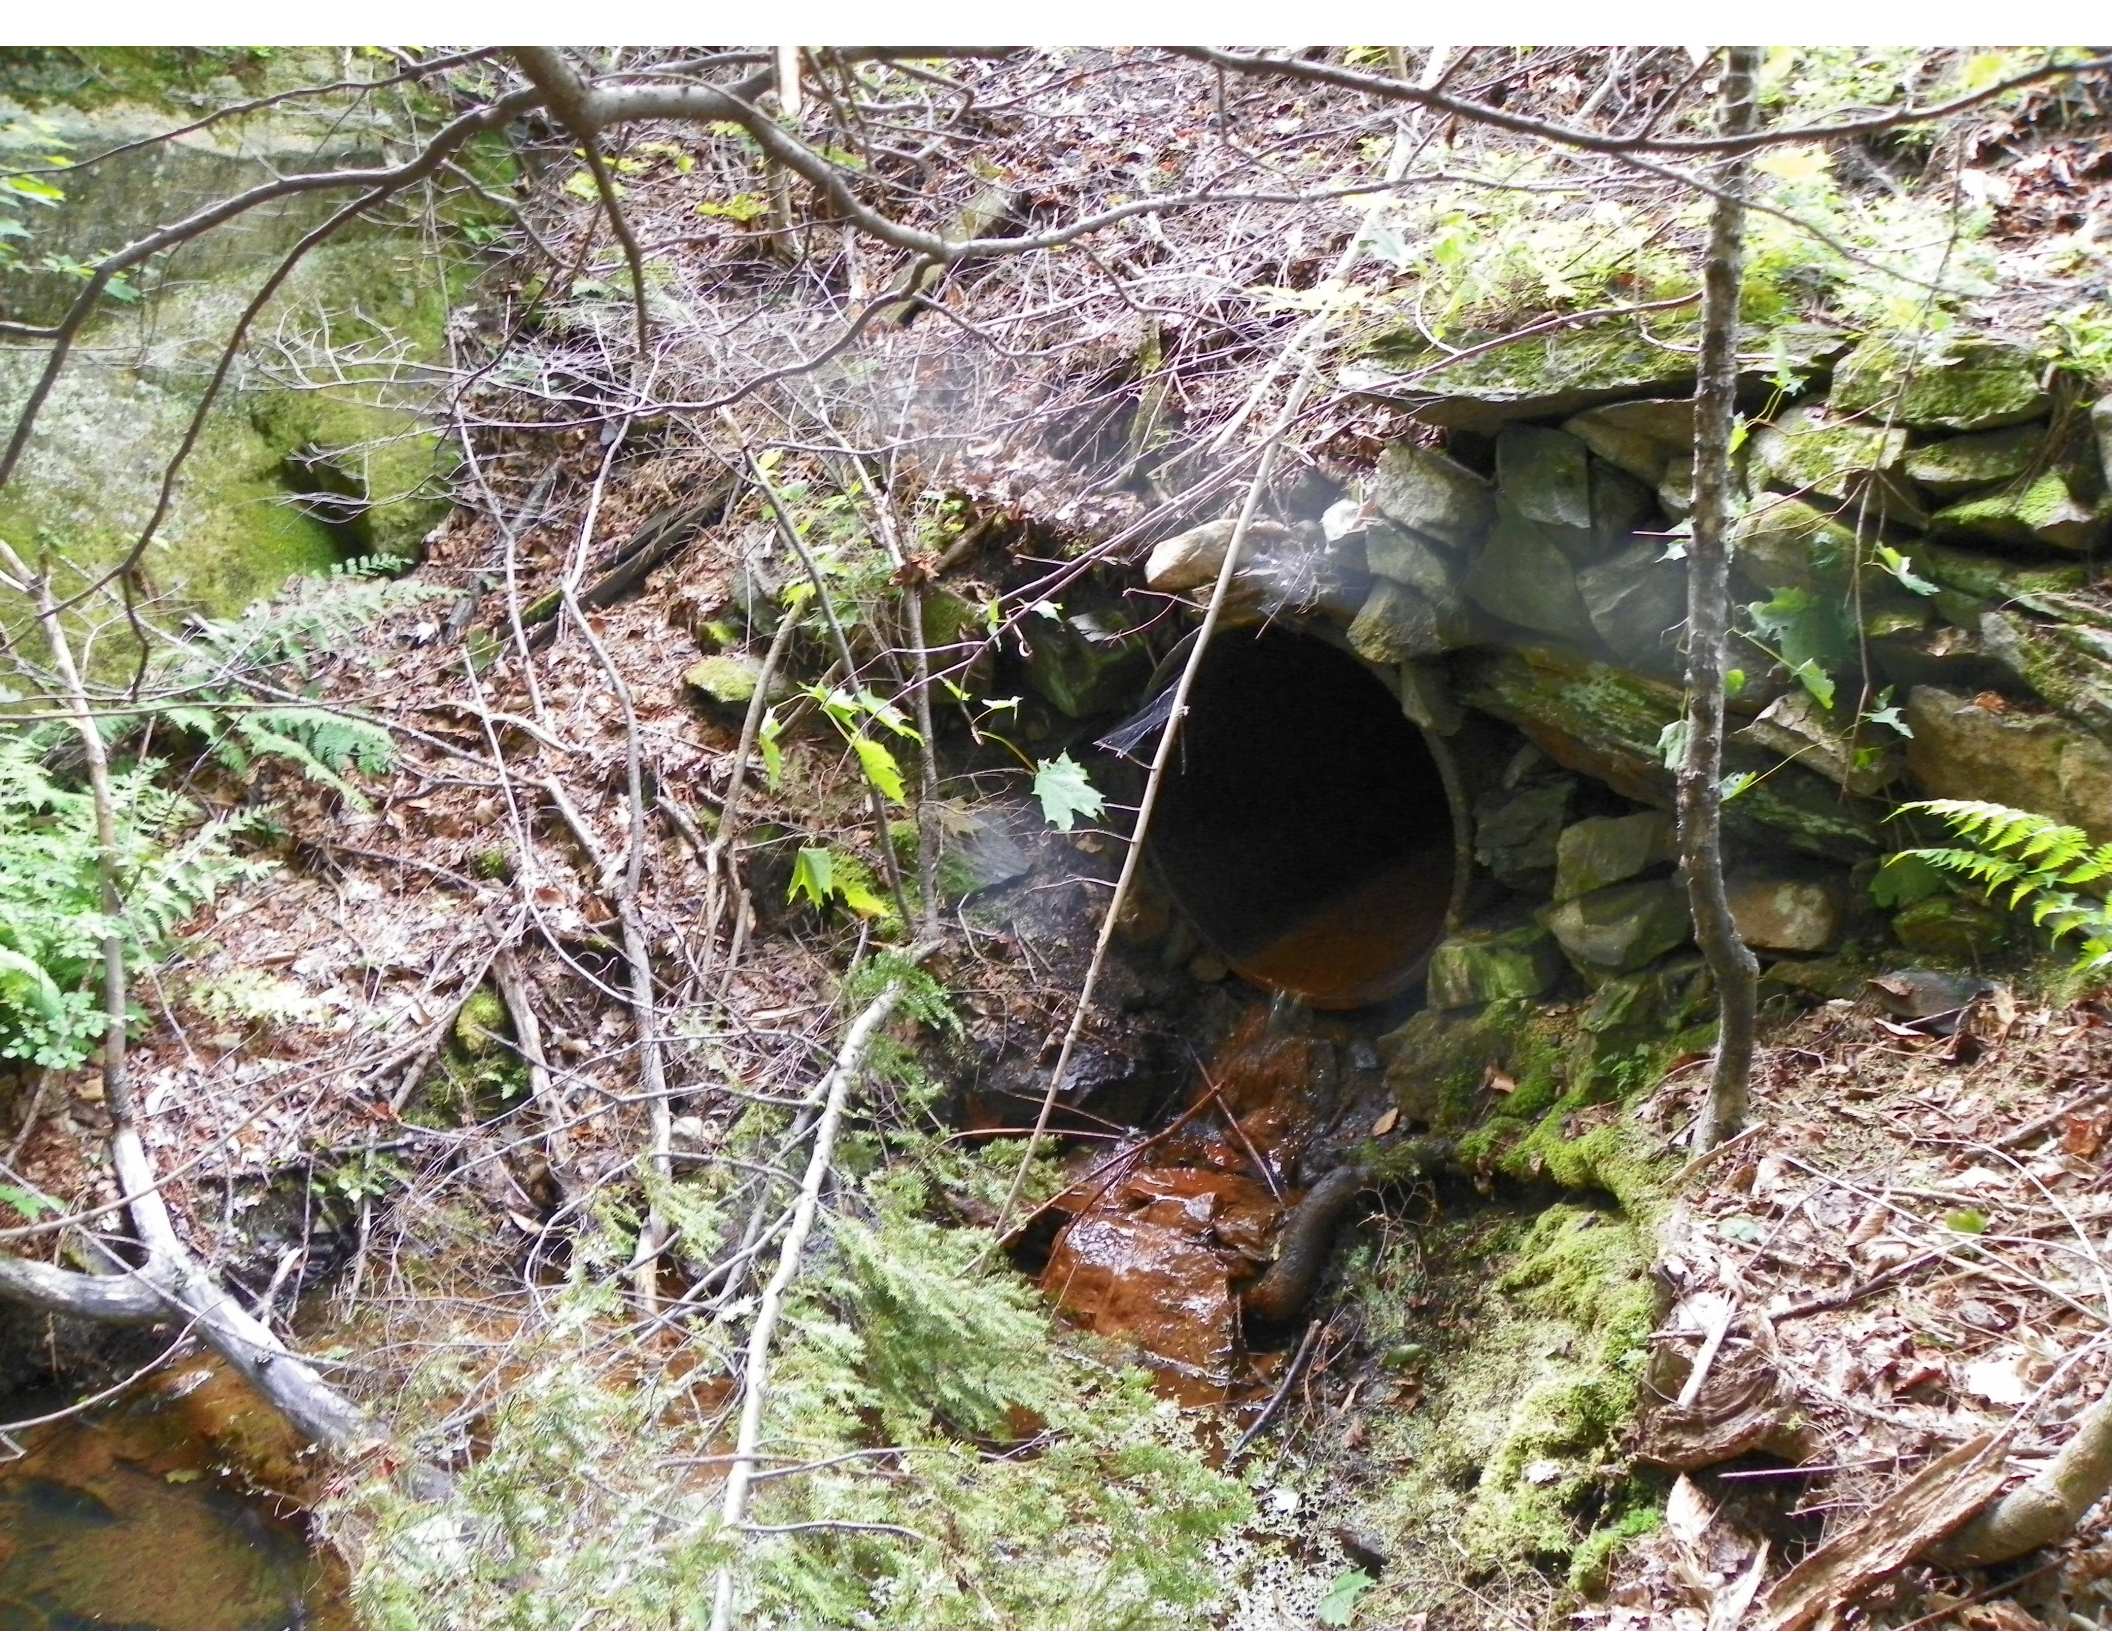
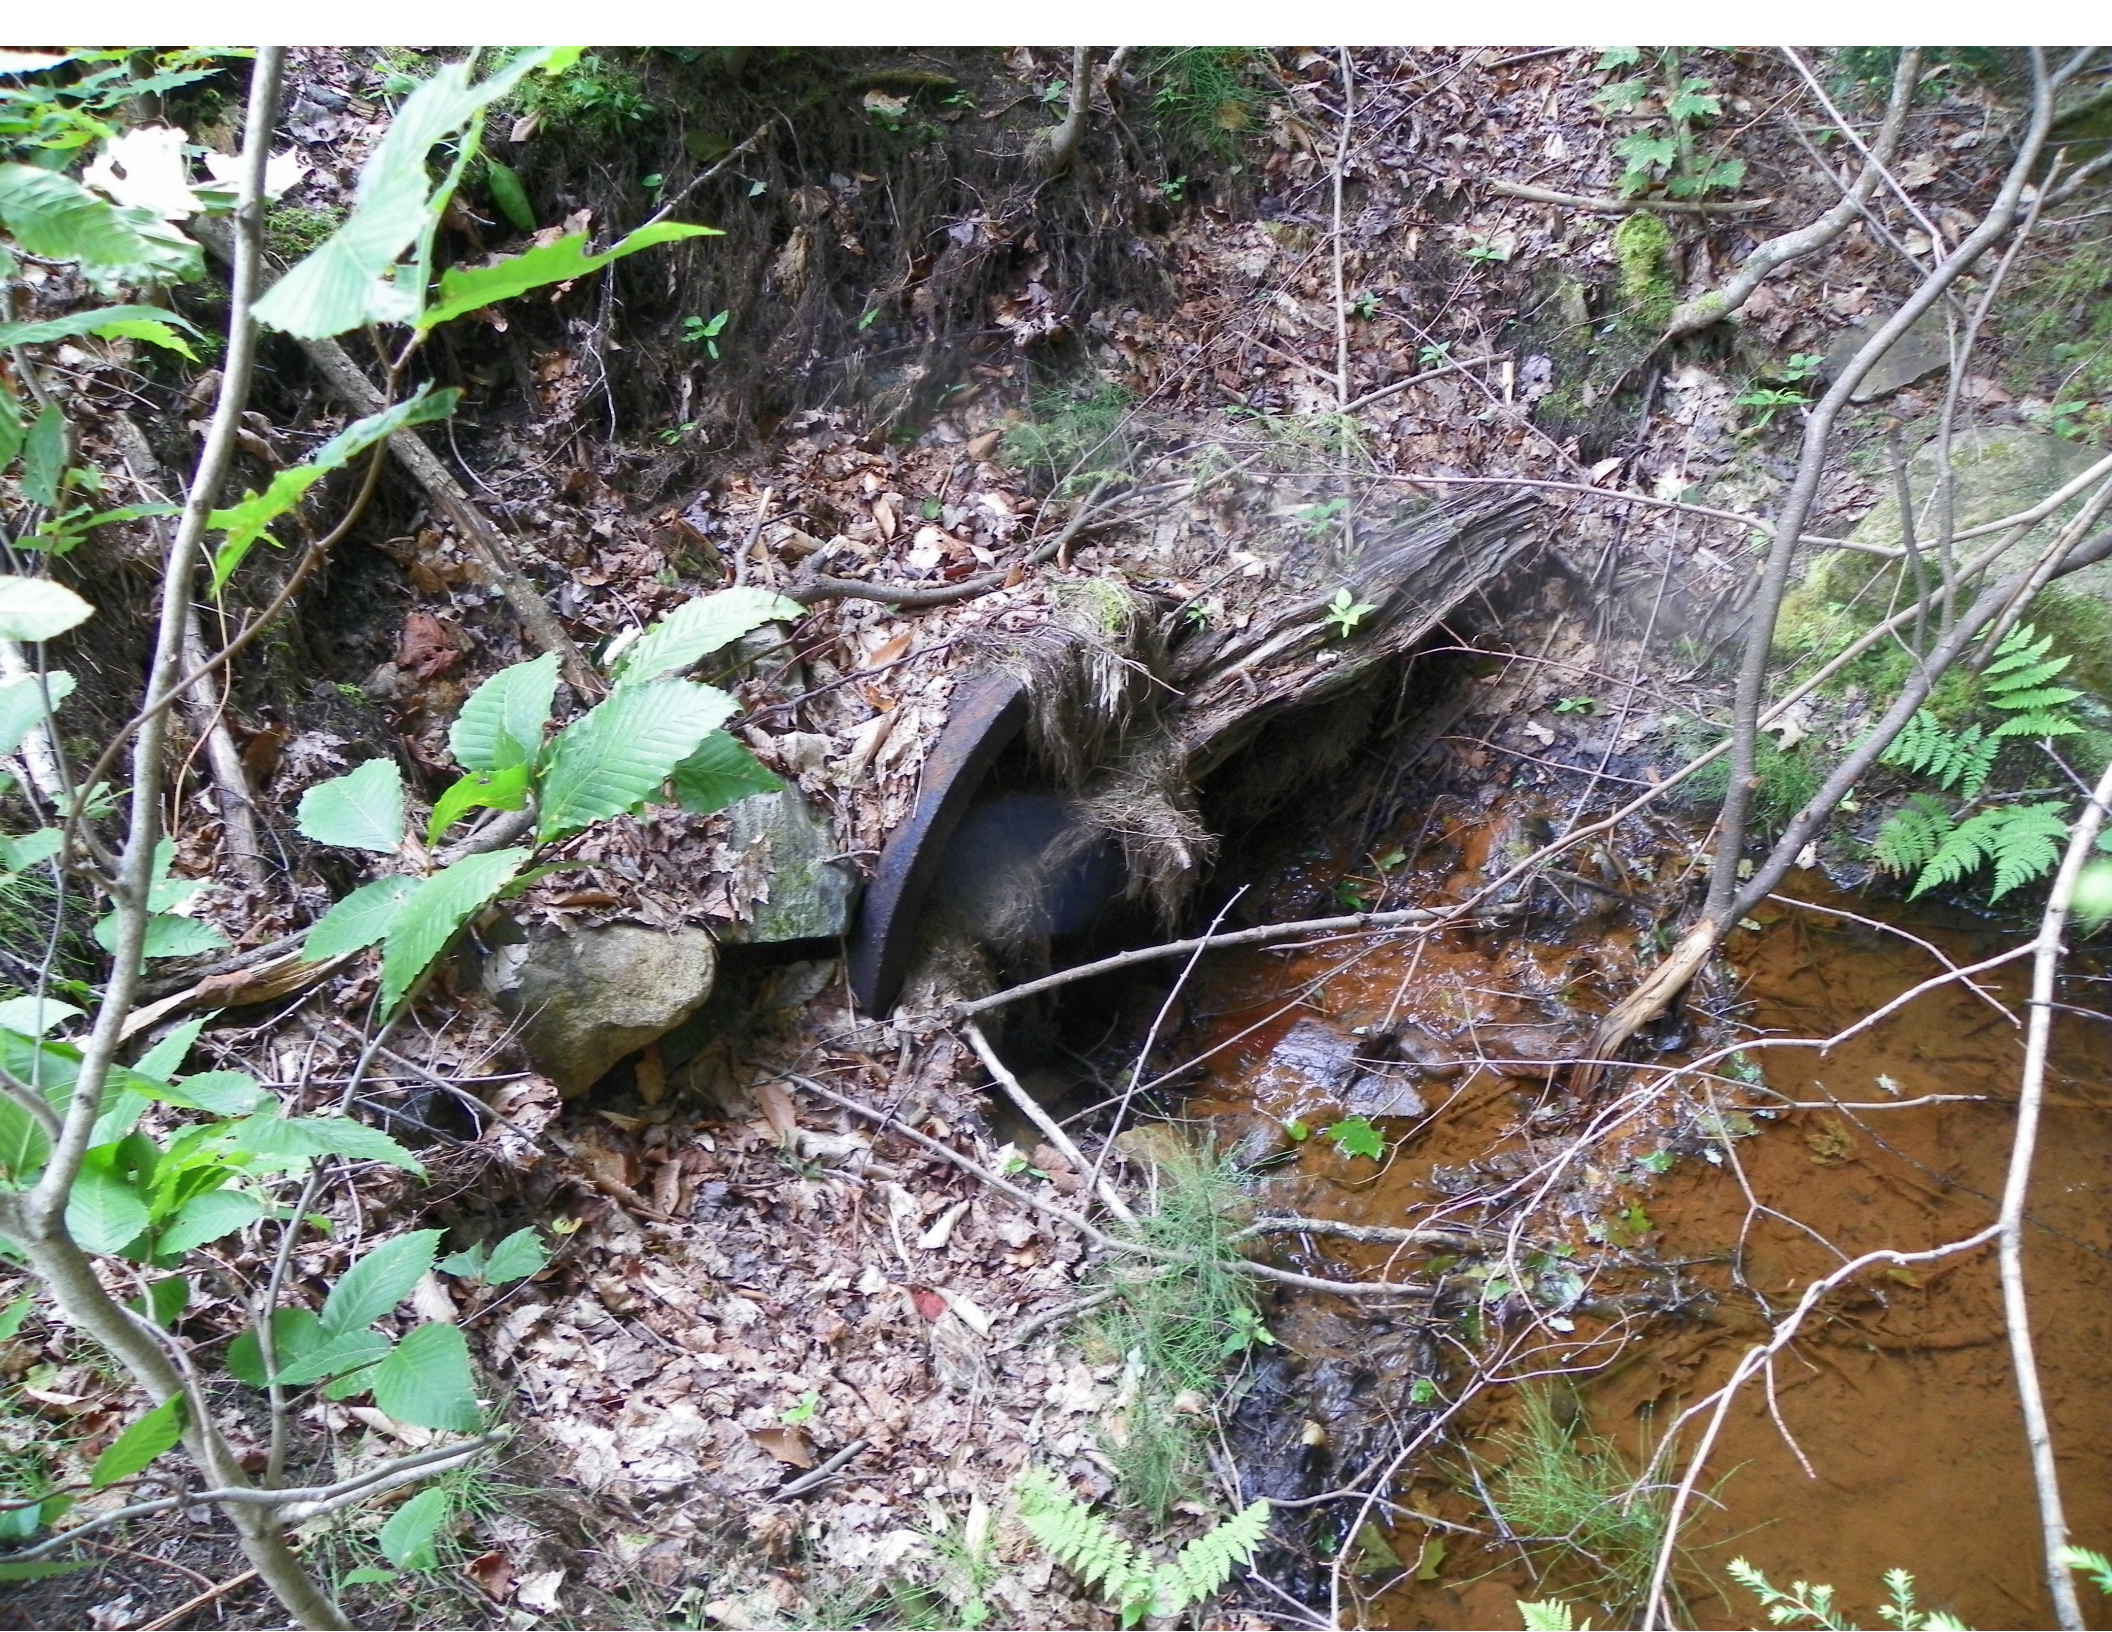
NORTH OUTLET HEADER BREAKING UP
