Culvert Inspection Form

| Railroad: GMRC | Town: <u>LUDLOW</u> |
| Valuation Sheet: V 3 / 30 | Valuation Stationing: <u>1559+02</u> |
| Mile Post: B 29.52 | GPS Coordinates: N: <u>43.41945</u> W: <u>72.71783</u> |

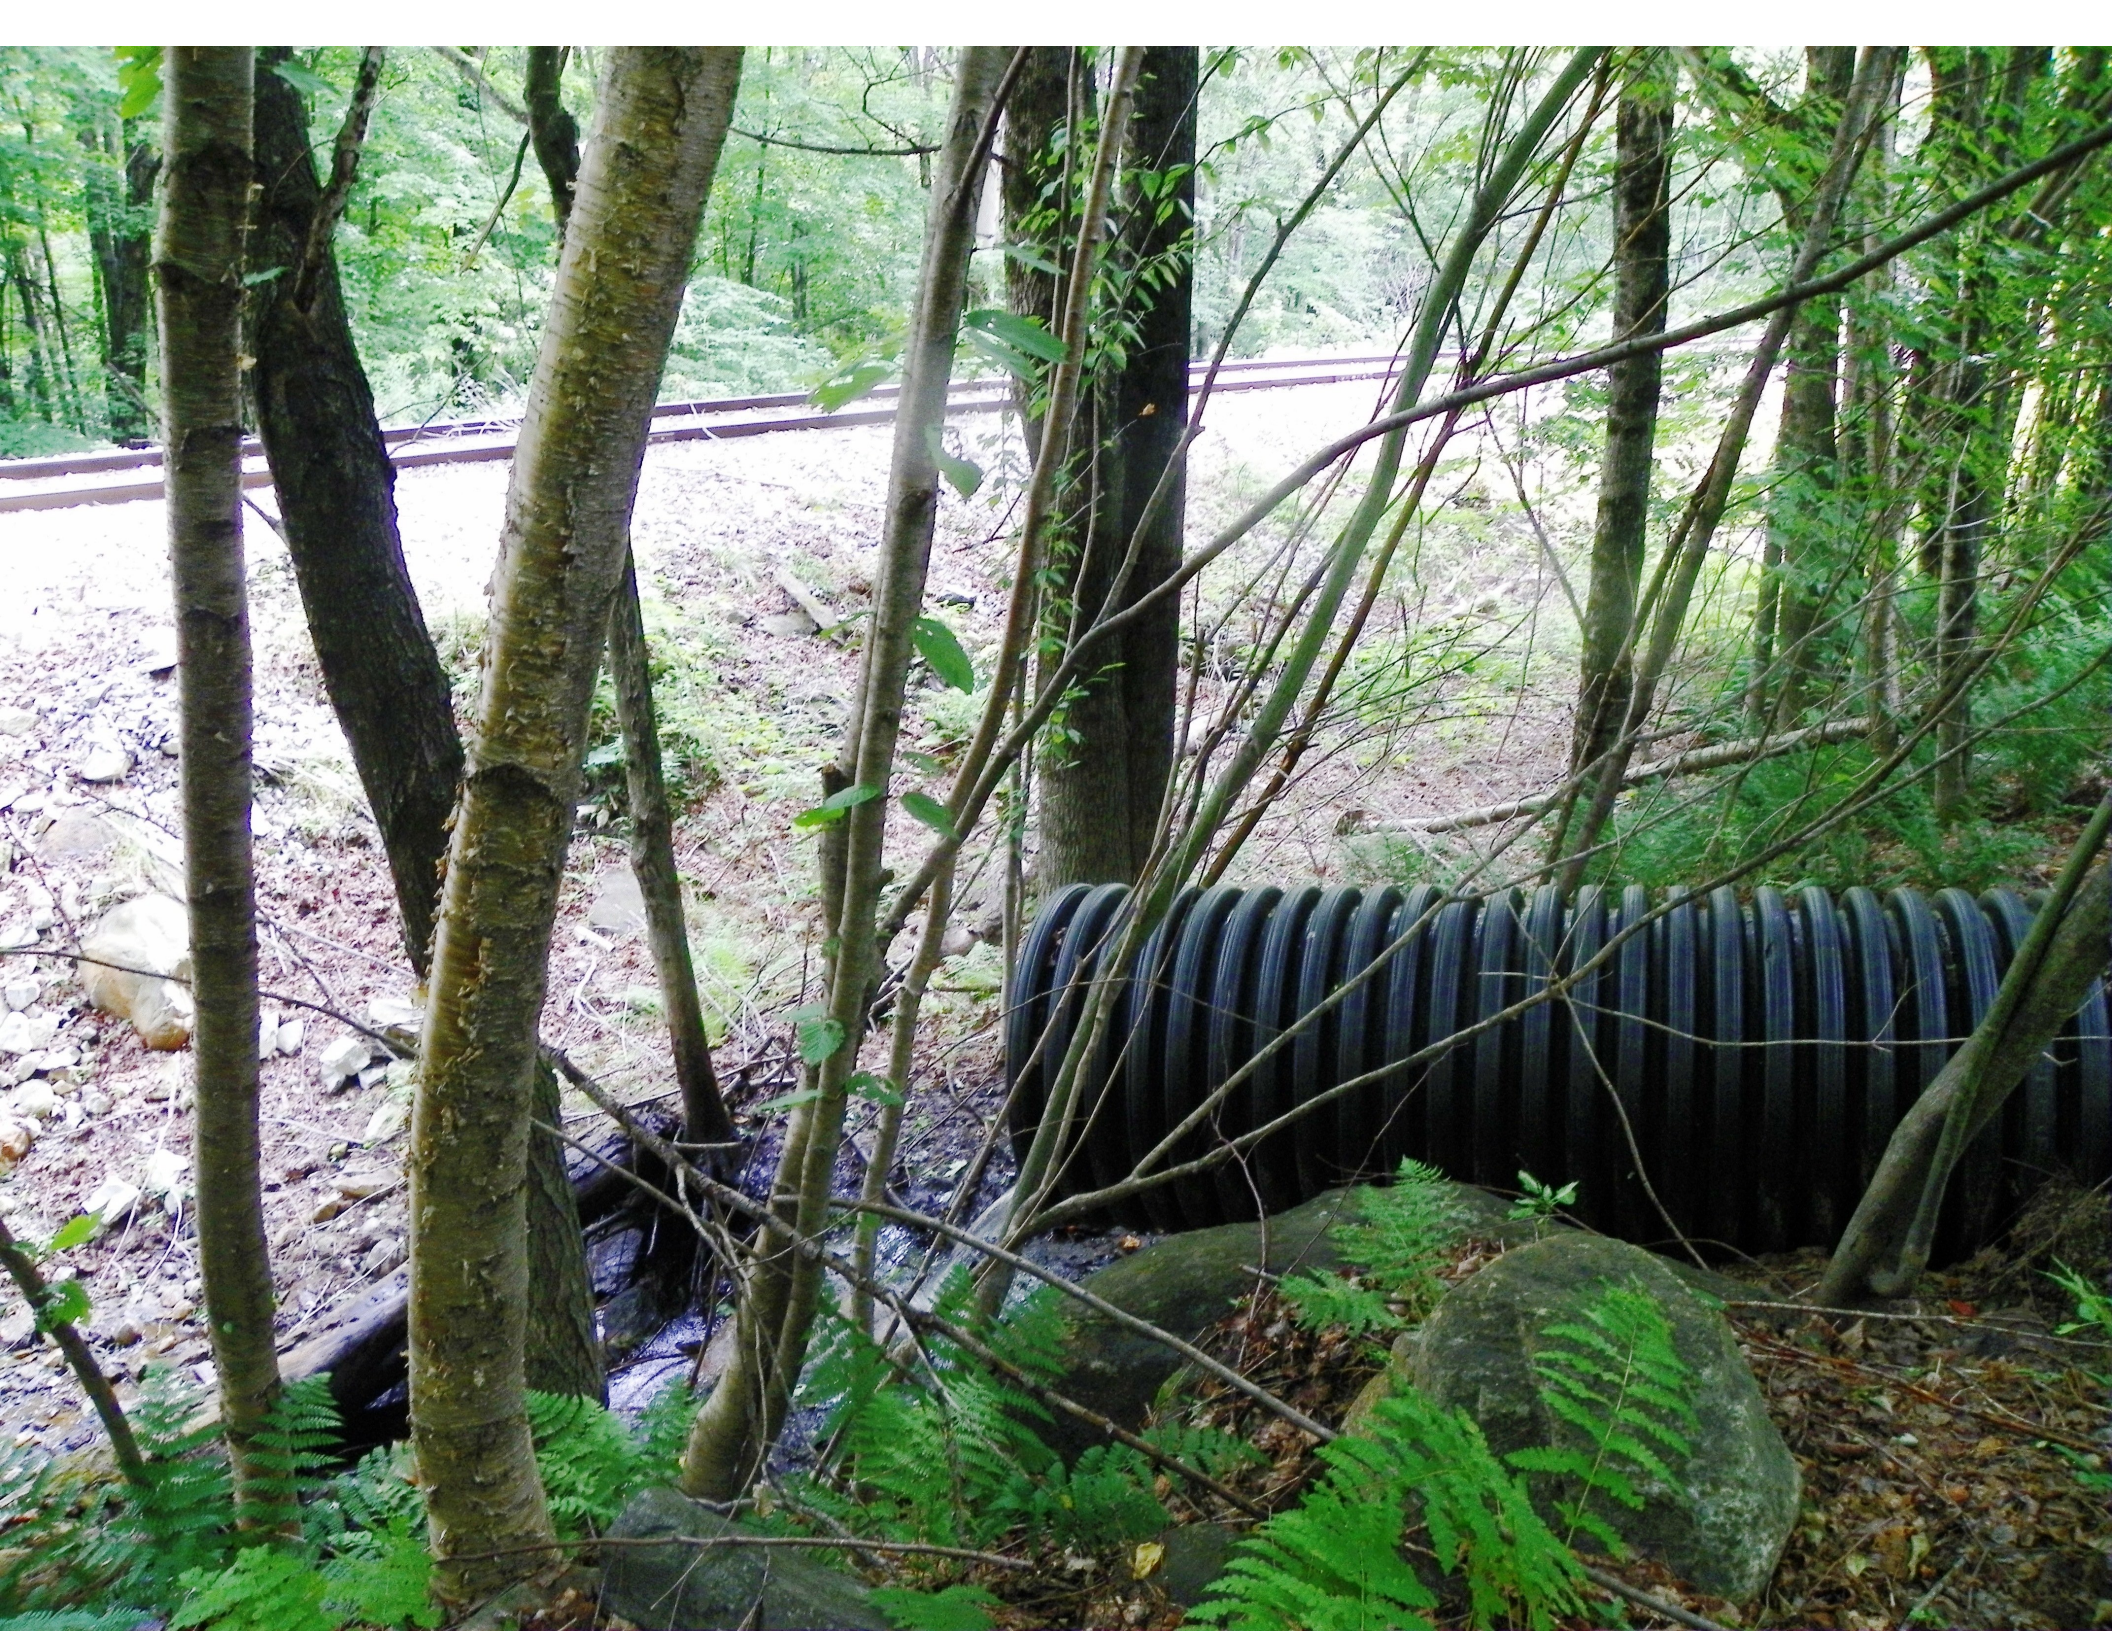
SOUTH INLET NEEDS CLEANING
NORTH OUTLET TOTALLY COLLAPSED
