**Culvert Inspection Form**

| Railroad: <b>GMRC</b> | Town: <u>LUDLOW</u> |
| Mile Post: <b>B 29.79</b> | GPS Coordinates:<br>N: <u>43.42254</u><br>W: <u>72.72112</u> |

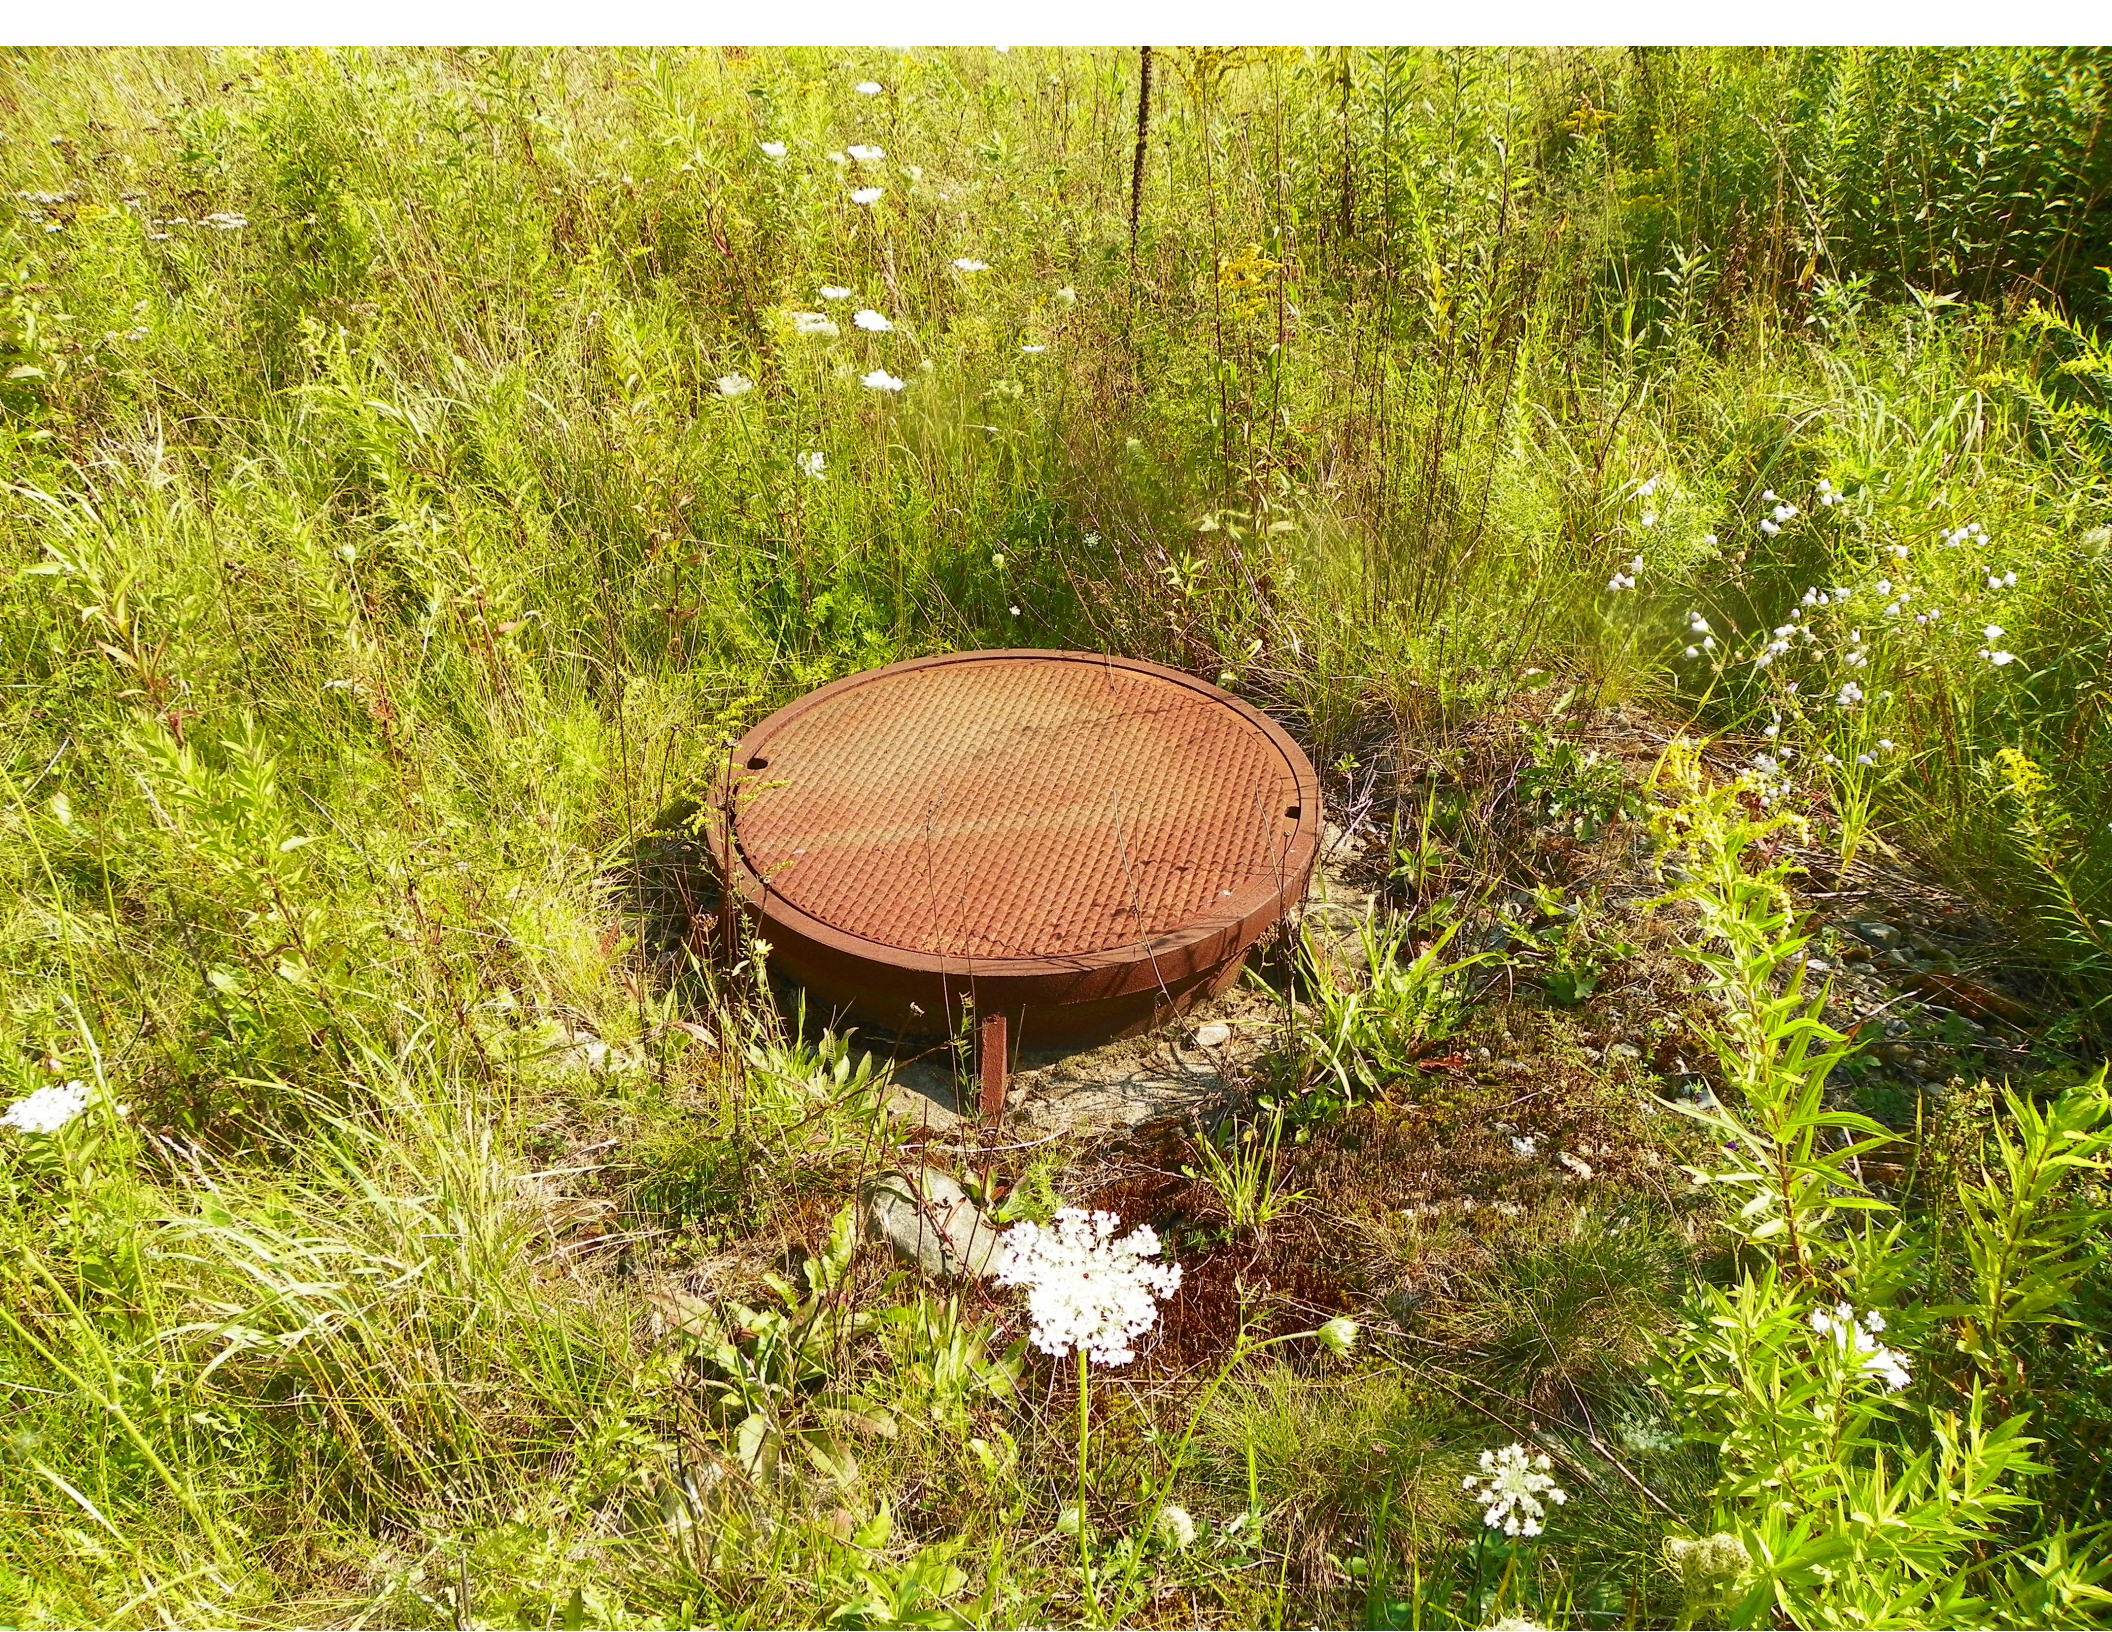
36" STONE HEADER SOUTH INLET      DRAIN TILE NORTH OUTLET
