### Culvert Inspection Form

Railroad: <b>GMRC</b>	Town: <u>Mt. Holly</u>
Valuation Sheet: <b>V 3 / 33</b>	Valuation Stationing: <u>1711+77</u>
Mile Post: <b>B 32.41</b>	GPS Coordinates: N: <u>43.43336</u> W: <u>72.75876</u>

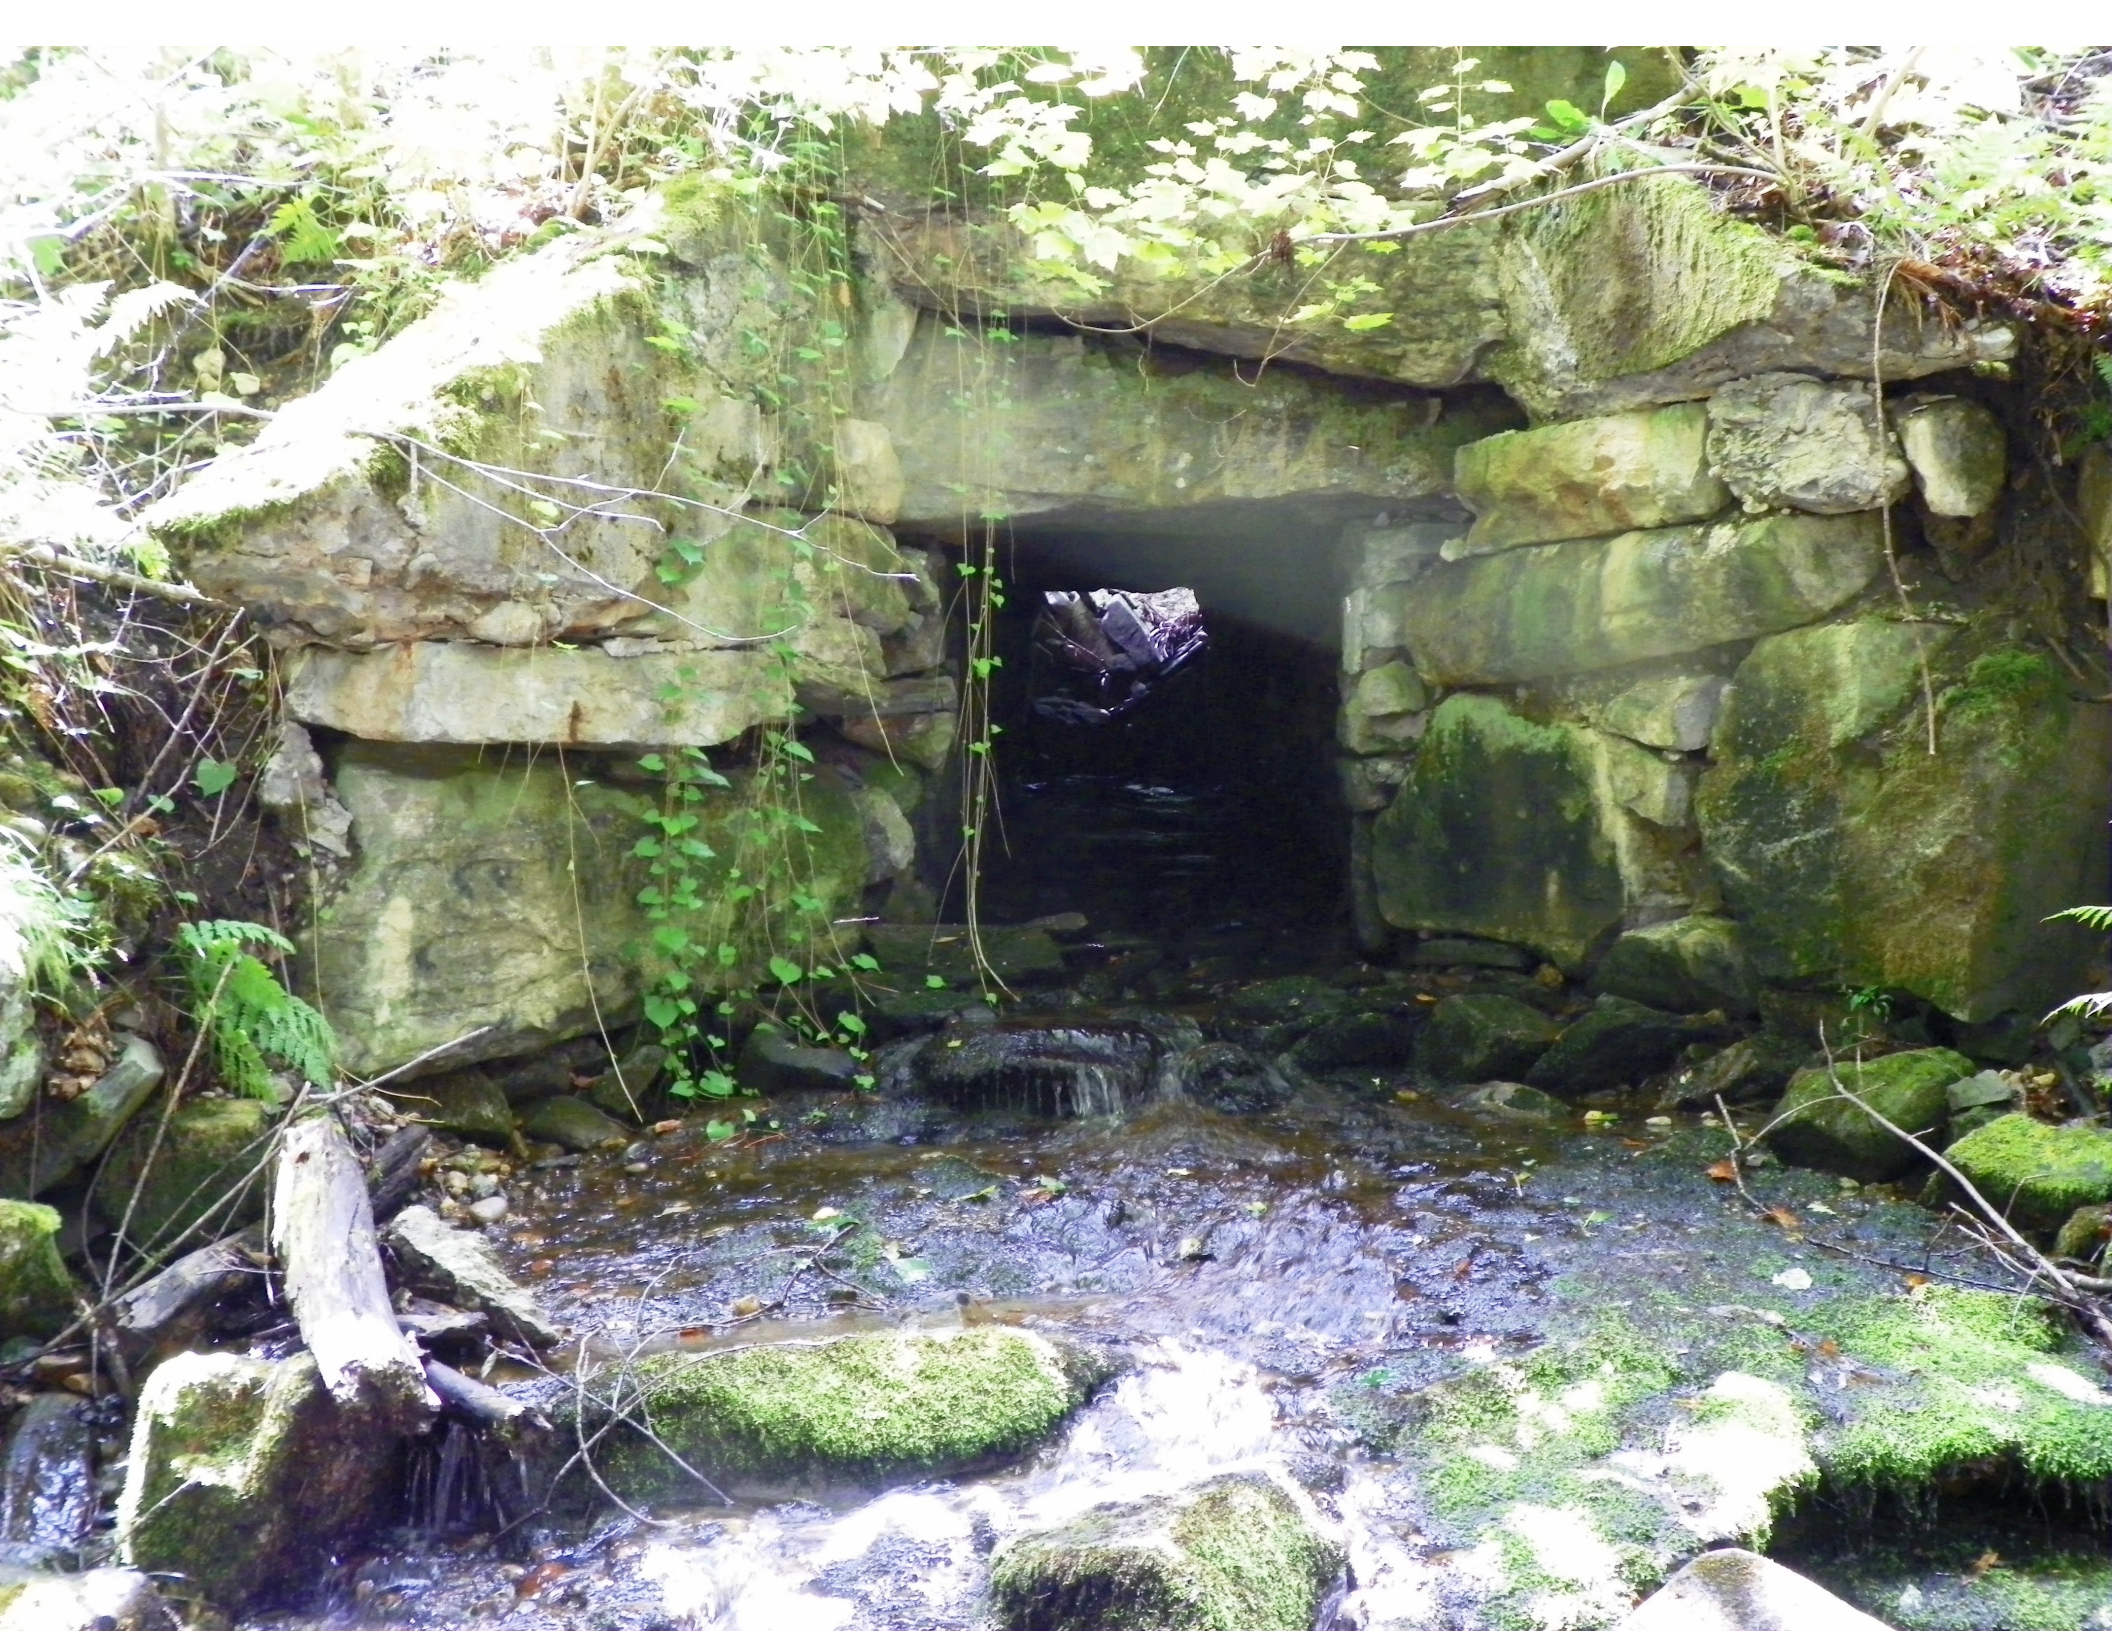
EAST WINGWALL AT SOUTH INLET WAS COLLAPSED
