Culvert Inspection Form

Railroad: GMRC	Town: <u>Mt. Holly</u>
Valuation Sheet: V 3 / 36	Valuation Stationing: <u>1888 + 62</u>
Mile Post: B 35.75	GPS Coordinates: N: <u>43.45246</u> W: <u>72.80840</u>

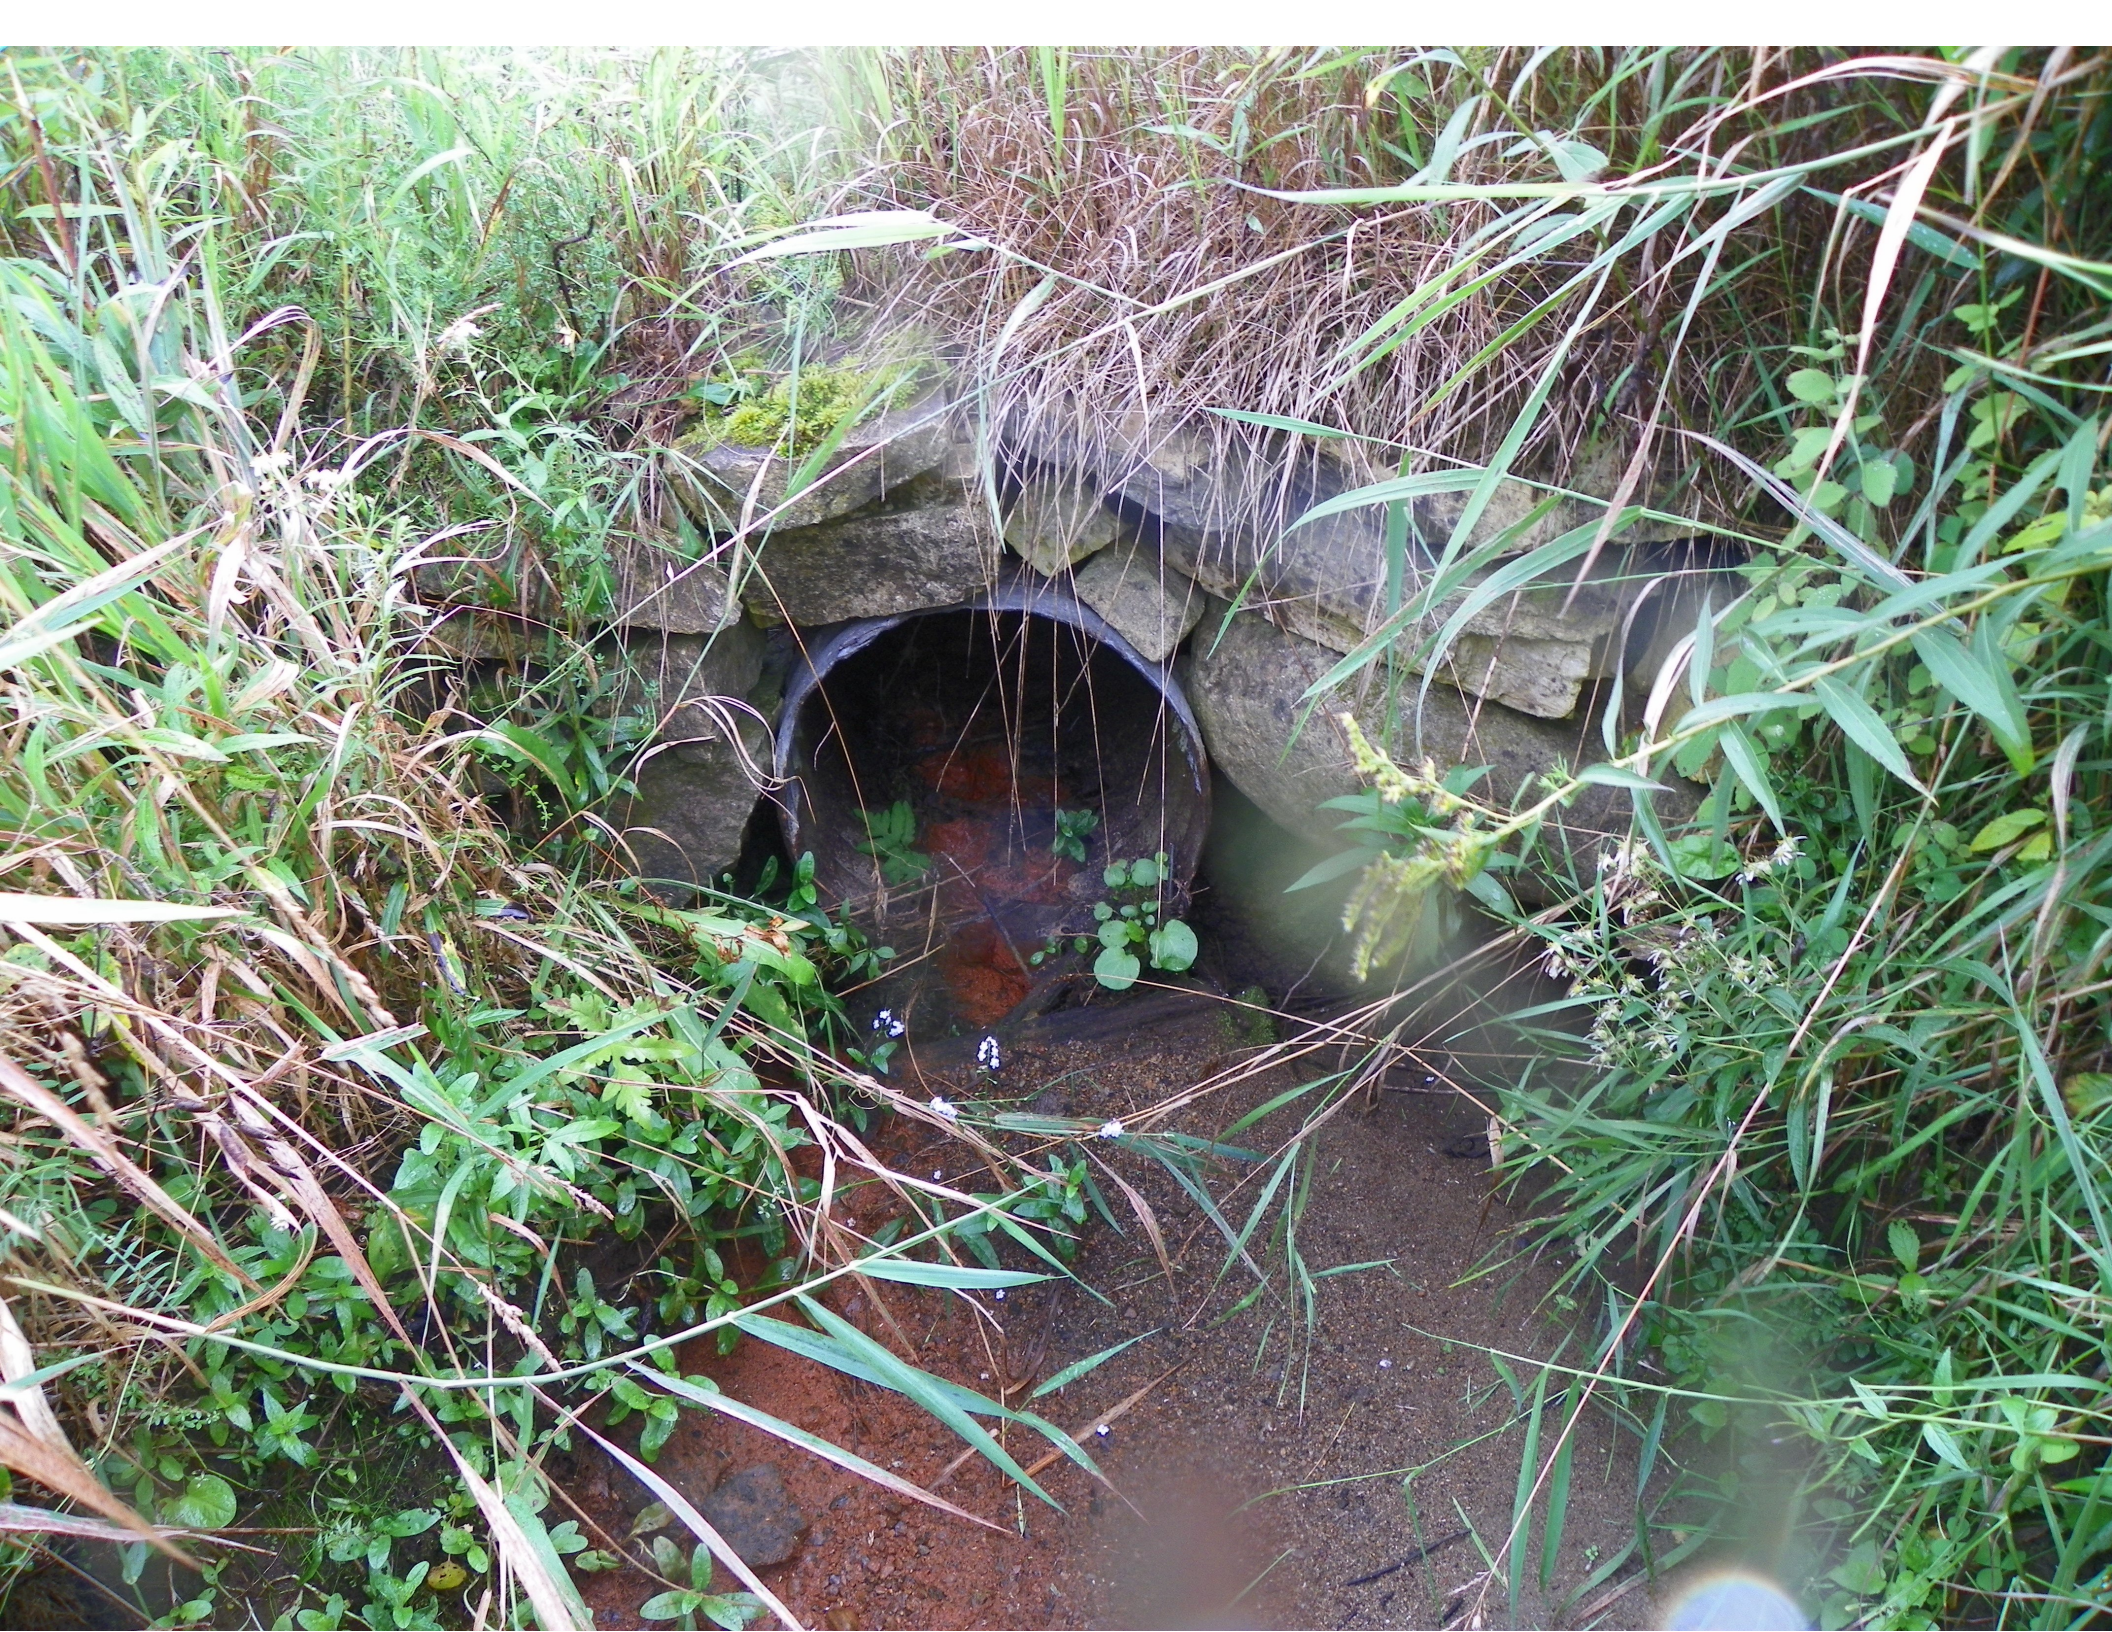
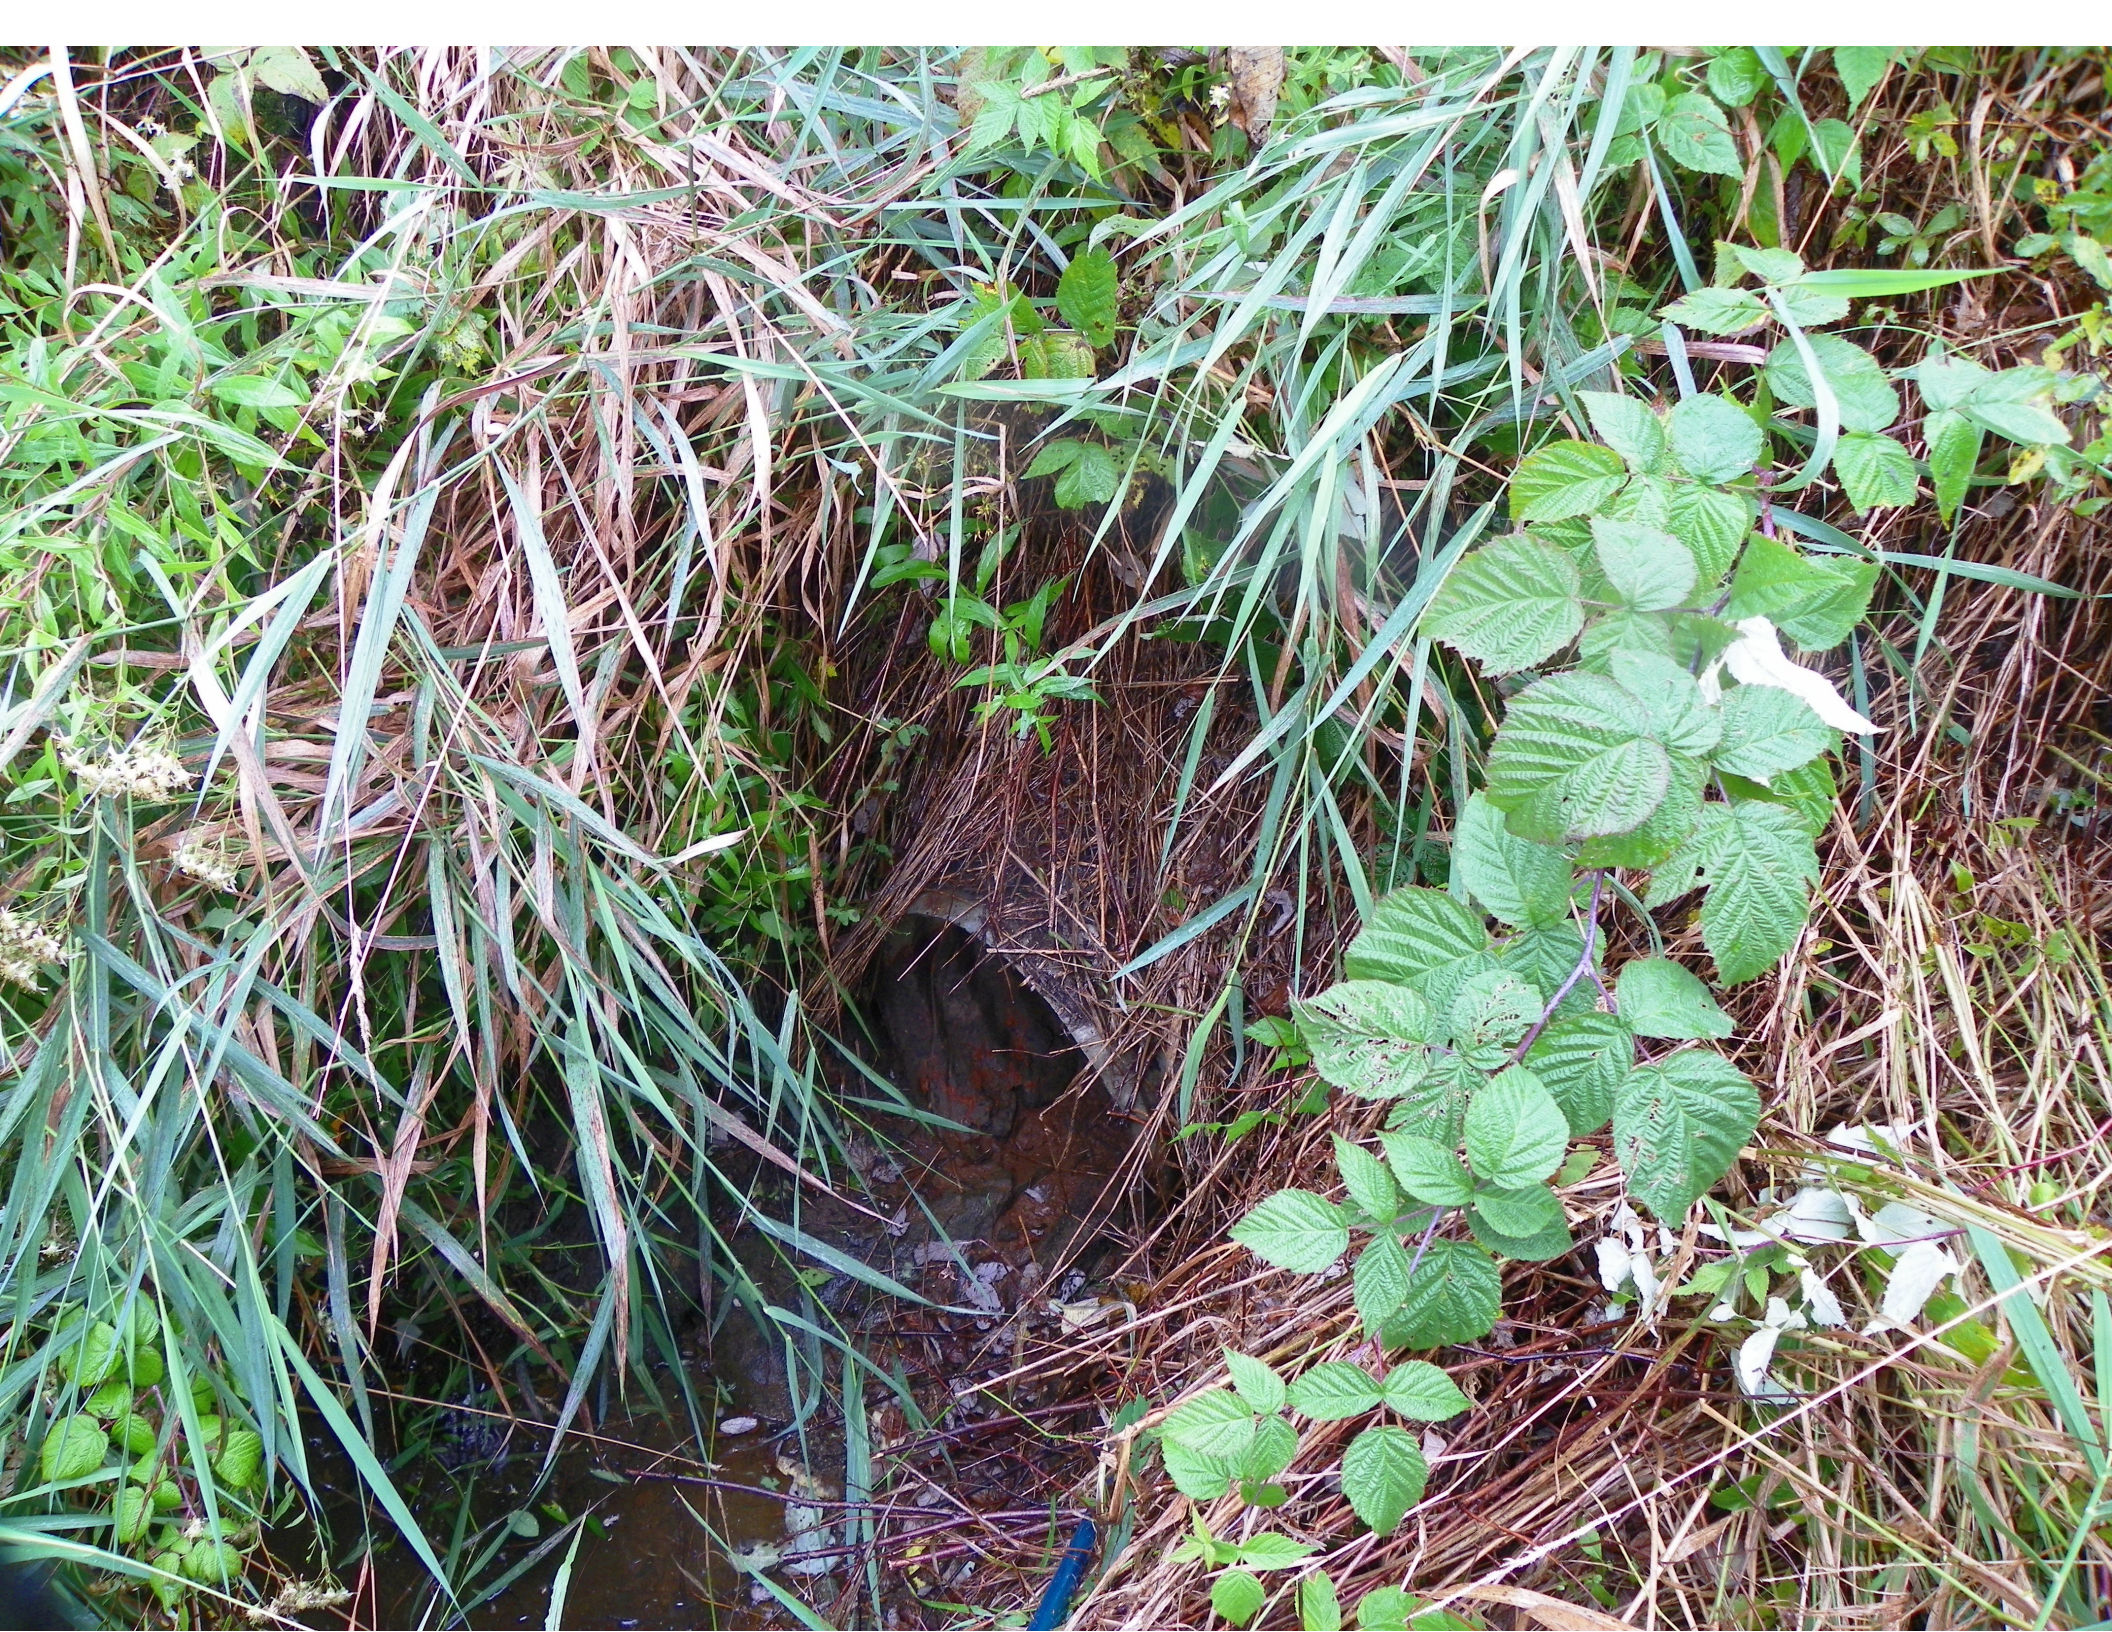
18" STONE MENDER AT NORTH INLET

BOTTOMS OF PIPE COMPLETELY RUSTED OUT THROUGHOUT
