**Culvert Inspection Form**

Railroad: <b>GMRC</b>	Town: <u>Mt. Holly</u>
Valuation Sheet: <b>V 3 / 37</b>	Valuation Stationing: <u>1916 + 26</u>
Mile Post: <b>B 36.29</b>	GPS Coordinates: N: <u>43,44872</u> W: <u>72,81735</u>

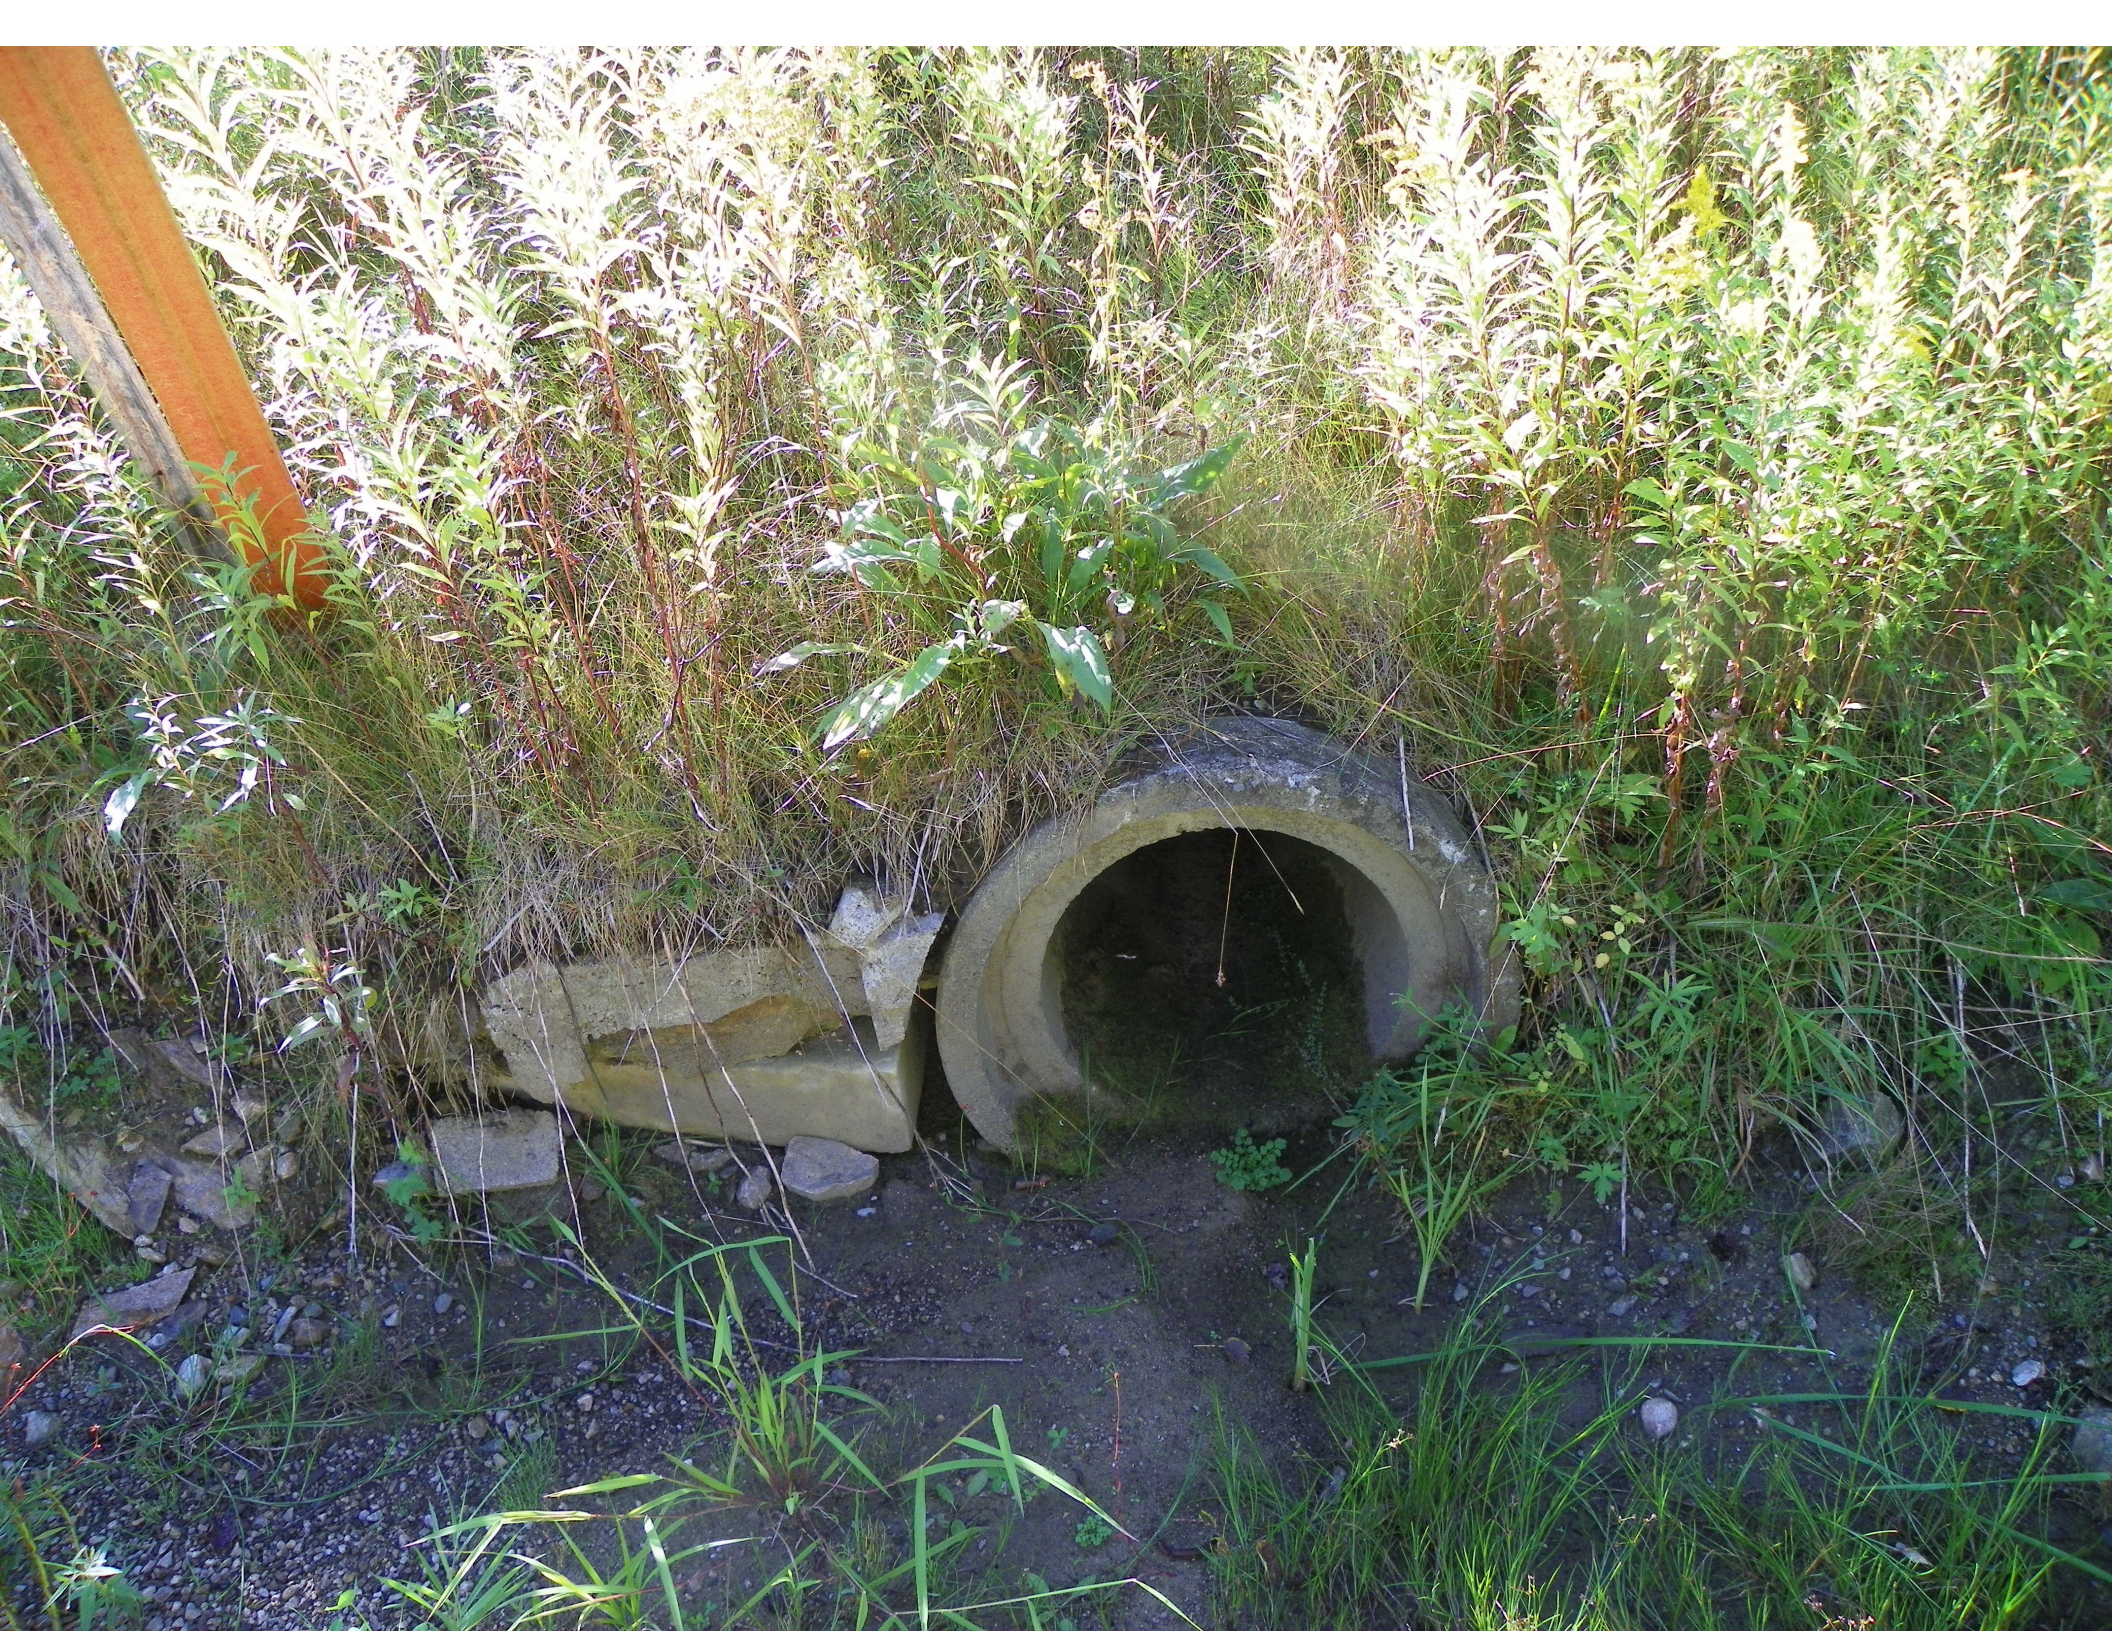
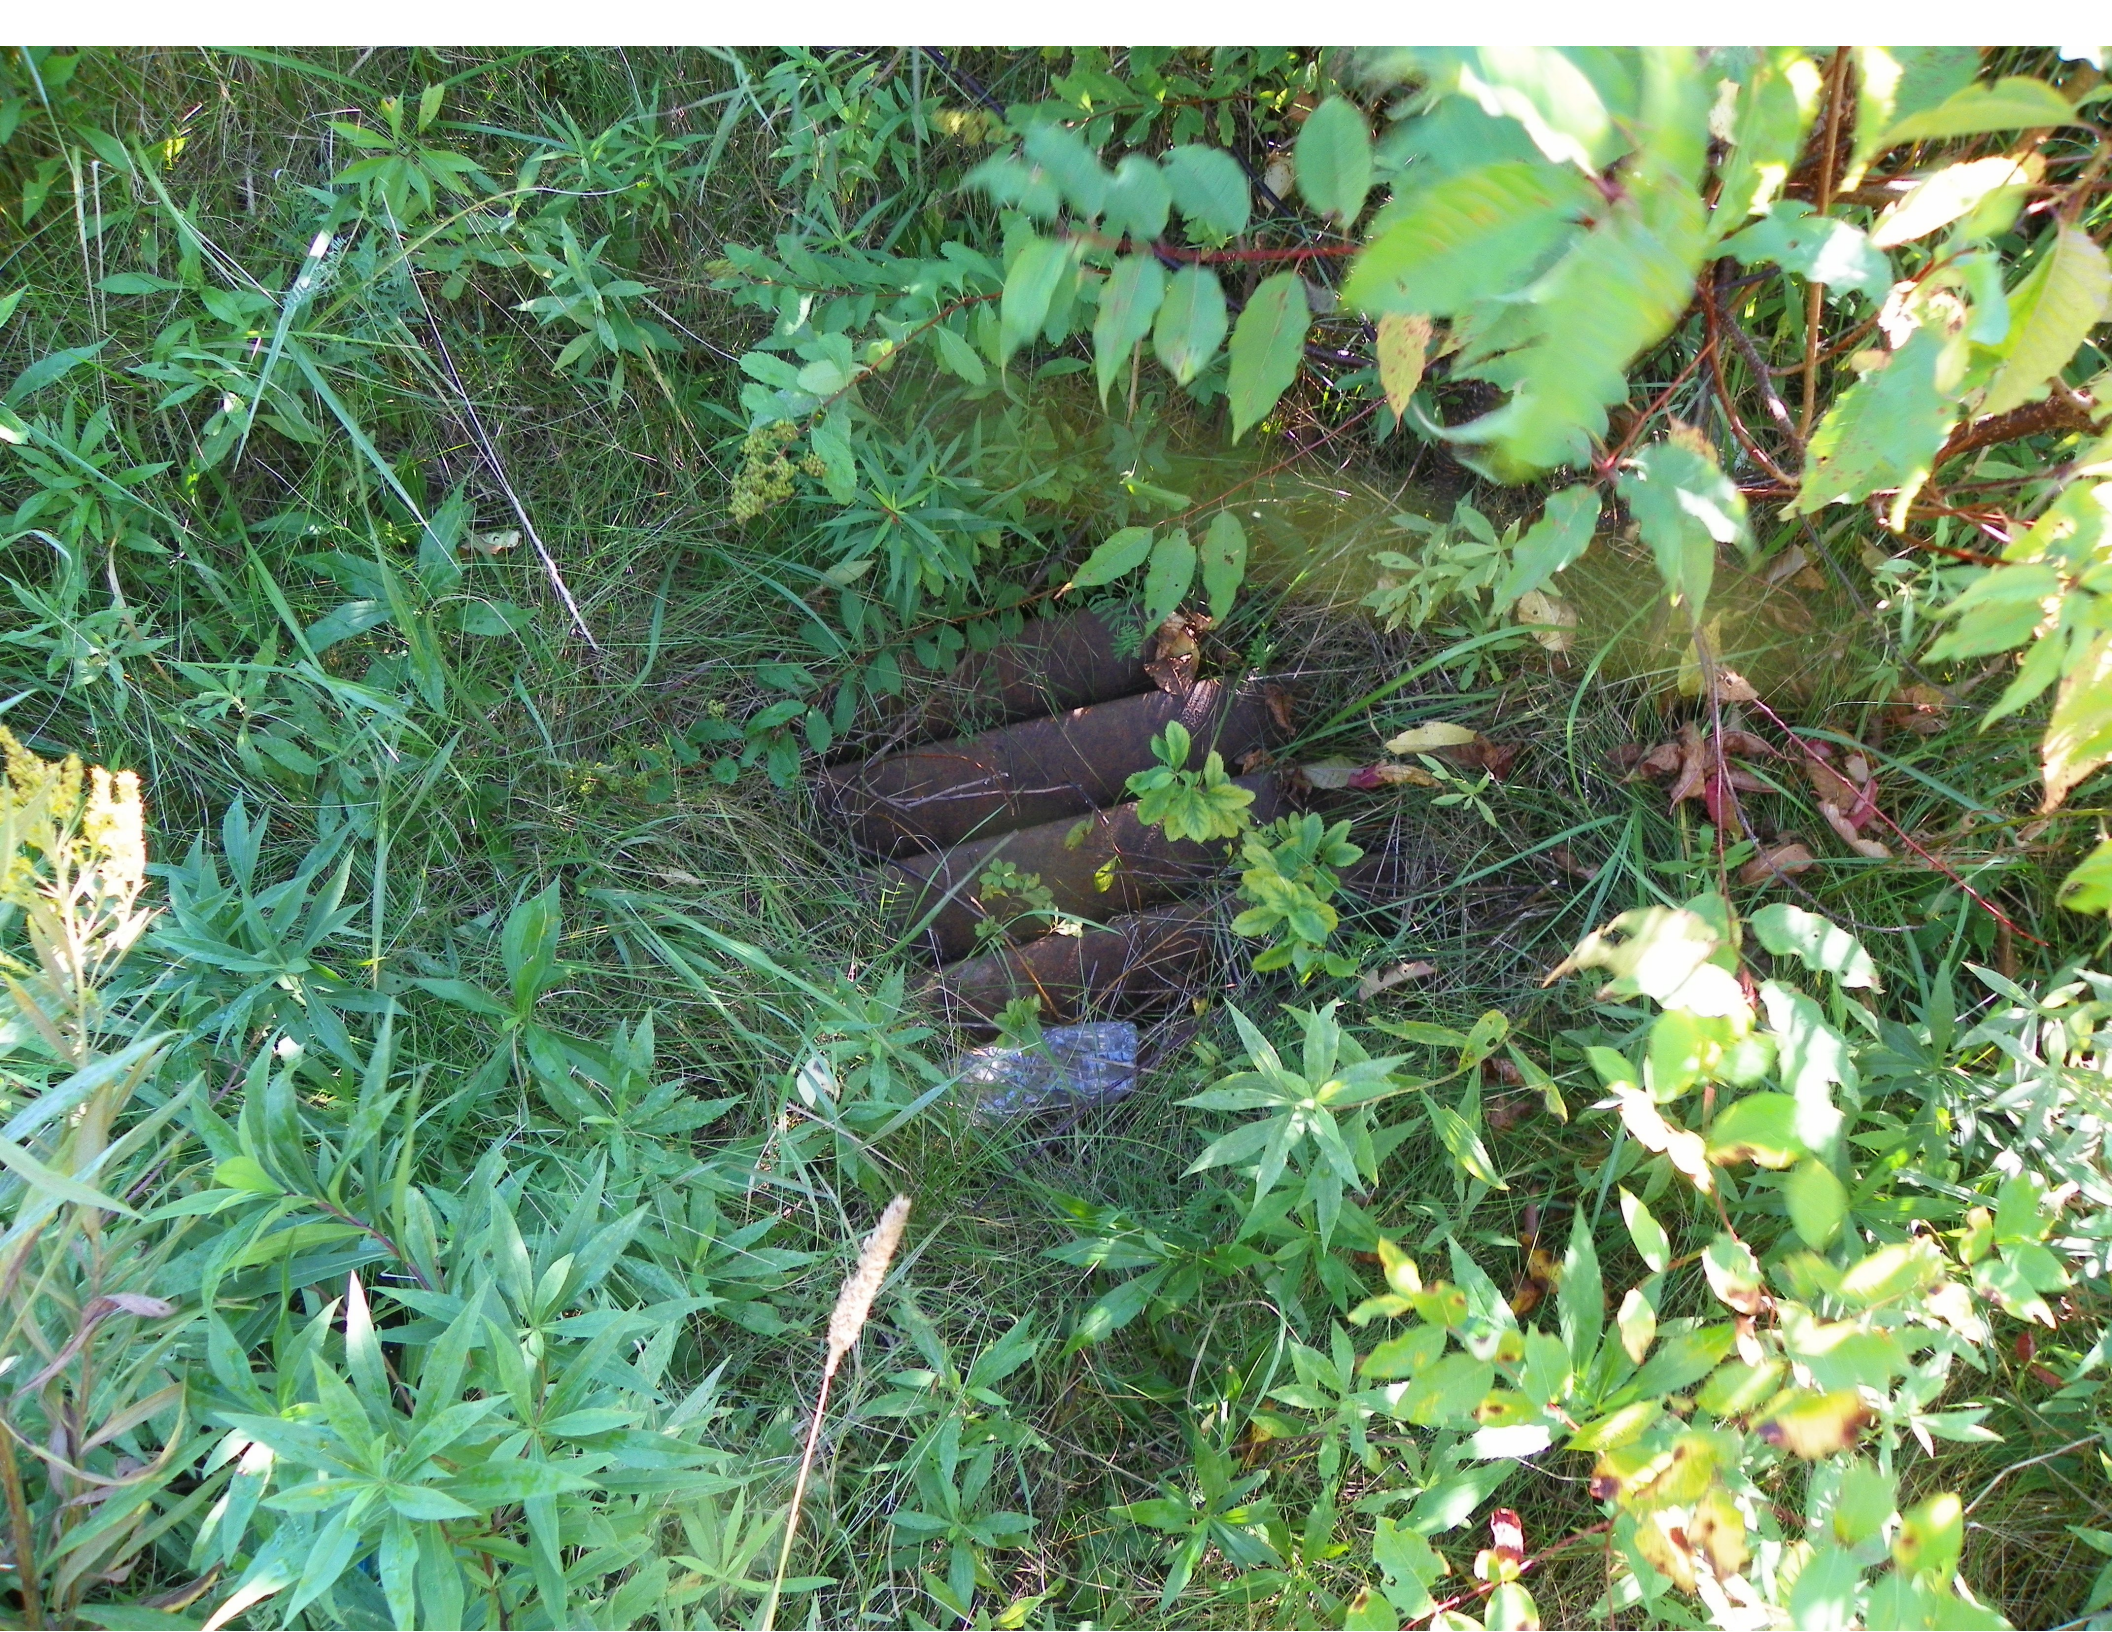
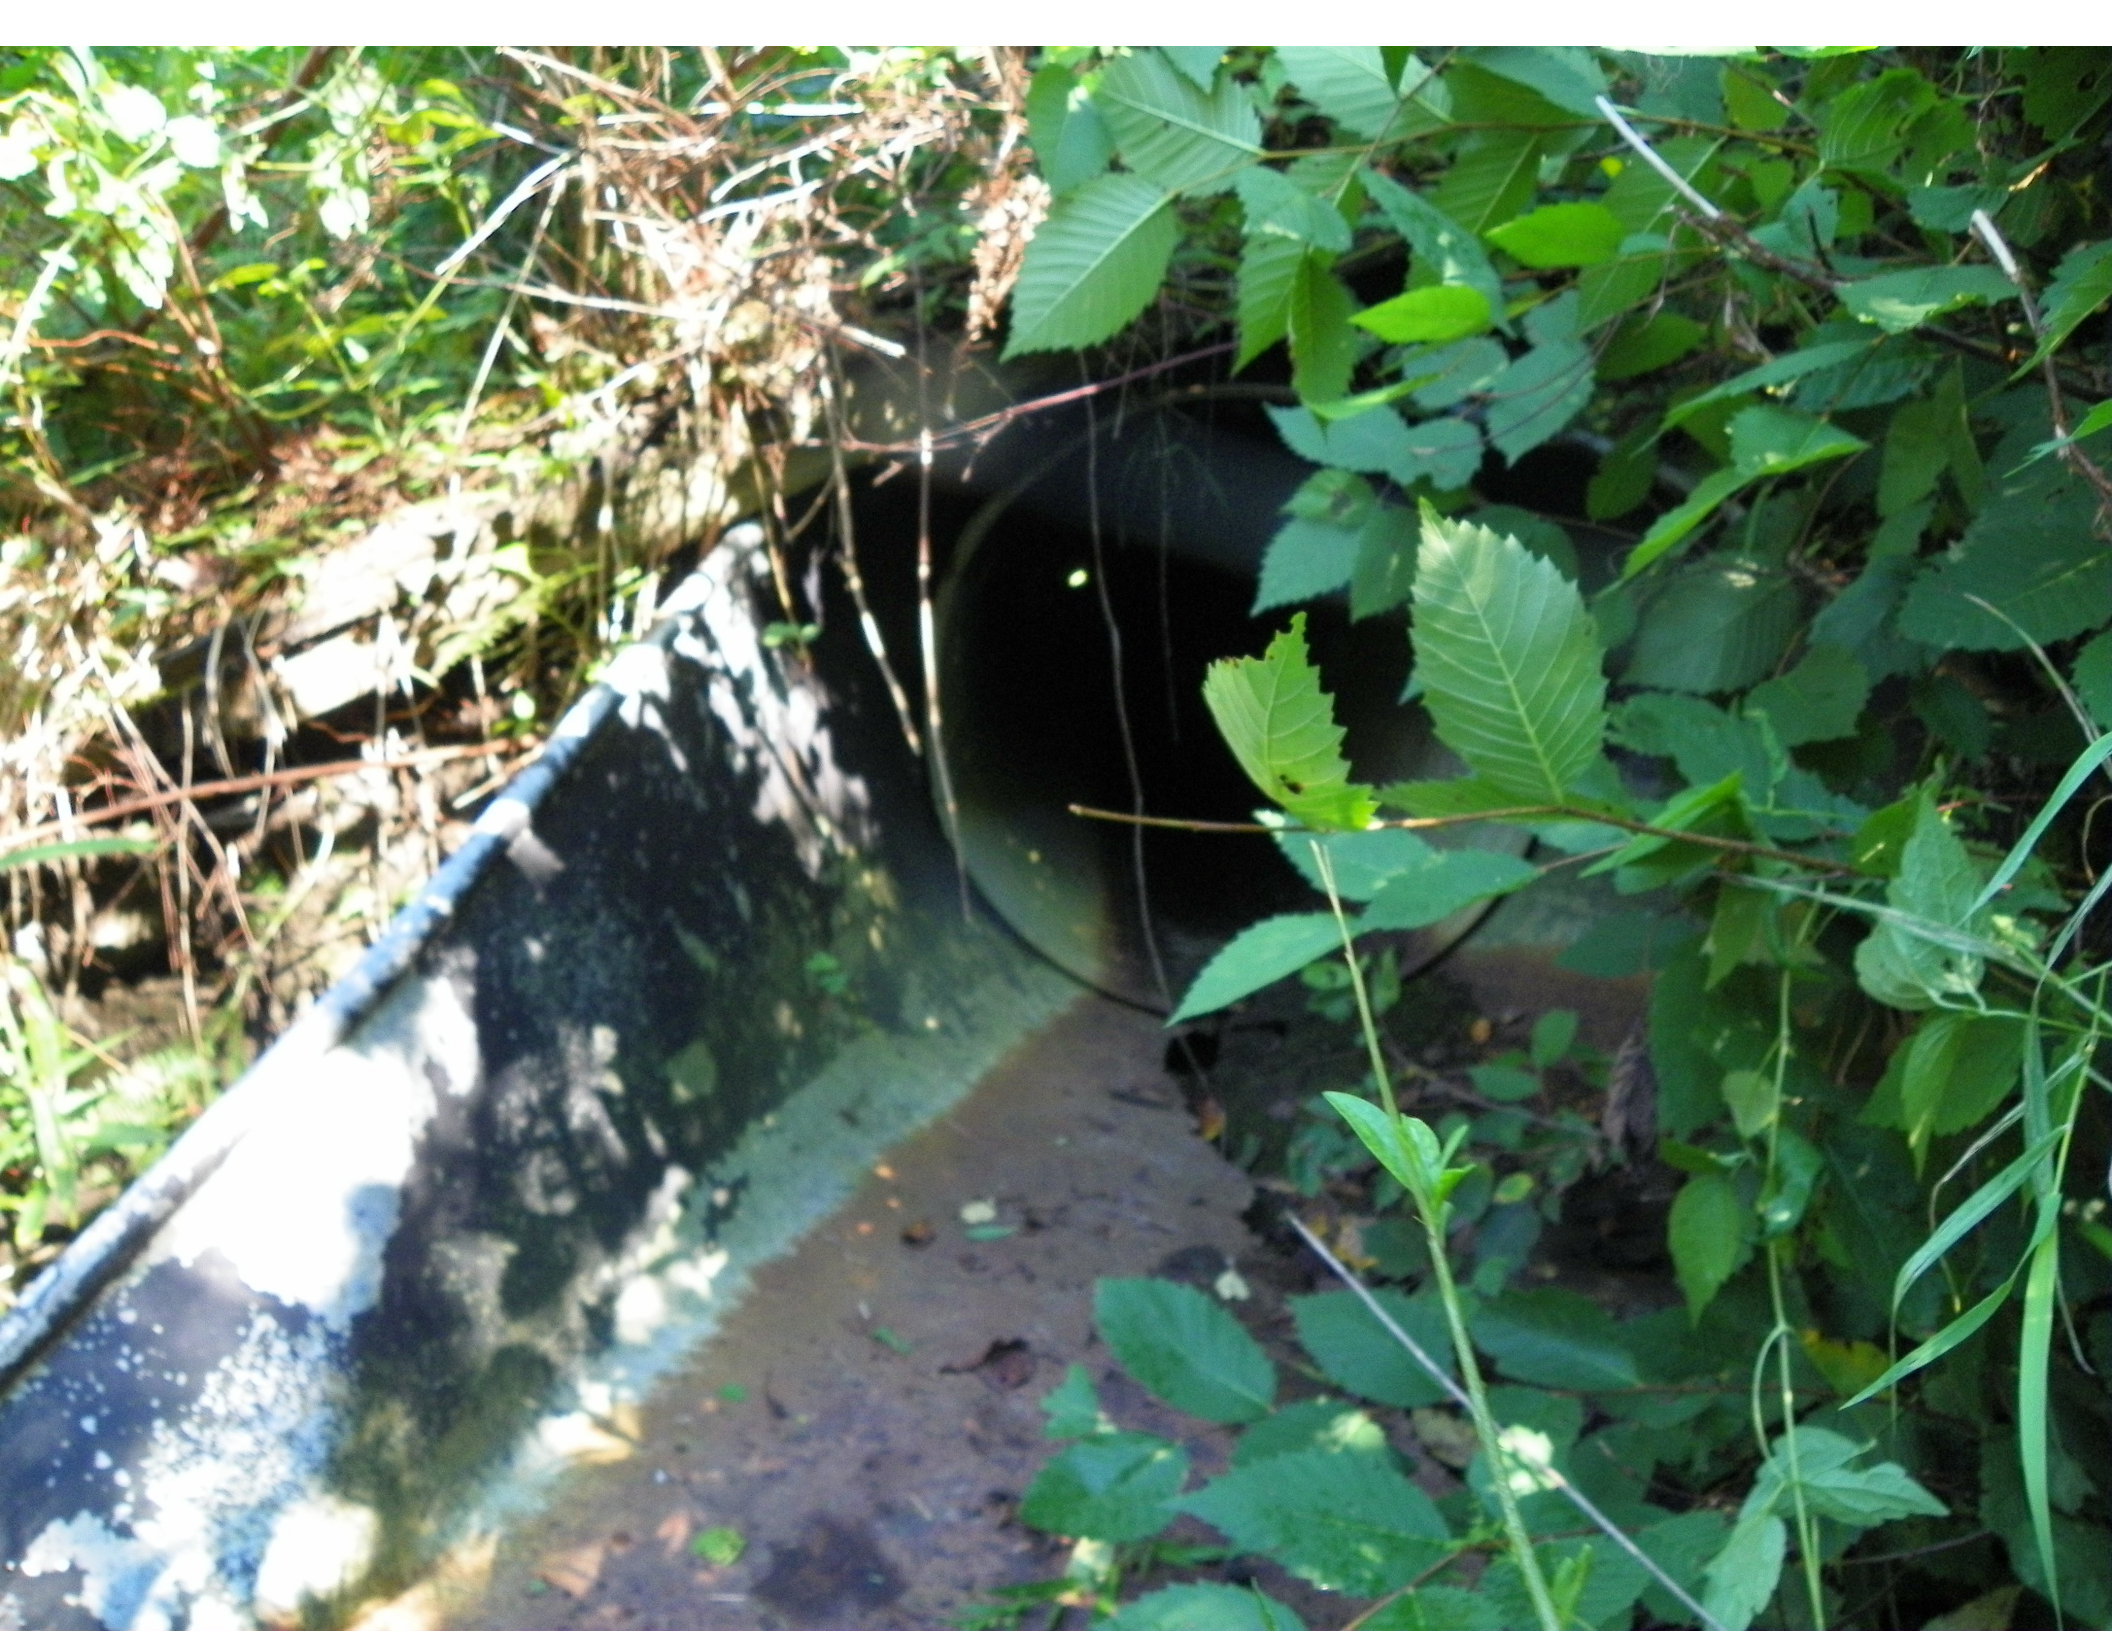
BOTTOM OF PIPE RUSTING OUT

2'x2' CAST IRON DI ON NORTH INLET (FROM HIGHWAY CULVERT)
