**Culvert Inspection Form**

Railroad: <b>GMRC</b>	Town: <u>Mt. Holly</u>
Valuation Sheet: <b>V 3 / 39</b>	Valuation Stationing: <u>2011 + 09</u>
Mile Post: <b>B 38.08</b>	GPS Coordinates: N: <u>43.44717</u> W: <u>72.85229</u>

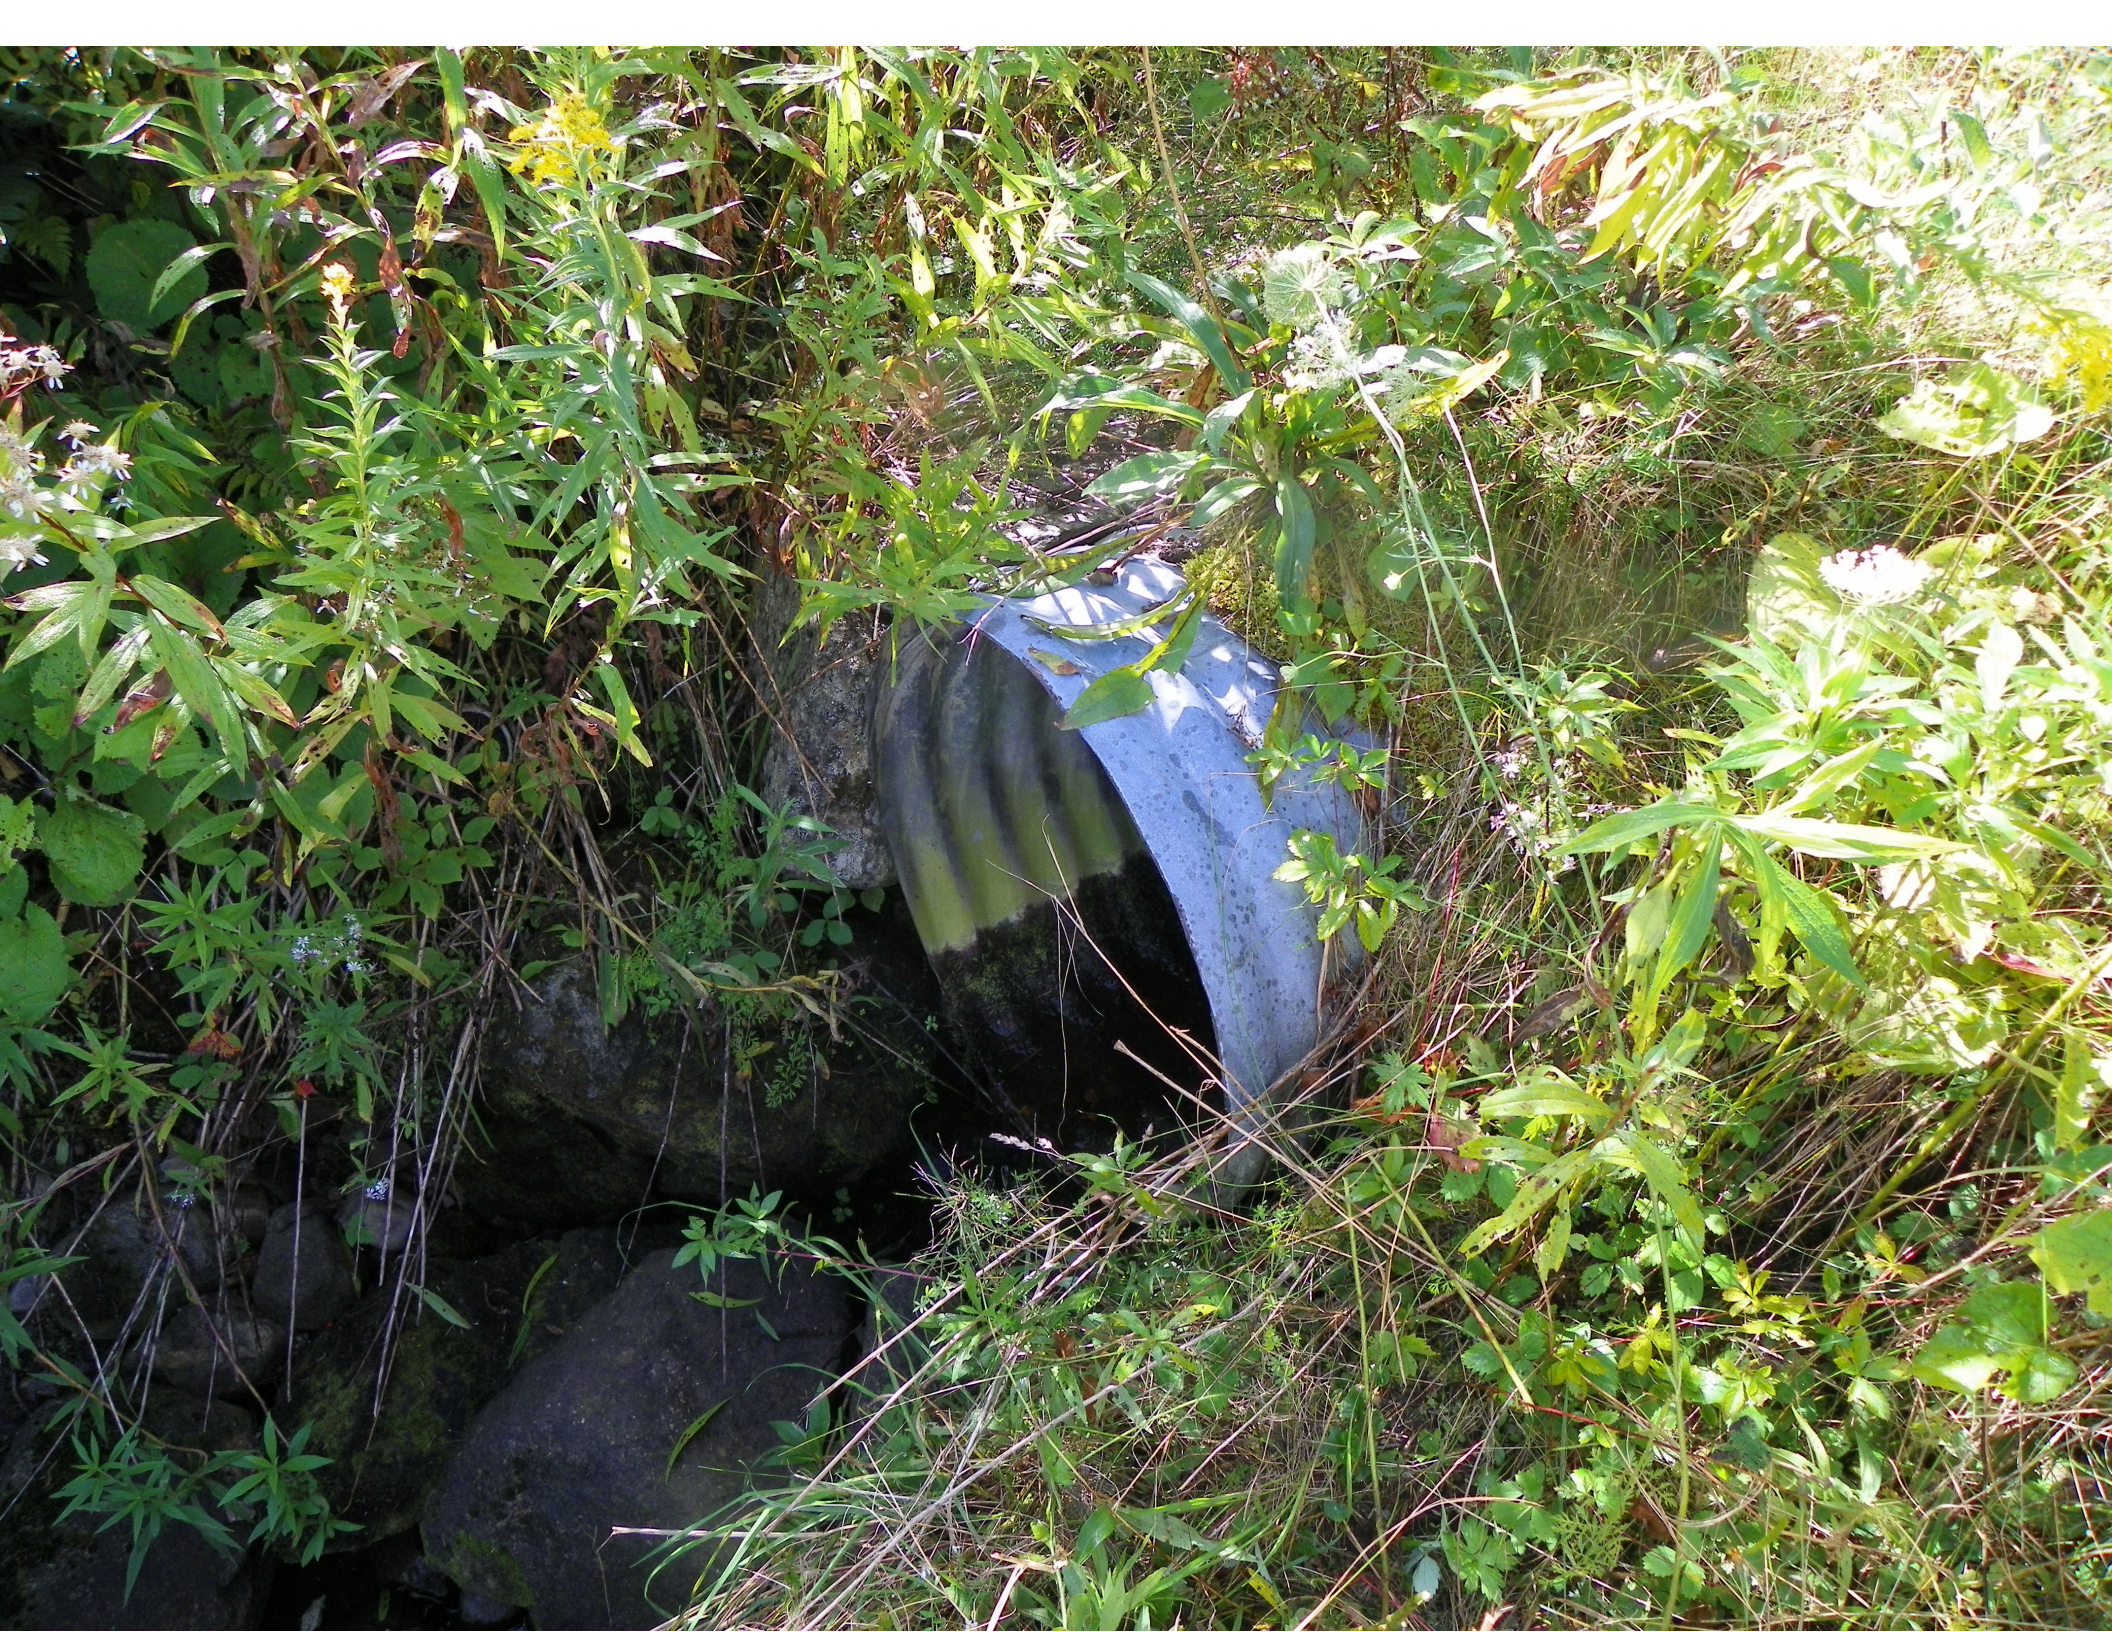
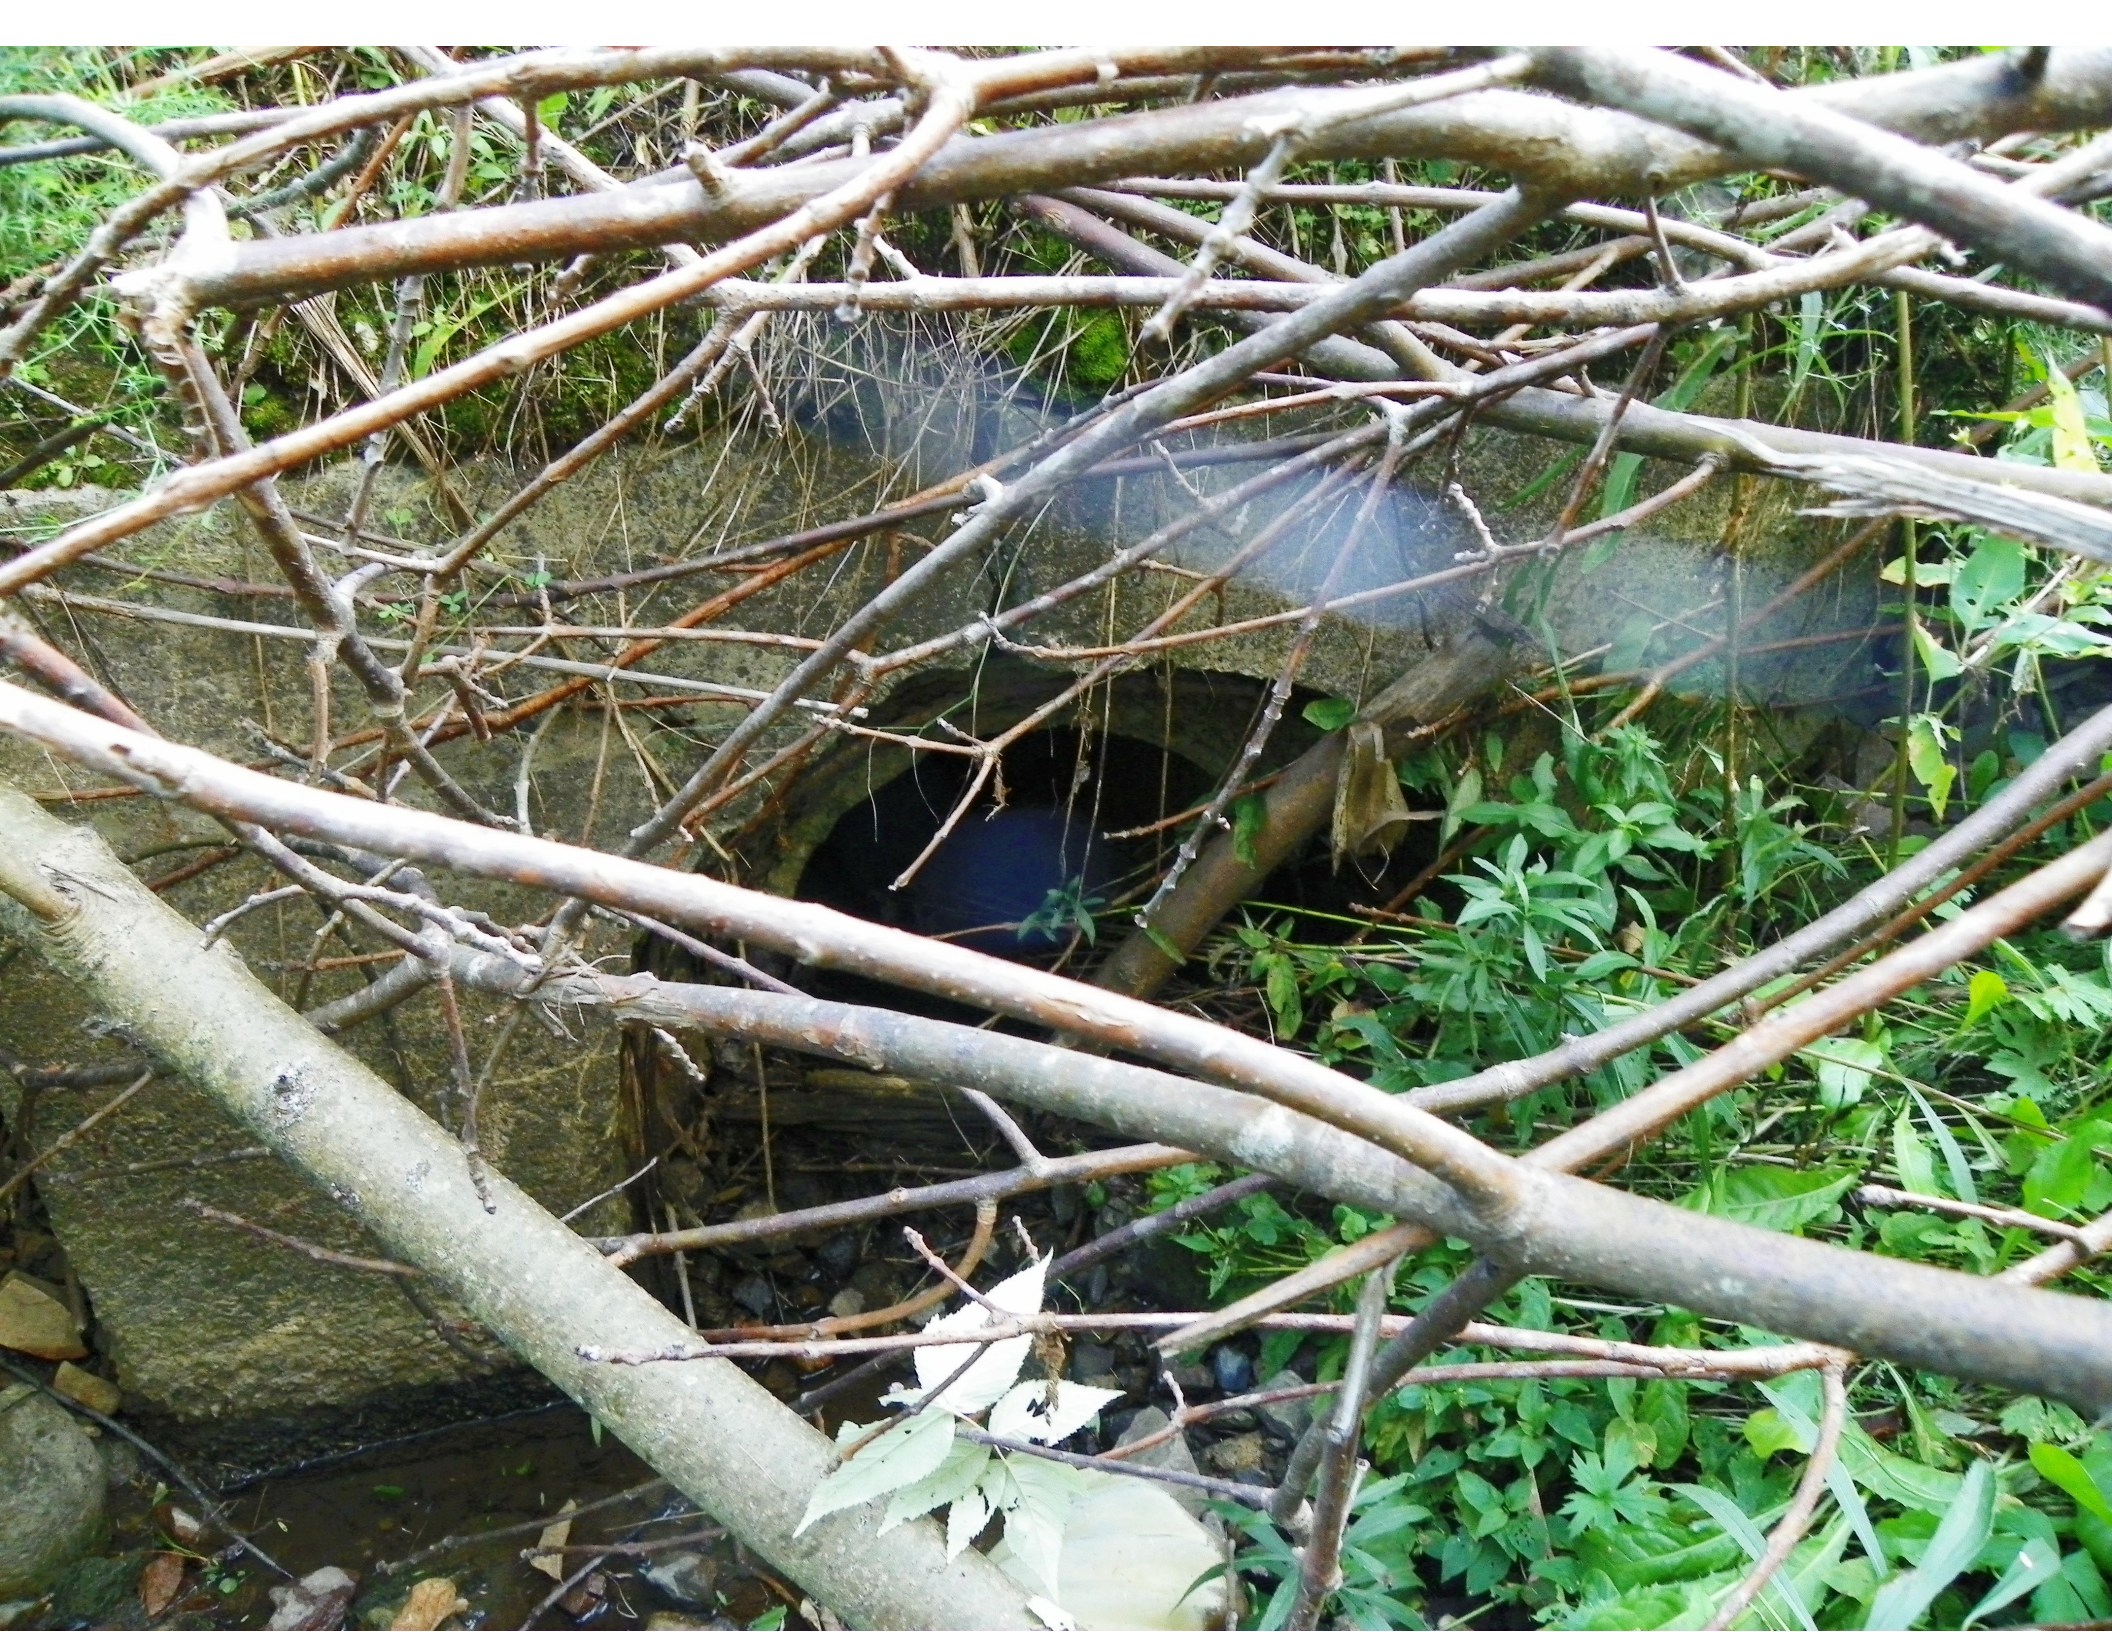
24" CONCRETE HENCK AT SOUTH INLET
