### Culvert Inspection Form

Railroad: <b>GMRC</b>	Town: <u>WALLINGFORD</u>
Valuation Sheet: <b>V 3 / 40</b>	Valuation Stationing: <u>2110 + 96</u>
Mile Post: <b>B 39.96</b>	GPS Coordinates: N: <u>43.45639</u> W: <u>72.87807</u>

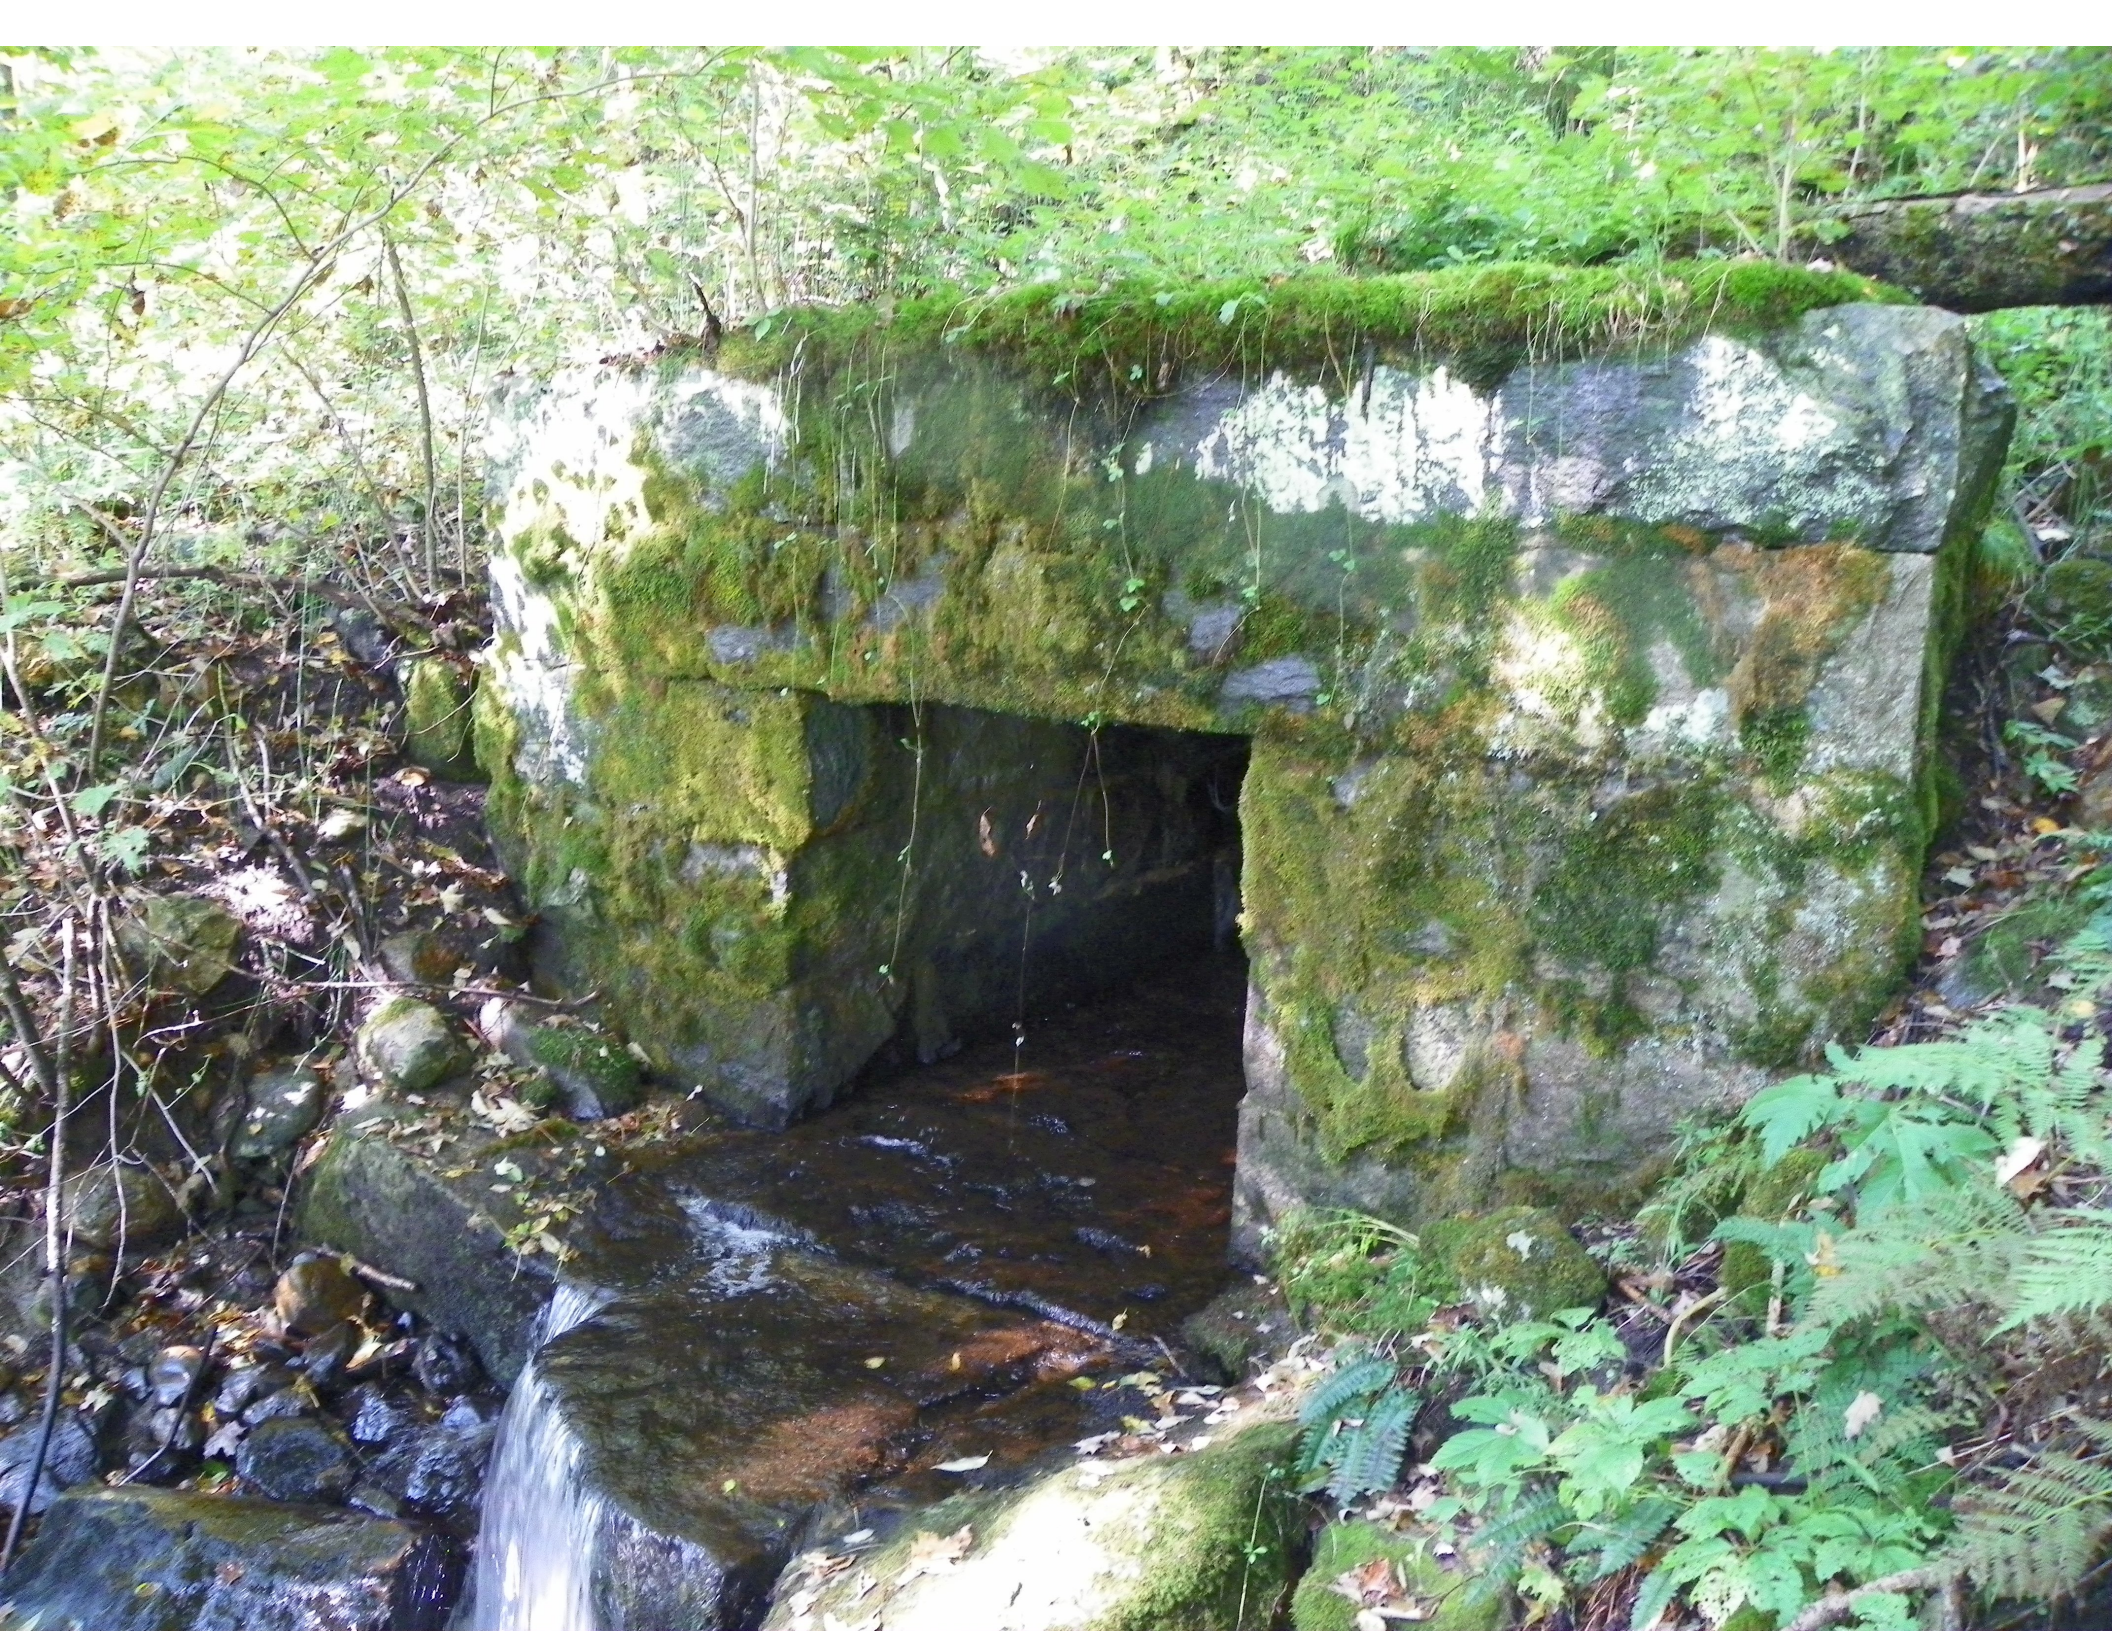
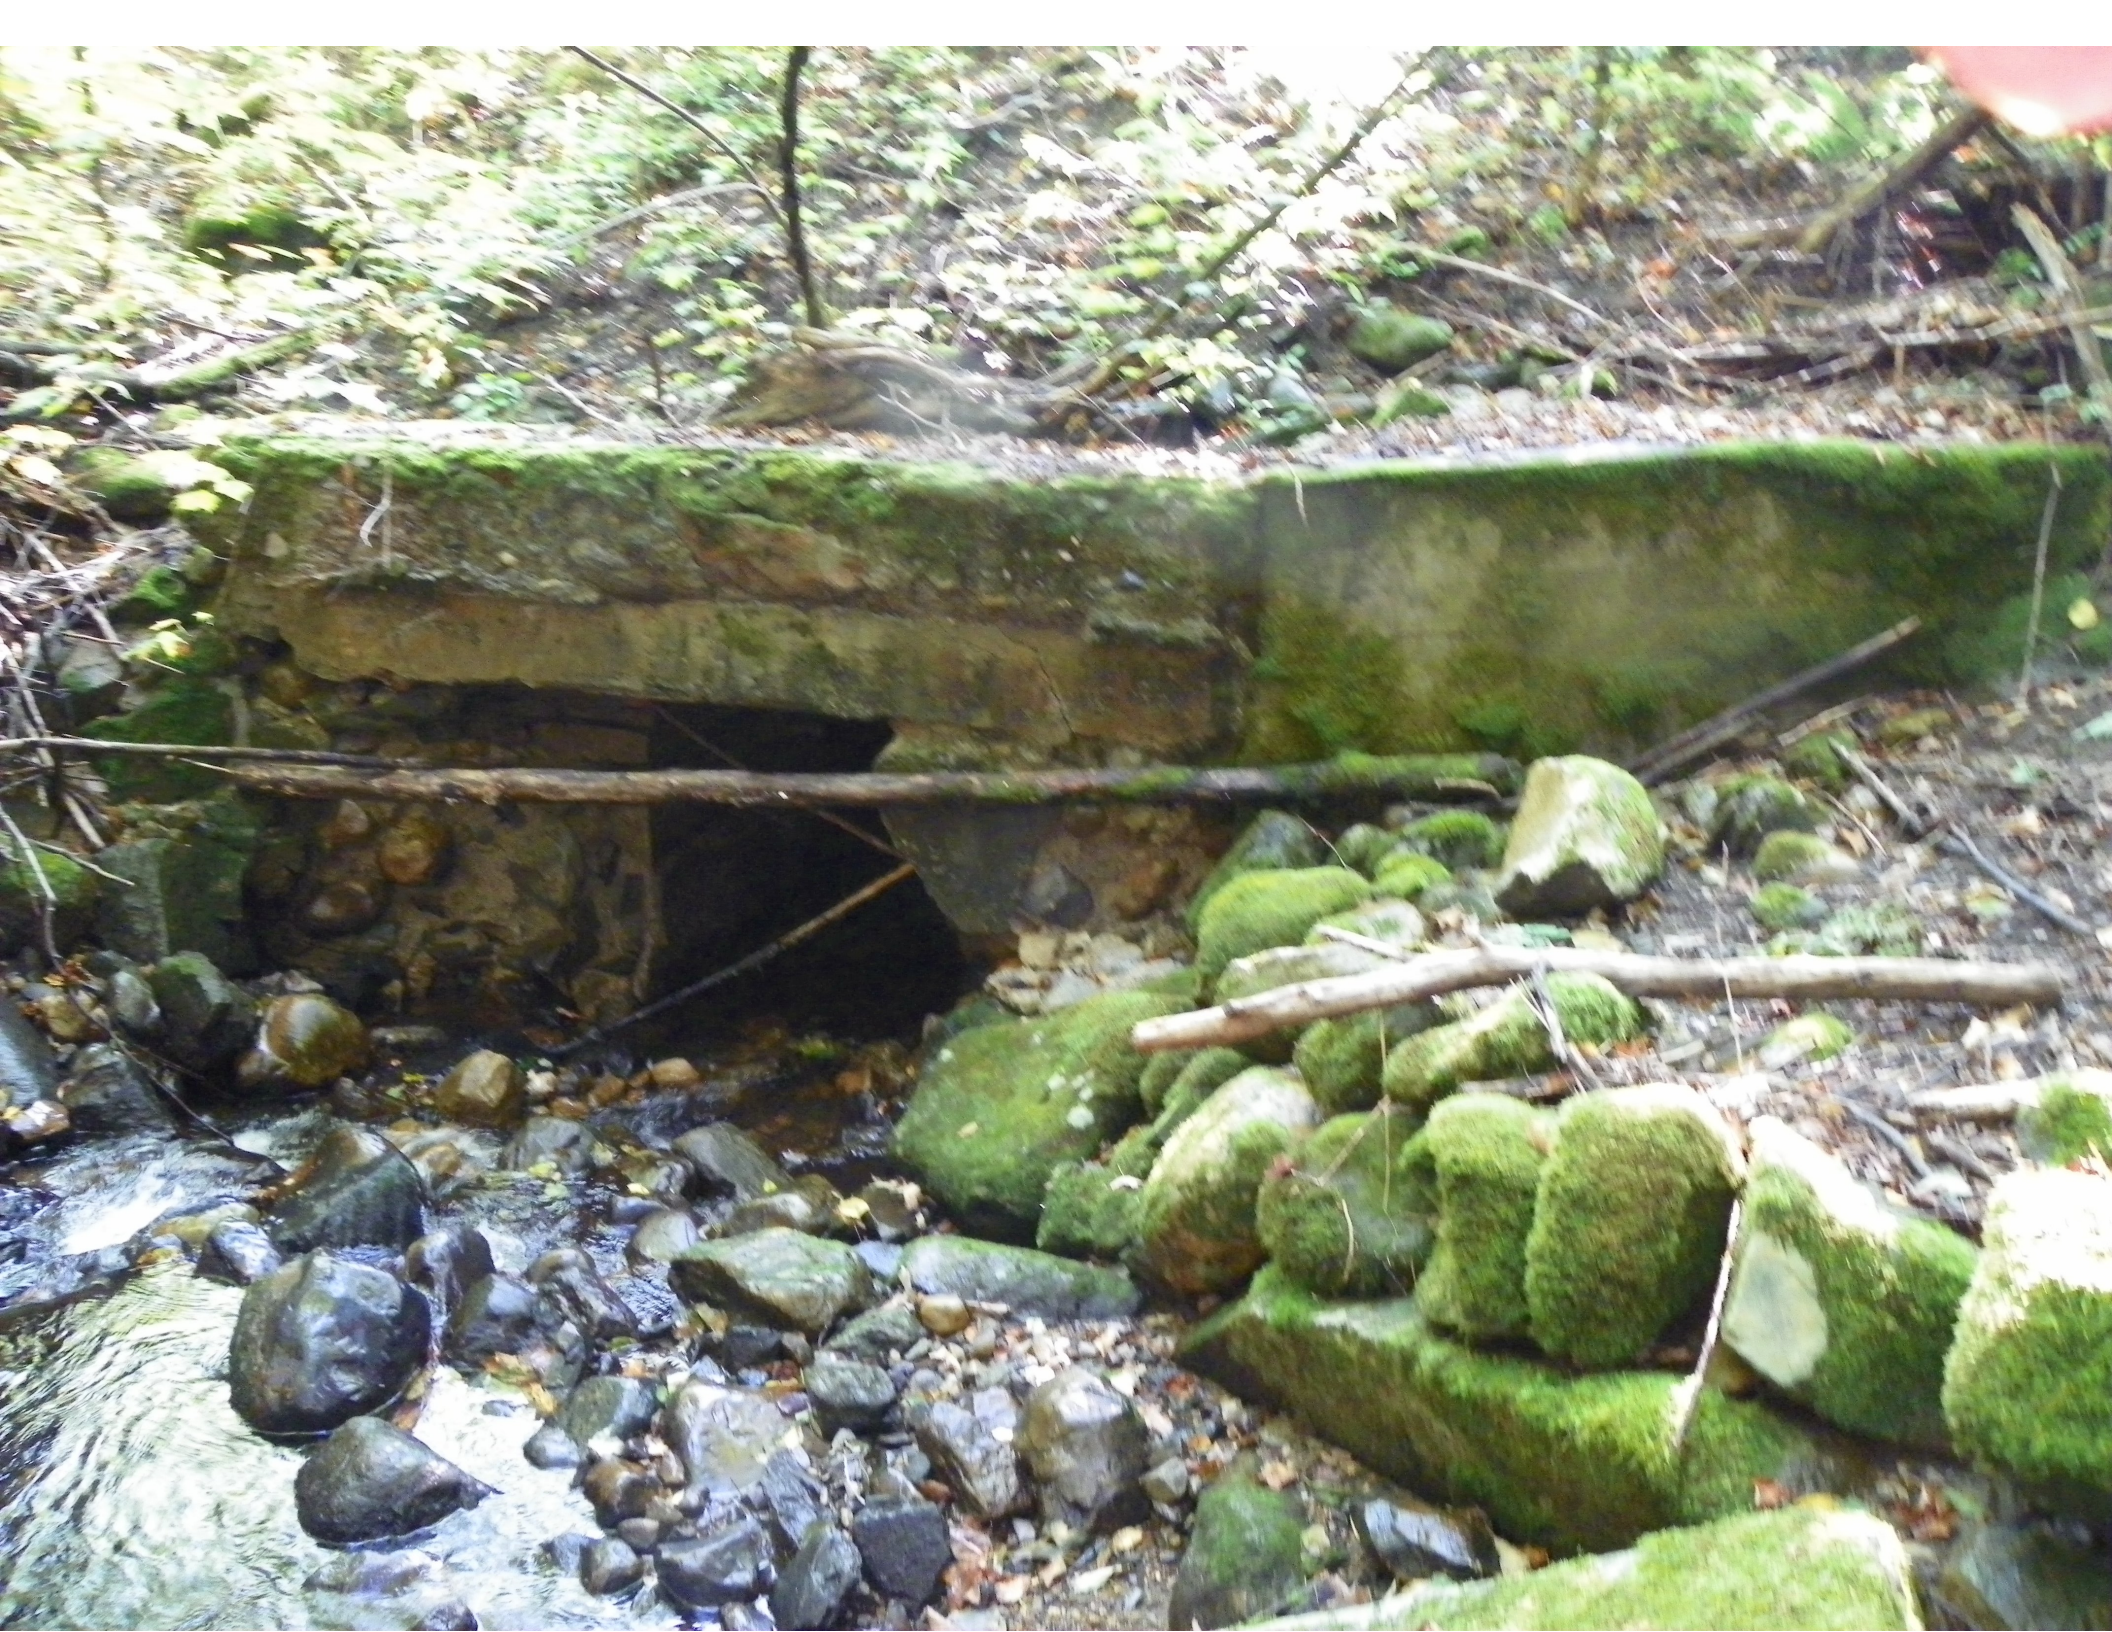
4'x5' BOX SOUTH INLET HEADER CRACKED
