### Culvert Inspection Form

Railroad: <b>GMRC</b>	Town: <u>SCREWSBURY</u>
Valuation Sheet: <b>V 3 / 43</b>	Valuation Stationing: <u>2249+16</u>
Mile Post: <b>B 42.59</b>	GPS Coordinates: N: <u>43.49180</u> W: <u>72.88048</u>

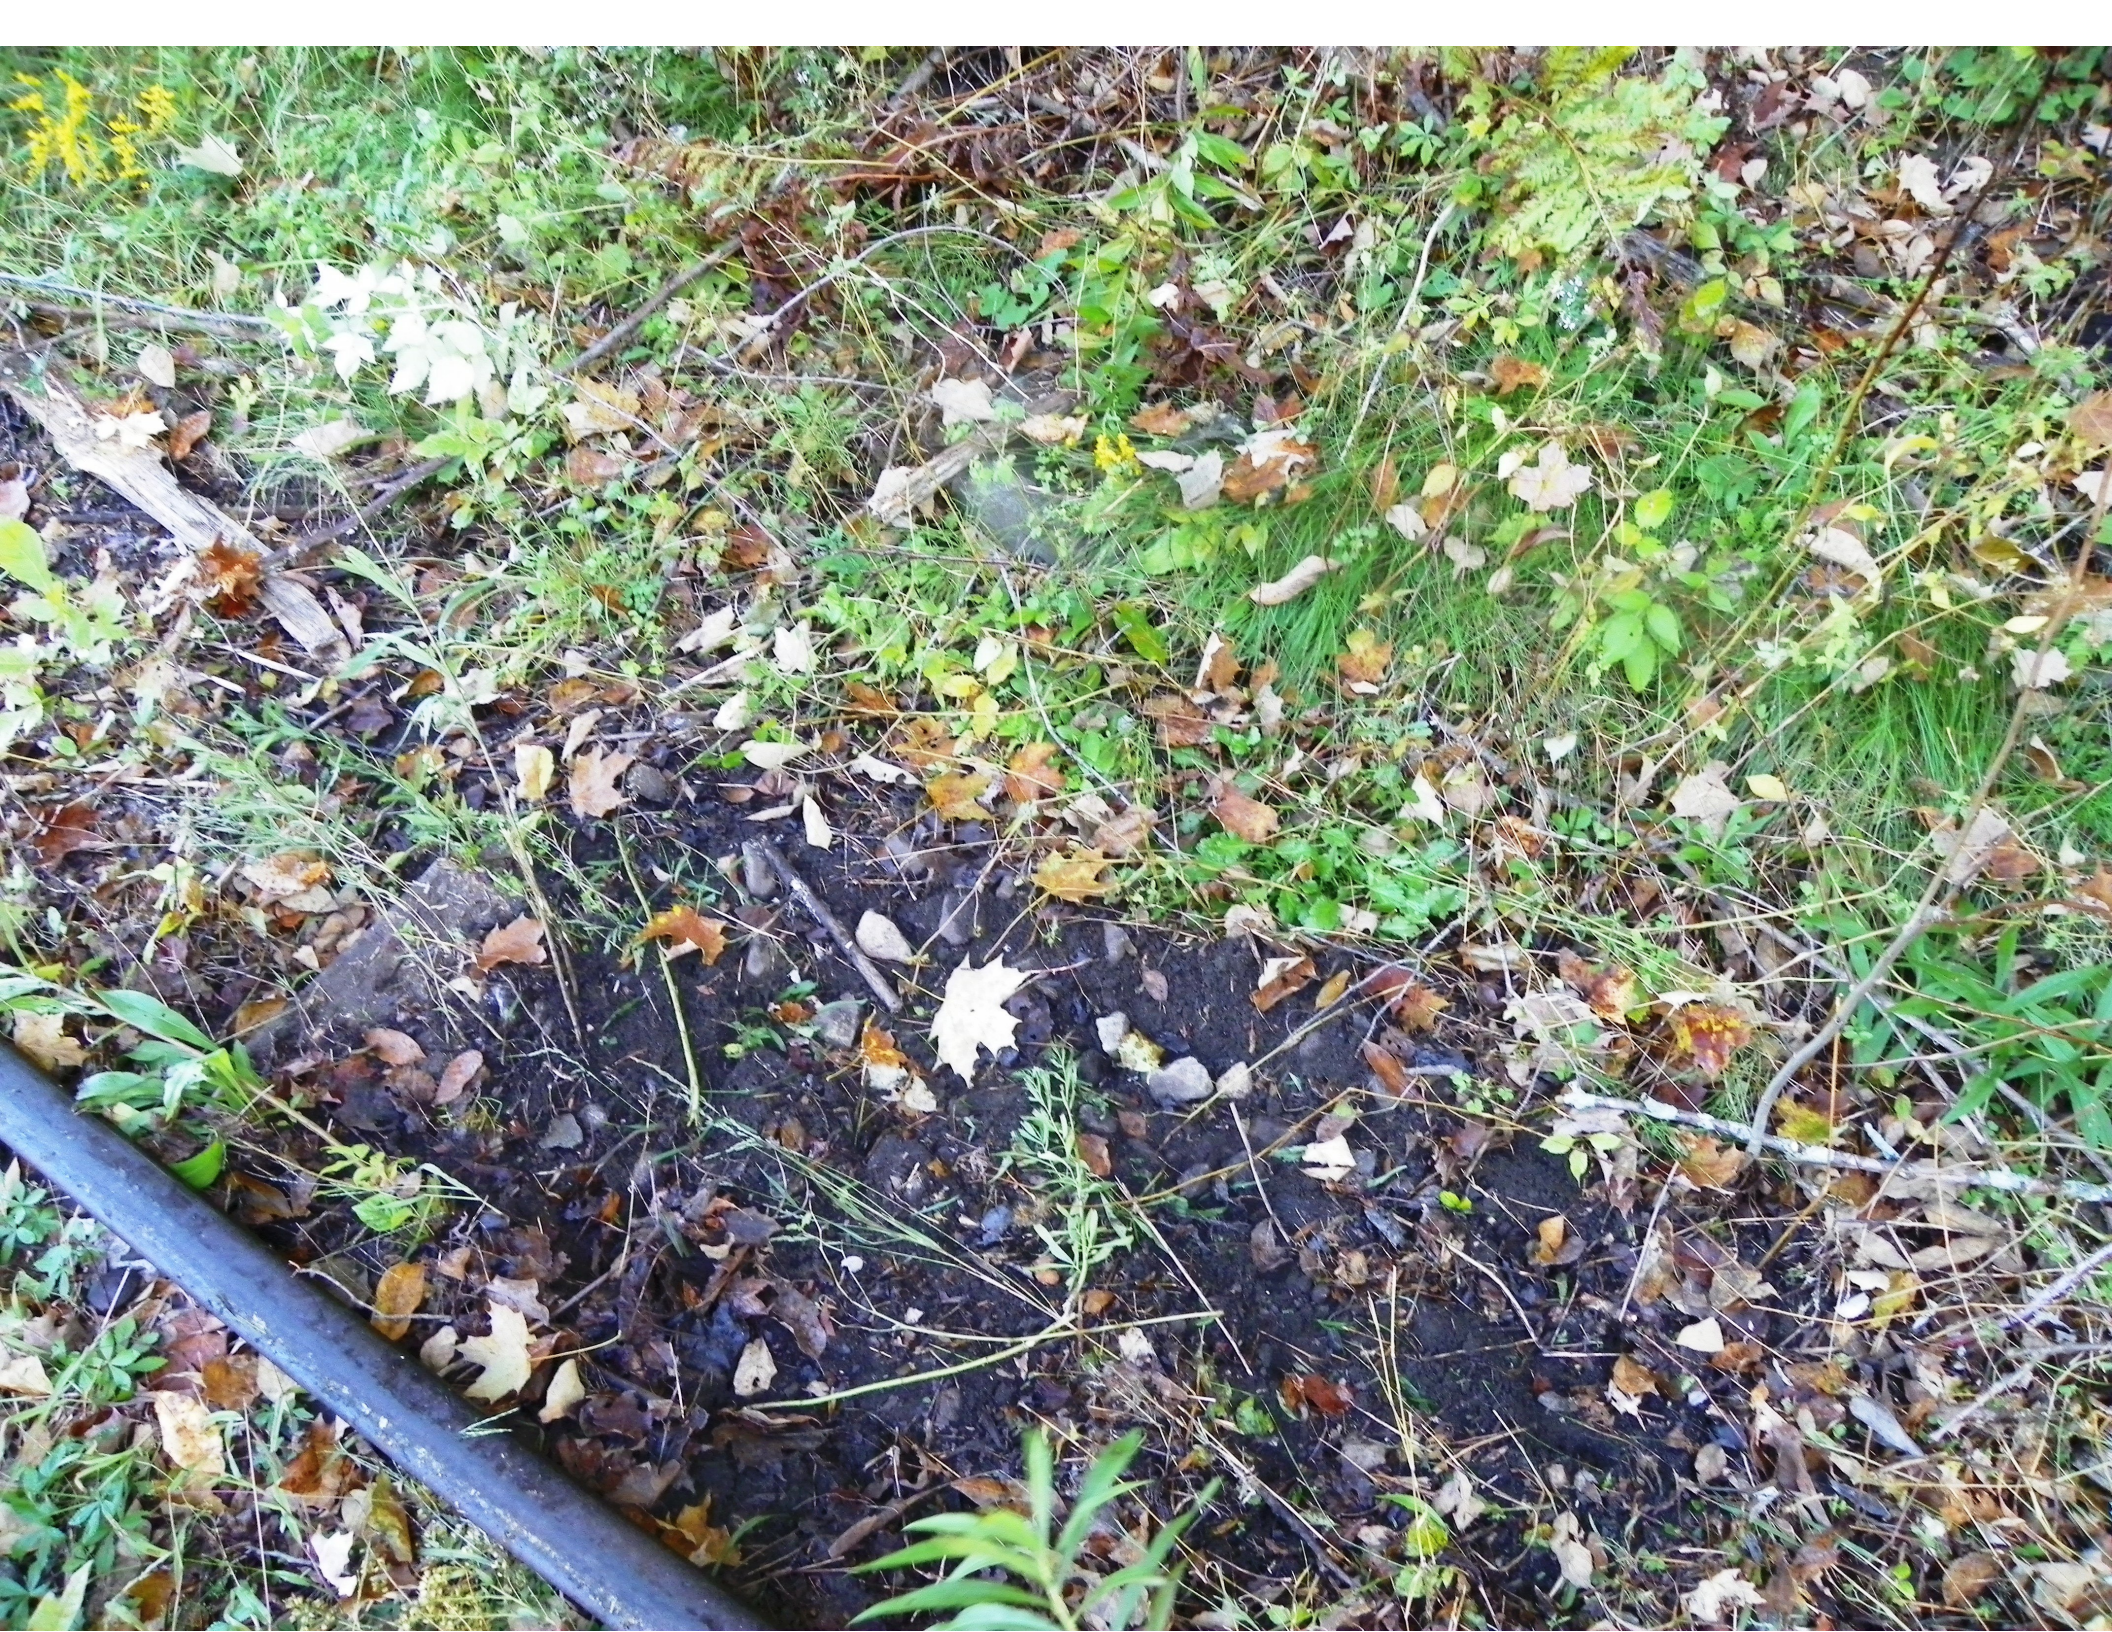
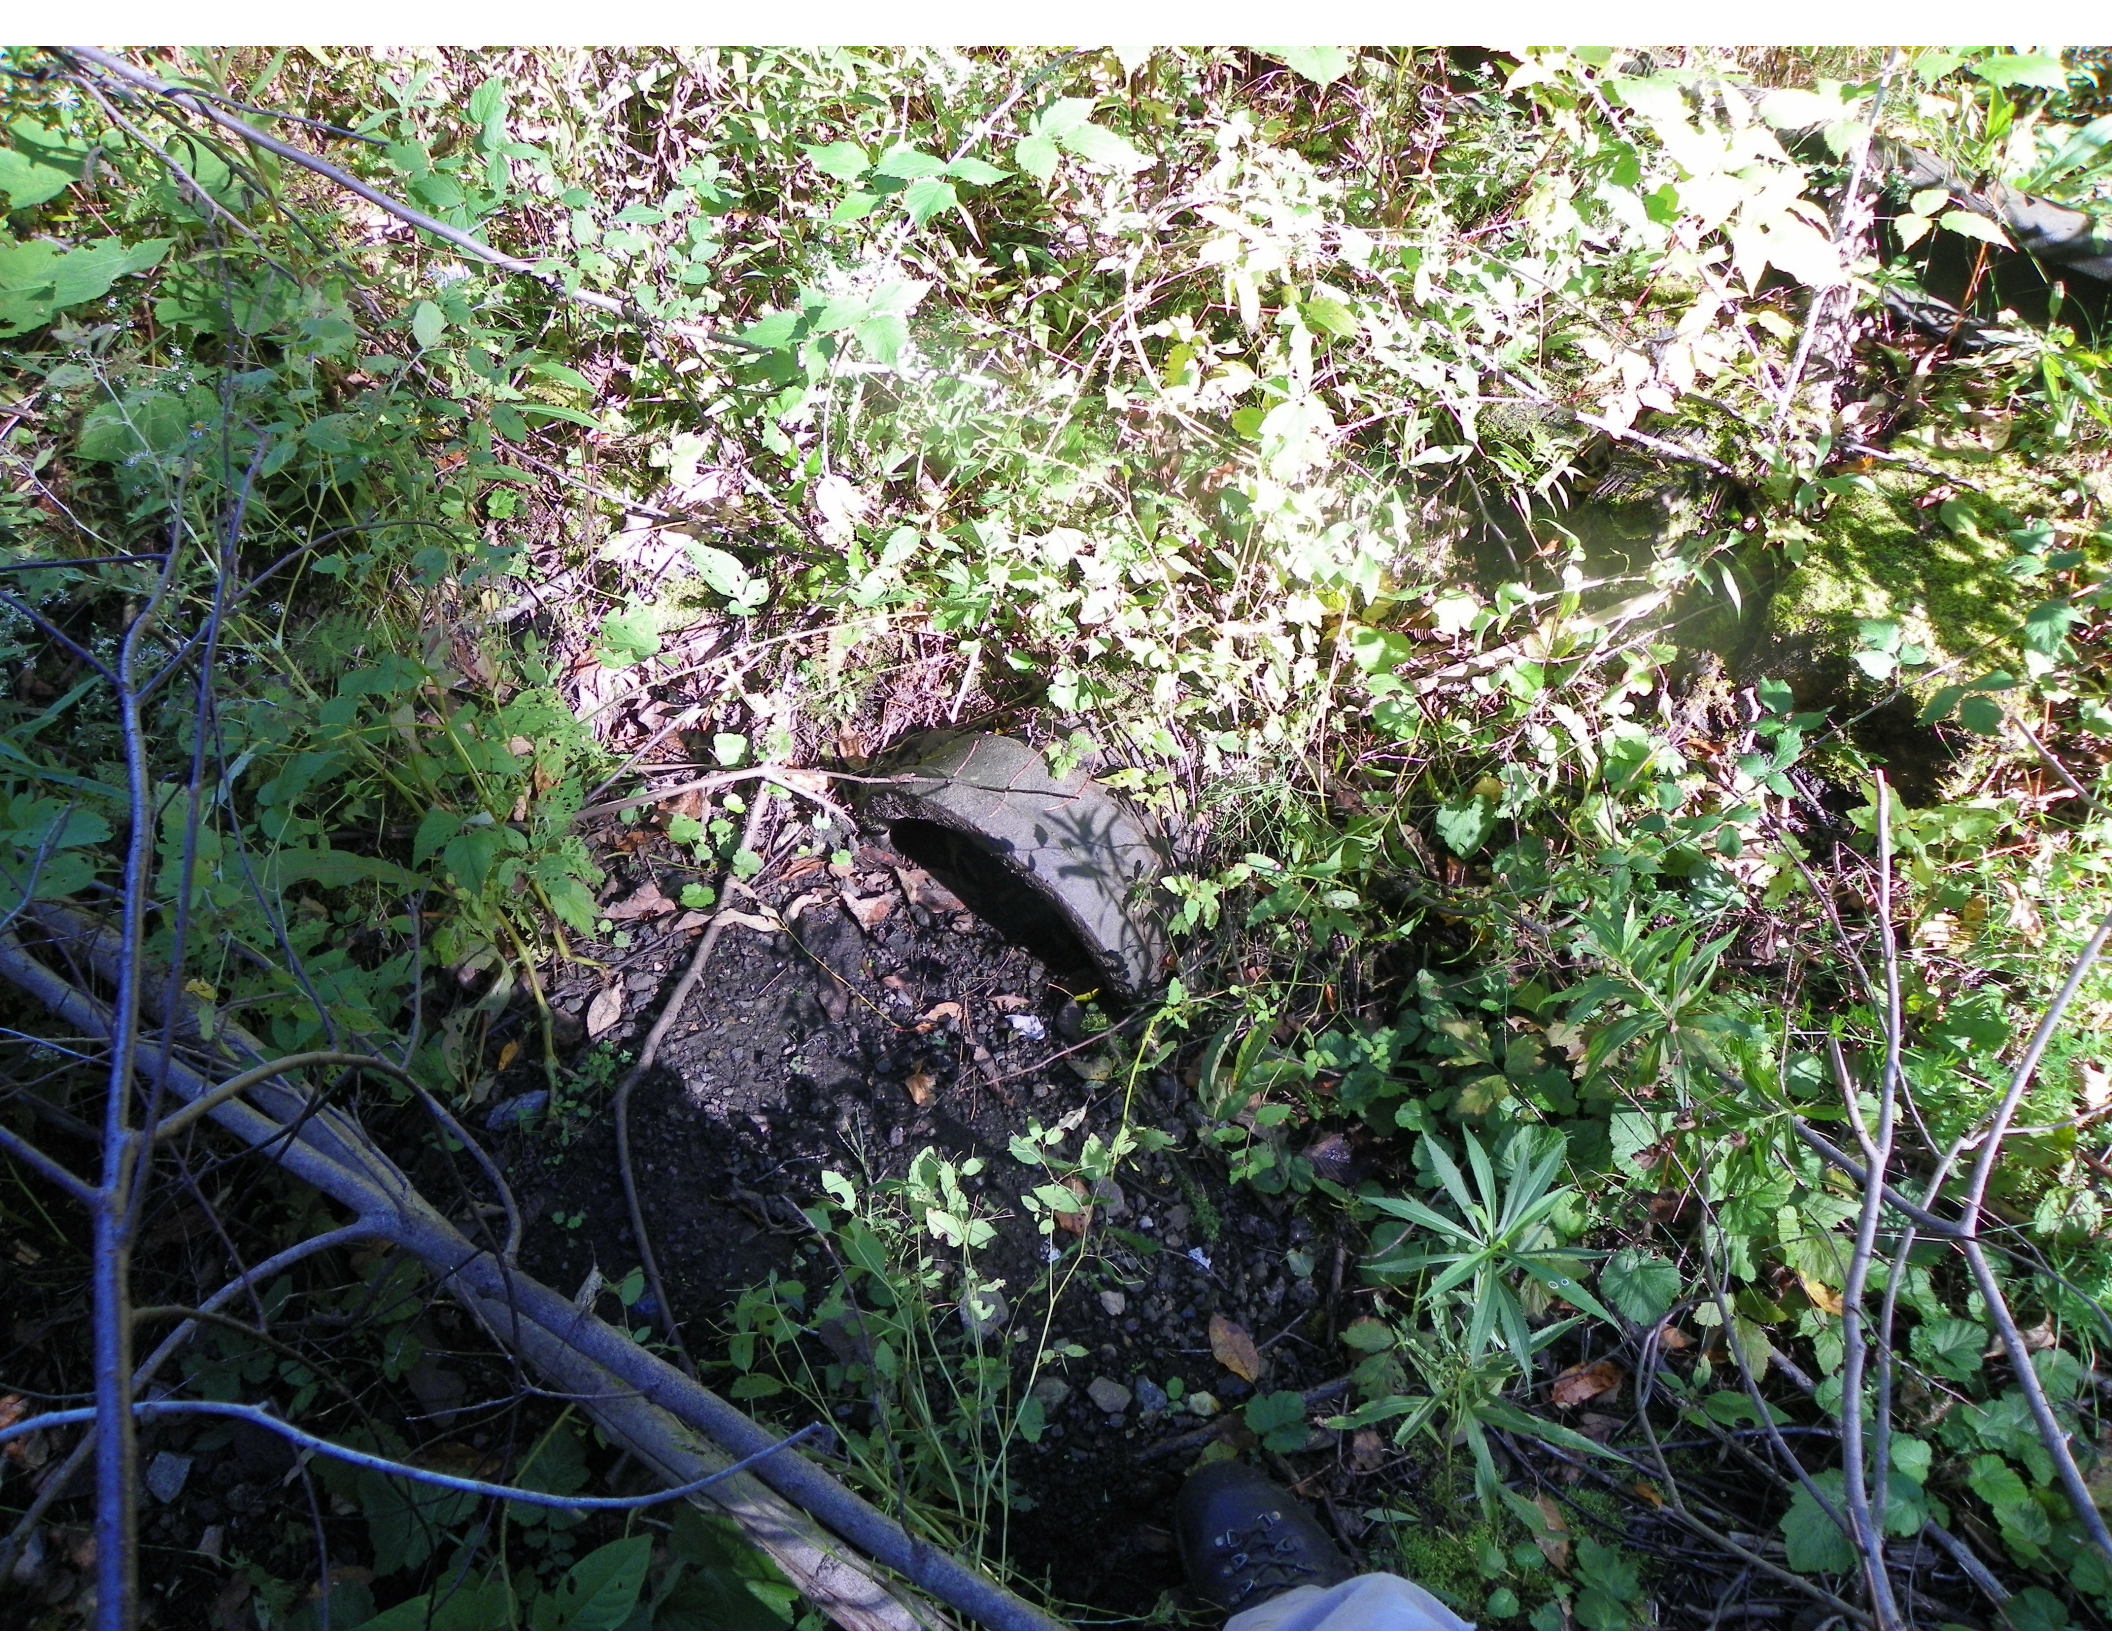
NO INLET COMPLETELY FILLED
