### Culvert Inspection Form

Railroad: <b>GMRC</b>	Town: <u>SAREWSBURY</u>
Valuation Sheet: <b>V 3 / 45</b>	Valuation Stationing: <u>2337+63</u>
Mile Post: <b>B 44.26</b>	GPS Coordinates: N: <u>43.50674</u> W: <u>72.90508</u>

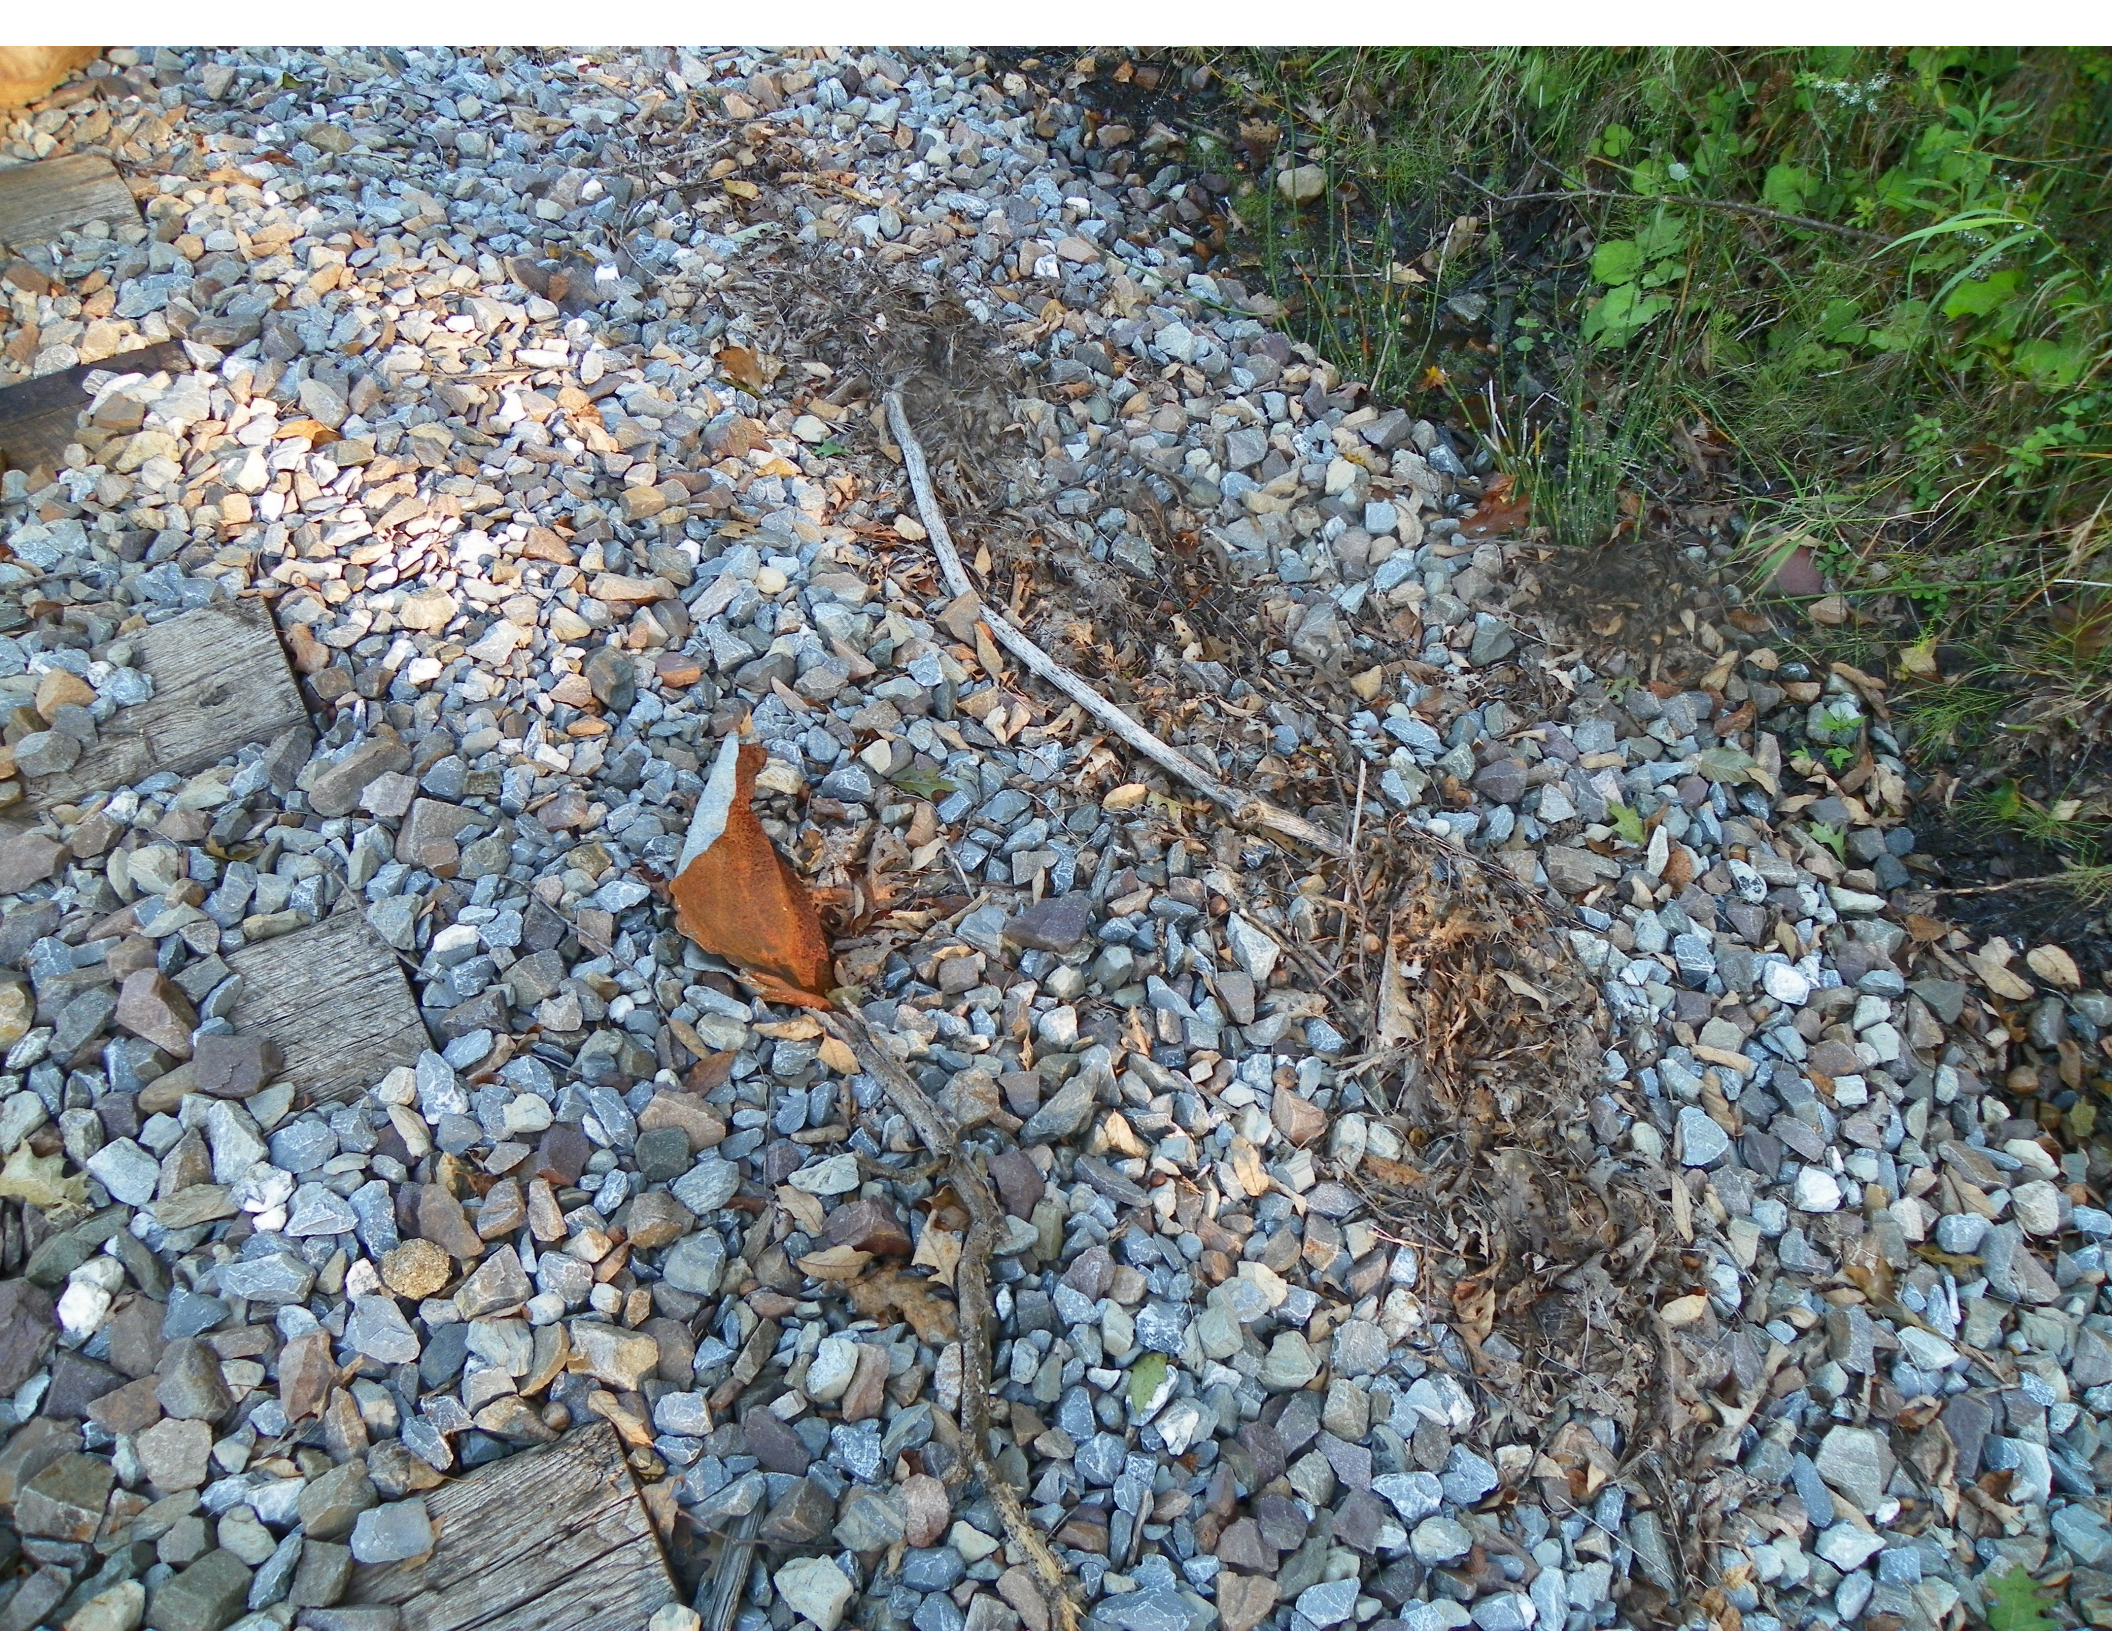
Aborn Inlet CRUSHED BY MAINTENANCE EQUIPMENT
