### Culvert Inspection Form

Railroad: <b>GMRC</b>	Town: <u>CLARENDON</u>
Valuation Sheet: <b>V 3 / 47</b>	Valuation Stationing: <u>2464 + 00</u>
Mile Post: <b>B 46.66</b>	GPS Coordinates: N: <u>43,53 222</u> W: <u>72,93 210</u>

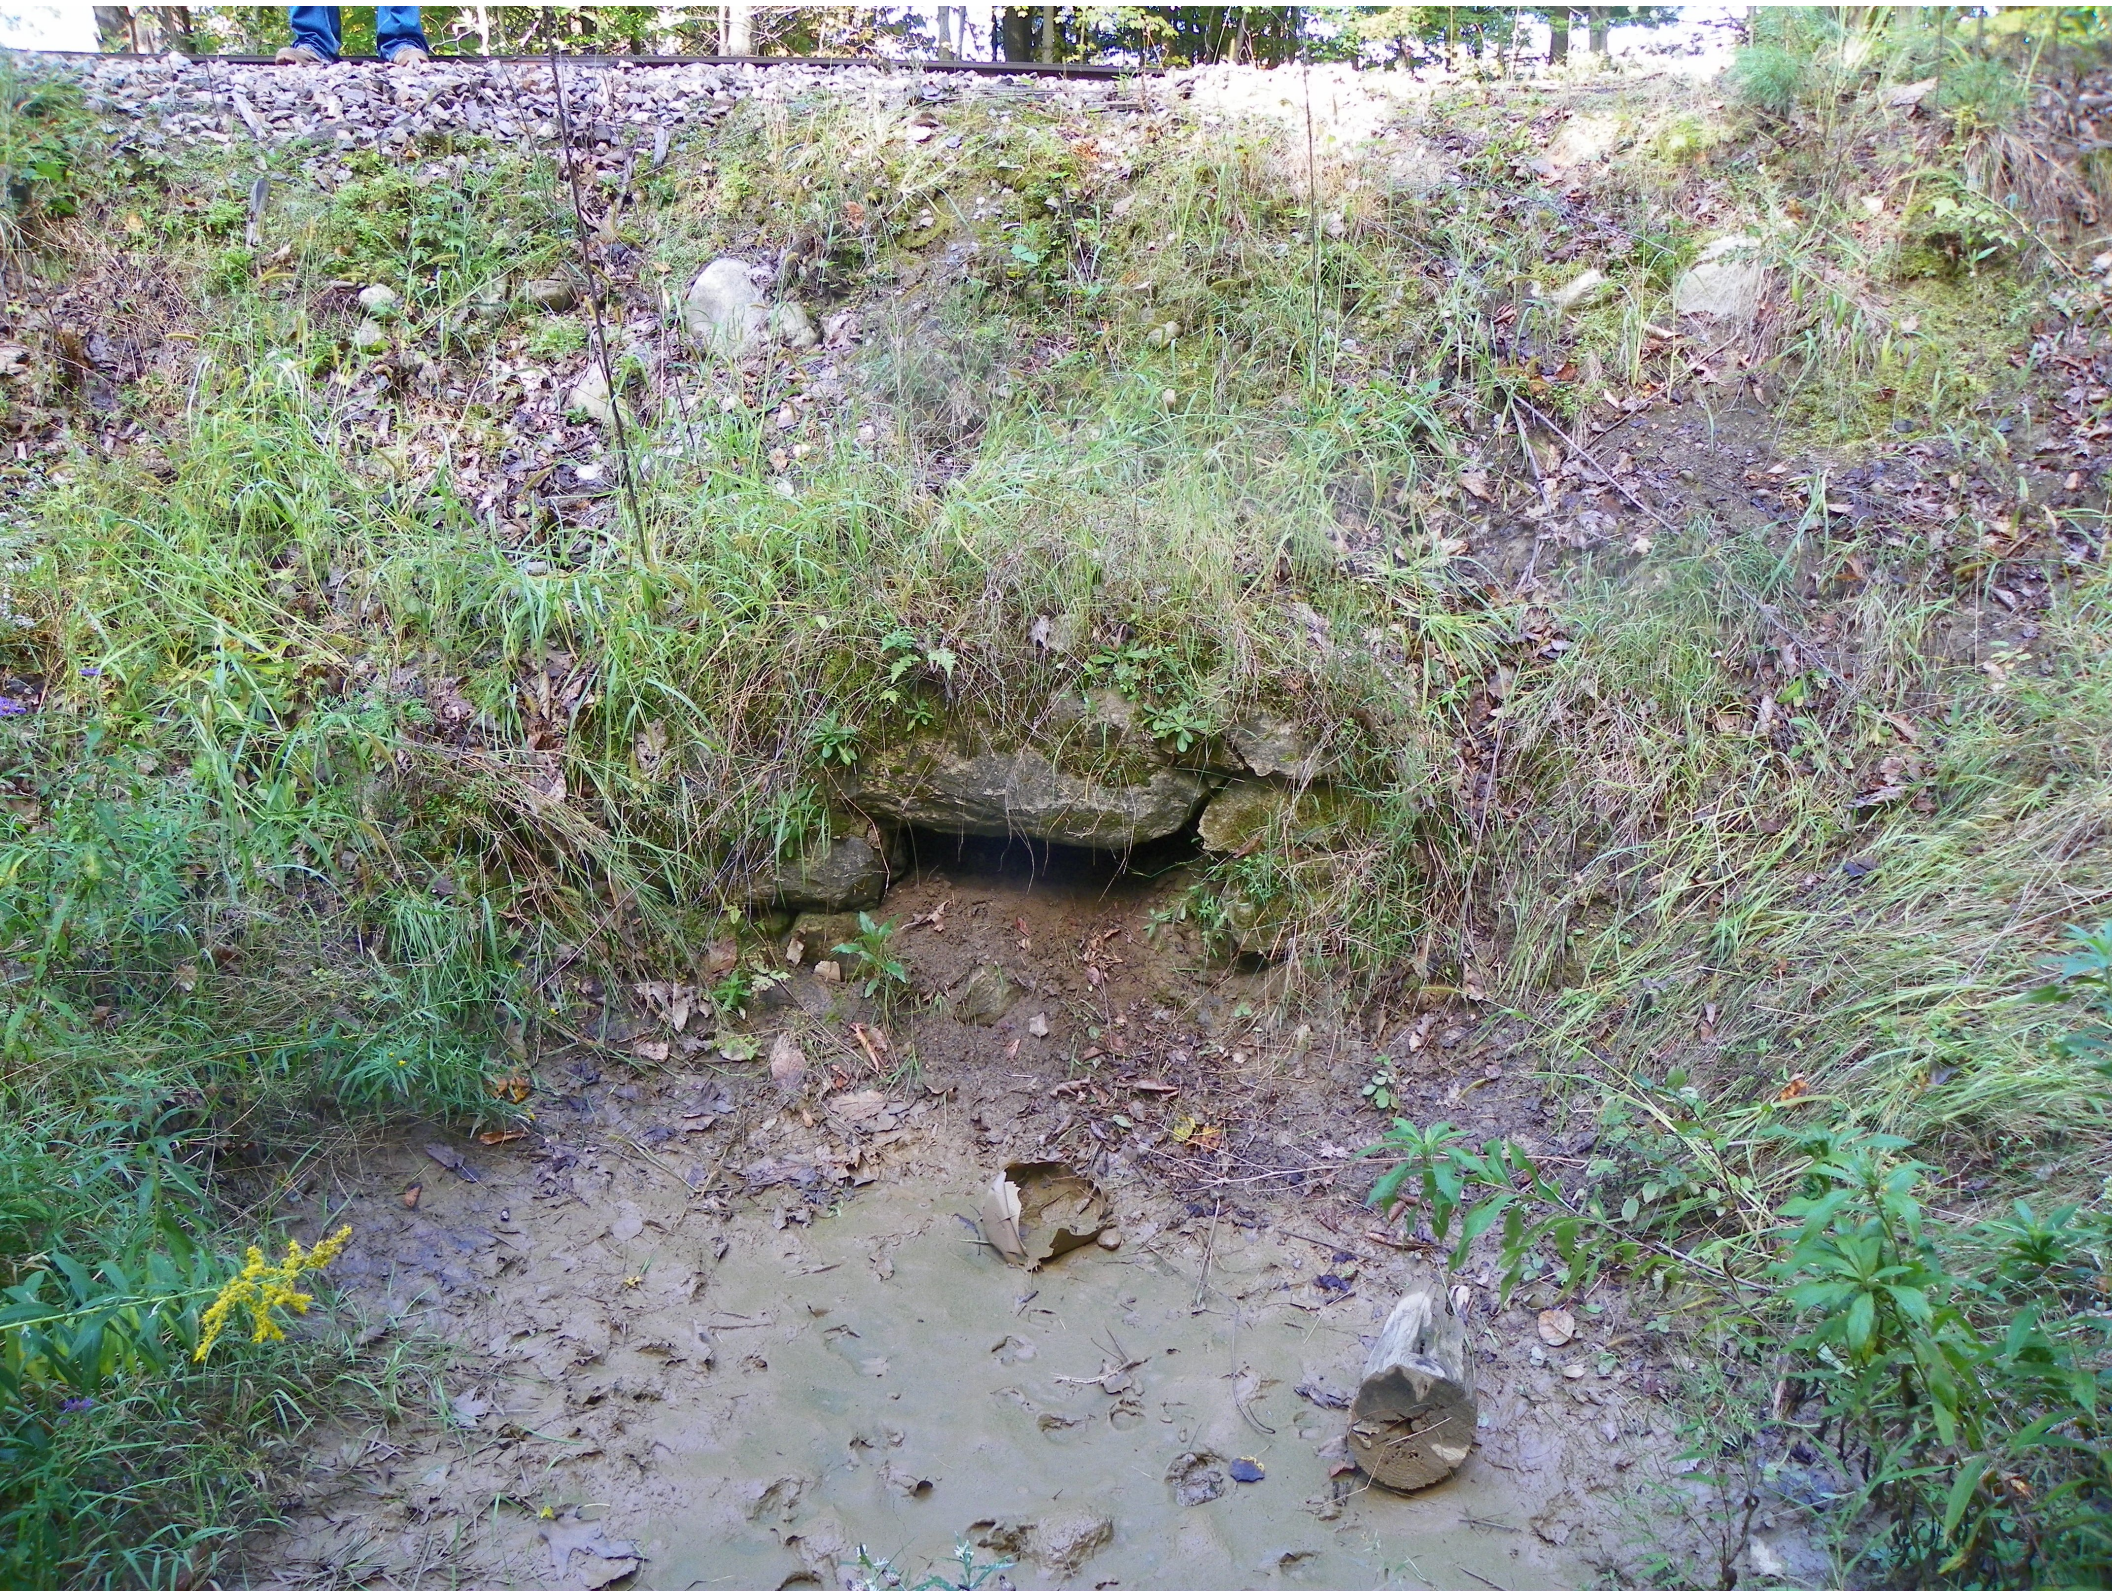
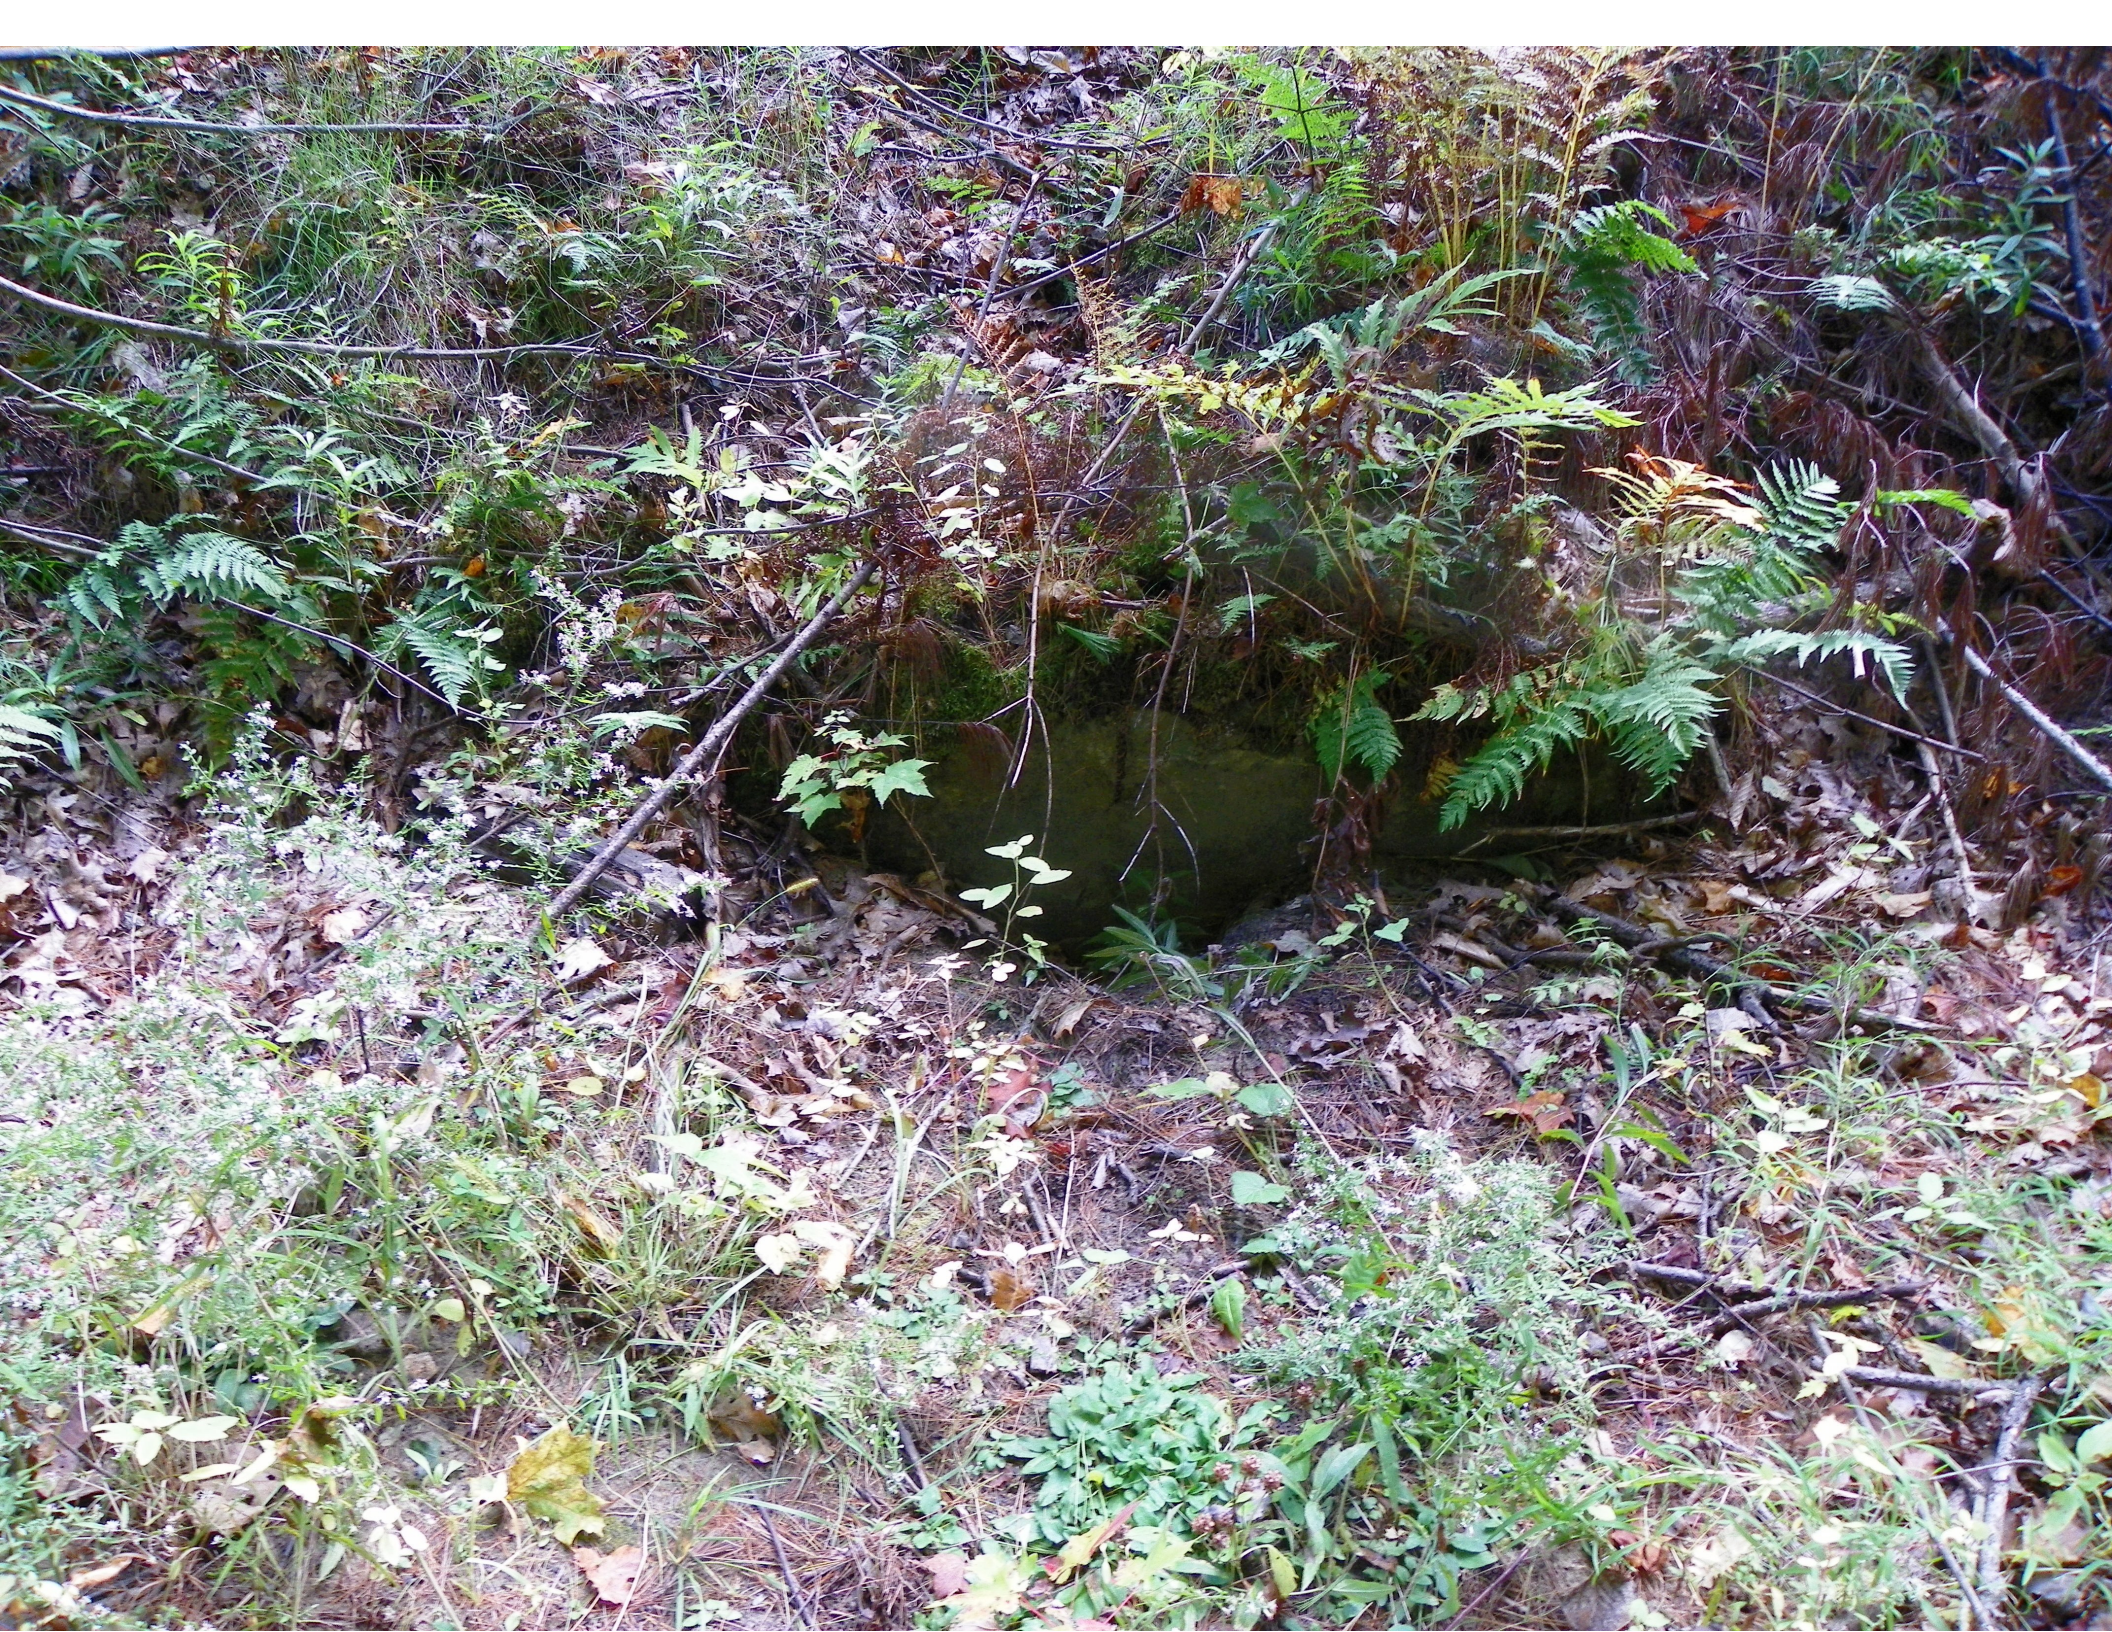
PLUGGED AT BOTH ENDS
