Culvert Inspection Form

Railroad: <u>WACR CRL</u>	Town: <u>BRADFORD</u>
Valuation Sheet: <u>V43</u> <u>27</u>	Valuation Stationing: <u>1416 + 44</u>
Mile Post: <u>D 14.15</u>	GPS Coordinates: N: <u>43 58 30</u> W: <u>72 06 58</u>

Culvert #: 149.85

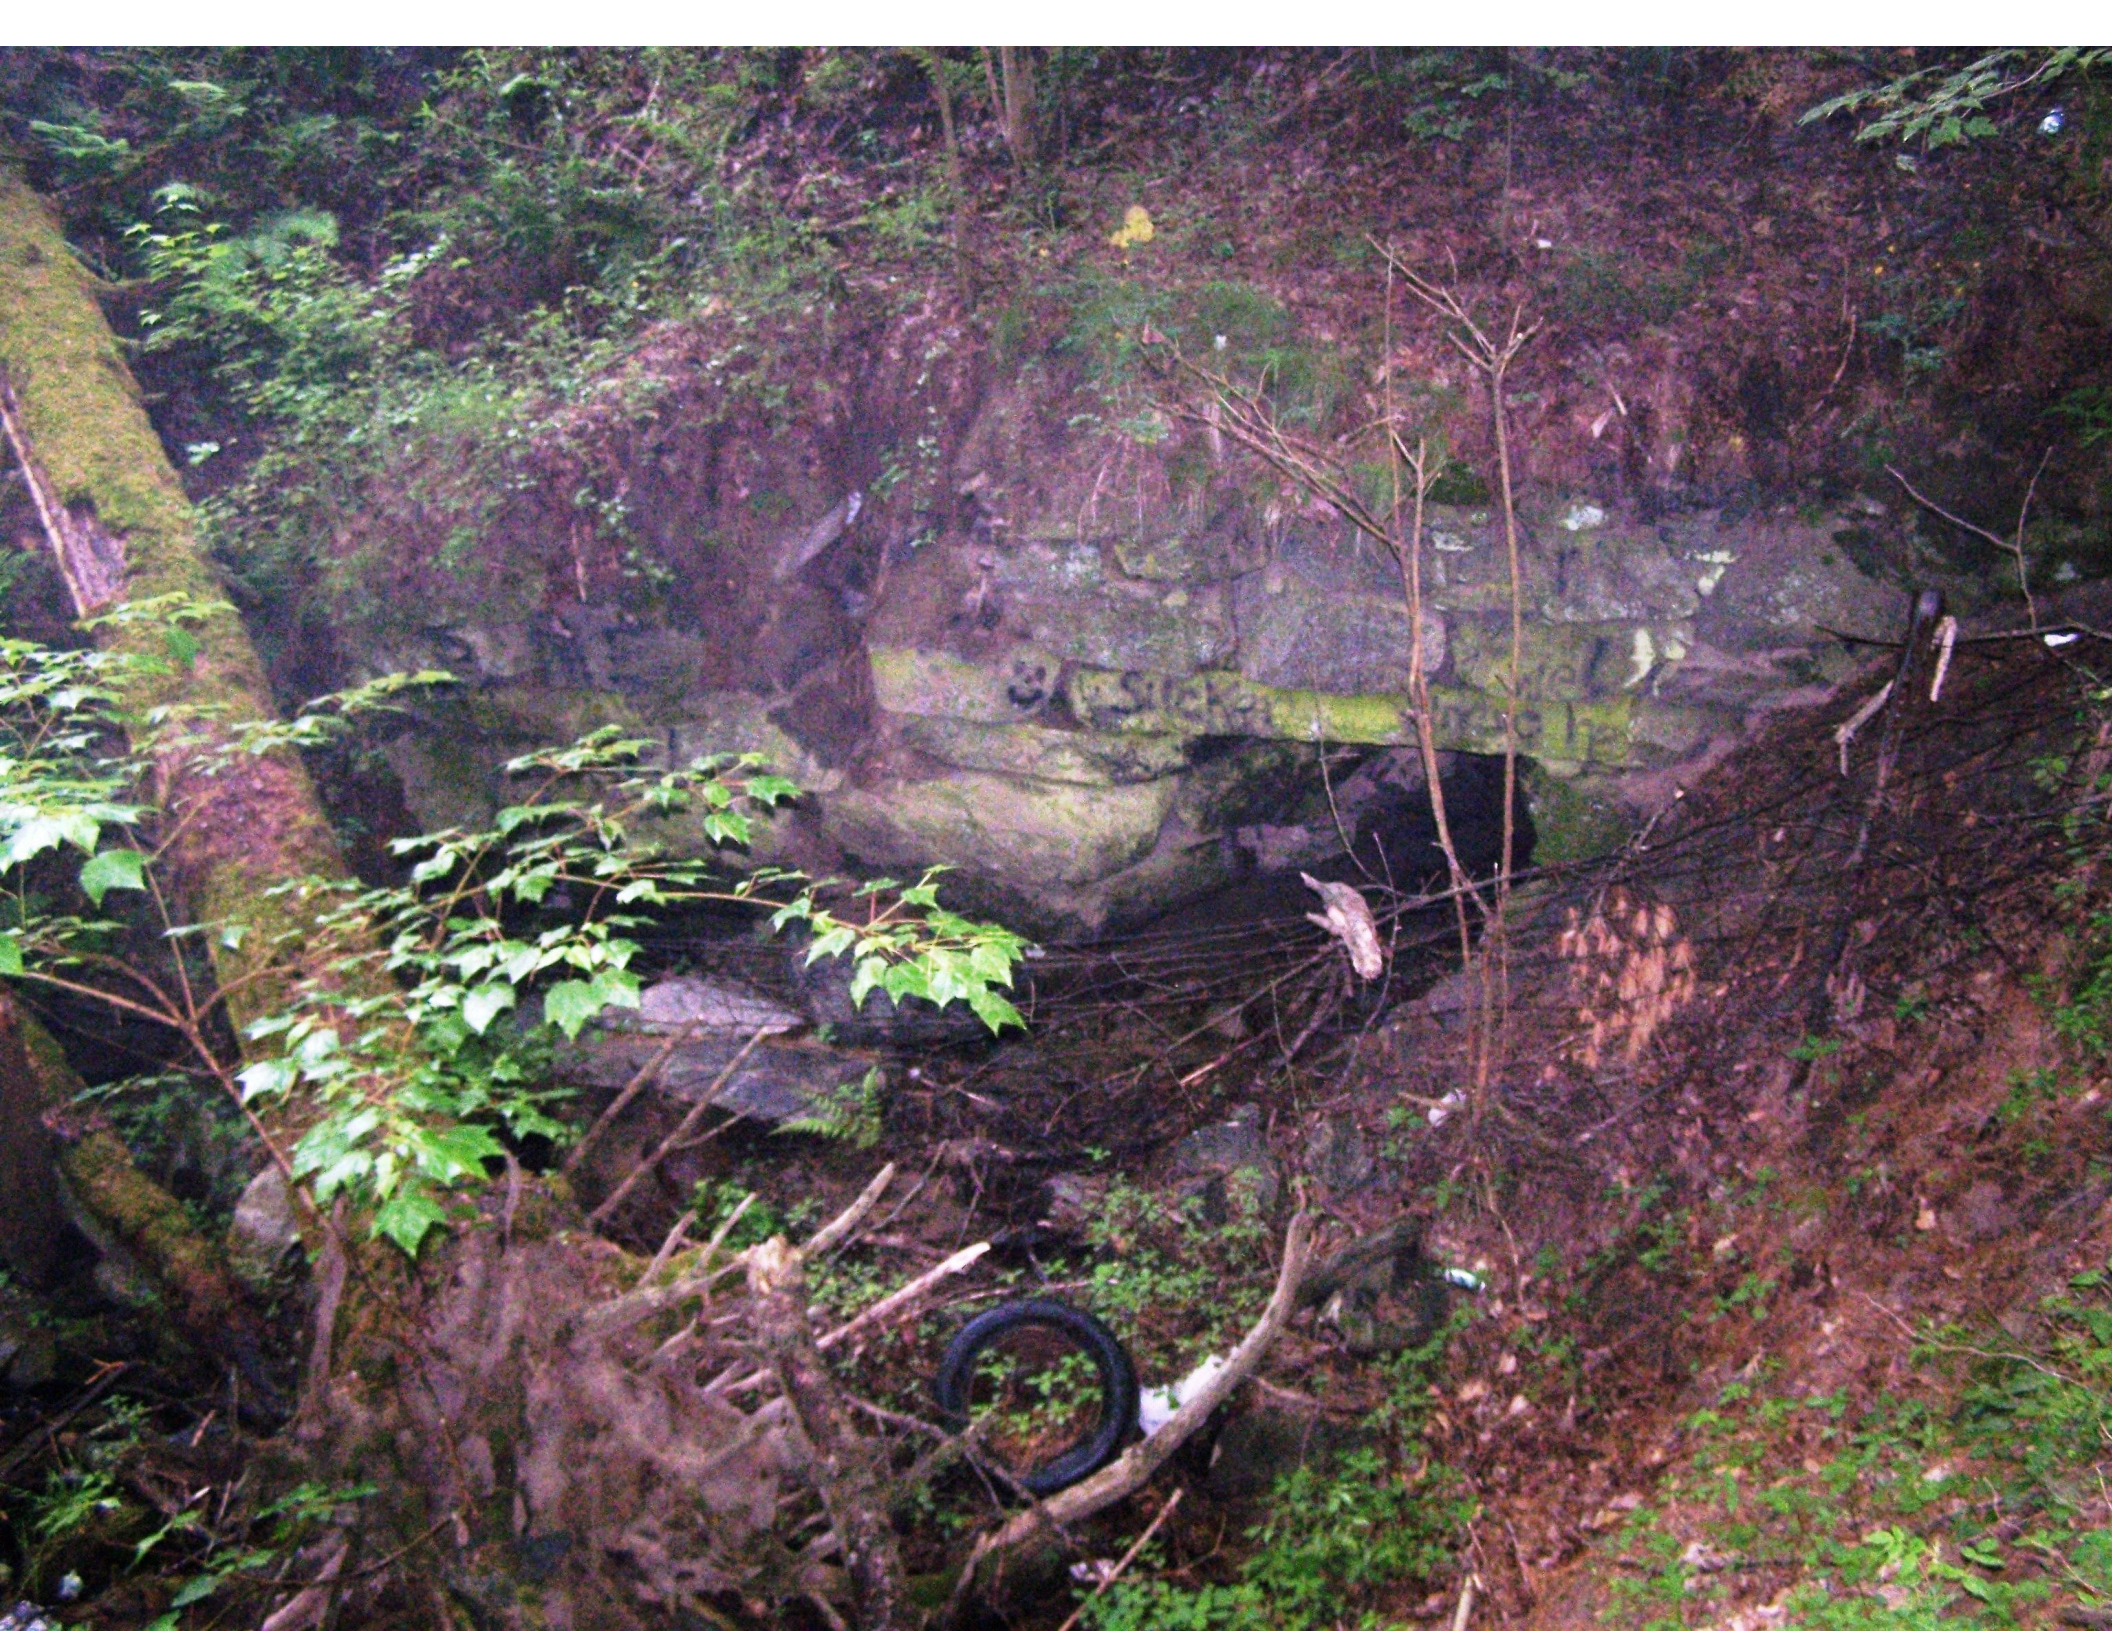
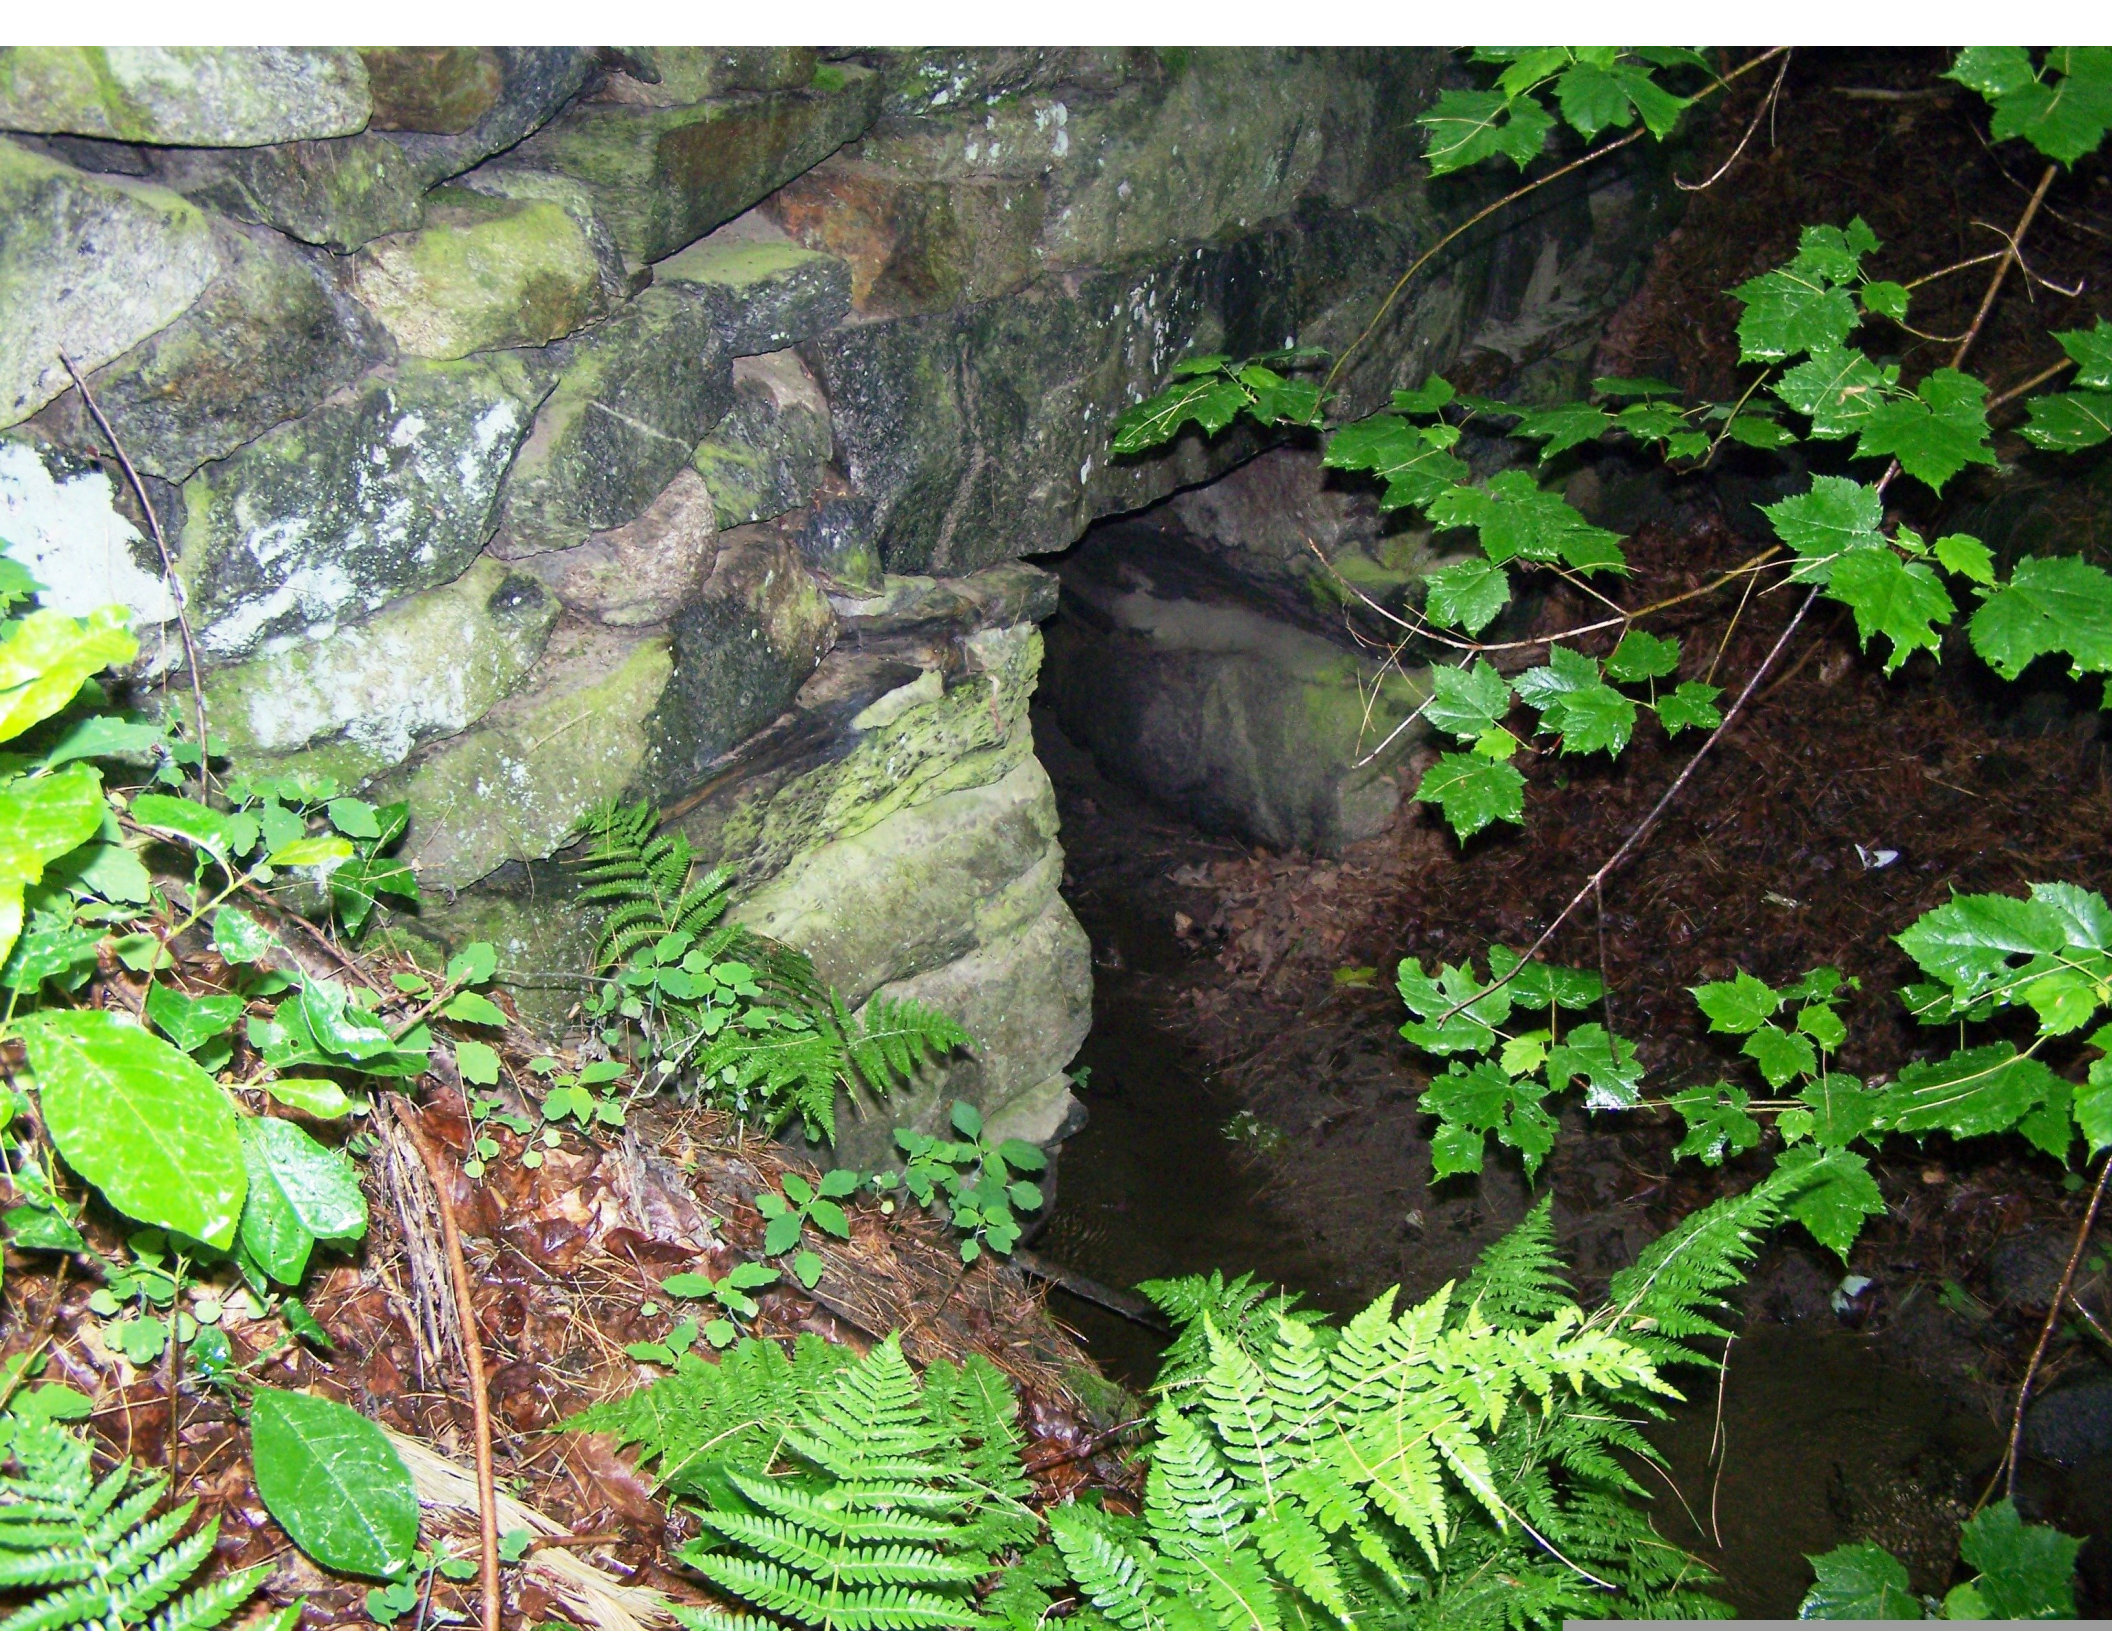
EAST HEADER WALL BREAKING UP ON SOUTH SIDE
