**Culvert Inspection Form**

Railroad: <u>WACR CRL</u>	Town: <u>FAIRLEE</u>
Valuation Sheet: <u>V43</u> <u>22</u>	Valuation Stationing: <u>1151 + 71</u>
Mile Post: <u>D 19.16</u>	GPS Coordinates: N: <u>43 54 29</u> W: <u>72 08 26</u>

Culvert #: 144, 84

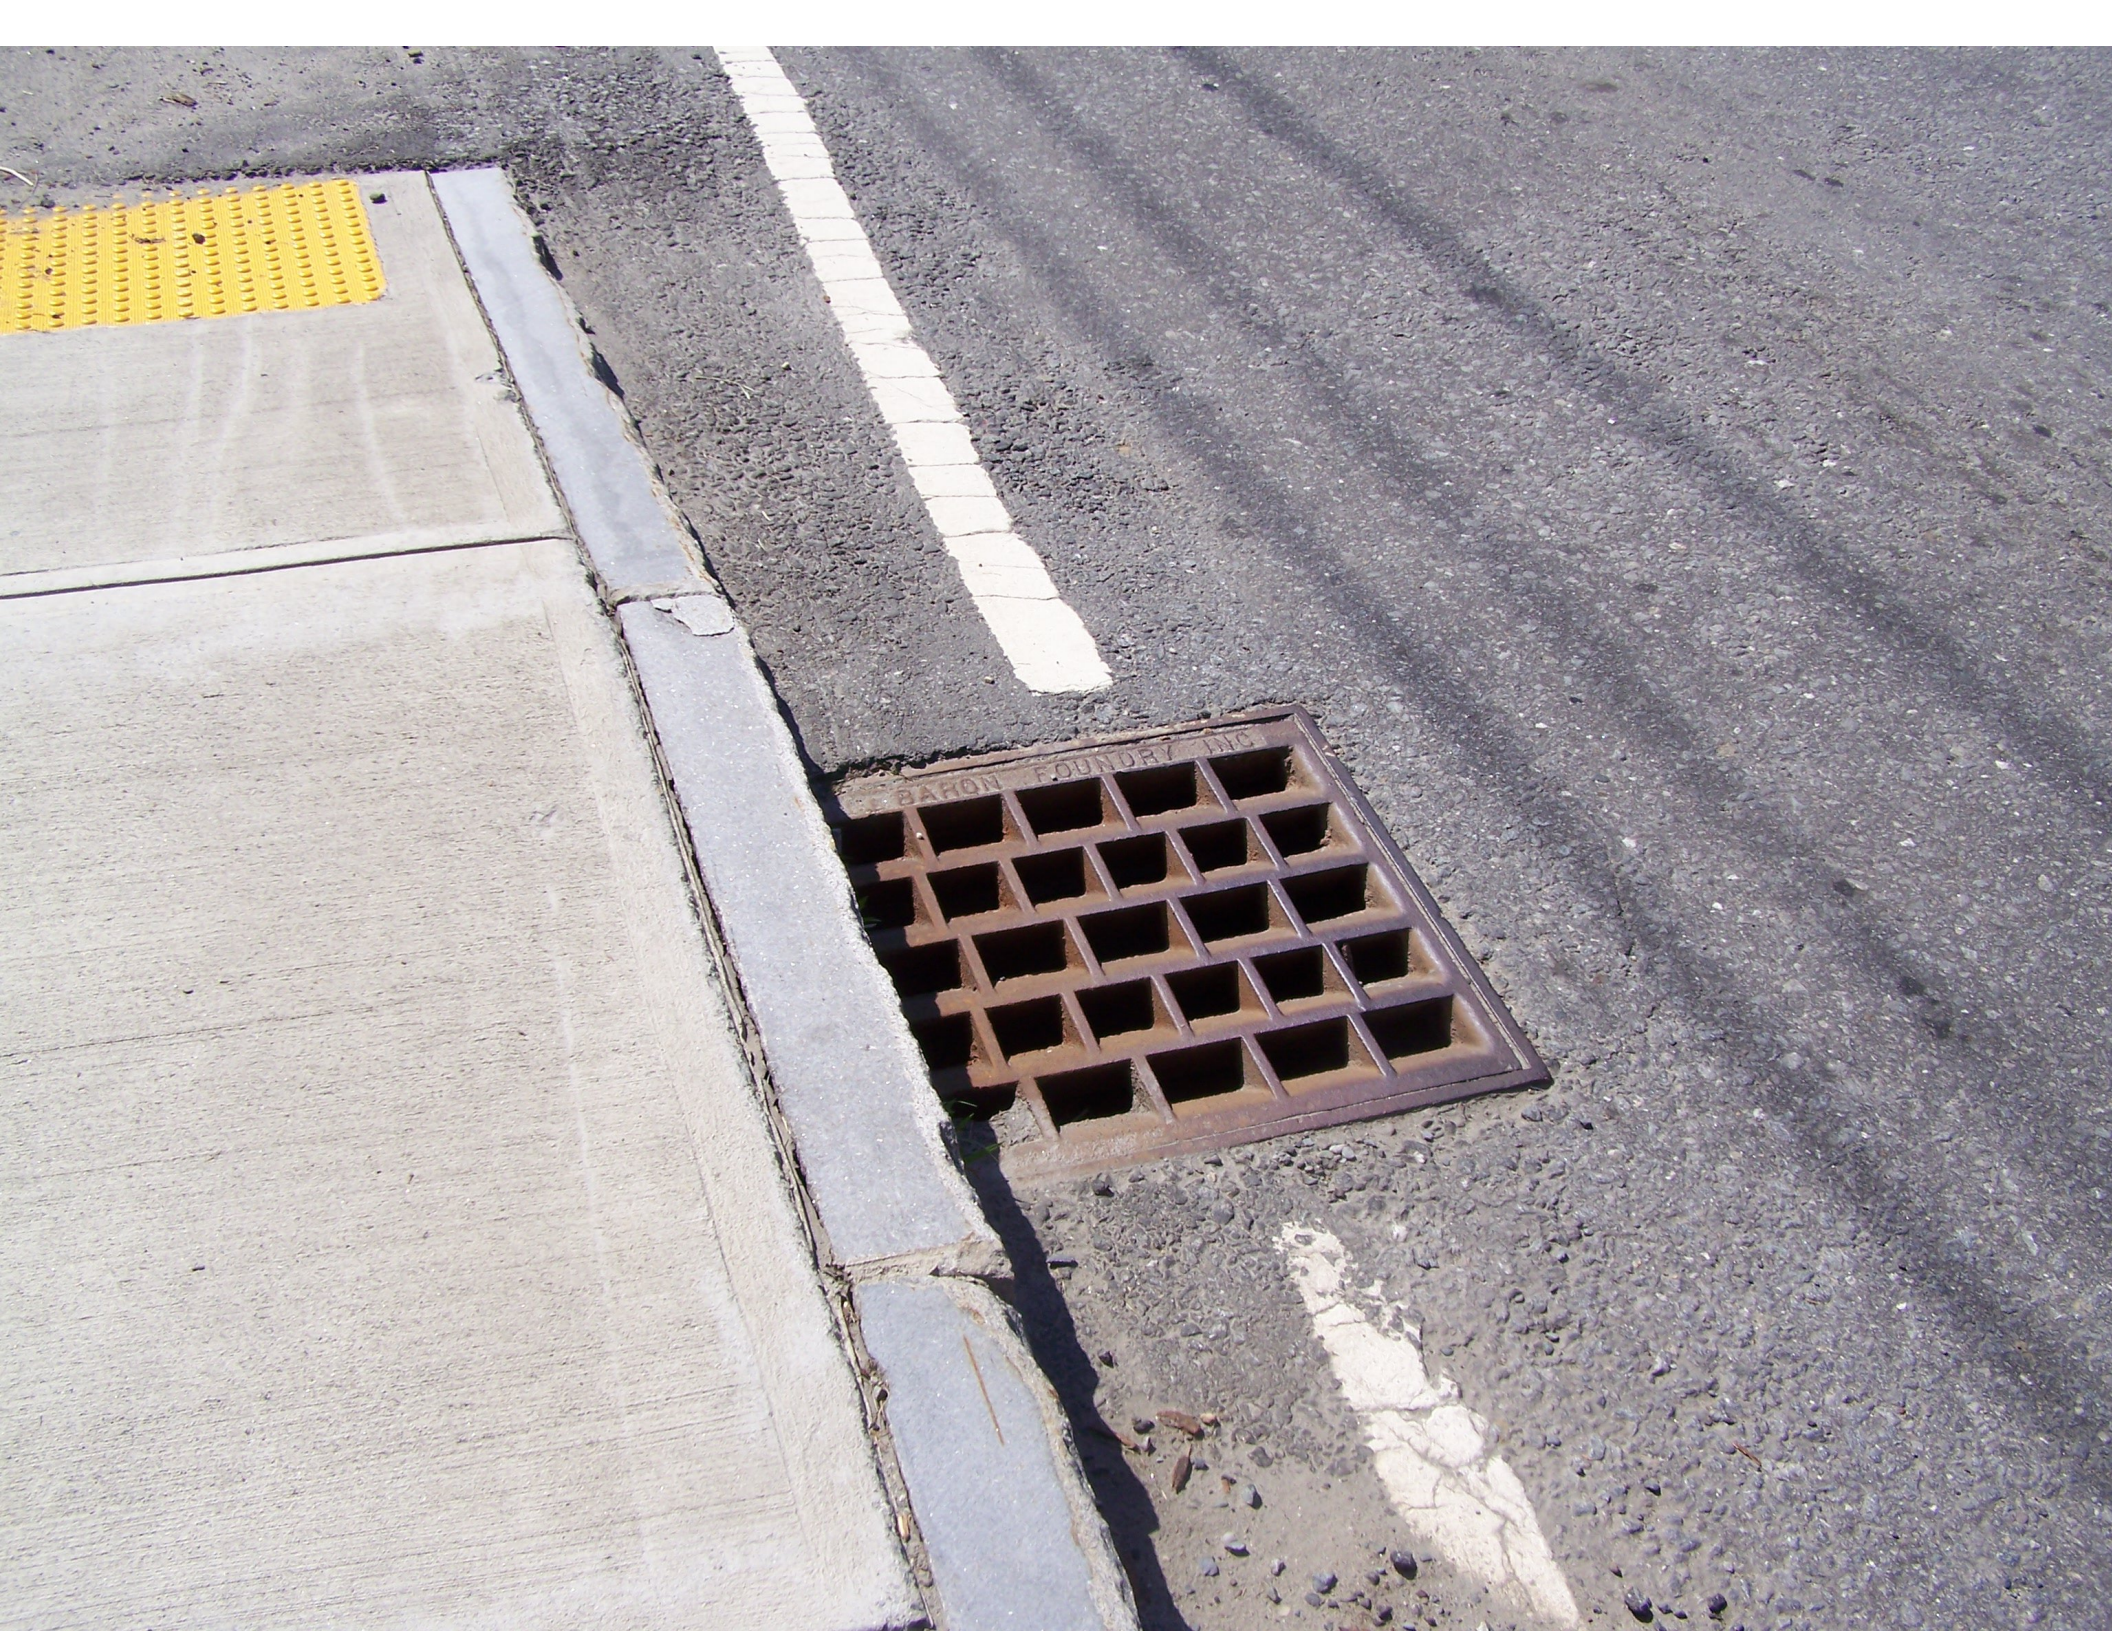
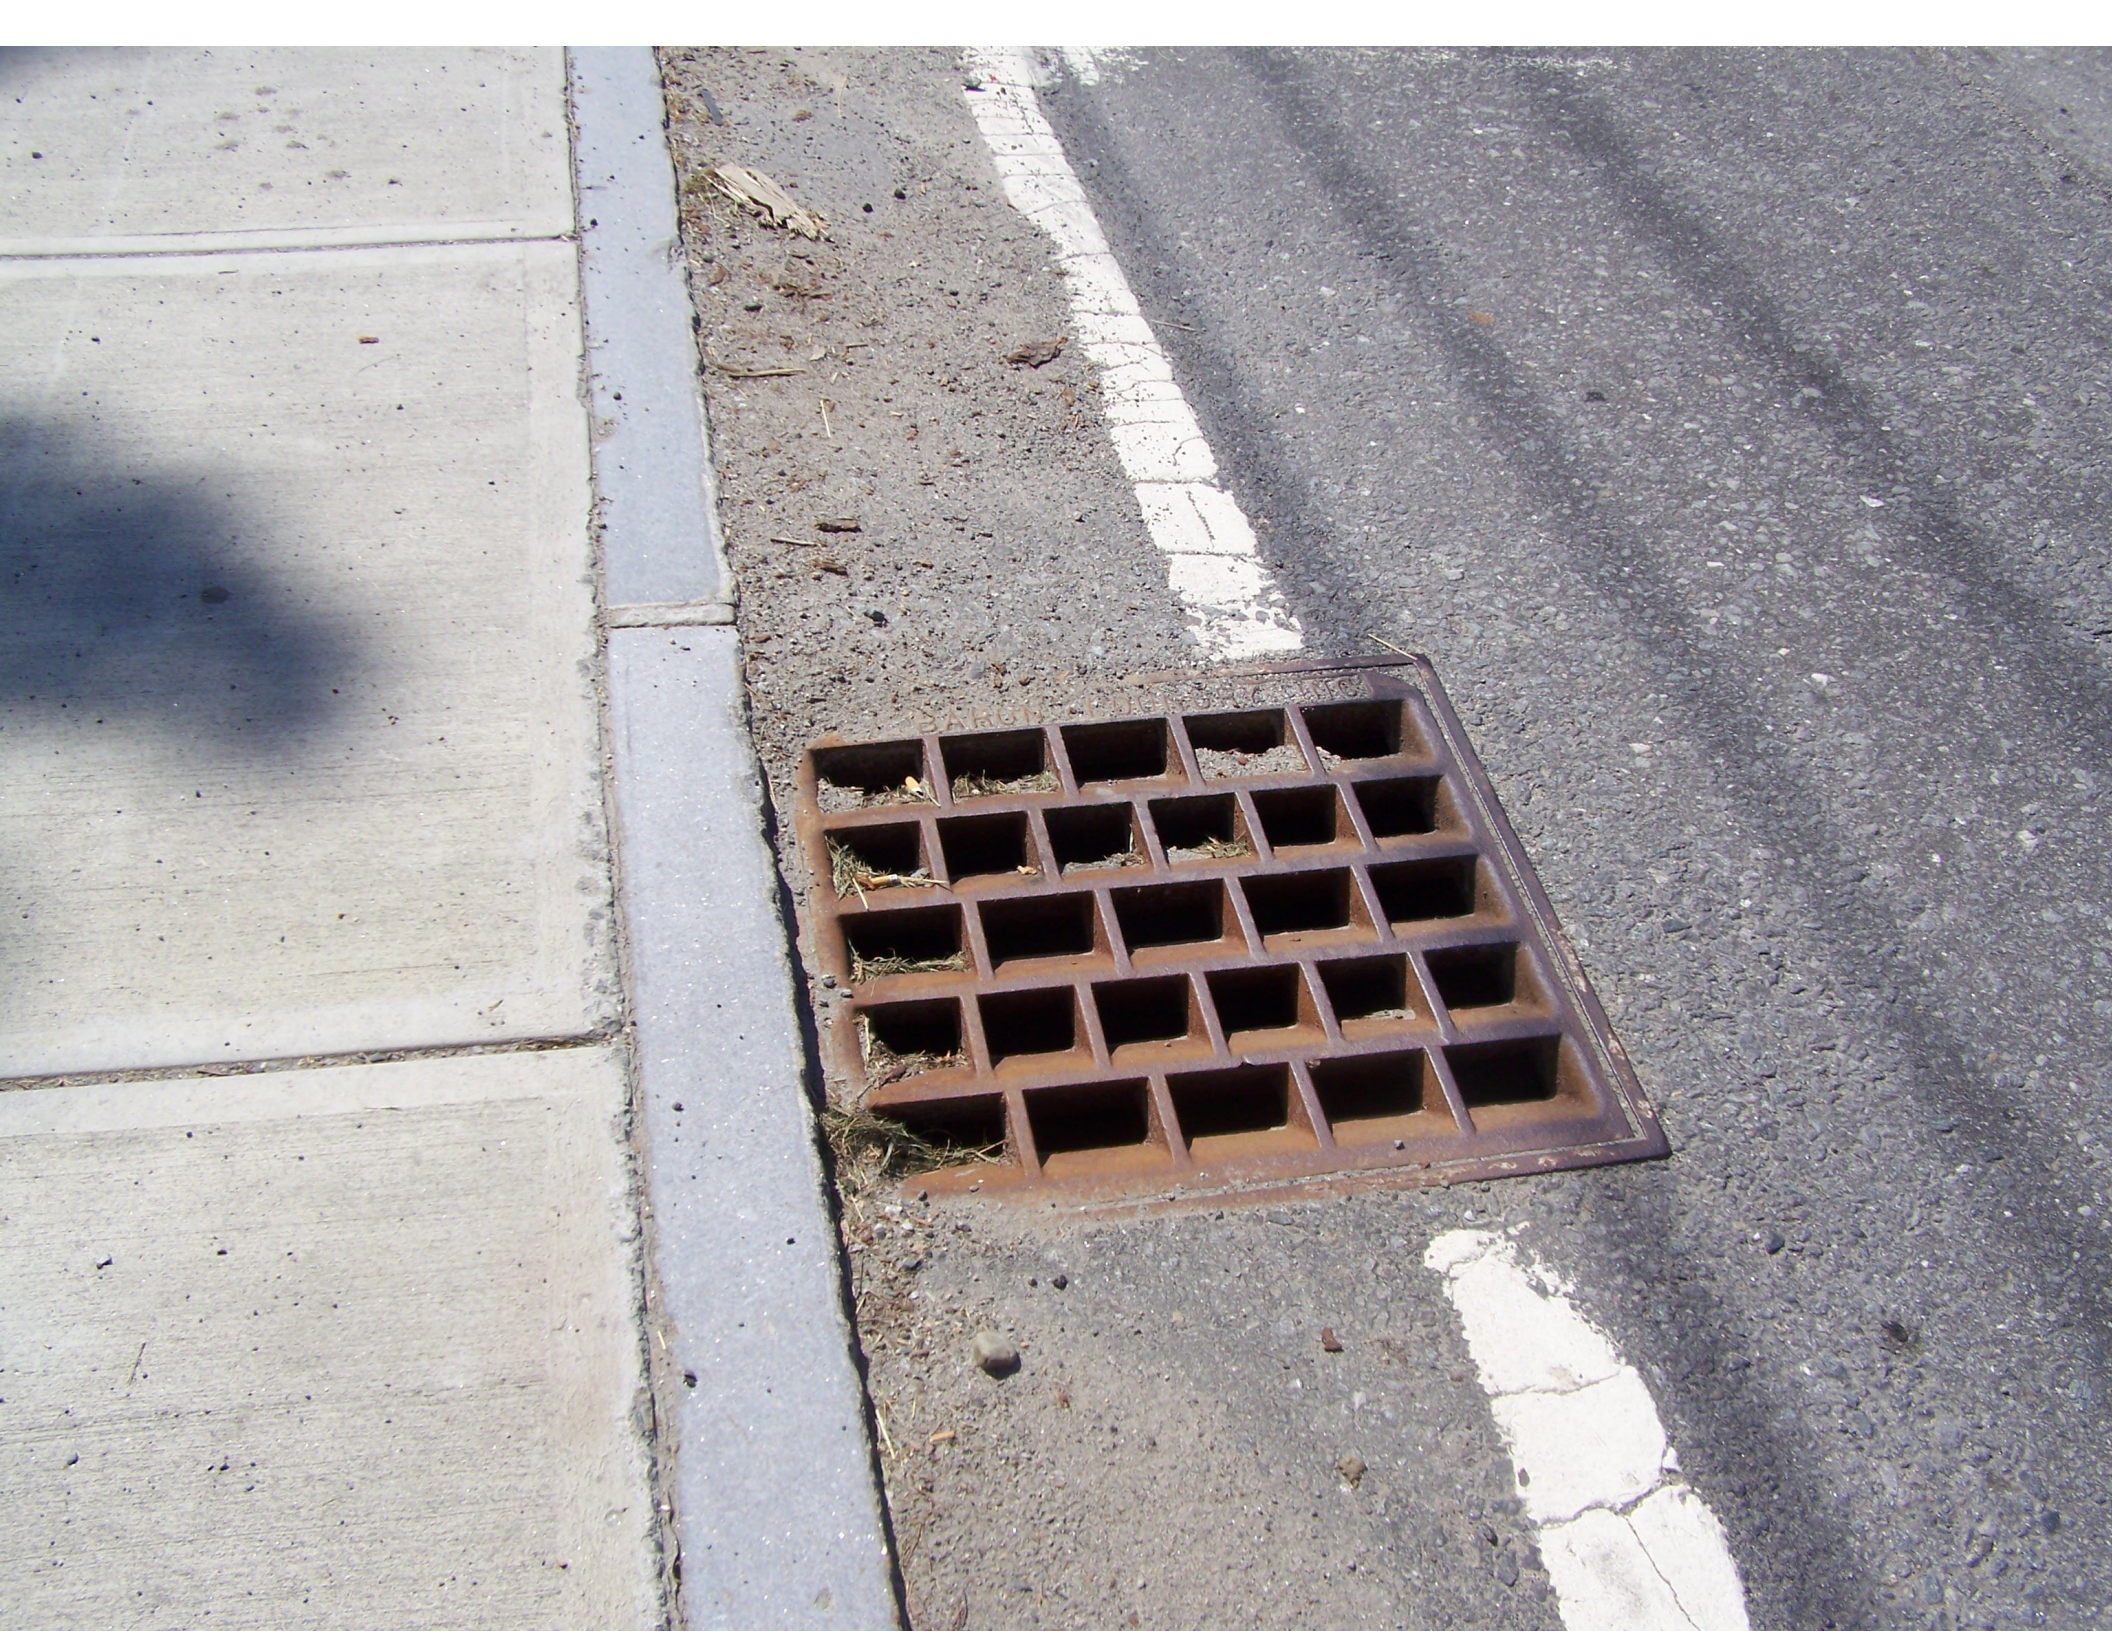
DRAIN IS 2x2

Condition:  Good  Fair  Poor
