### Culvert Inspection Form

Railroad: <u>WACR CRL</u>	Town: <u>BARTON</u>
Valuation Sheet: <u>V43/88</u>	Valuation Stationing: <u>4603 + 48.5</u>
Mile Post: <u>L 17.01</u>	GPS Coordinates: N: <u>44 42.892</u> W: <u>72 08.490</u>

Culvert #: 66 G

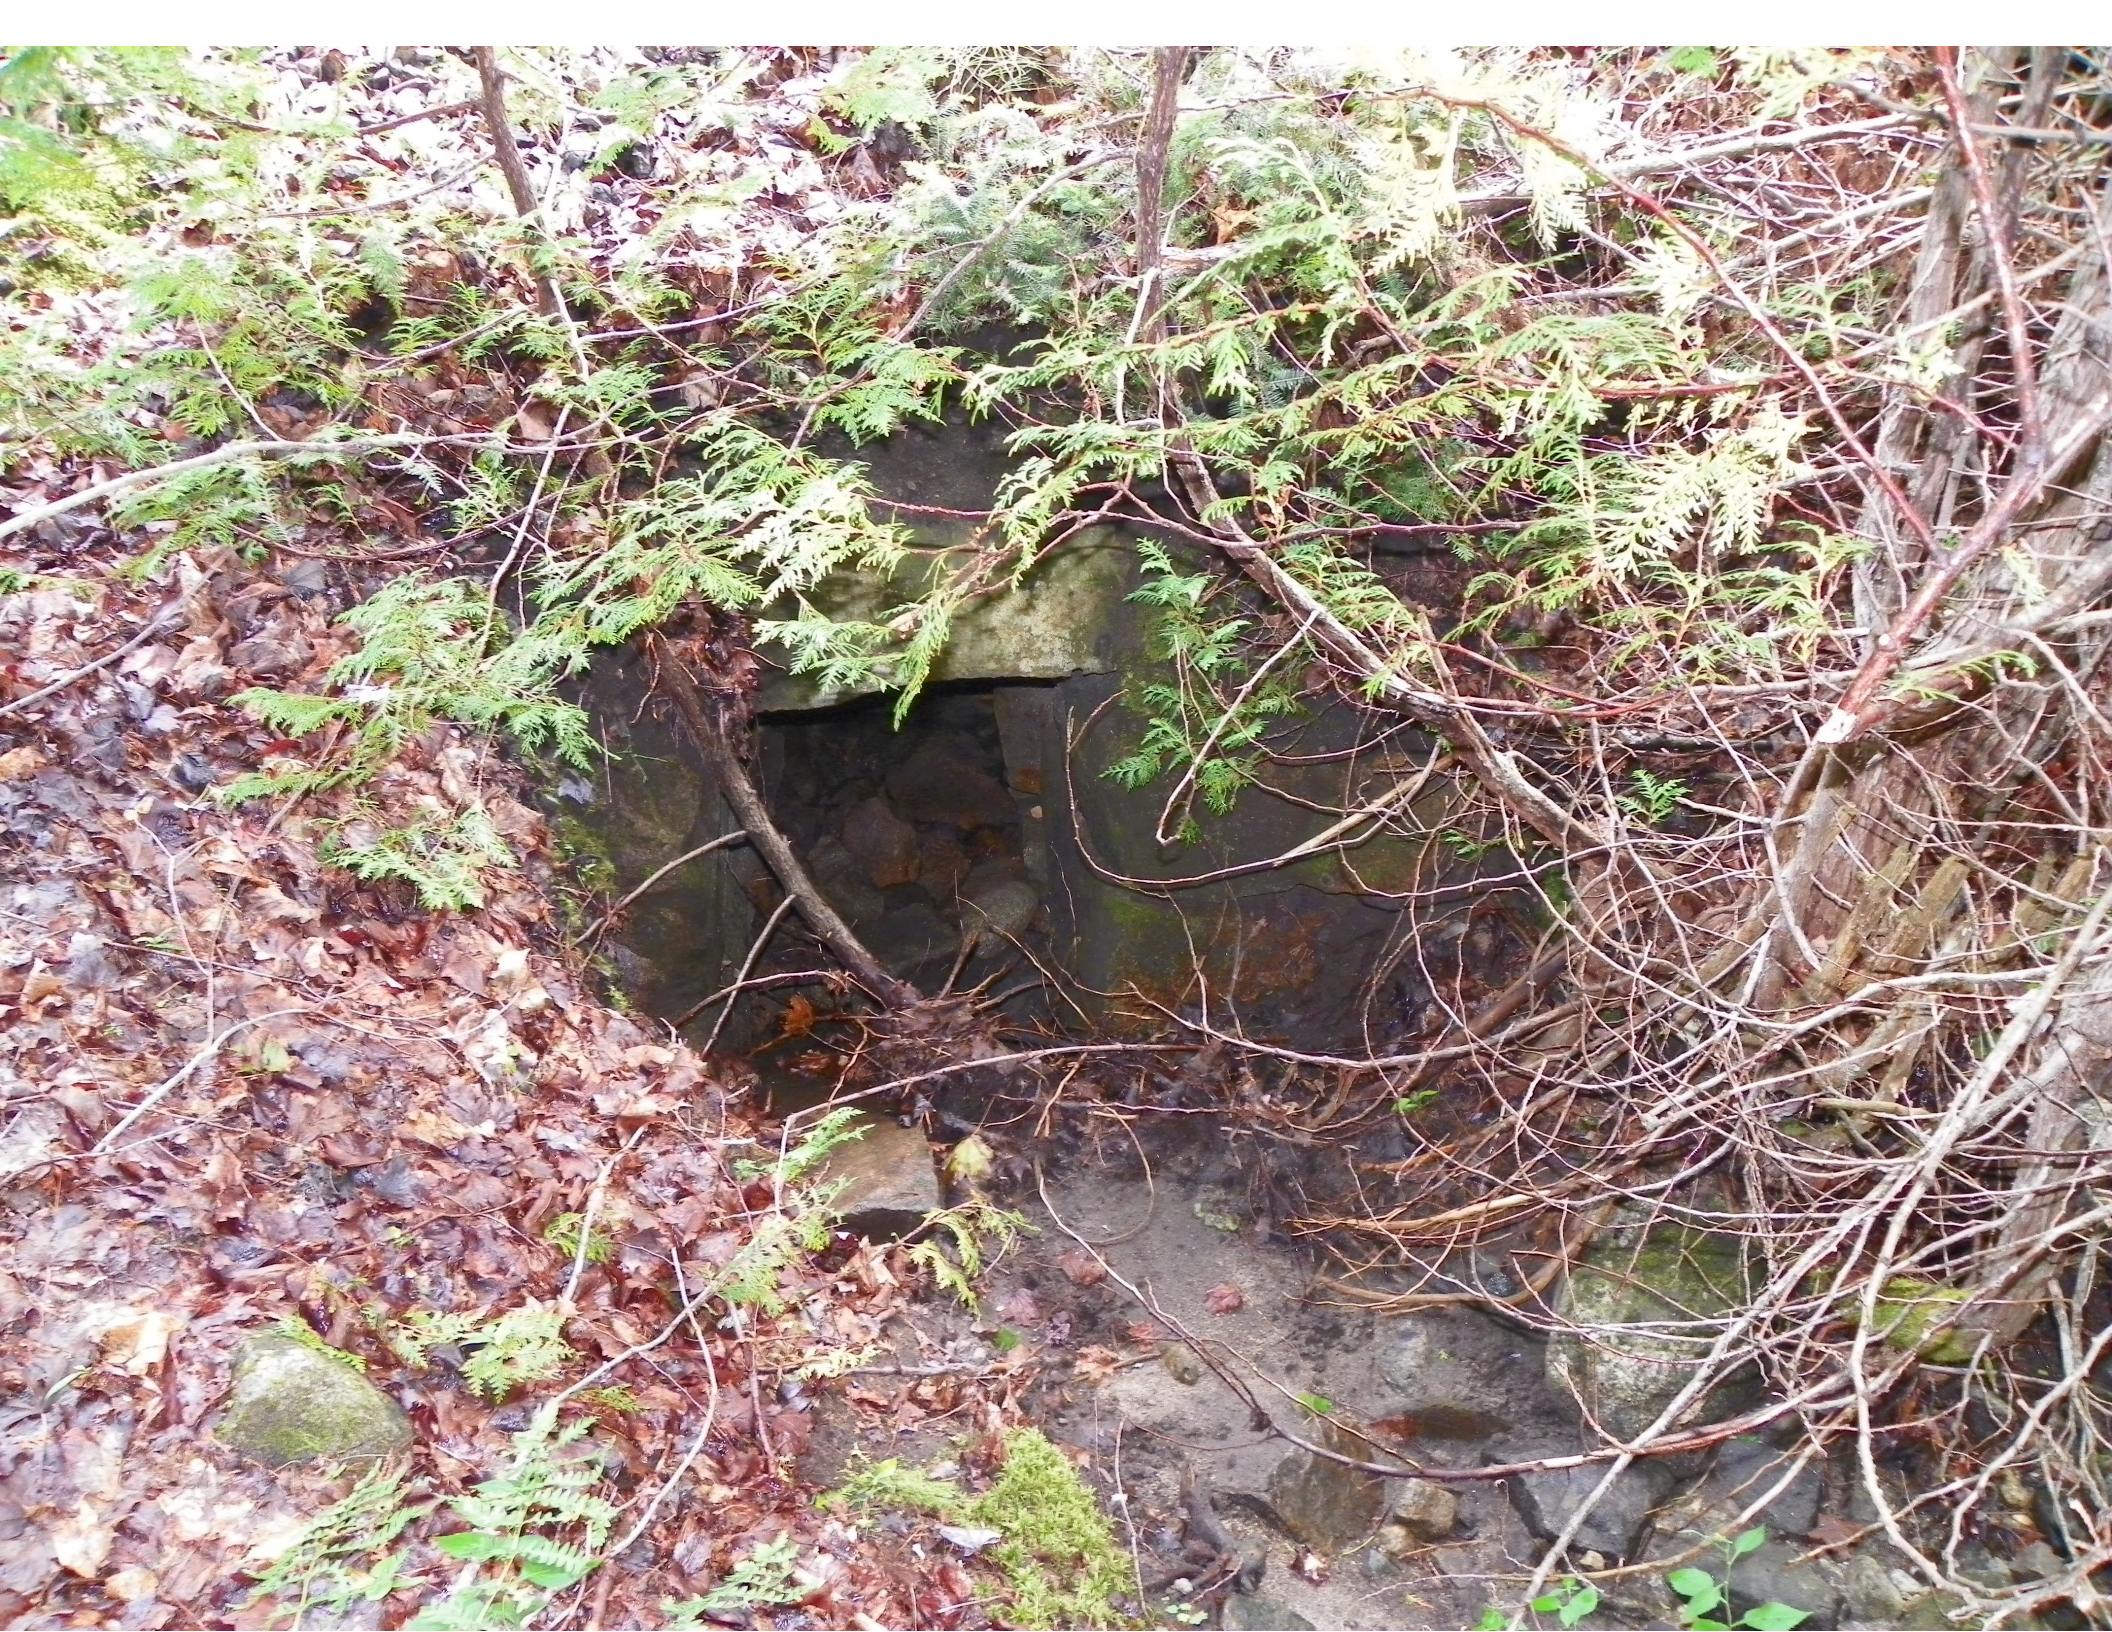
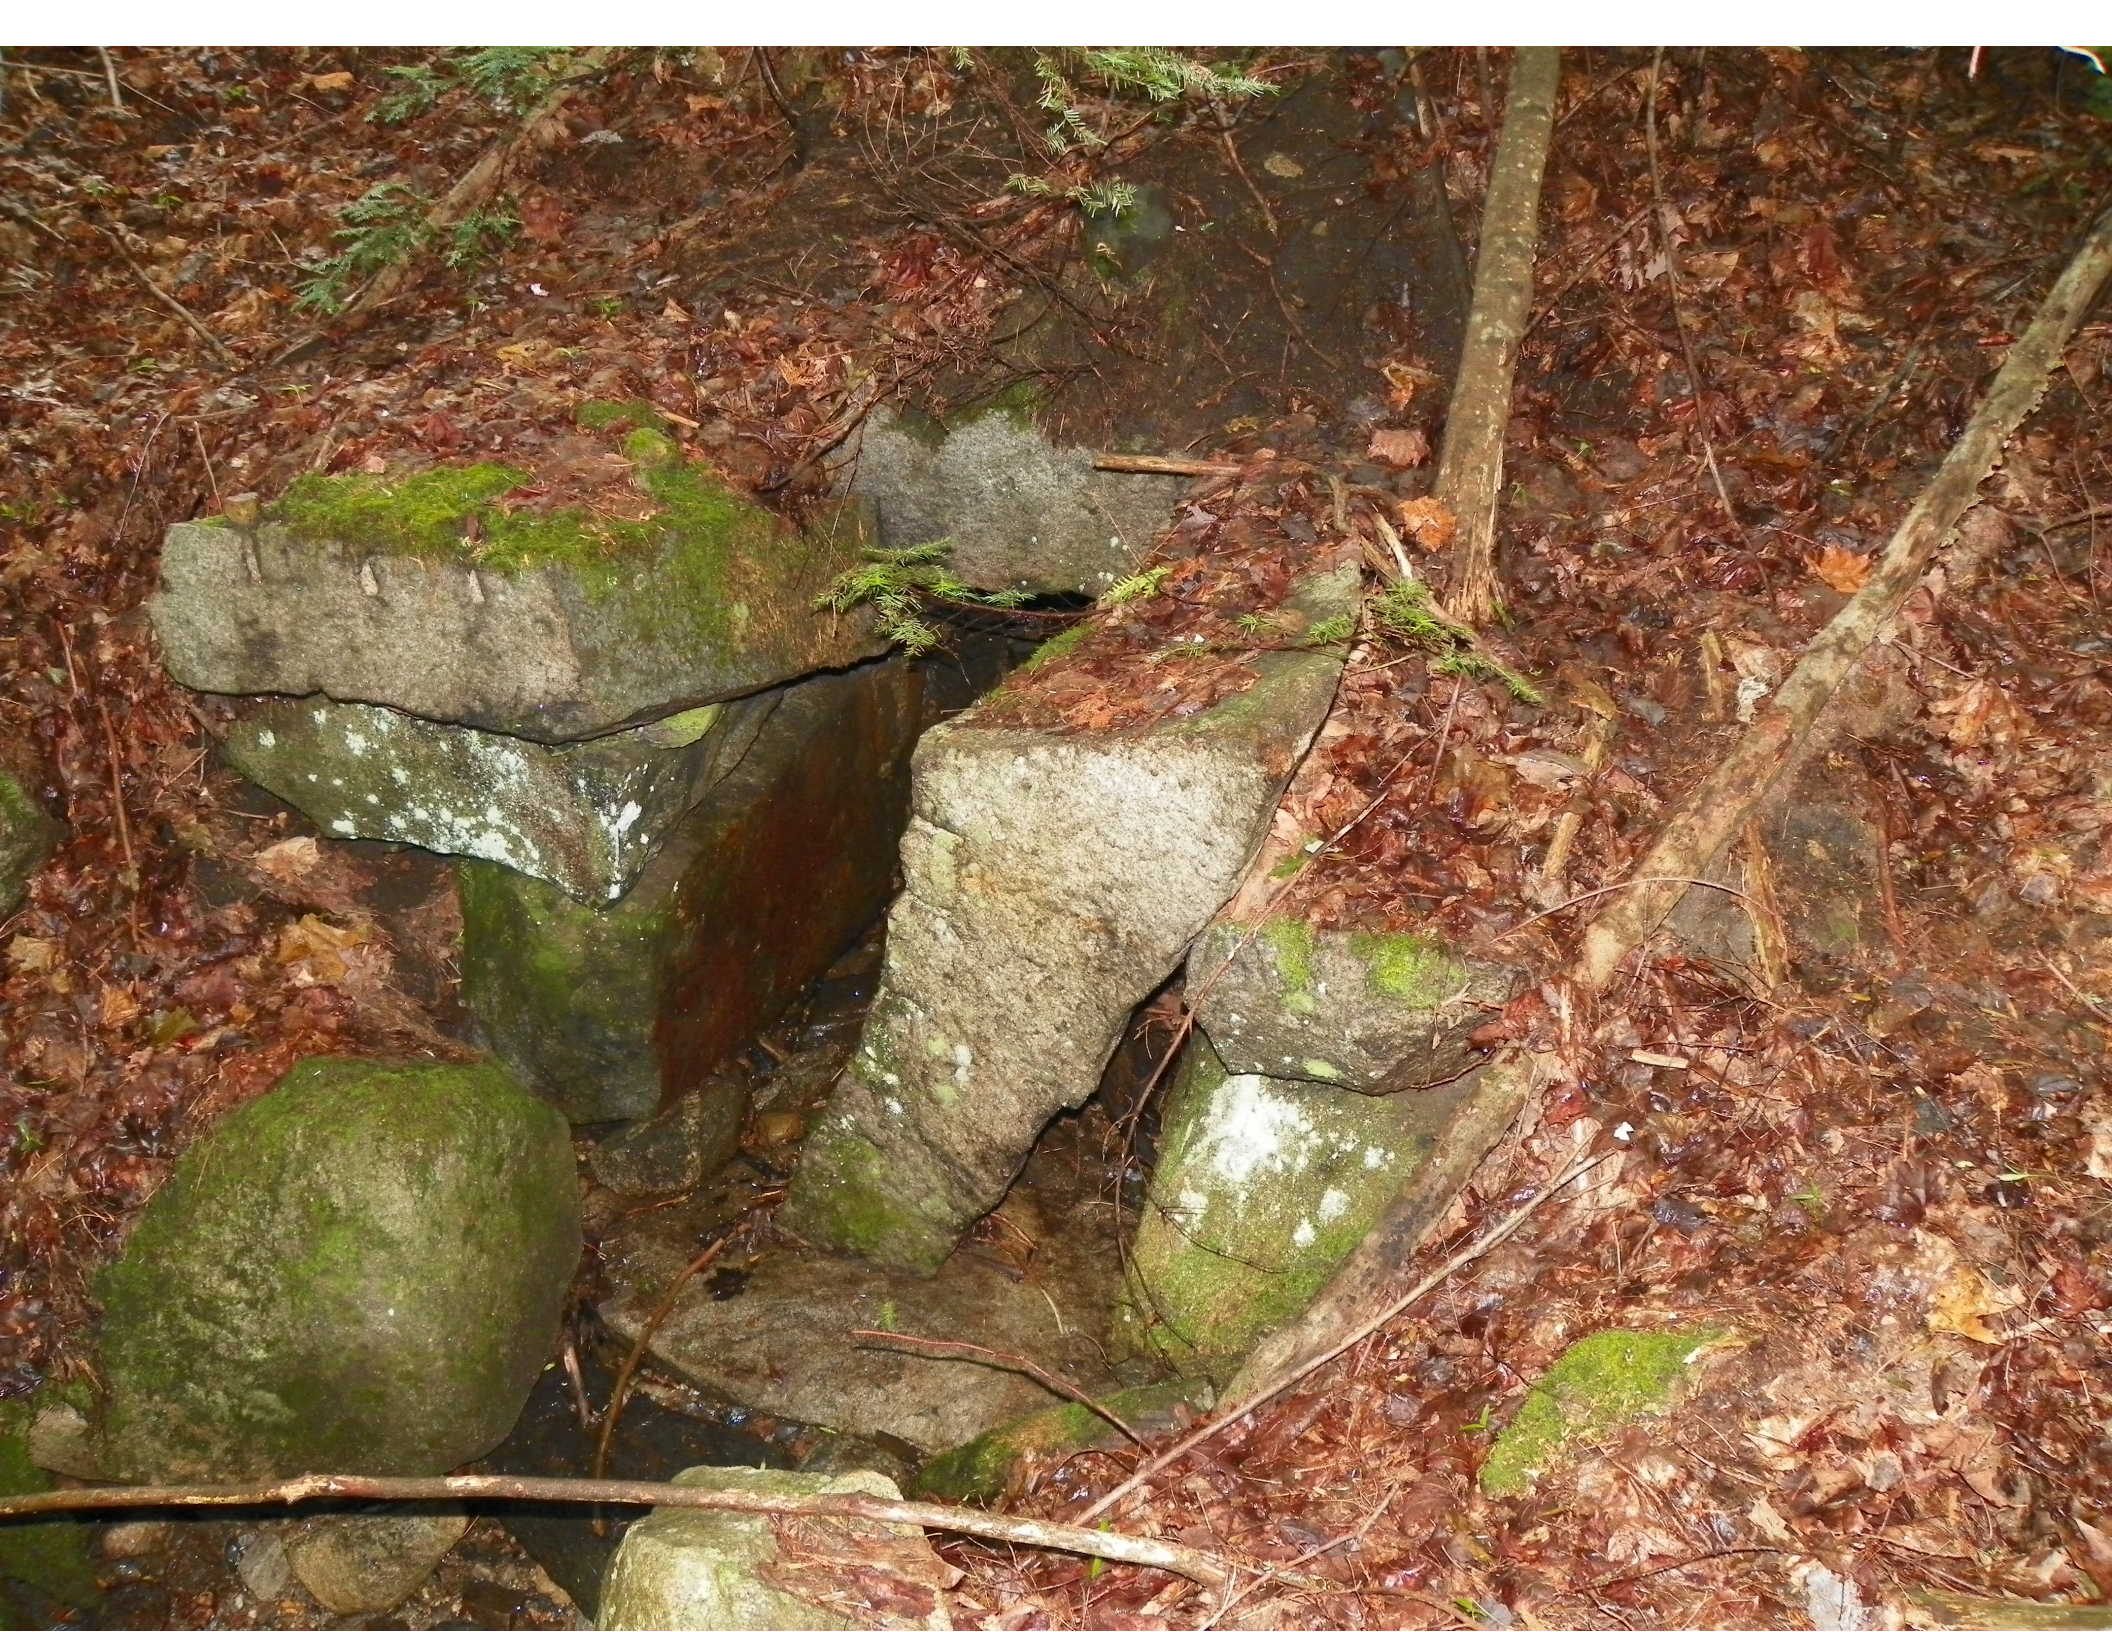
Remedial Action (if any):  
CAPSTONE BROKEN ON EAST END (OUTLET)
