### Culvert Inspection Form

Railroad: <u>WACR CRL</u>	Town: <u>BARTON</u>
Valuation Sheet: <u>V43/86</u>	Valuation Stationing: <u>4510 + 48</u>
Mile Post: <u>L18.27</u>	GPS Coordinates: N: <u>44 42, 200</u> W: <u>72 06. 628</u>

Culvert #: 62A

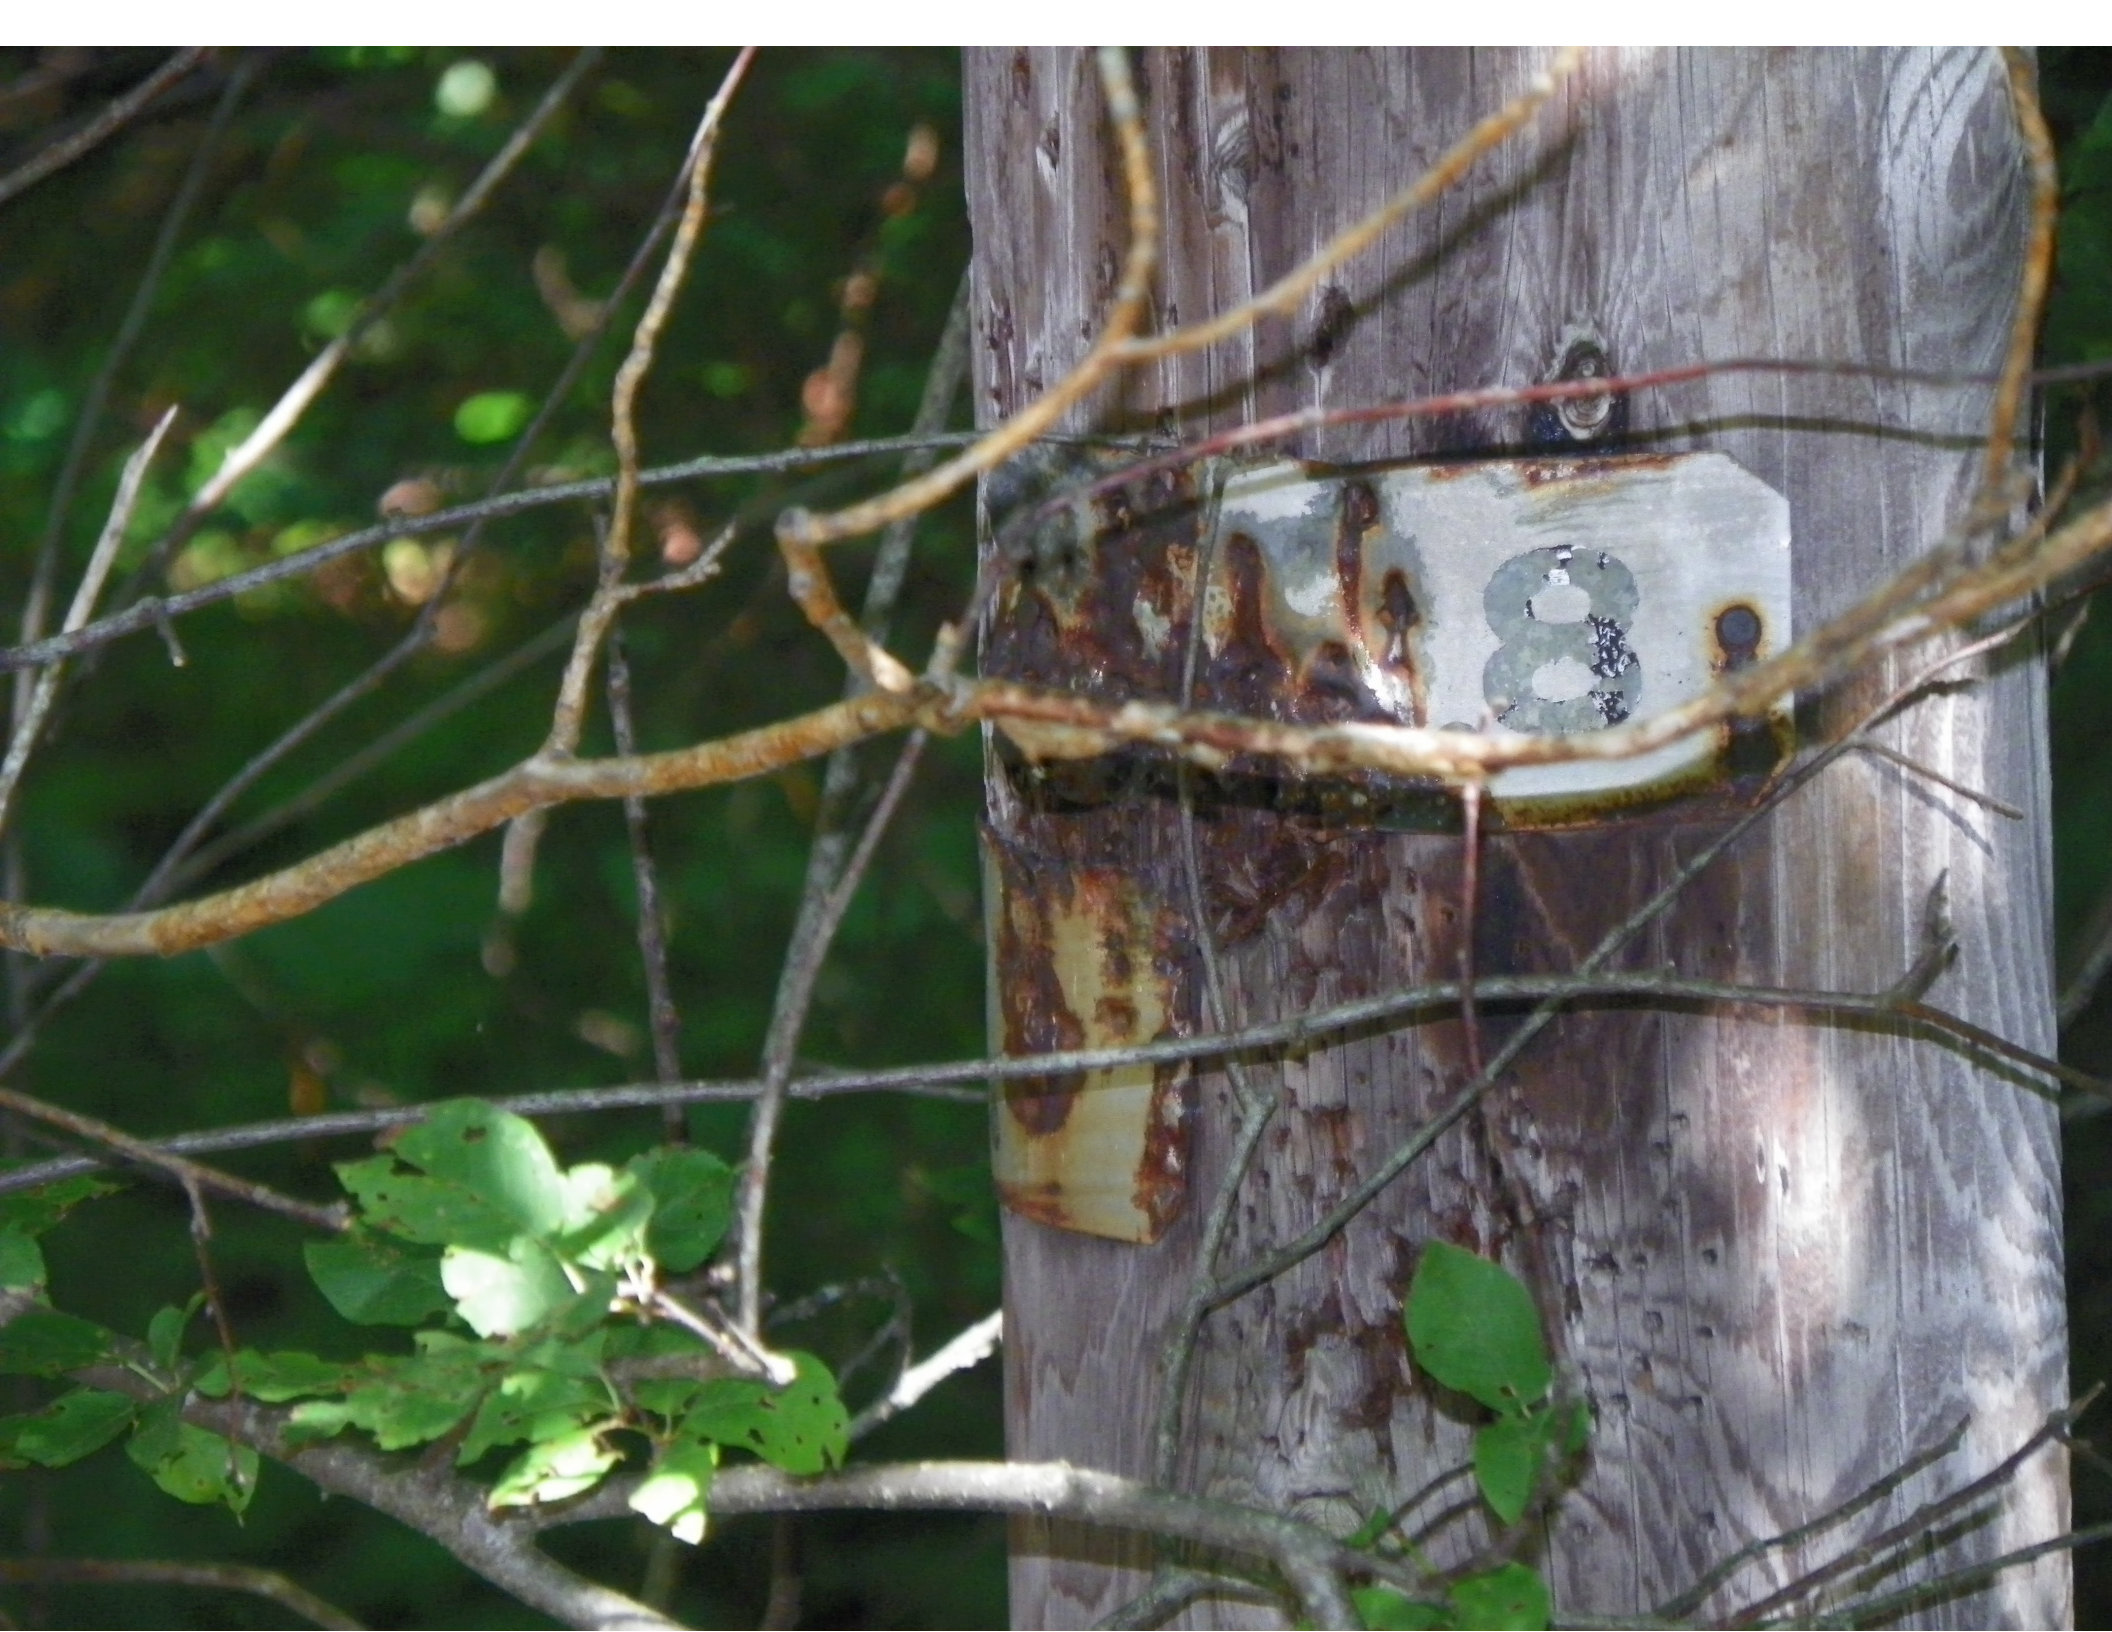
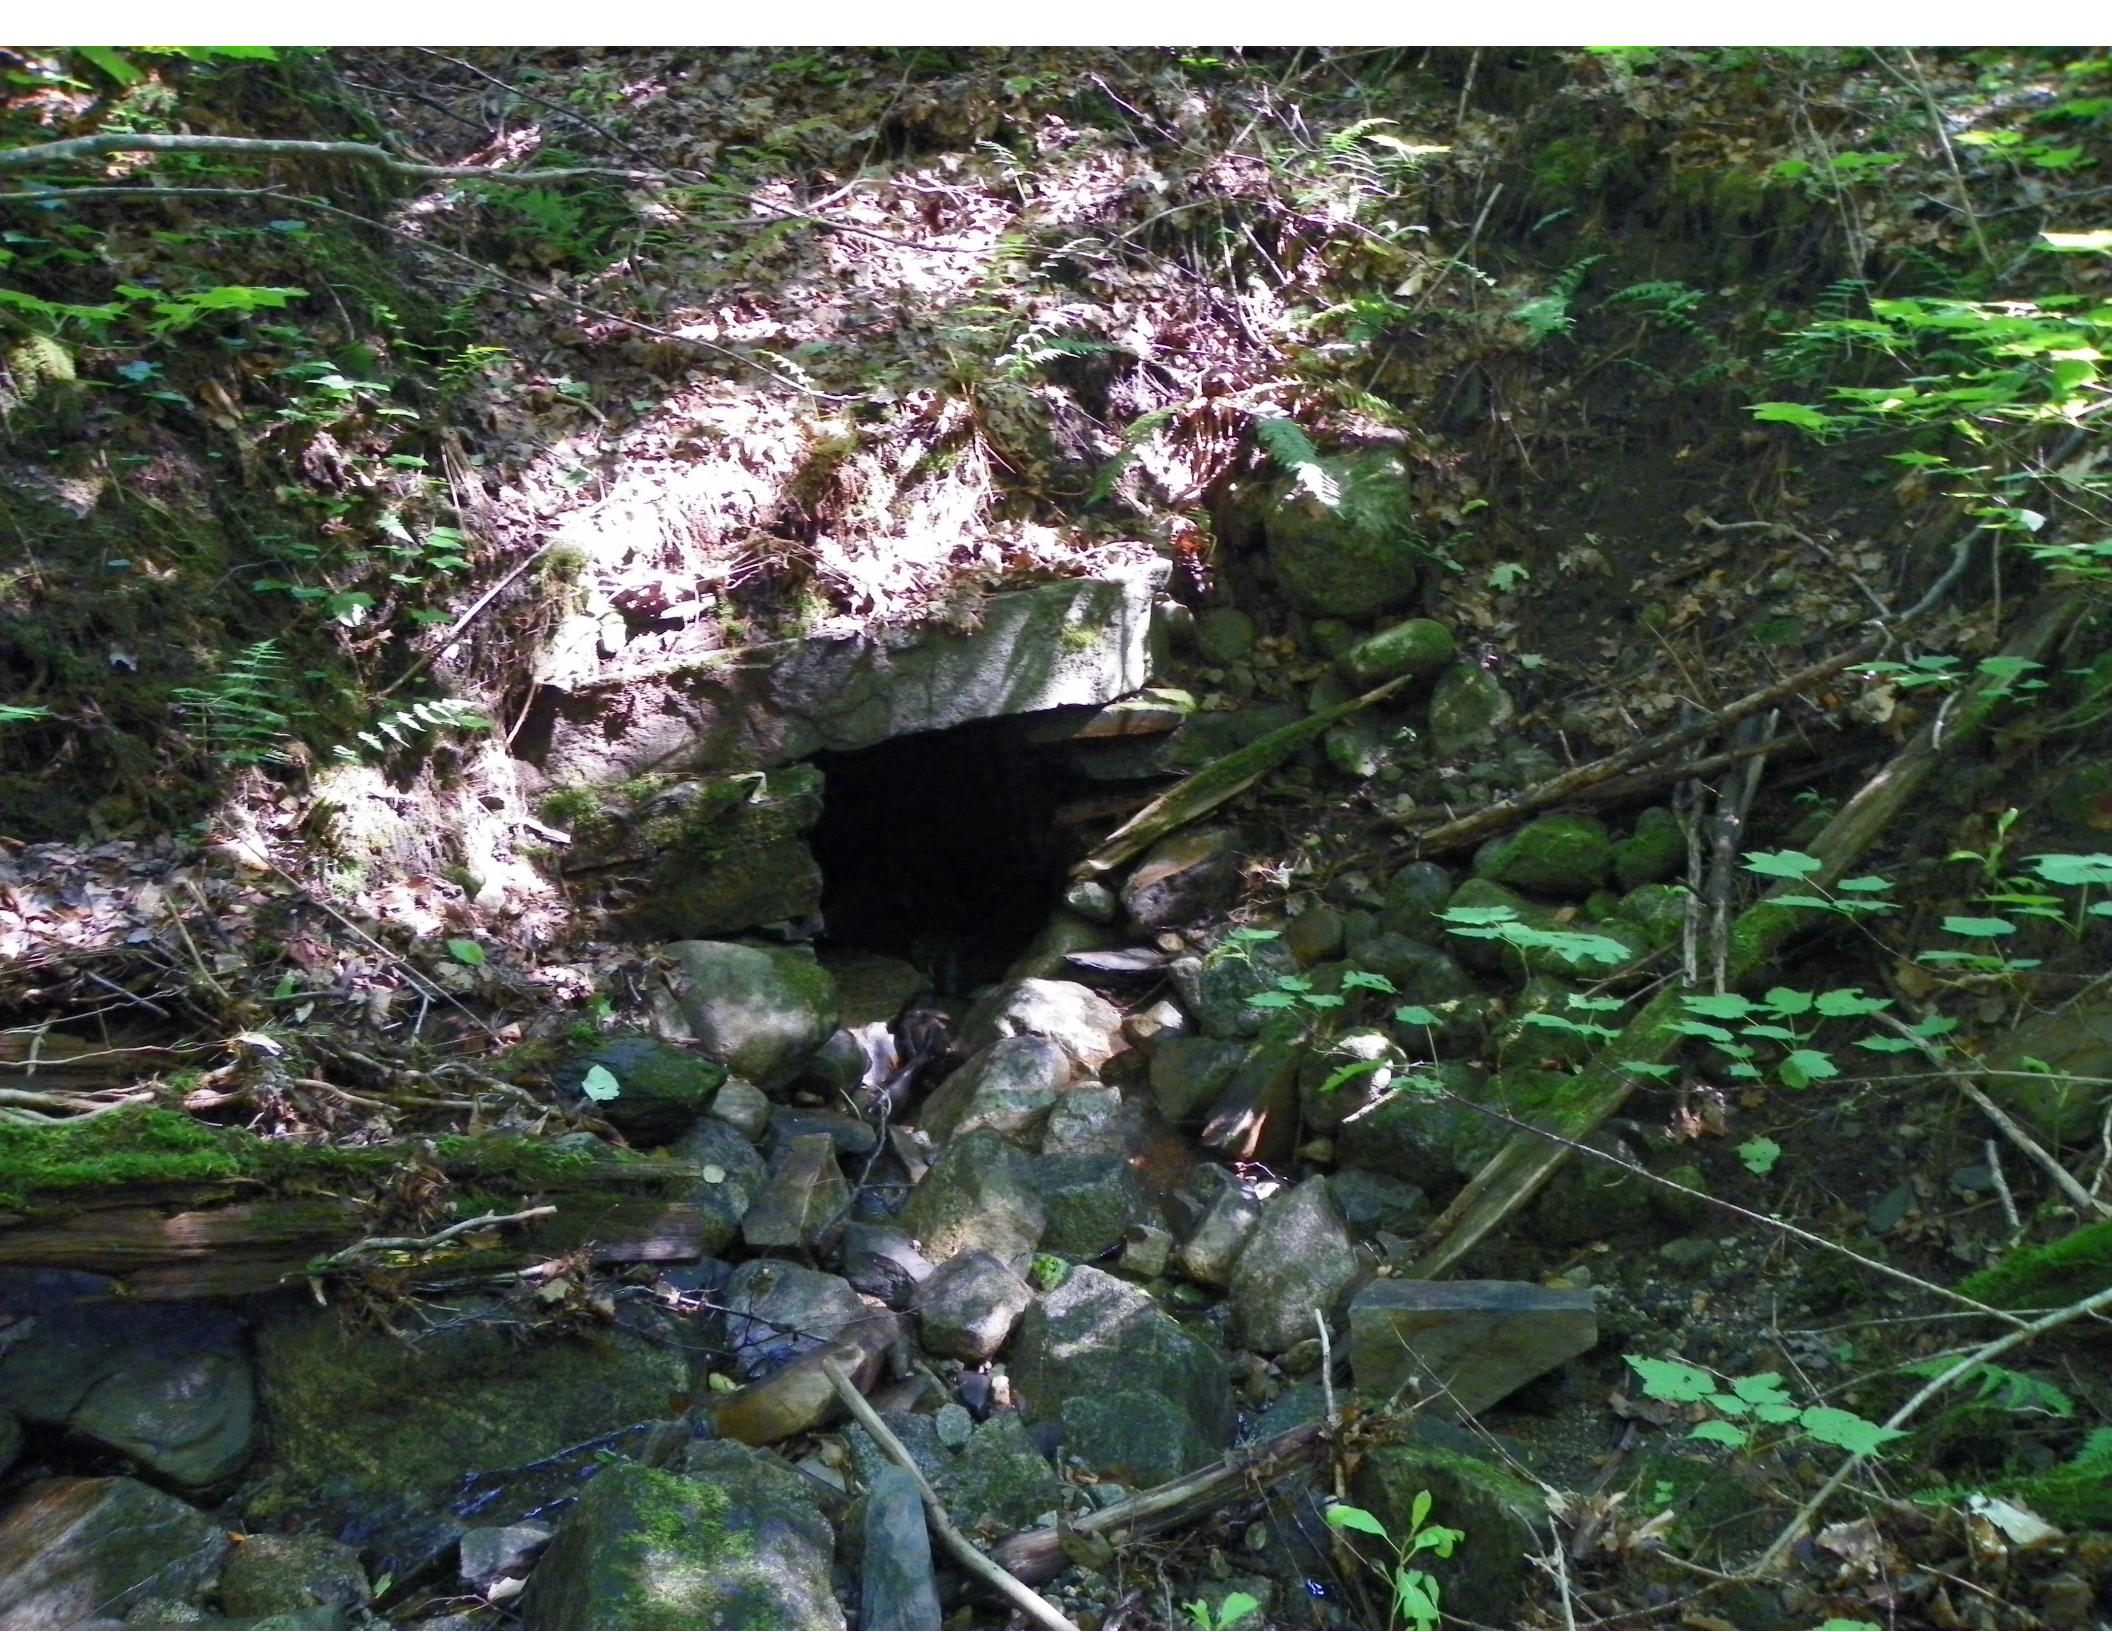
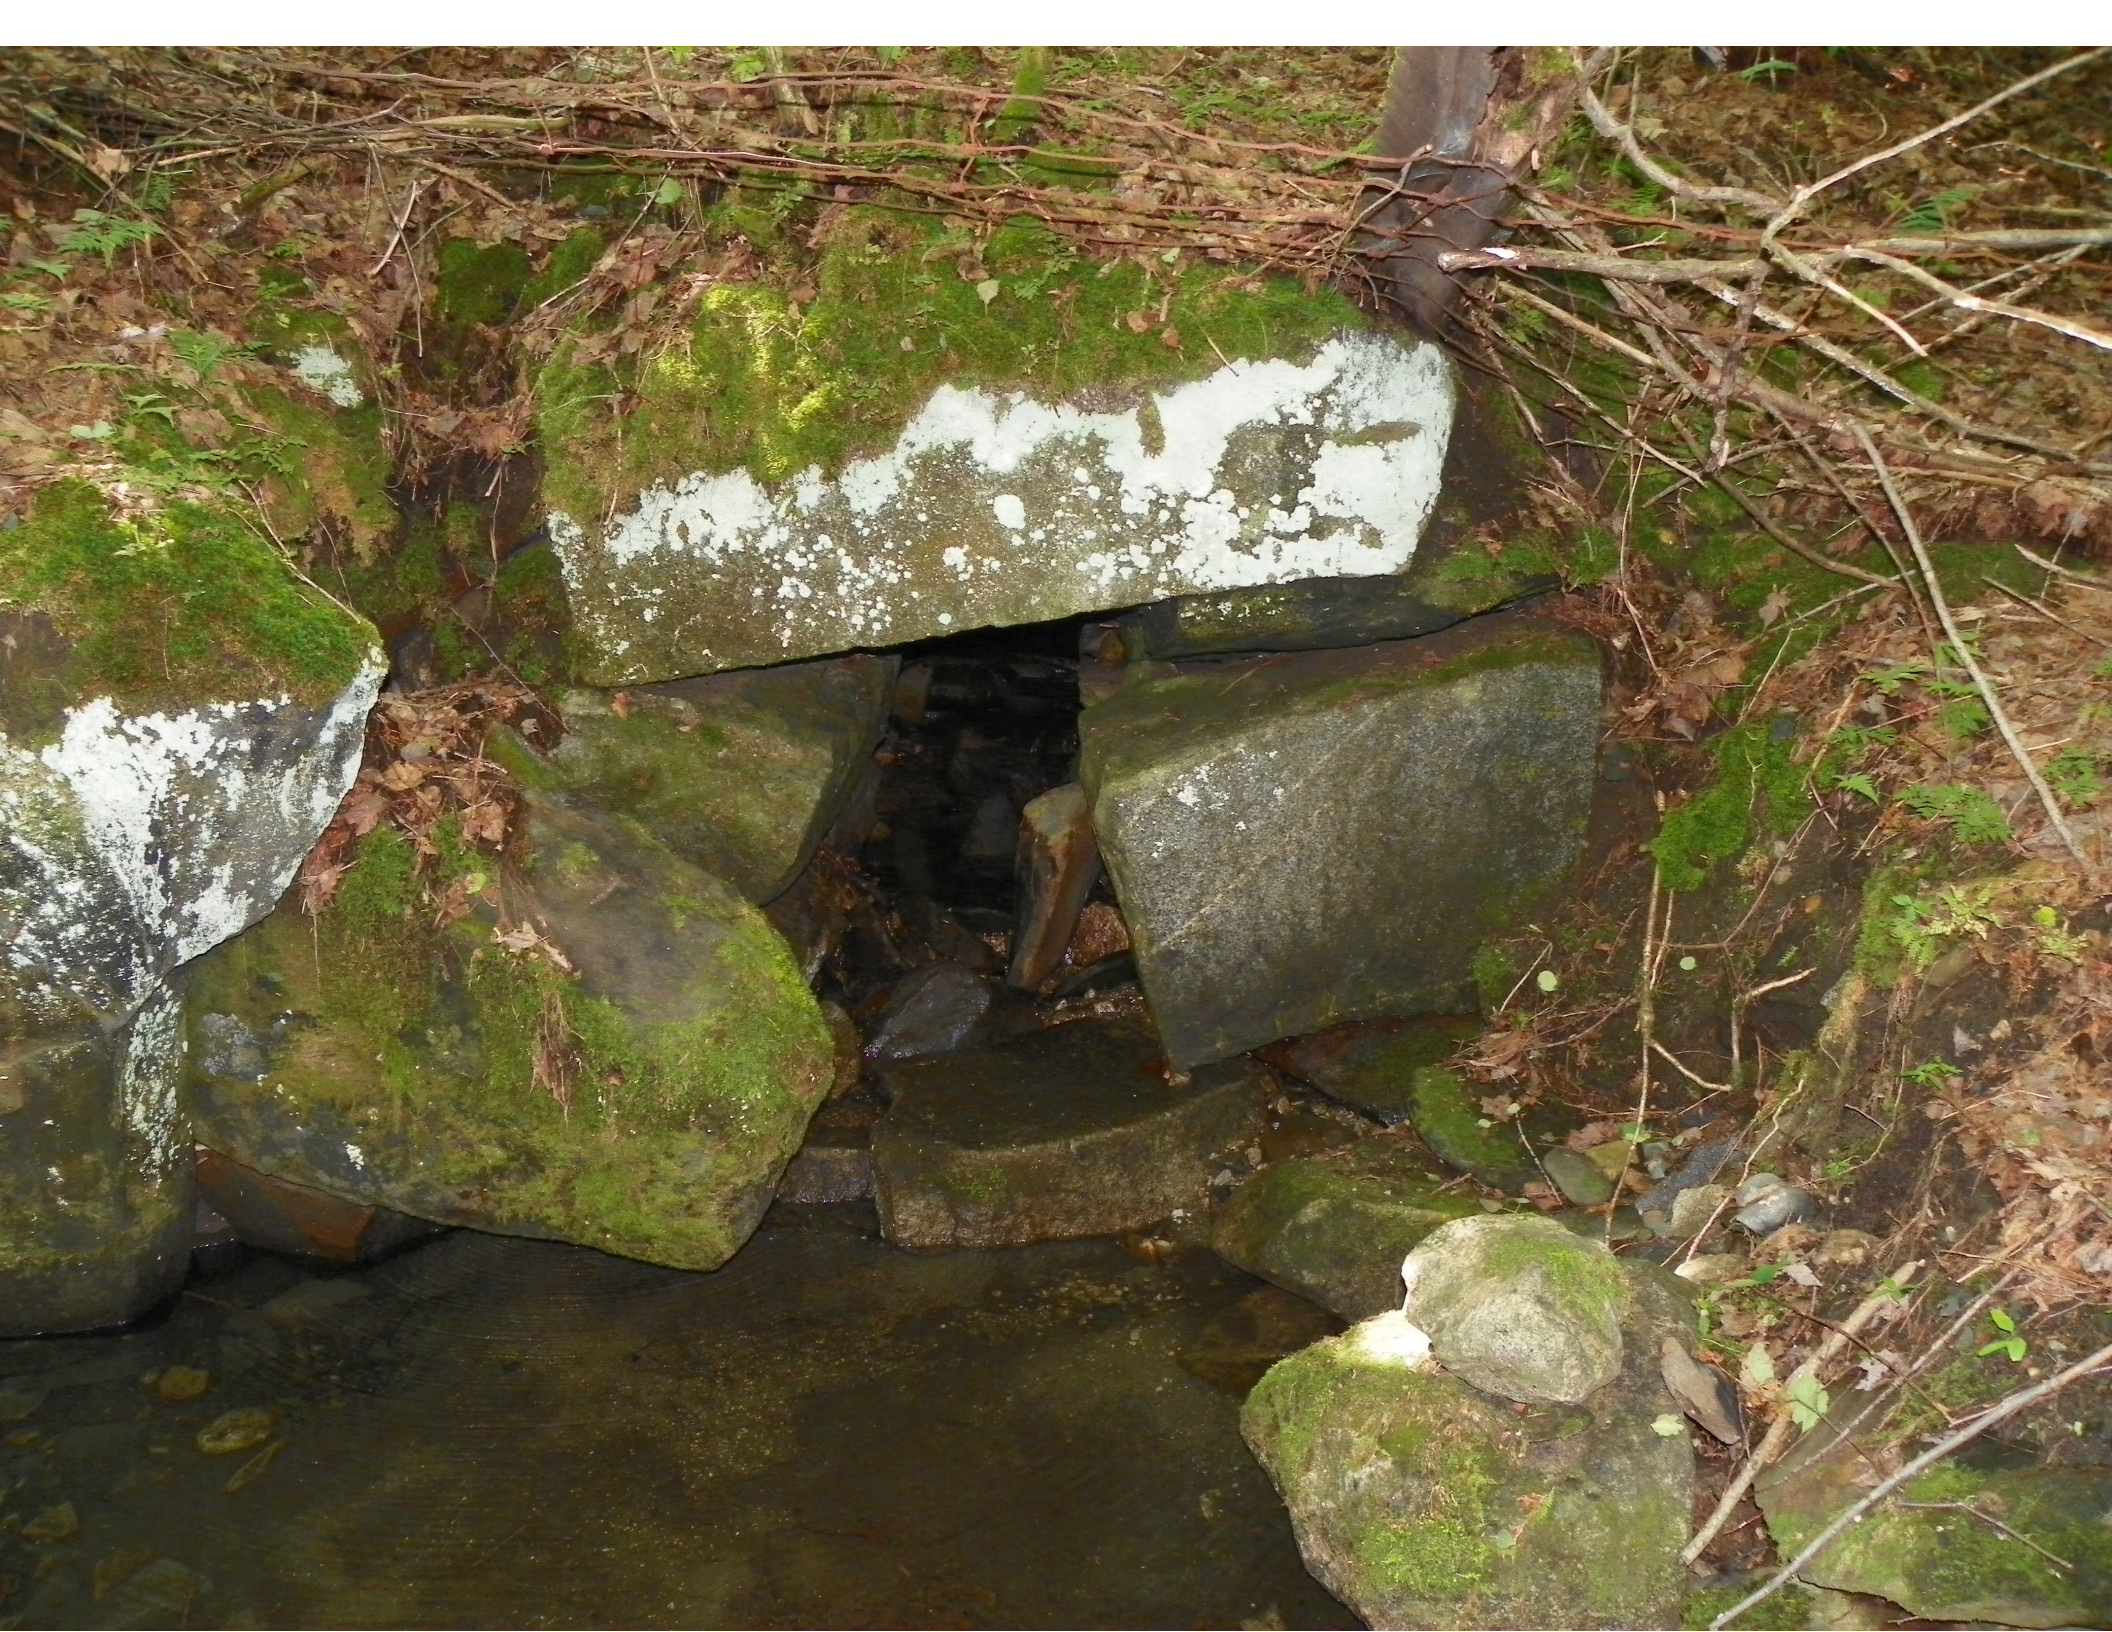
EAST END (OUTLET) STARTING TO BREAK UP
