### Culvert Inspection Form

Railroad: <u>WARR CRL</u>	Town: <u>LYNDON</u>
Valuation Sheet: <u>V43</u> <u>73</u>	Valuation Stationing: <u>3847 + 06.5</u>
Mile Post: <u>L 31.33</u>	GPS Coordinates: N: <u>44 34 50</u> W: <u>71 58 56</u>

Culvert #: 50-B

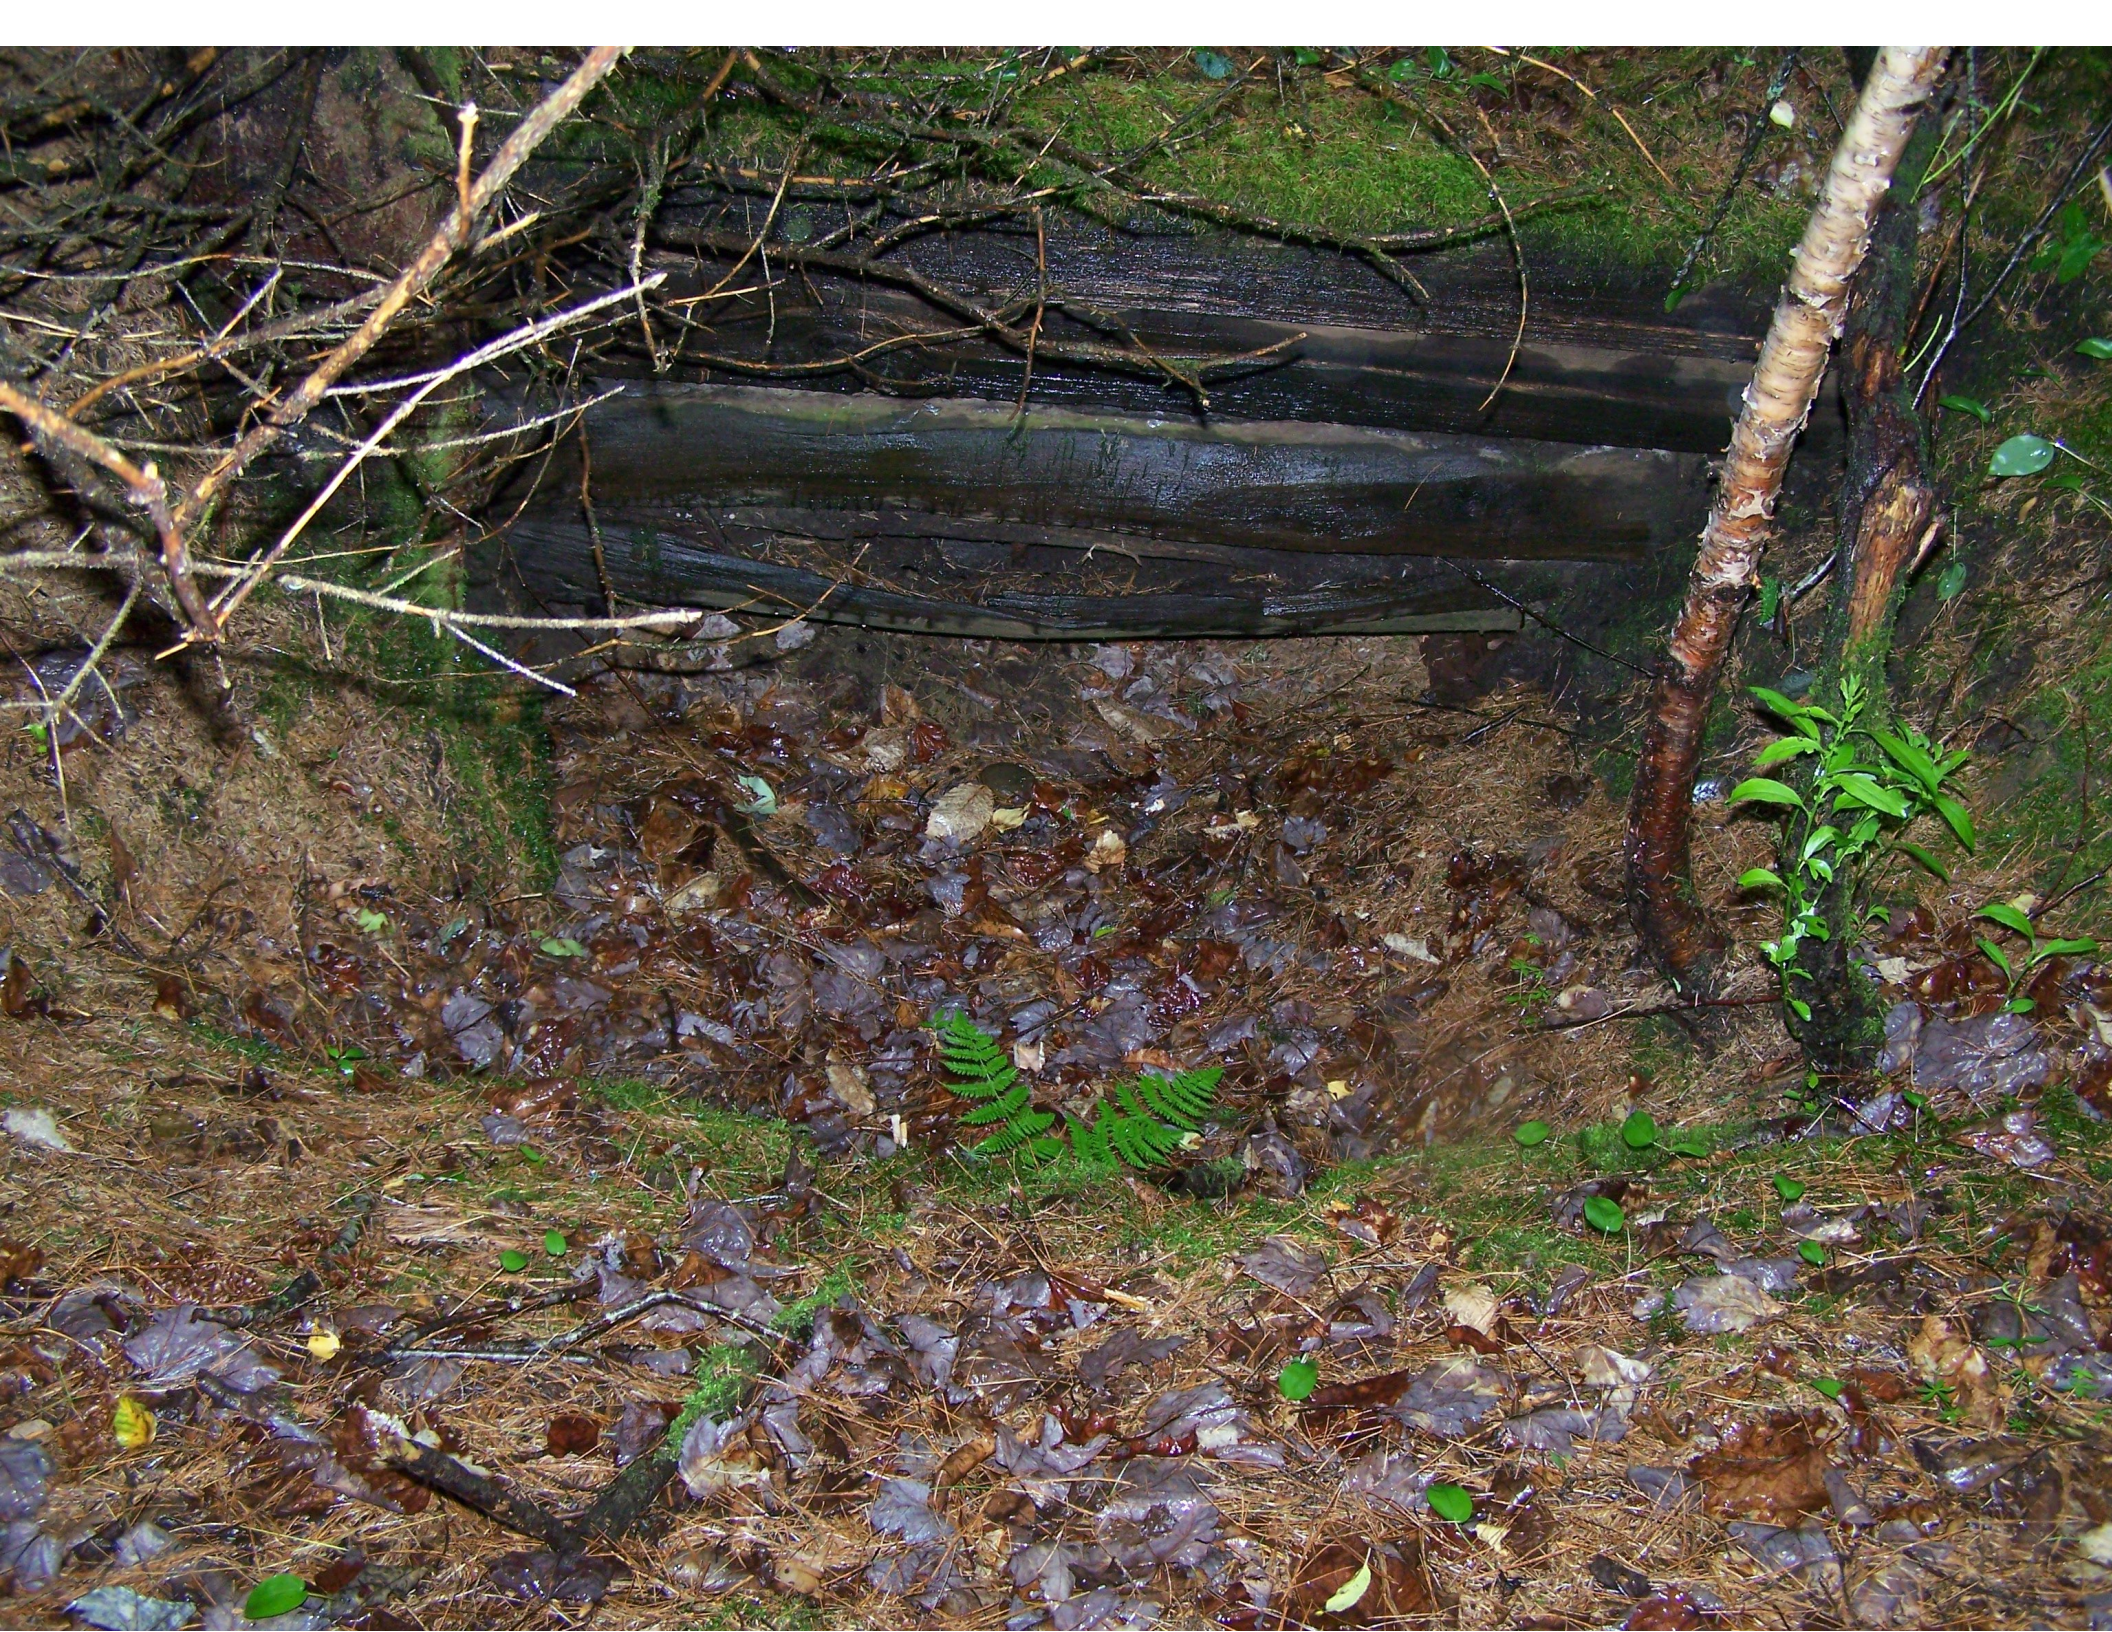
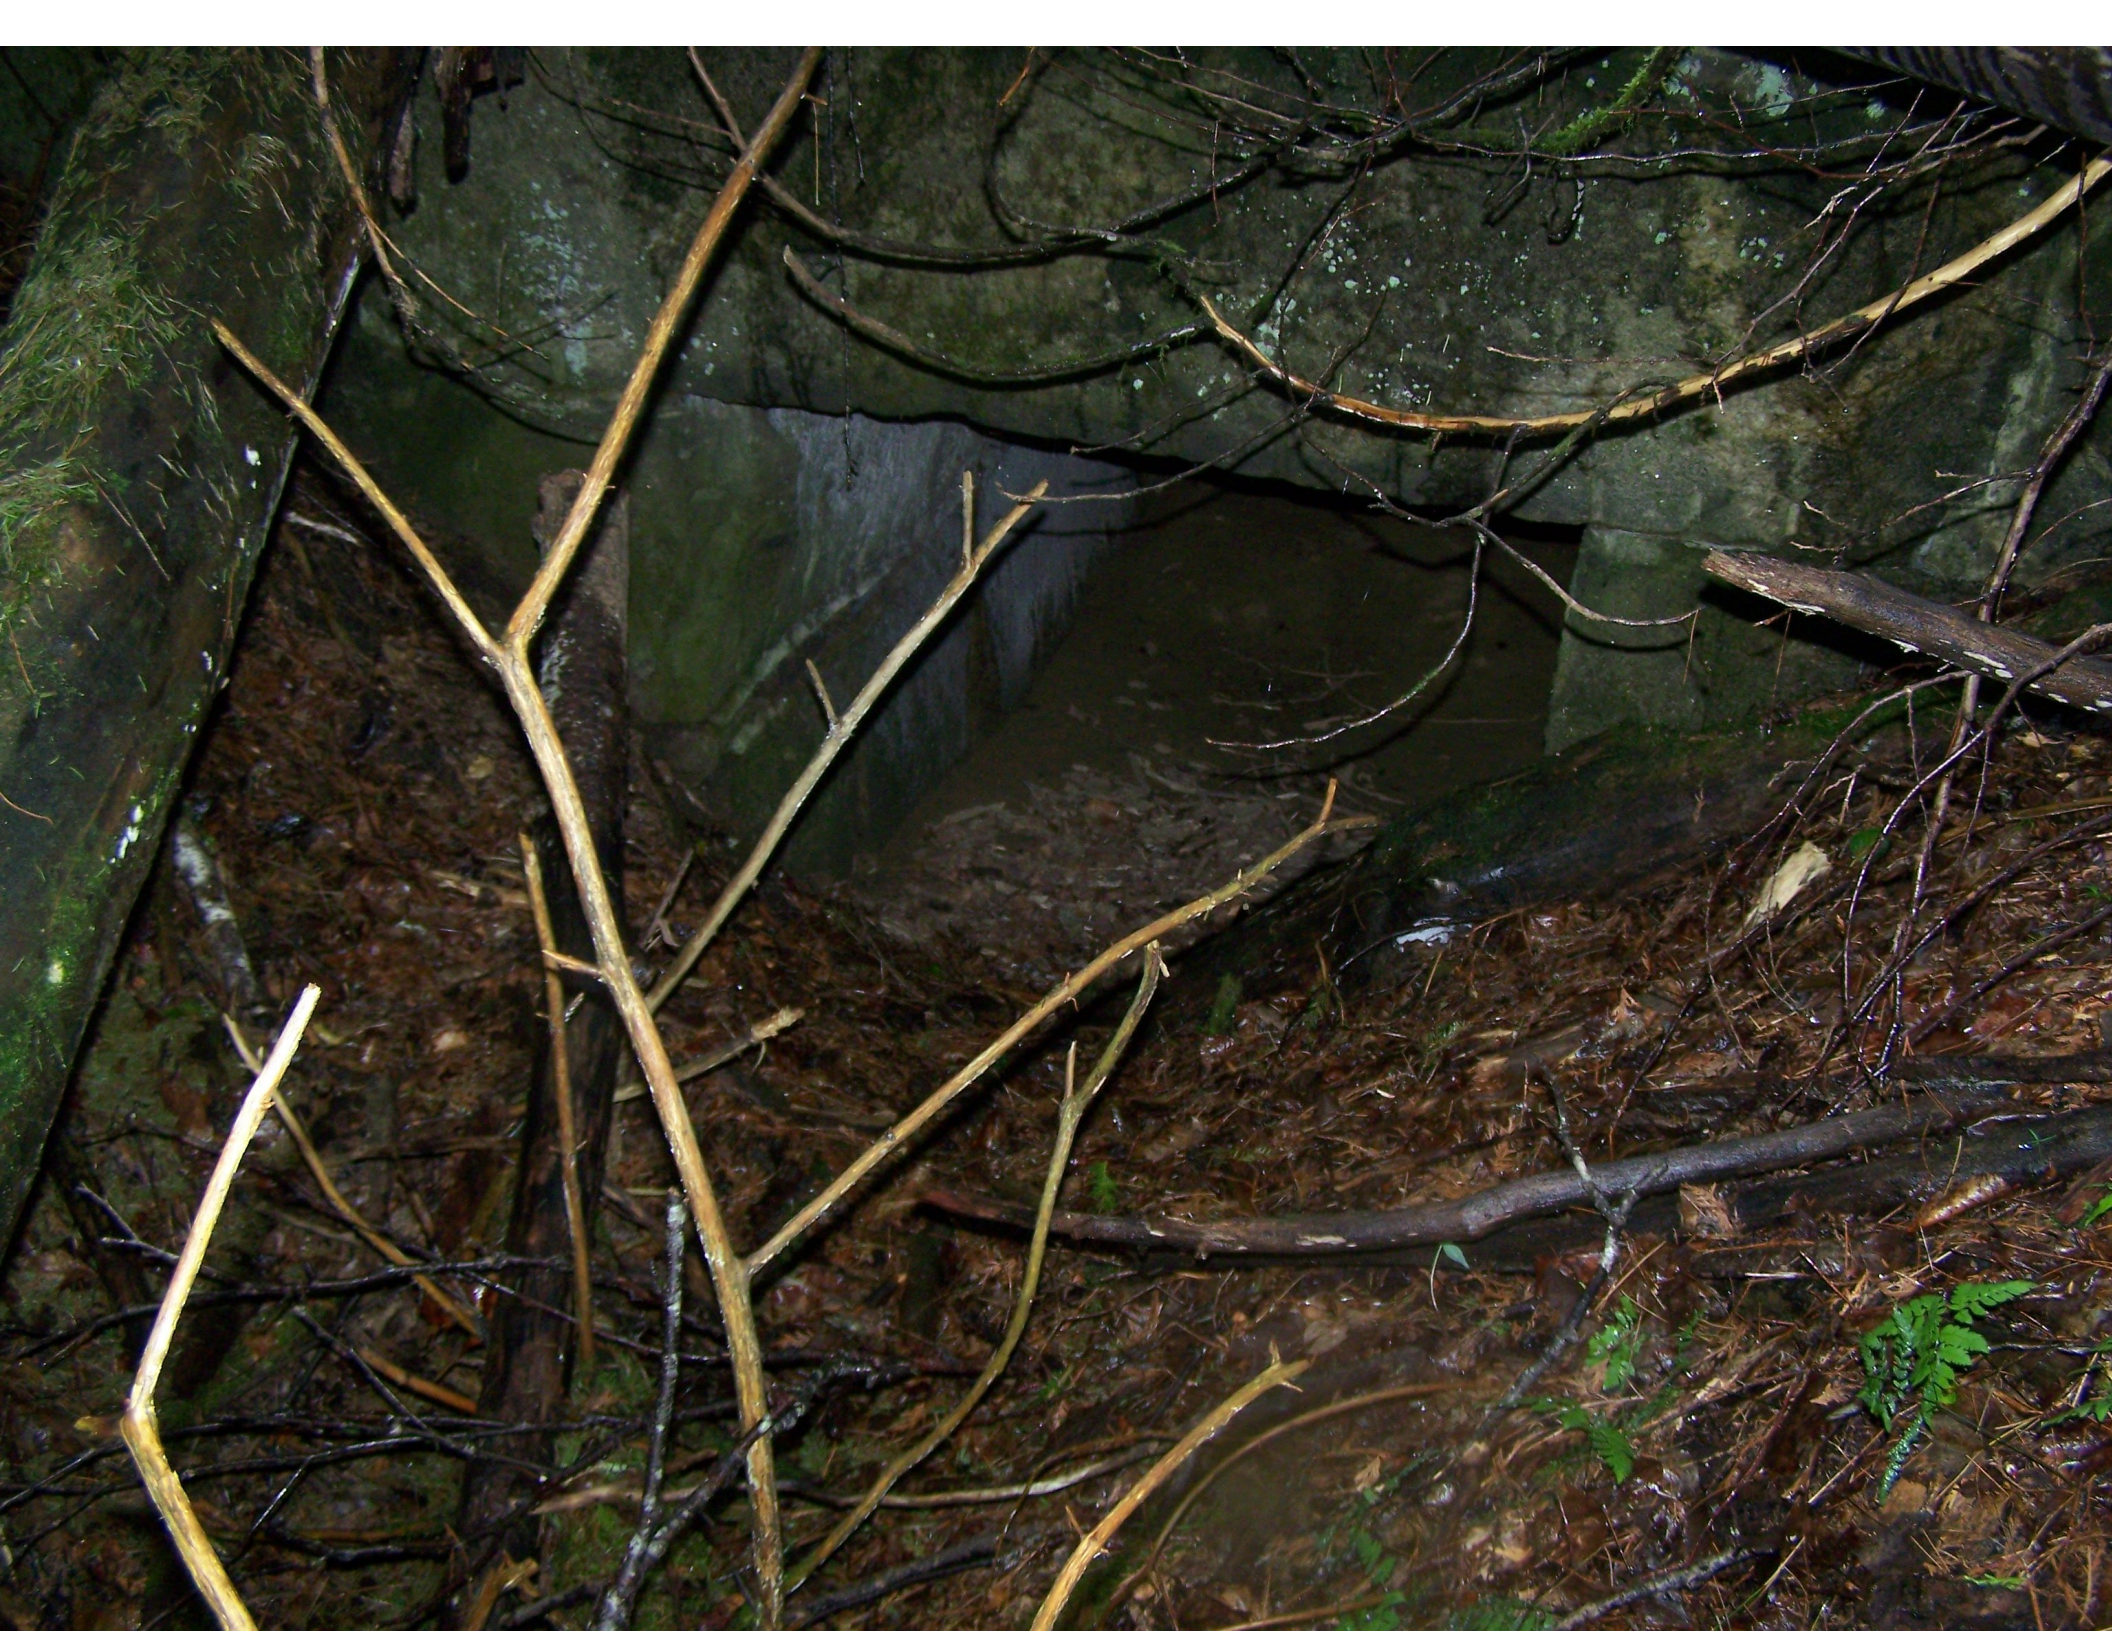
EAST END (INLET) 2/3 FULL
