Culvert Inspection Form

Railroad: <u>WACR CRL</u>	Town: <u>ST. JOHNSBURY</u>
Valuation Sheet: <u>V 43</u> <u>63</u>	Valuation Stationing: <u>3307 + 12.9</u>
Mile Post: <u>L 41.57</u>	GPS Coordinates: N: <u>44 26 38</u> W: <u>72 01 05</u>

Culvert #: 44 K

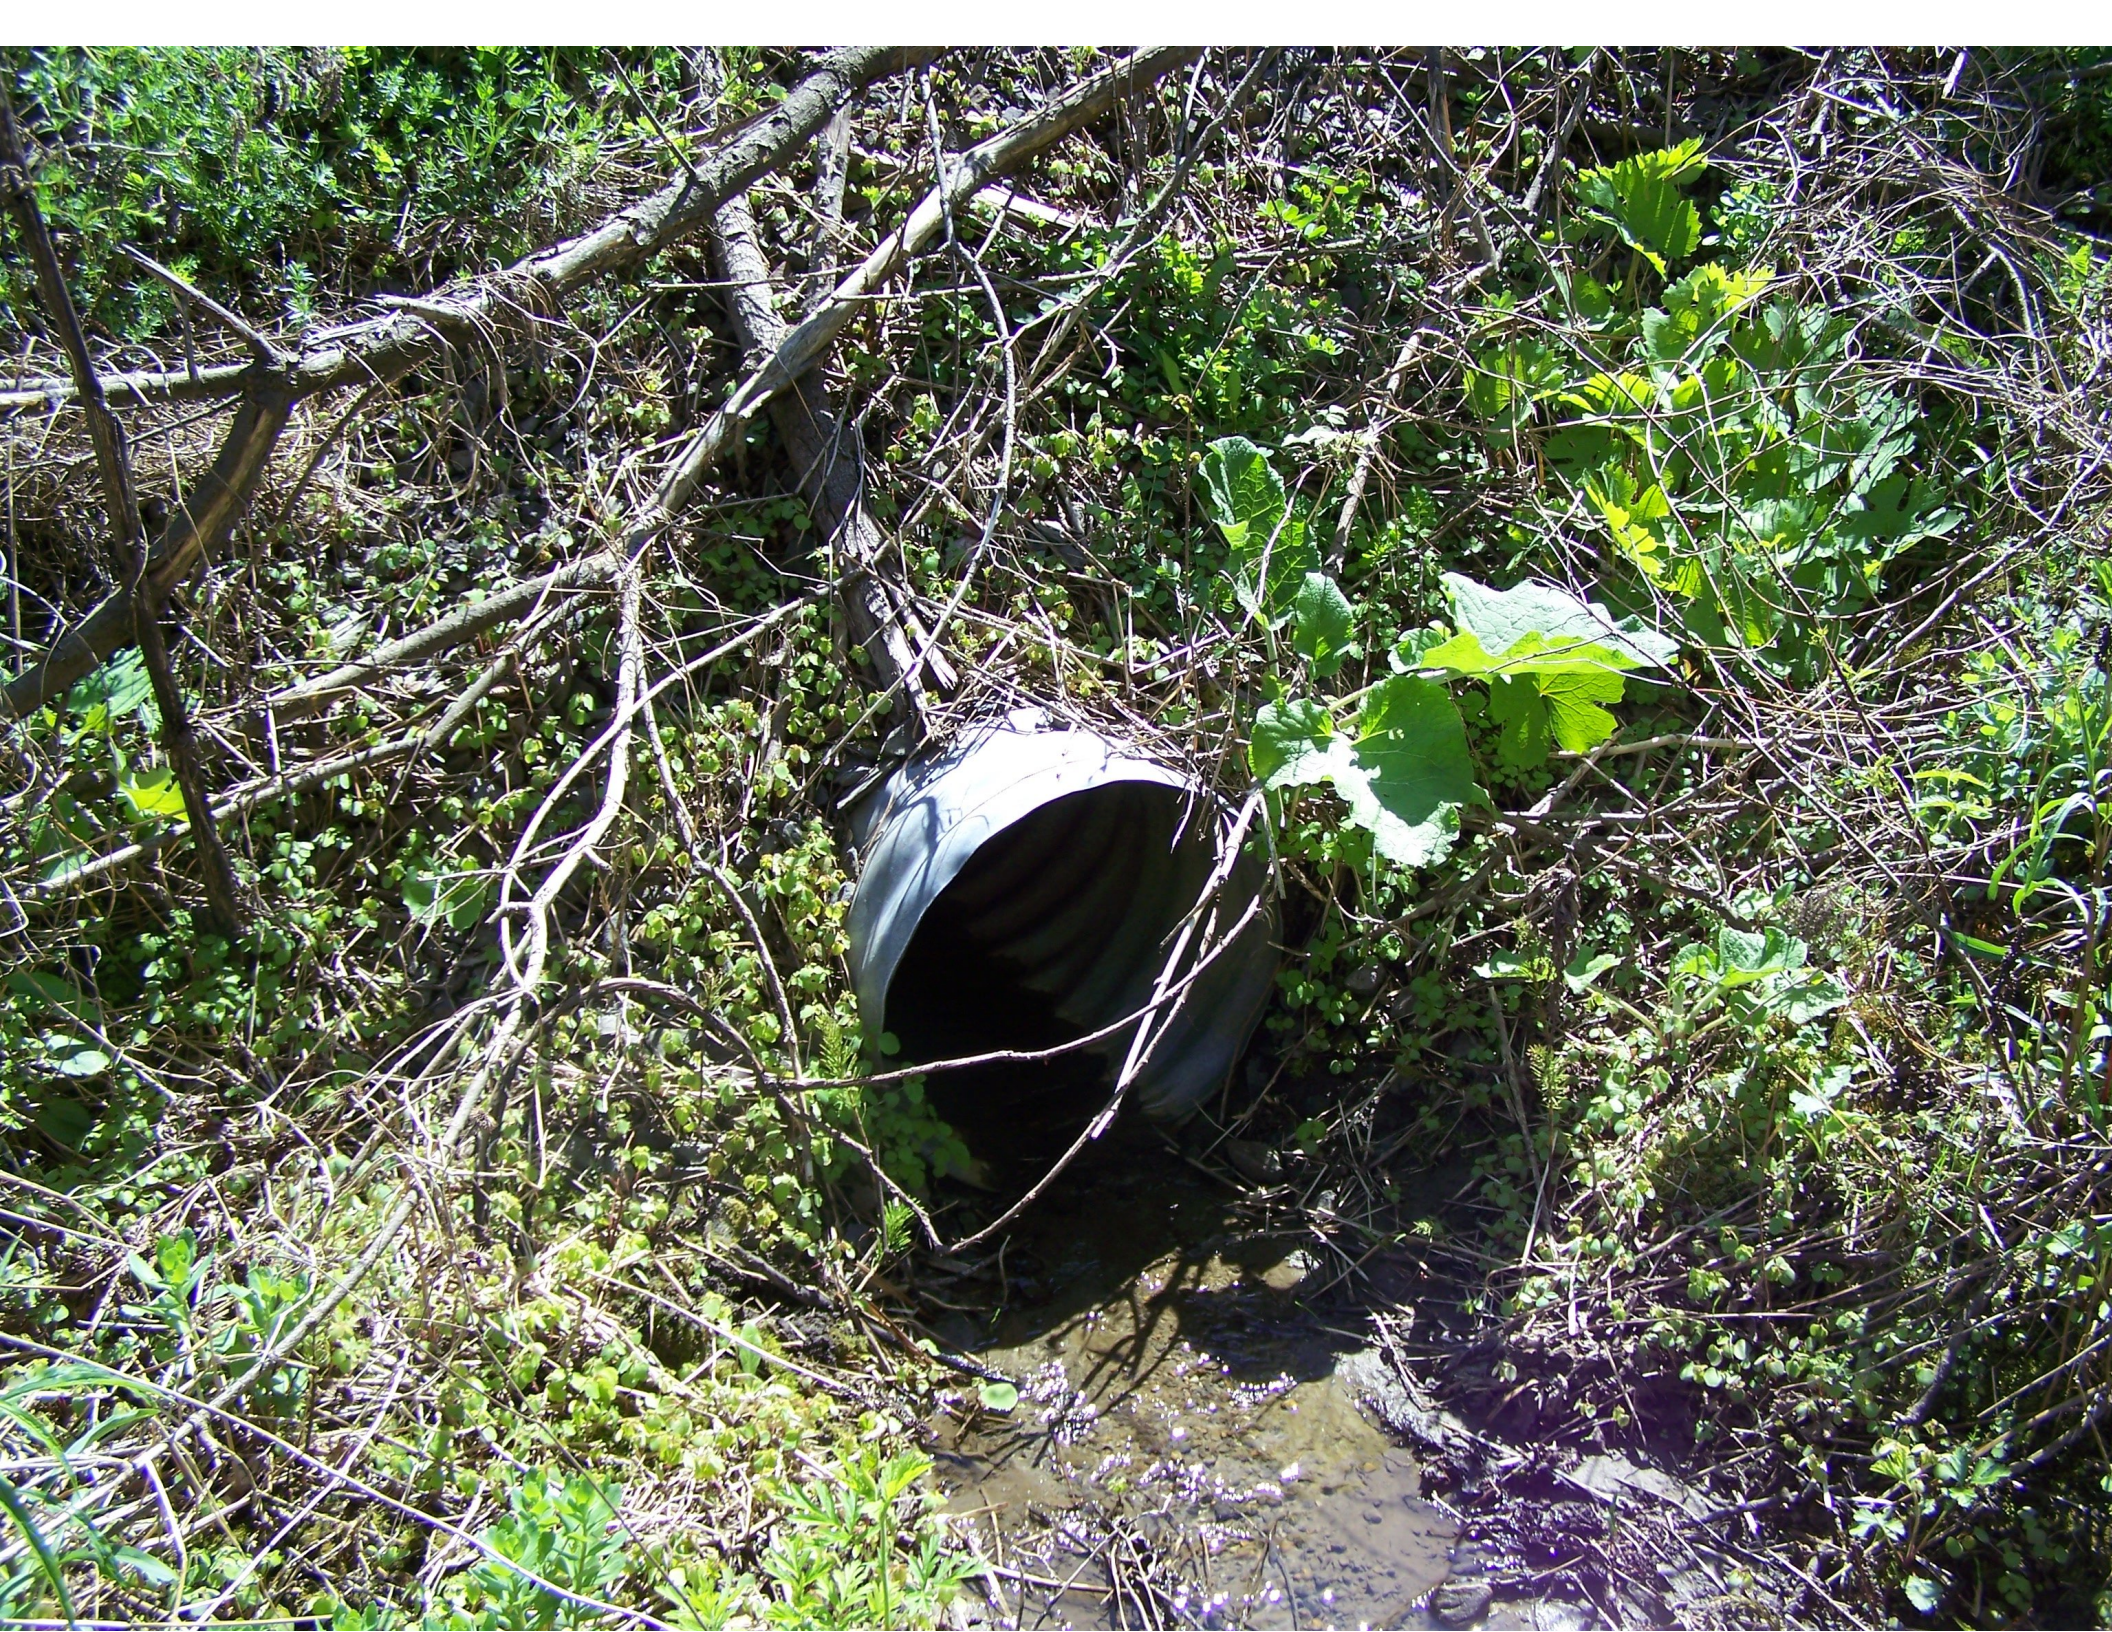
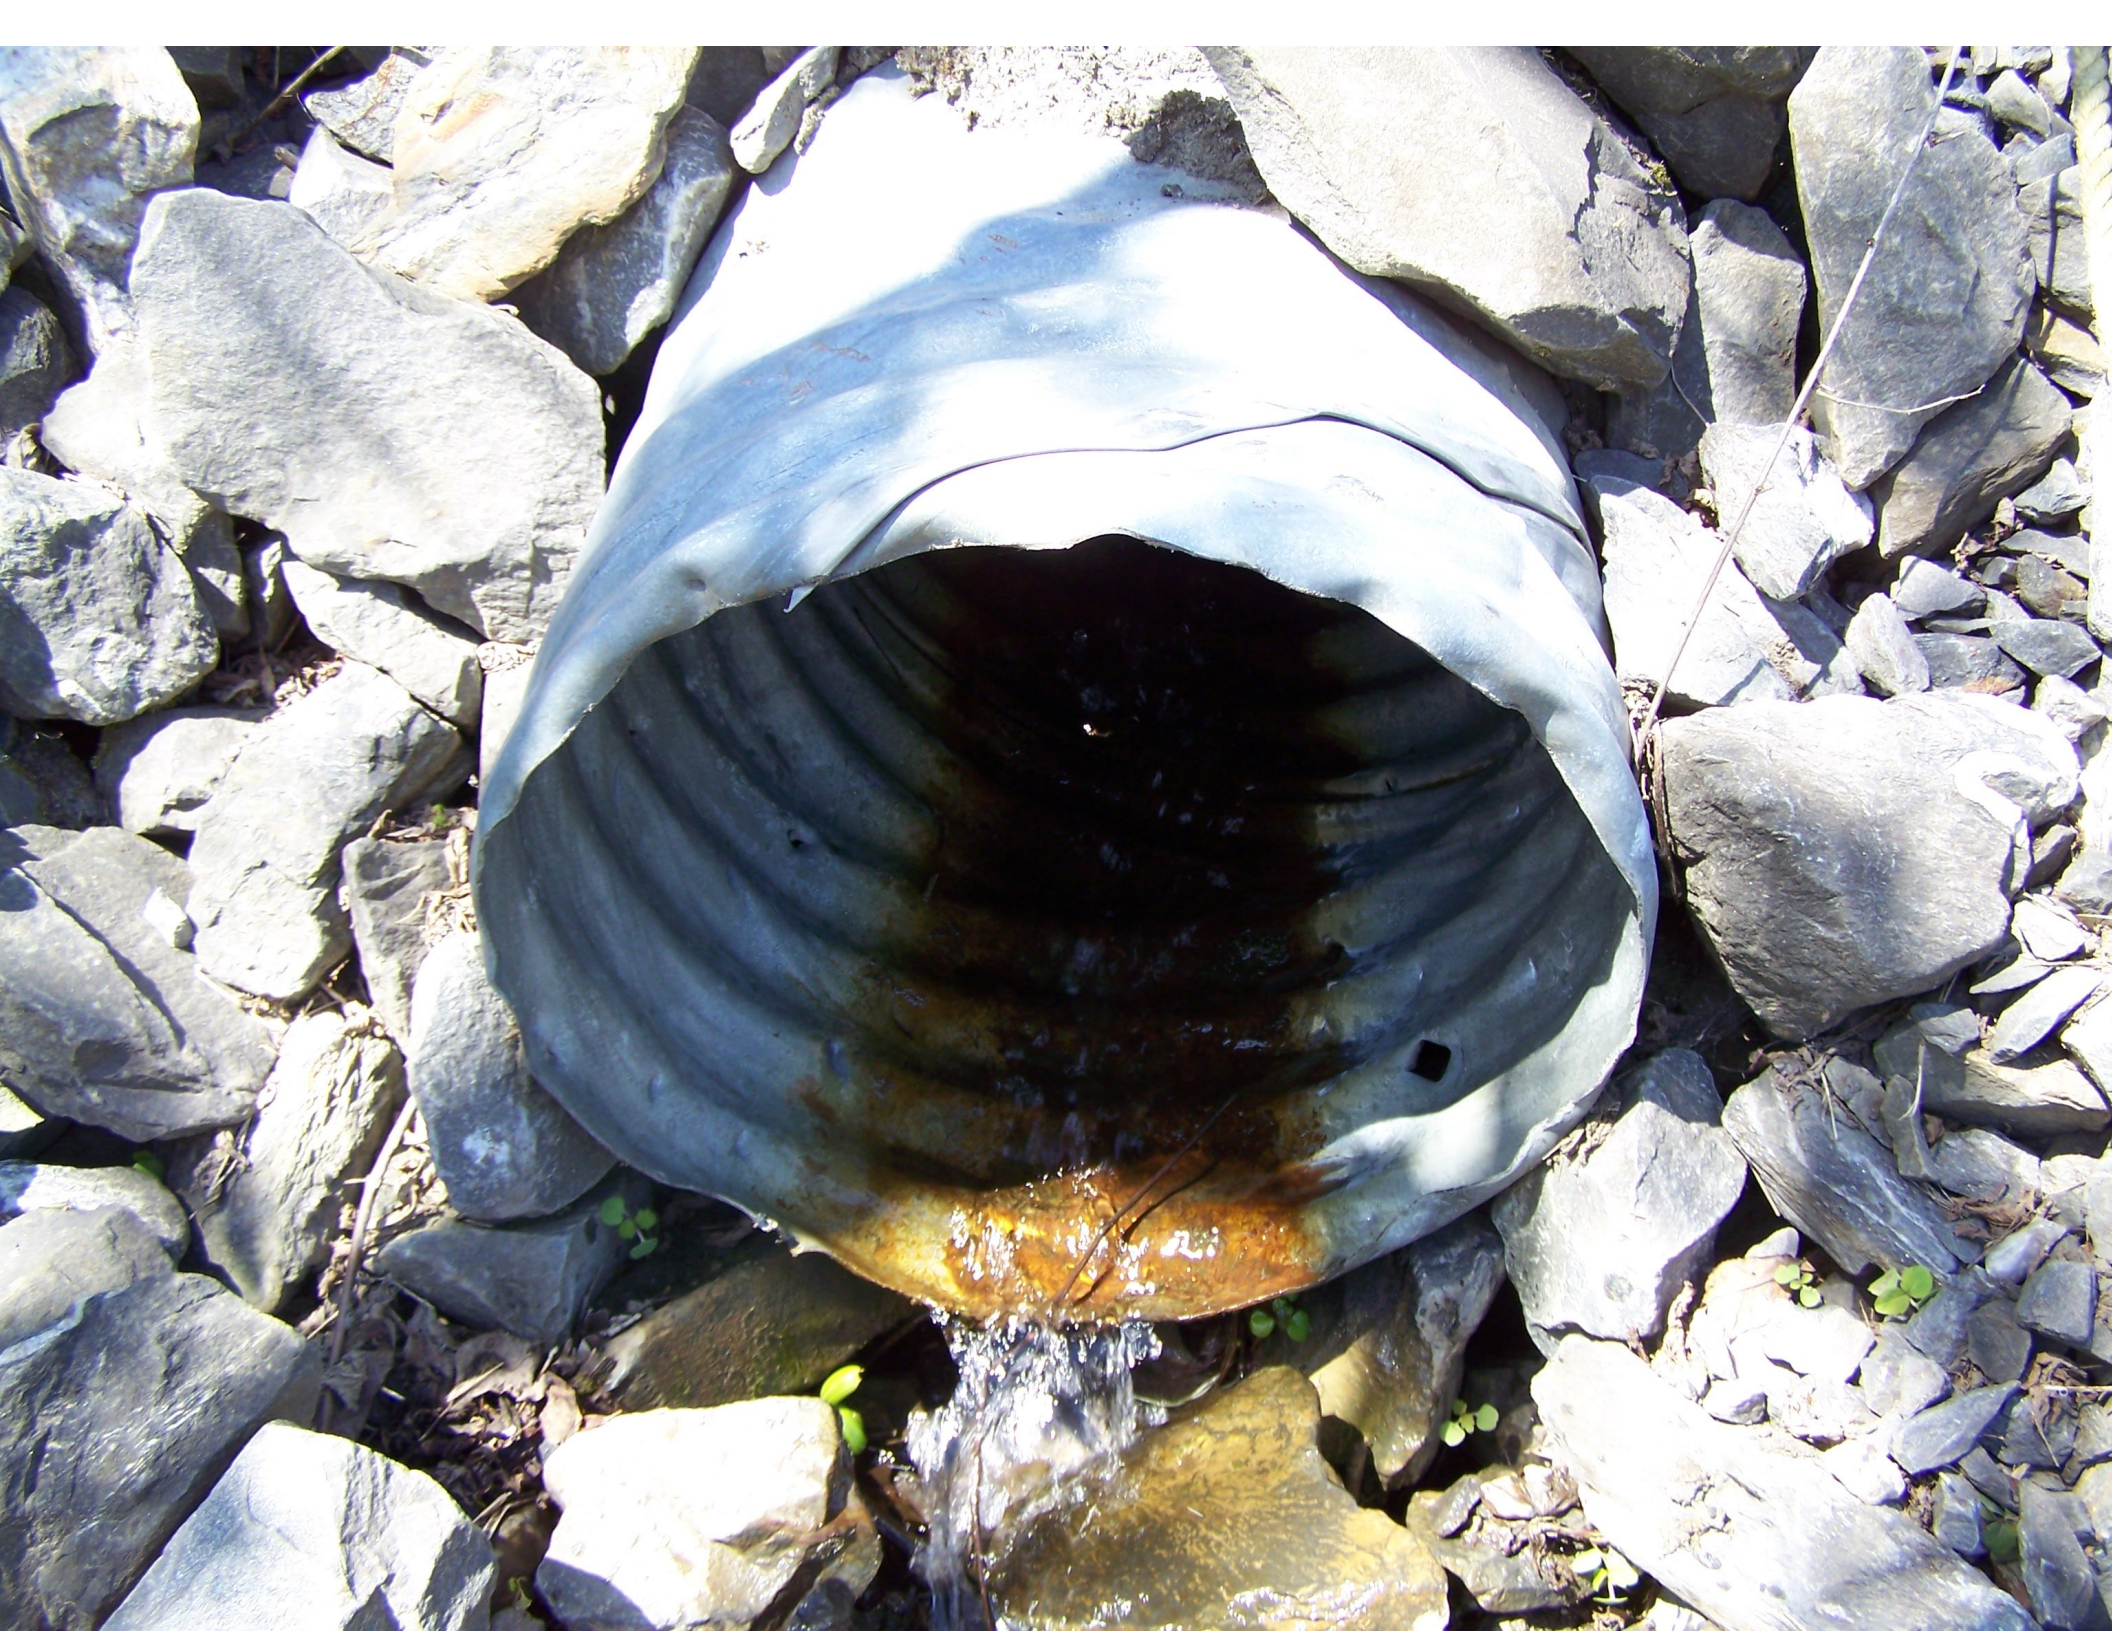
Additional Notes:  
PIPE IS BENDING  
\_\_\_\_\_  
\_\_\_\_\_
