**Culvert Inspection Form**

Railroad: <u>WACR CRL</u>	Town: <u>ST. JOHNSBURY</u>
Valuation Sheet: <u>V43/61</u>	Valuation Stationing: <u>3181 + 79.2</u>
Mile Post: <u>L 43.93</u>	GPS Coordinates: N: <u>44 24.661</u> W: <u>72 01.073</u>

Culvert #: 43A

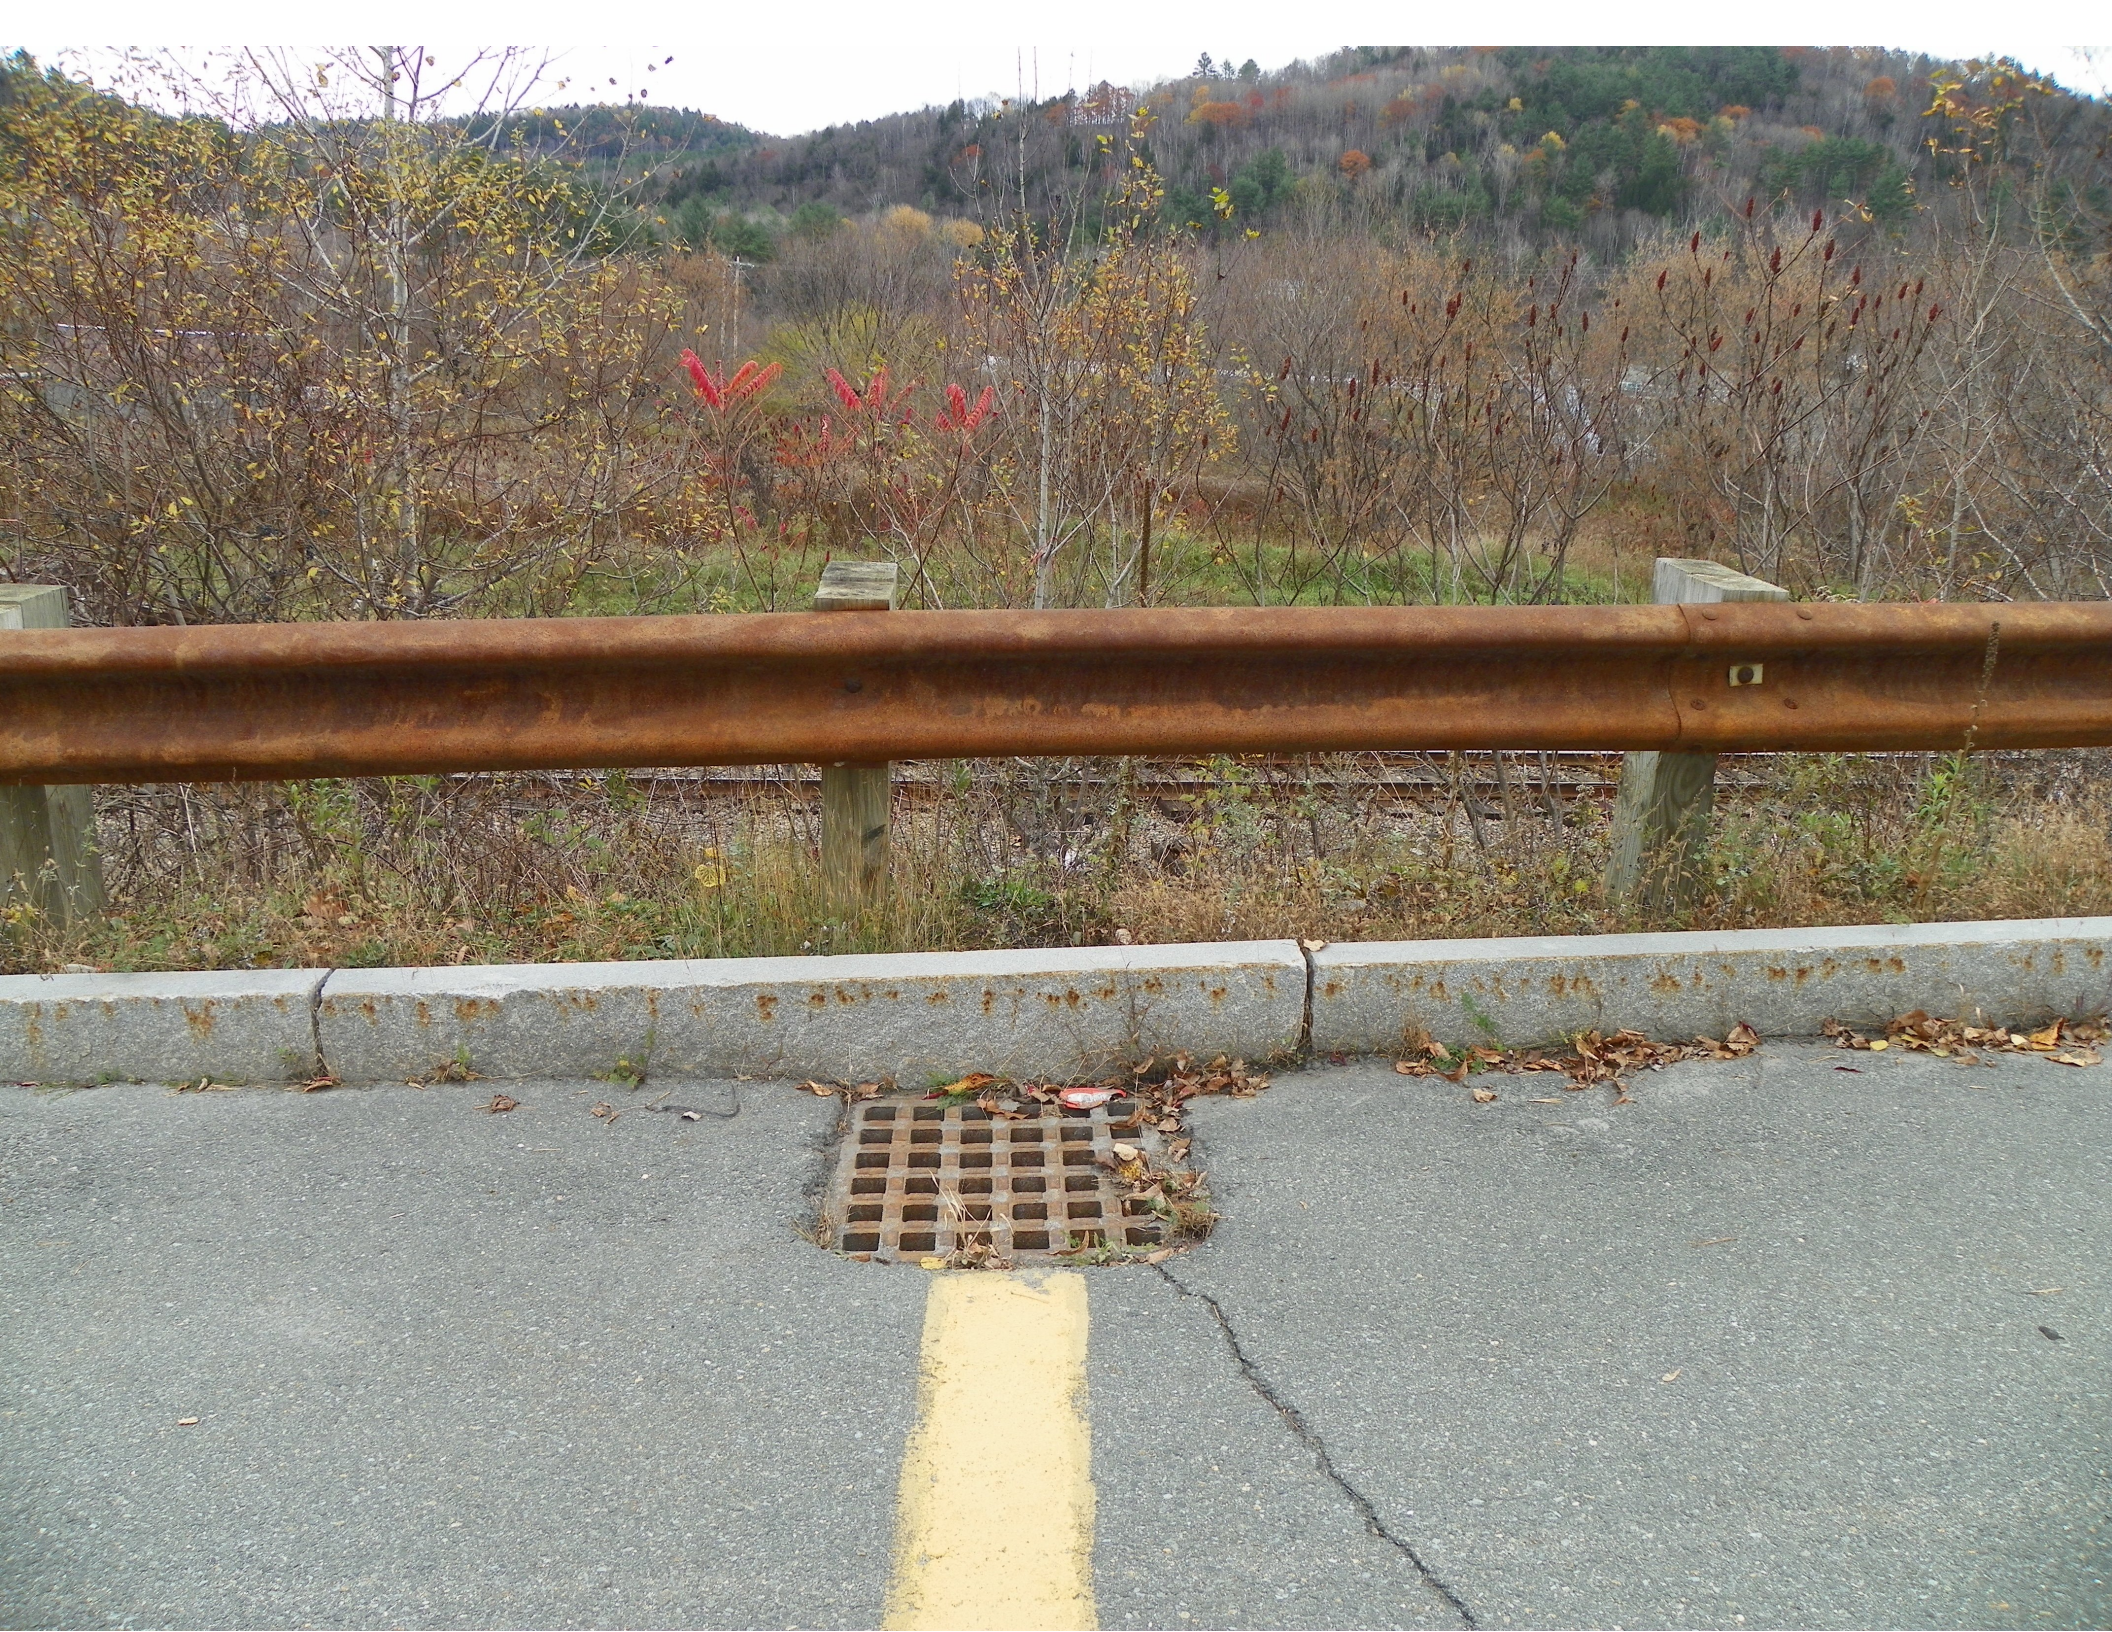
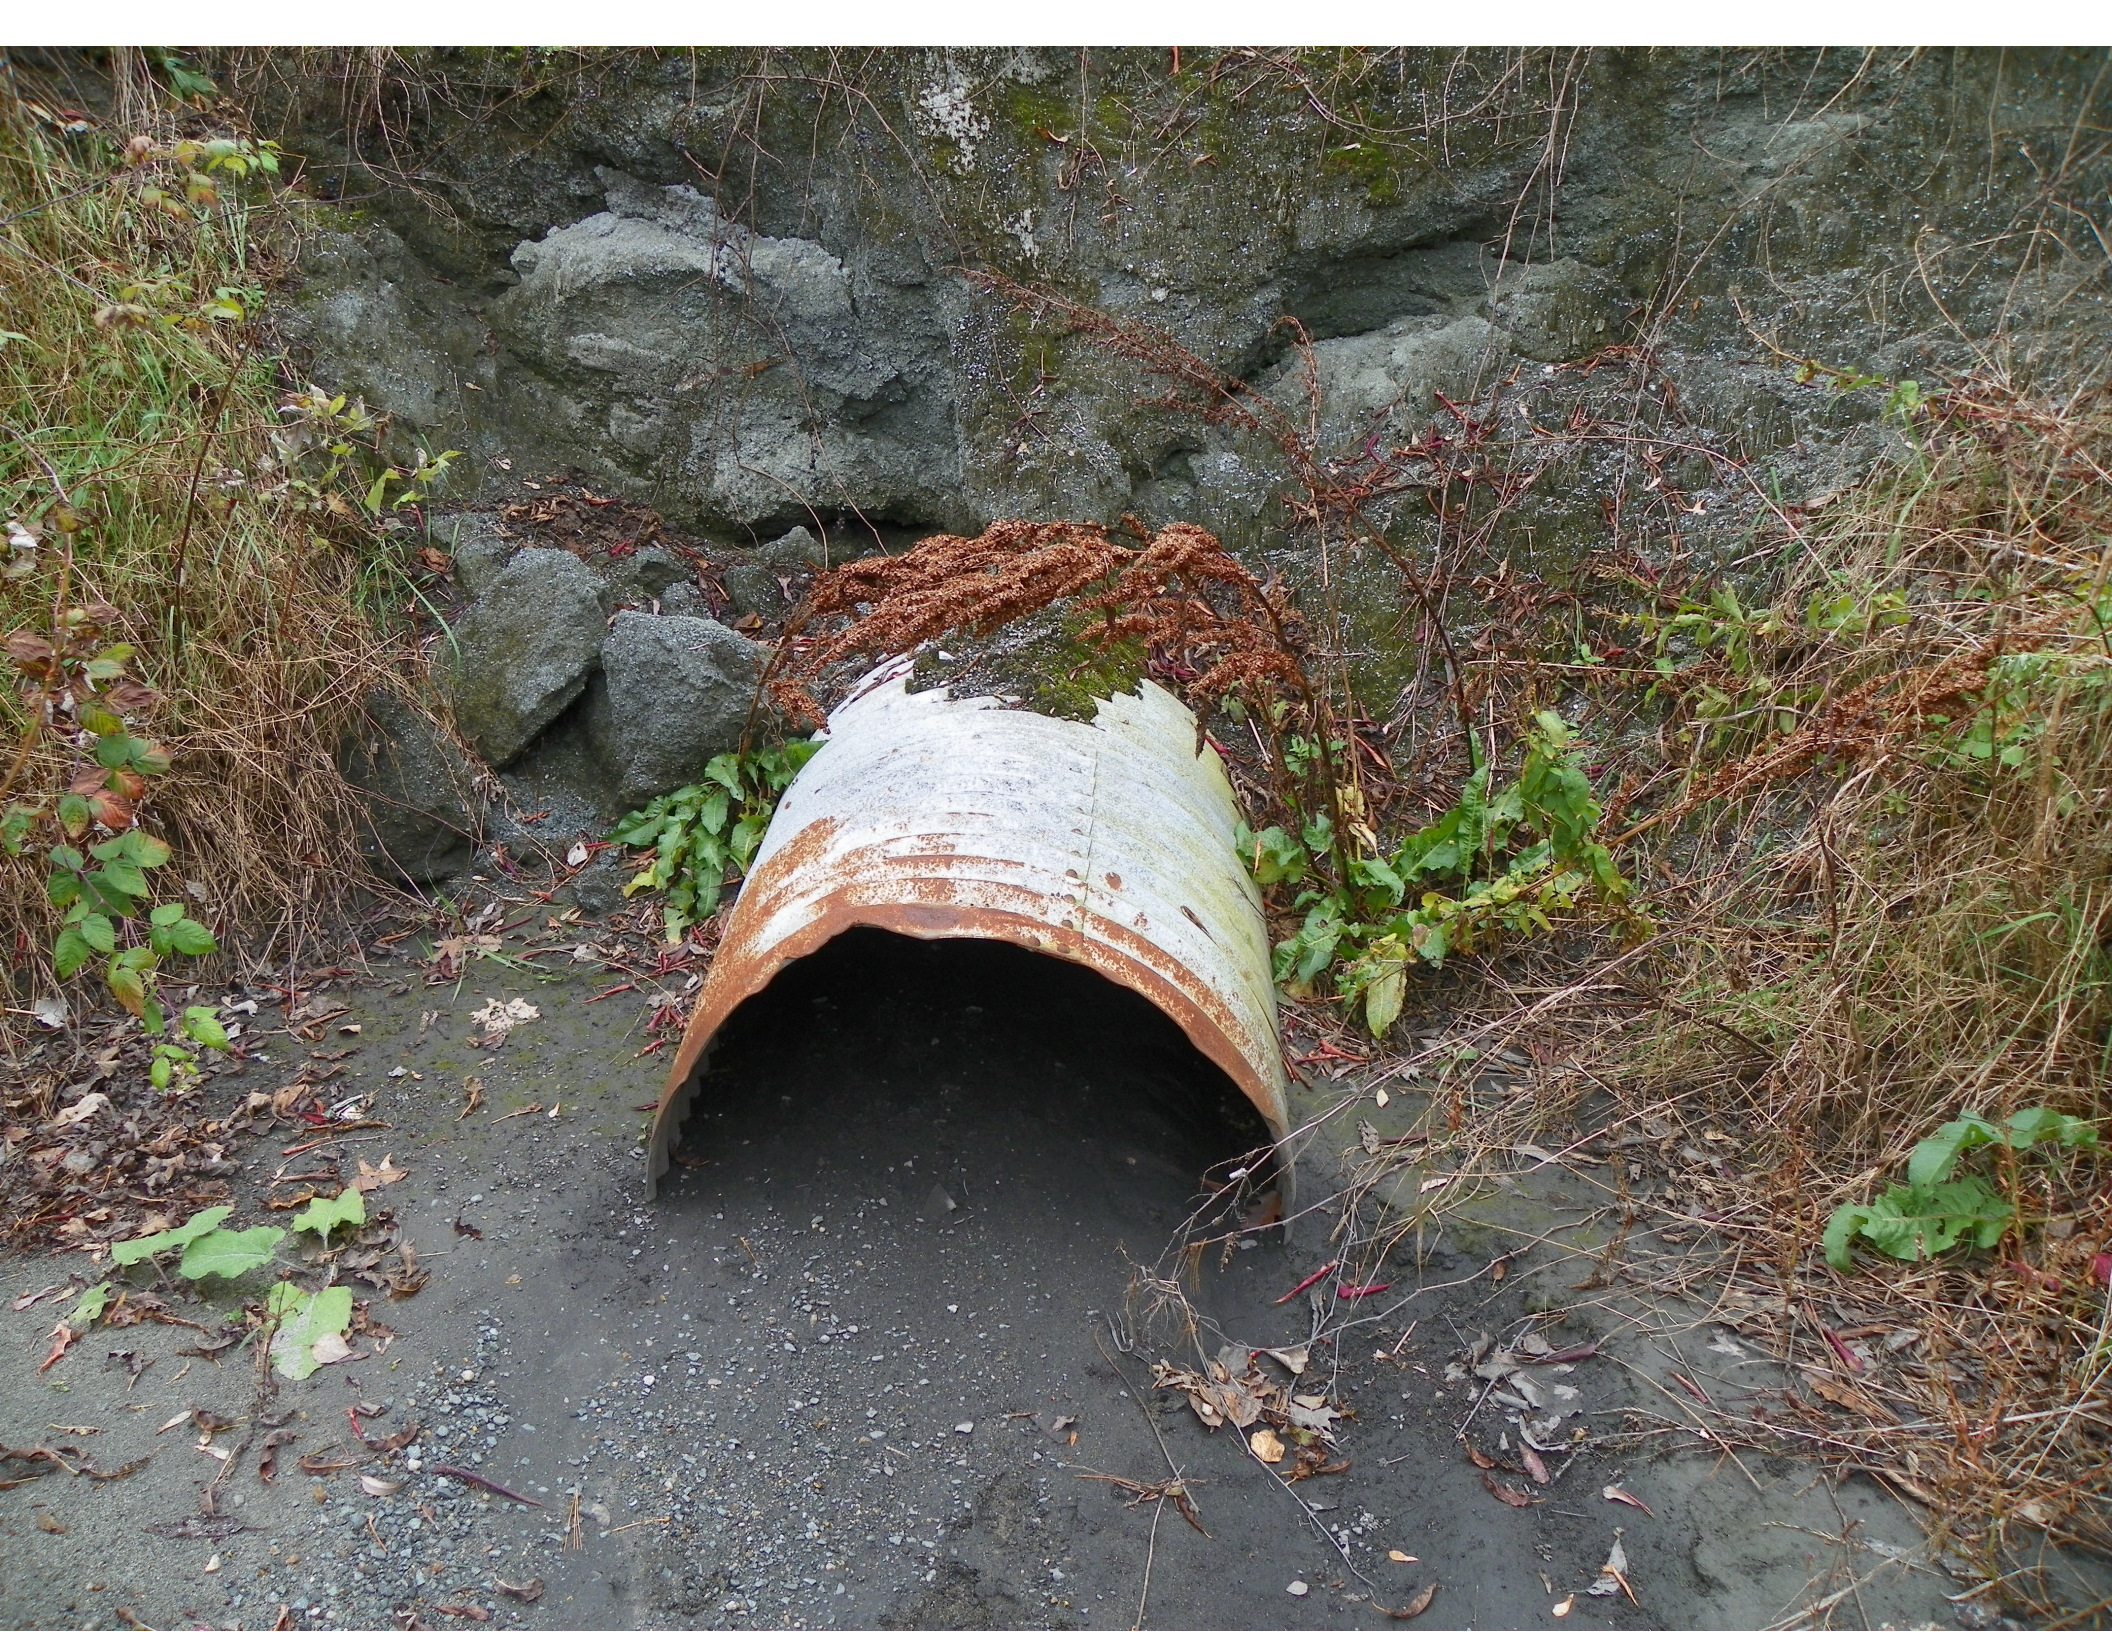
36" CONCRETE DI IN ROAD ON WEST SIDE

Height from Rail: 6'
