### Culvert Inspection Form

| Railroad: <u>WACC CRL</u> | Town: <u>RYEGATE</u> |
| Valuation Sheet: $\frac{VAB}{46}$ | Valuation Stationing: <u>2430 + 46</u> |

Culvert #: 27 G

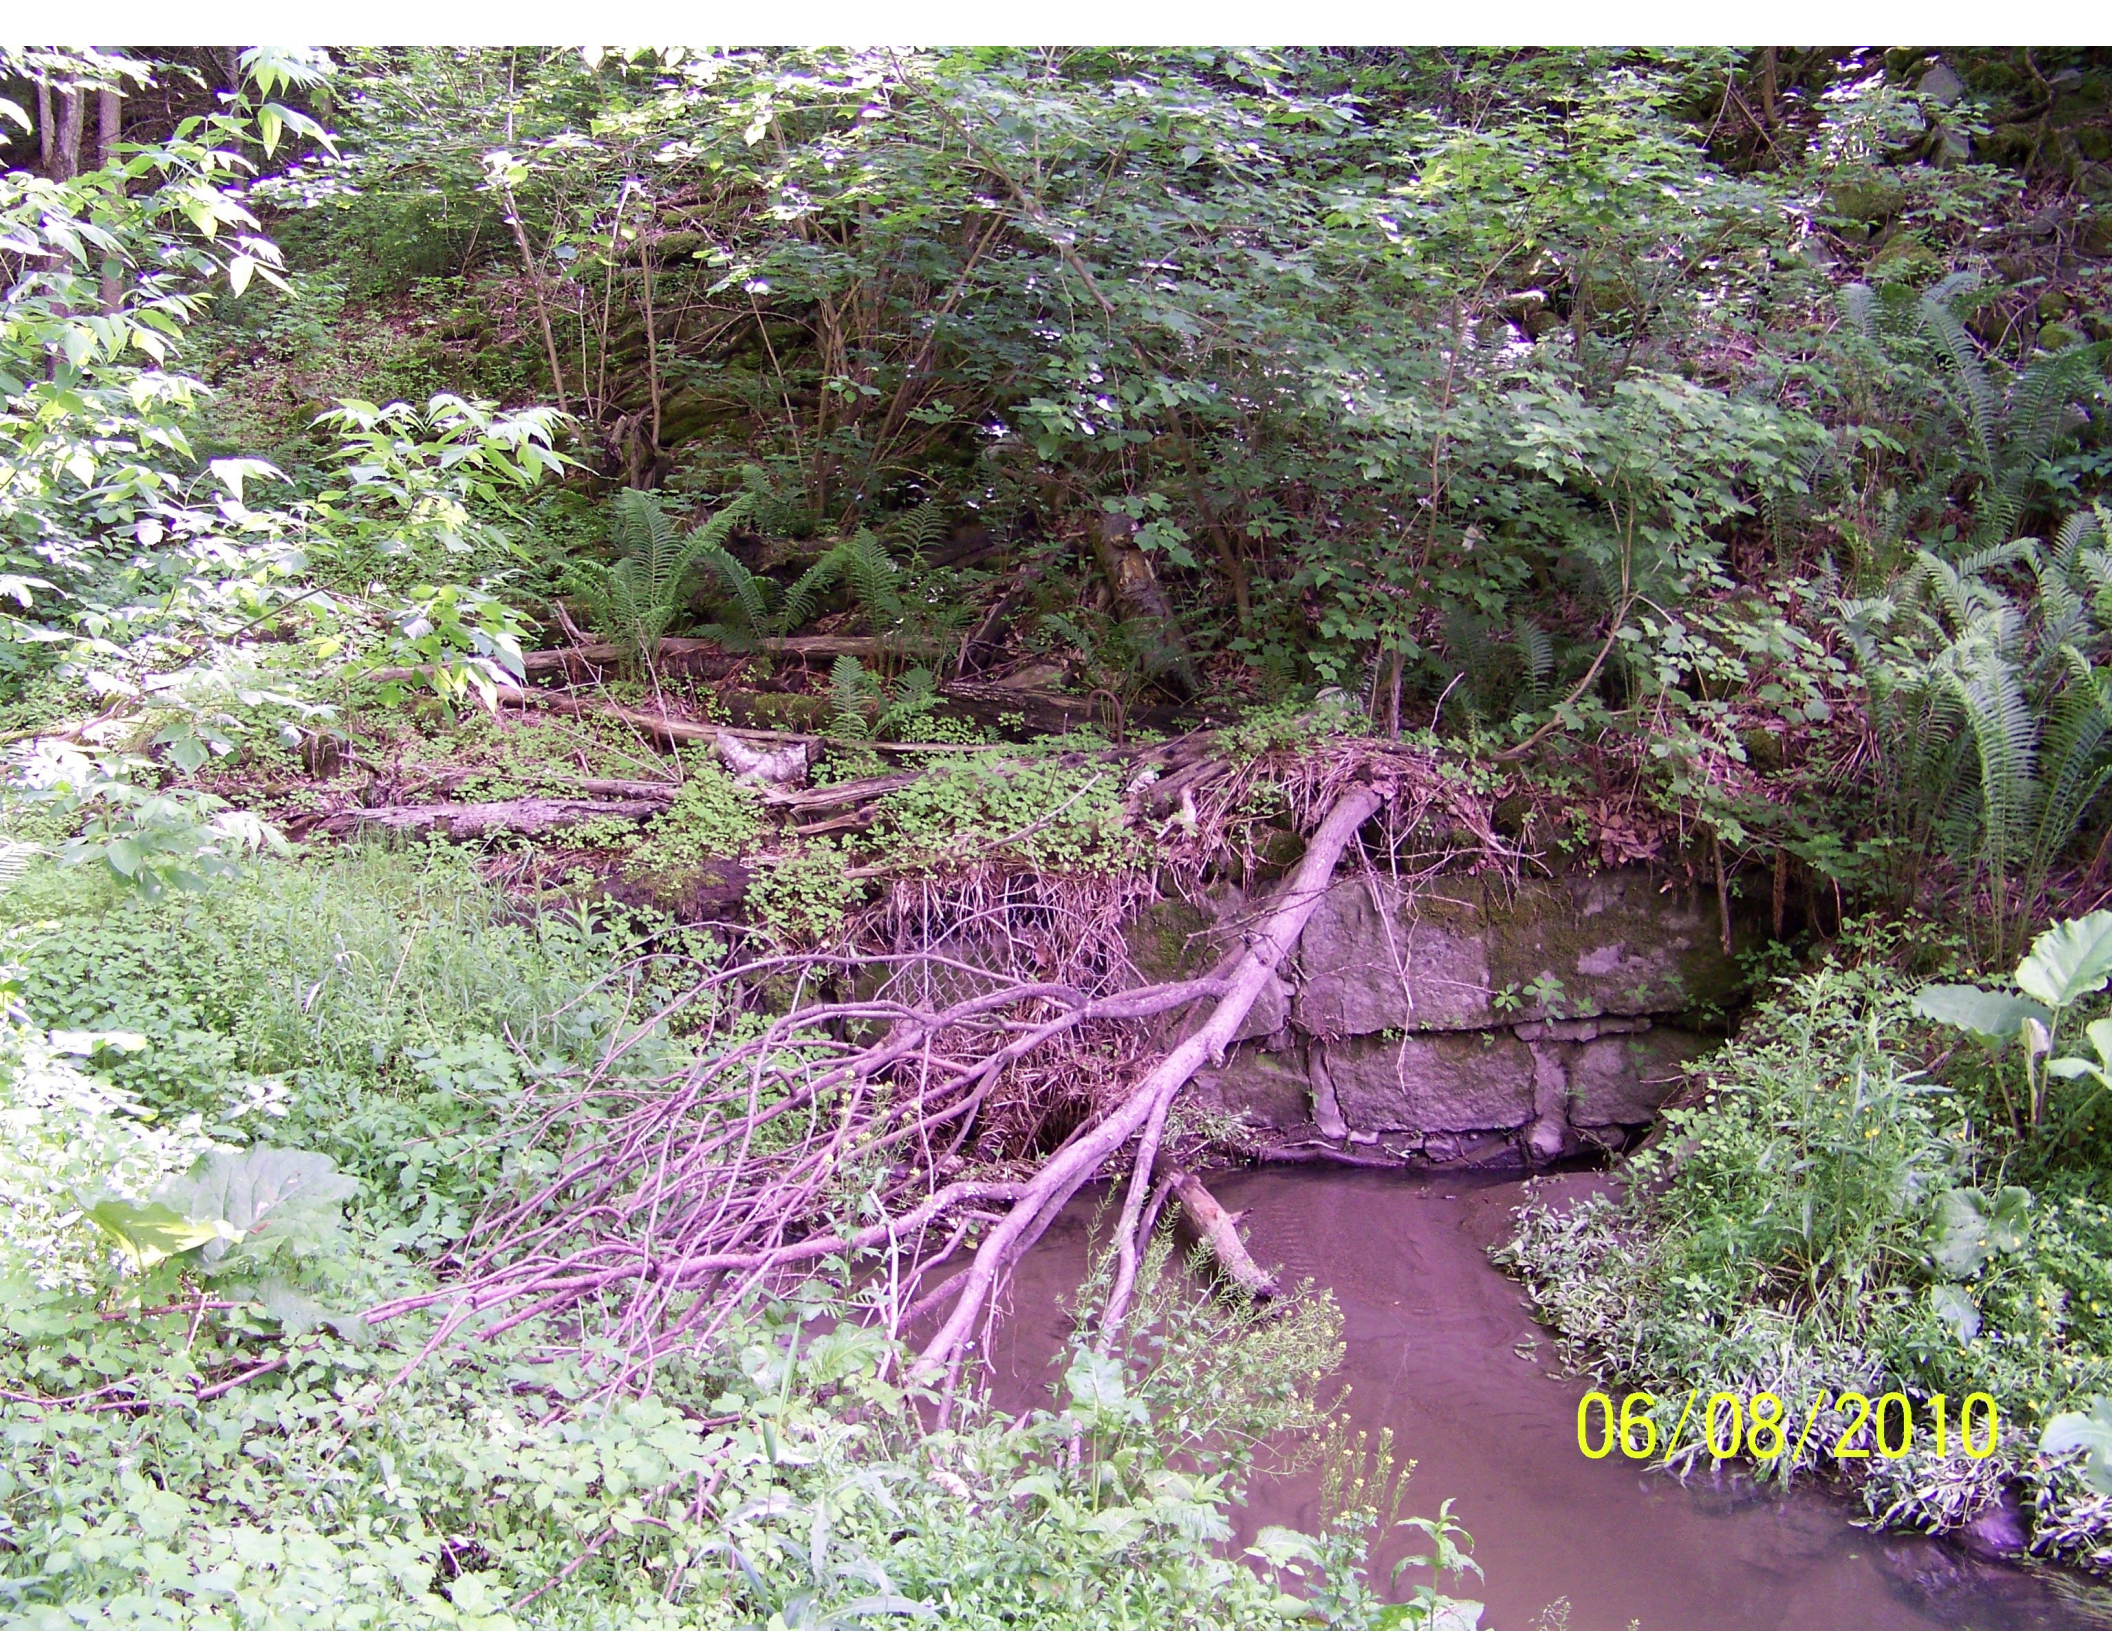
EAST END (OUTLET WAS COLLAPSED)
