### Culvert Inspection Form

Railroad: <u>WACR CRL</u>	Town: <u>RYEGATE</u>
Valuation Sheet: <u>V43</u> <u>43</u>	Valuation Stationing: <u>2855 + 83</u>
Mile Post: <u>L 61.47</u>	GPS Coordinates: N: <u>44 11 00</u> W: <u>72 03 39</u>

Culvert #: 26 Q

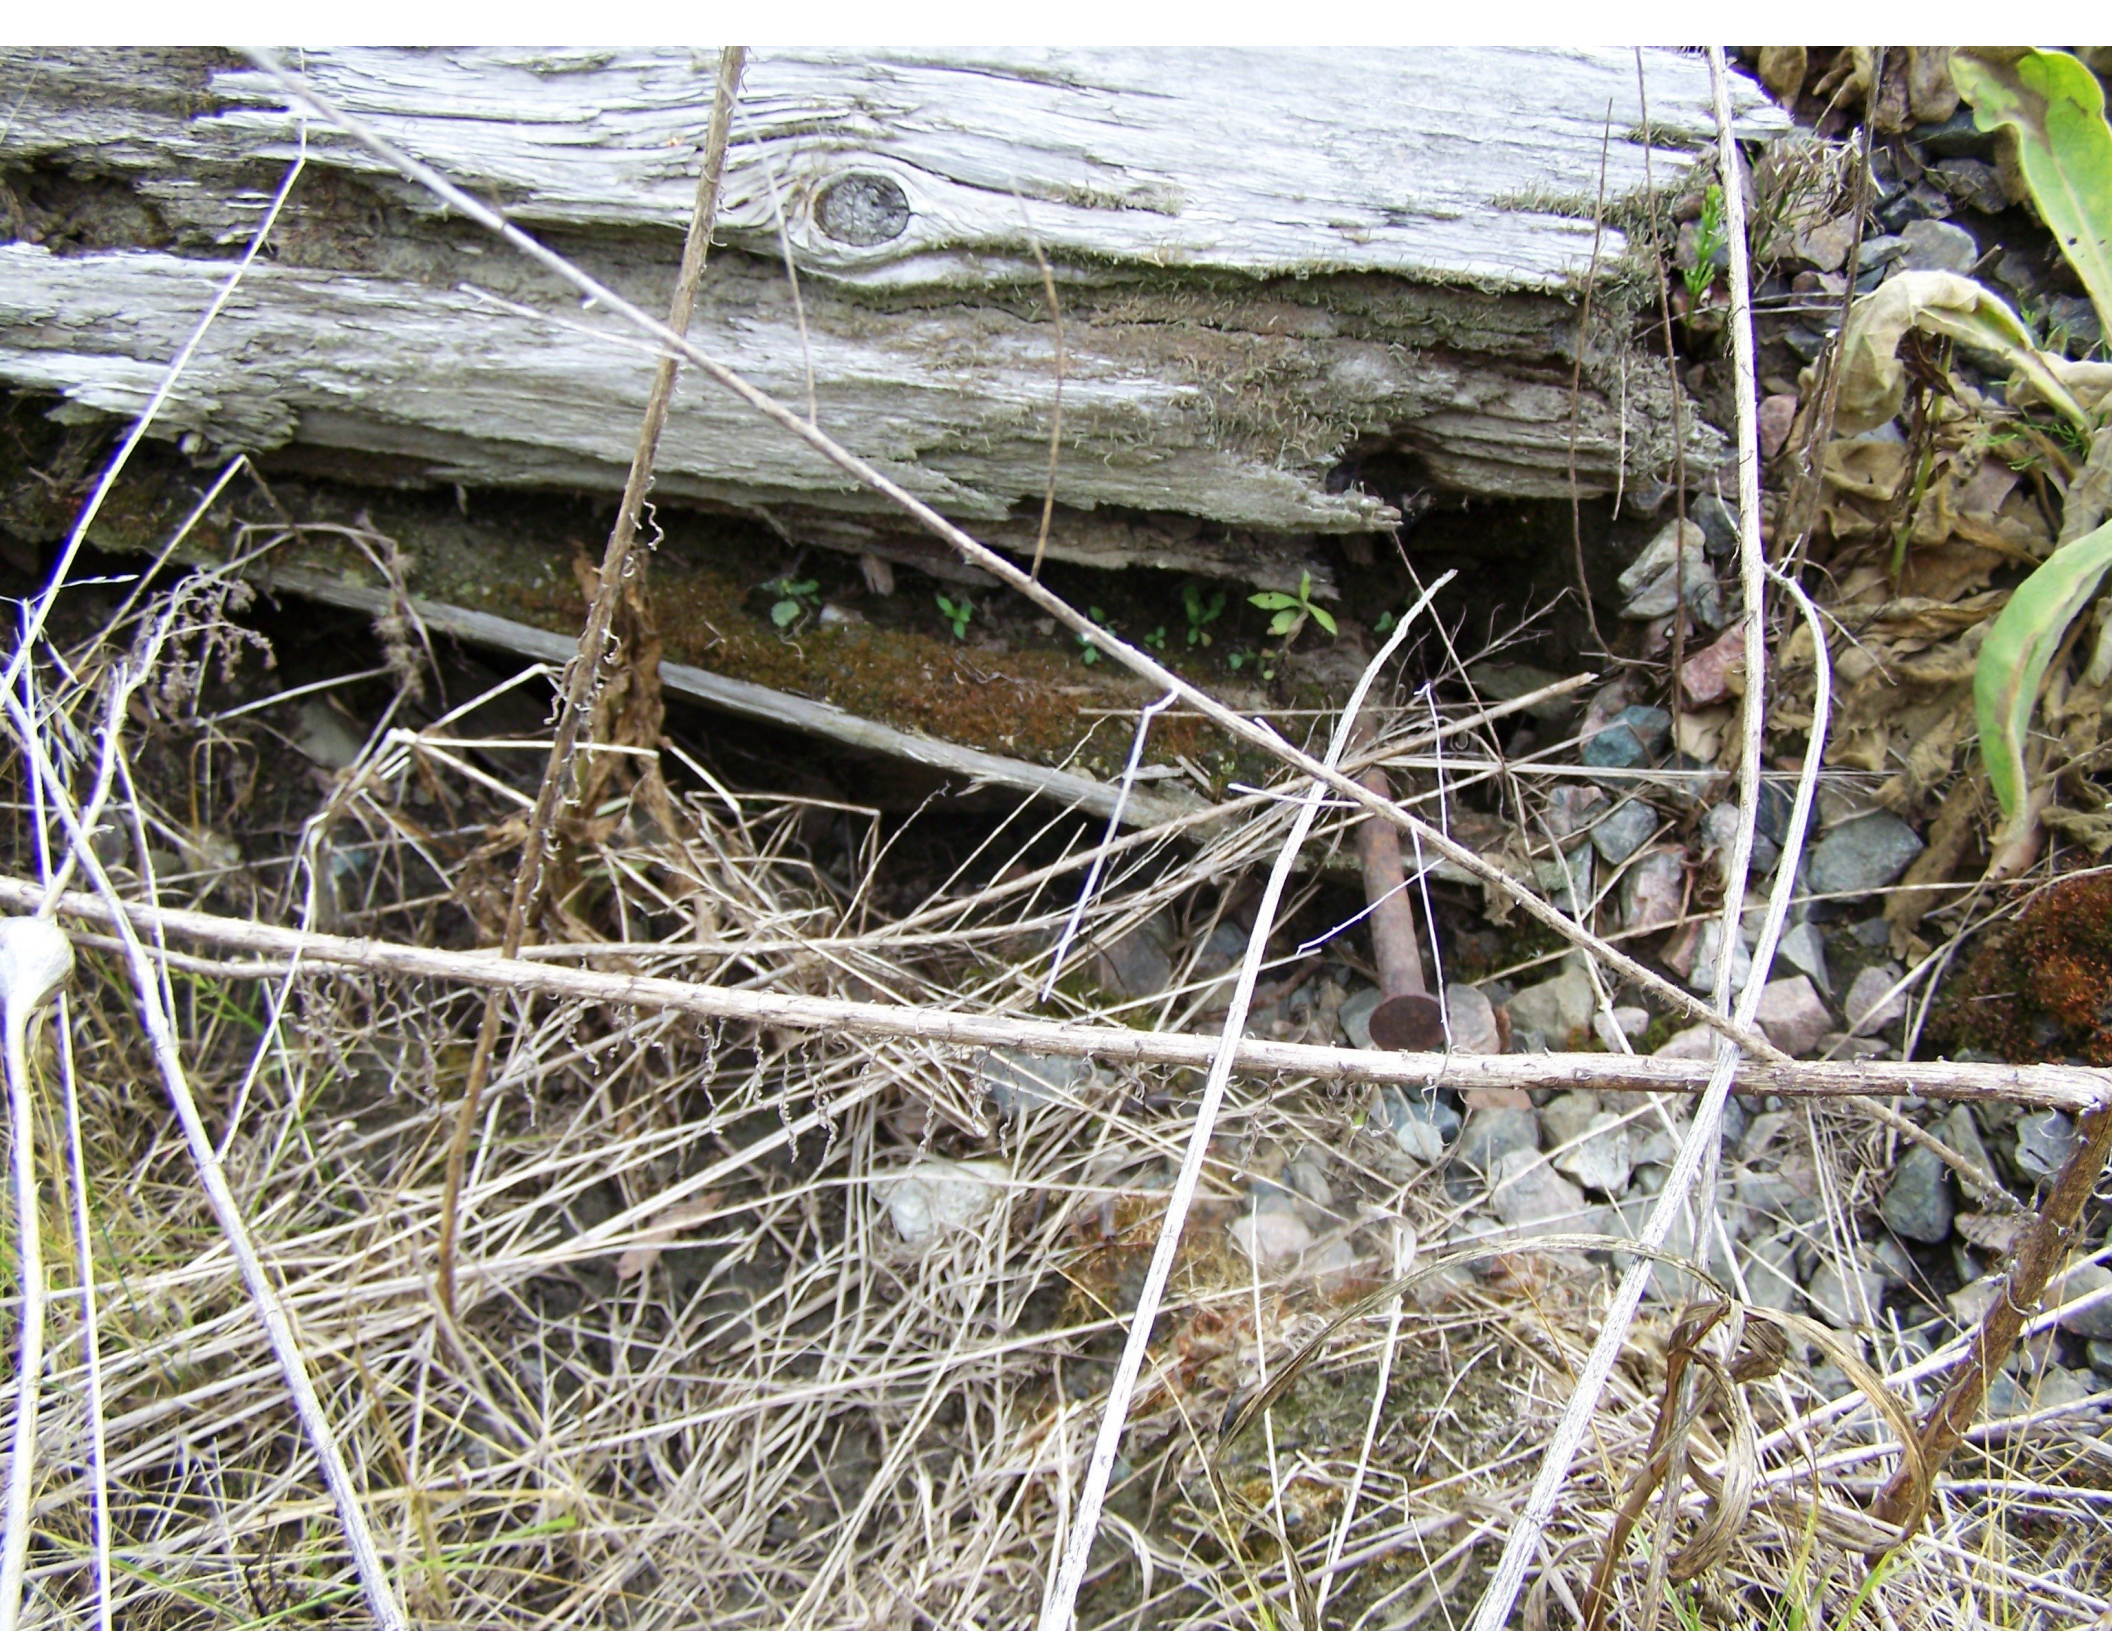
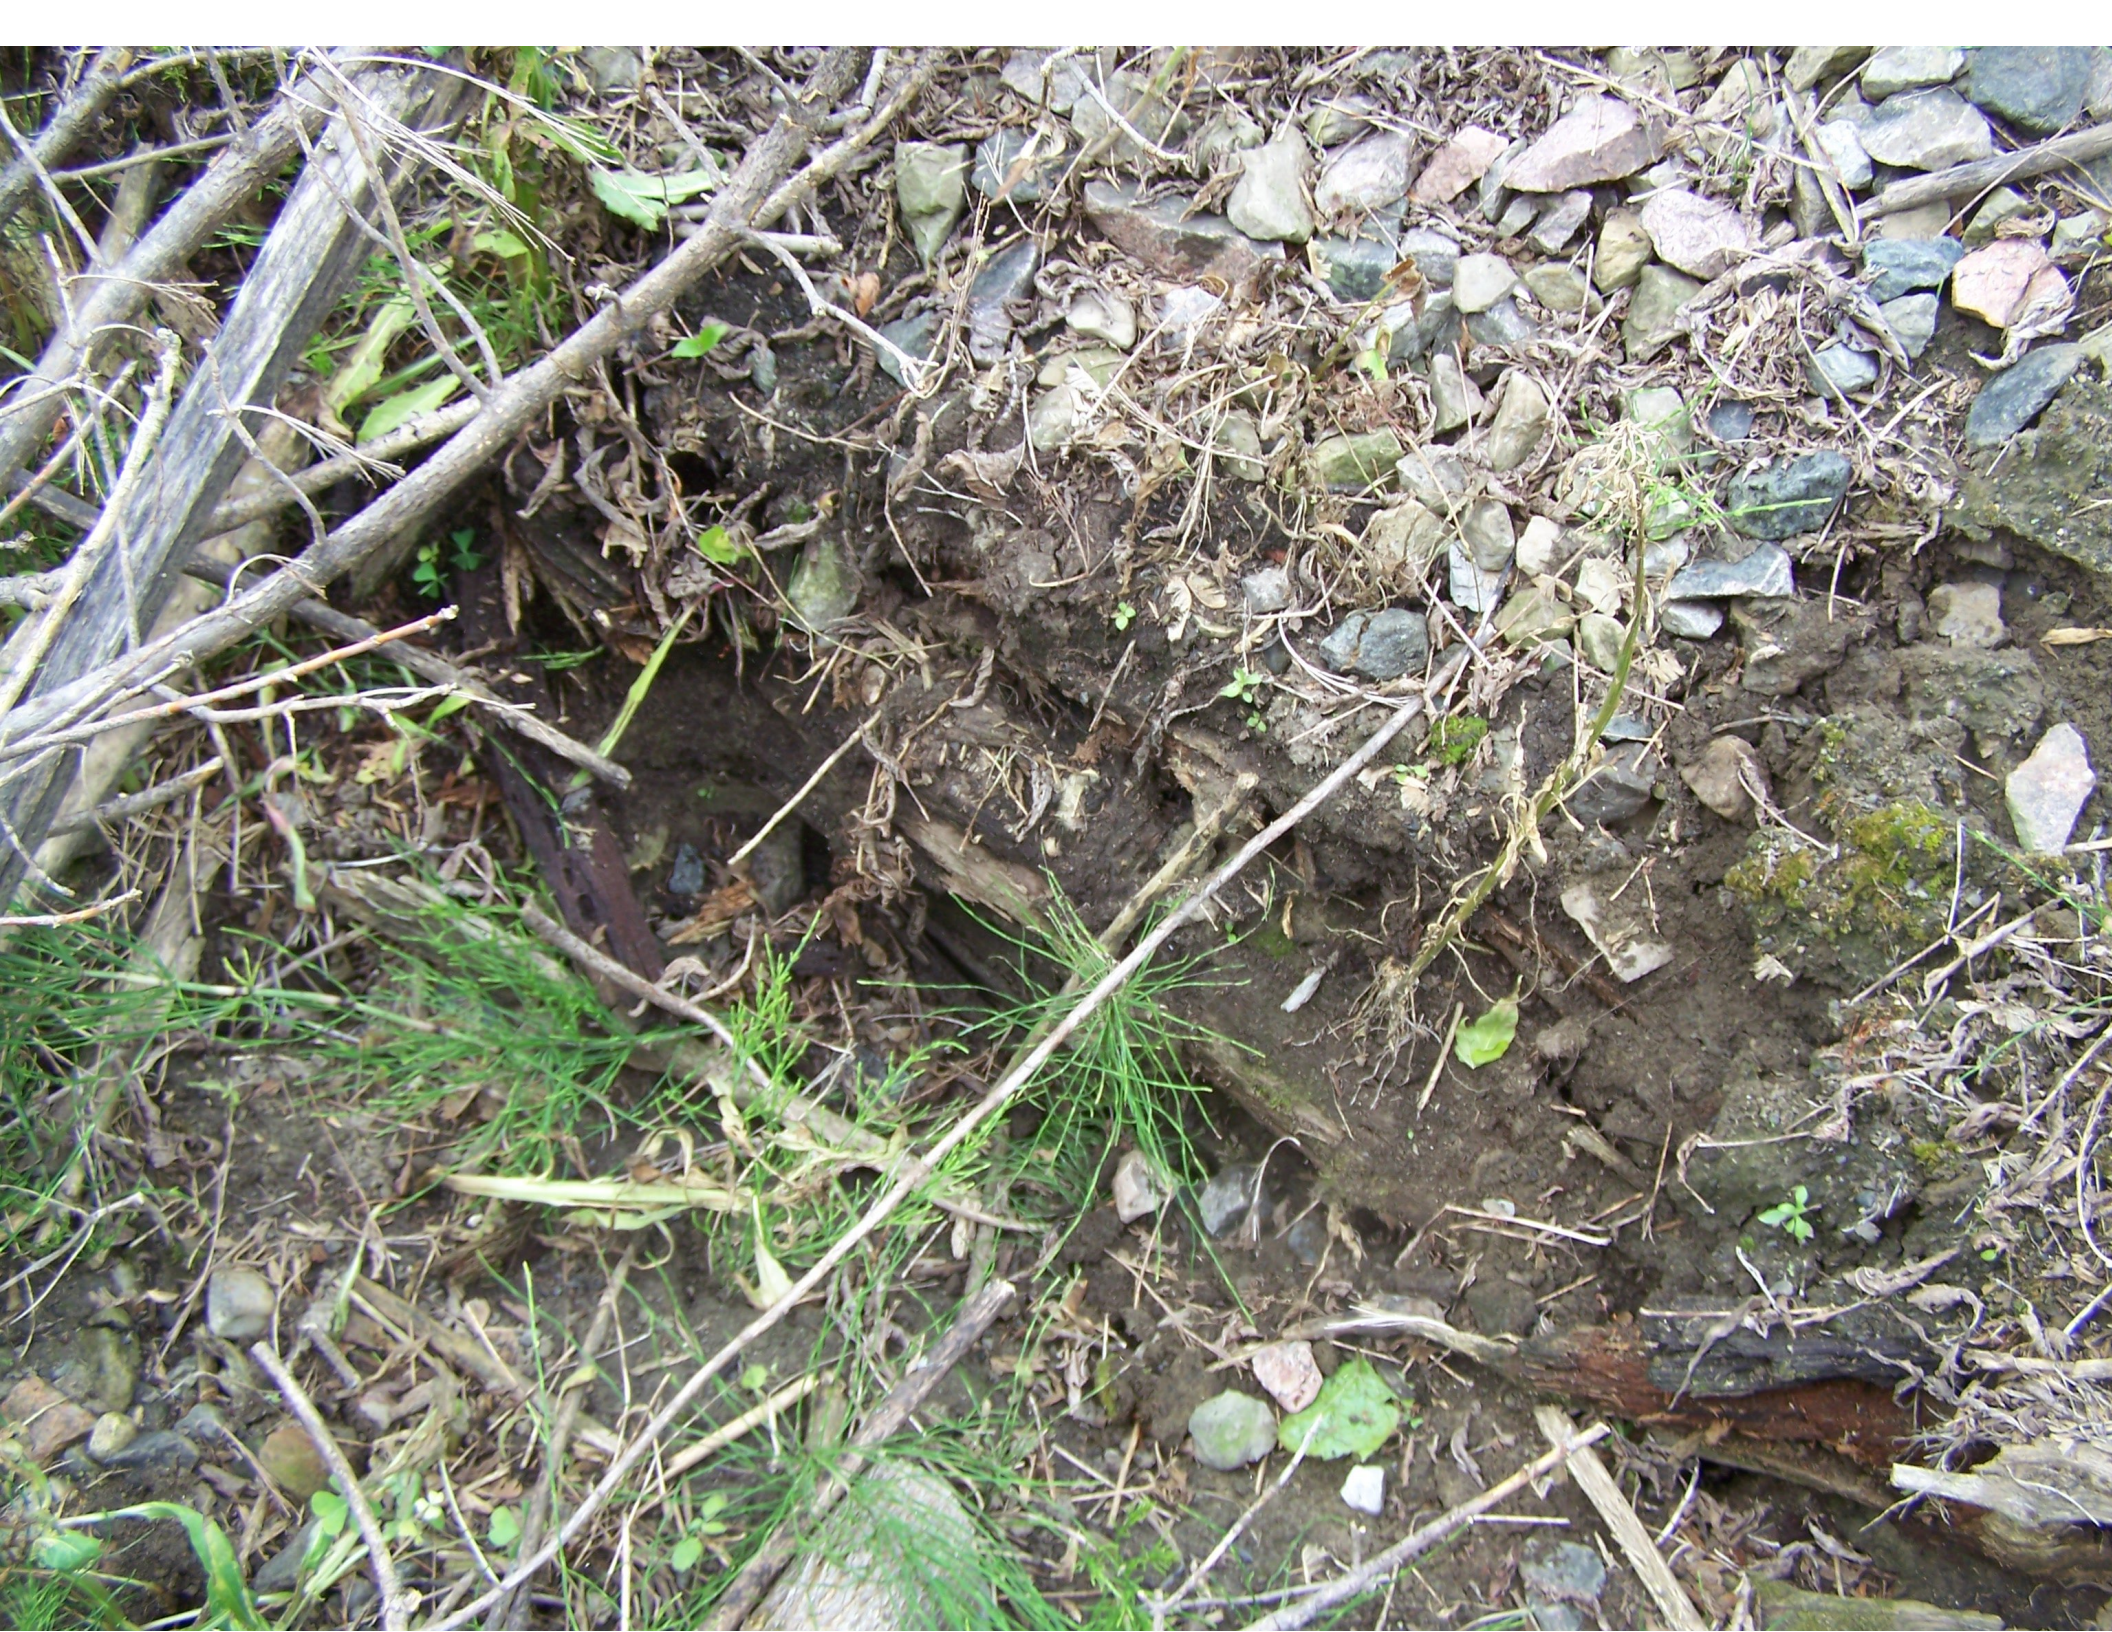
NOT VISIBLE

WOODEN HANDRAILS COLLAPSED
