**Culvert Inspection Form**

Railroad: <u>WACR CR1</u>	Town: <u>RYEGATE</u>
Valuation Sheet: <u>V43</u> <u>42</u>	Valuation Stationing: <u>22.10 + 62</u>
Mile Post: <u>L 62.32</u>	GPS Coordinates: N: <u>44 10 18</u> W: <u>72 03 16</u>

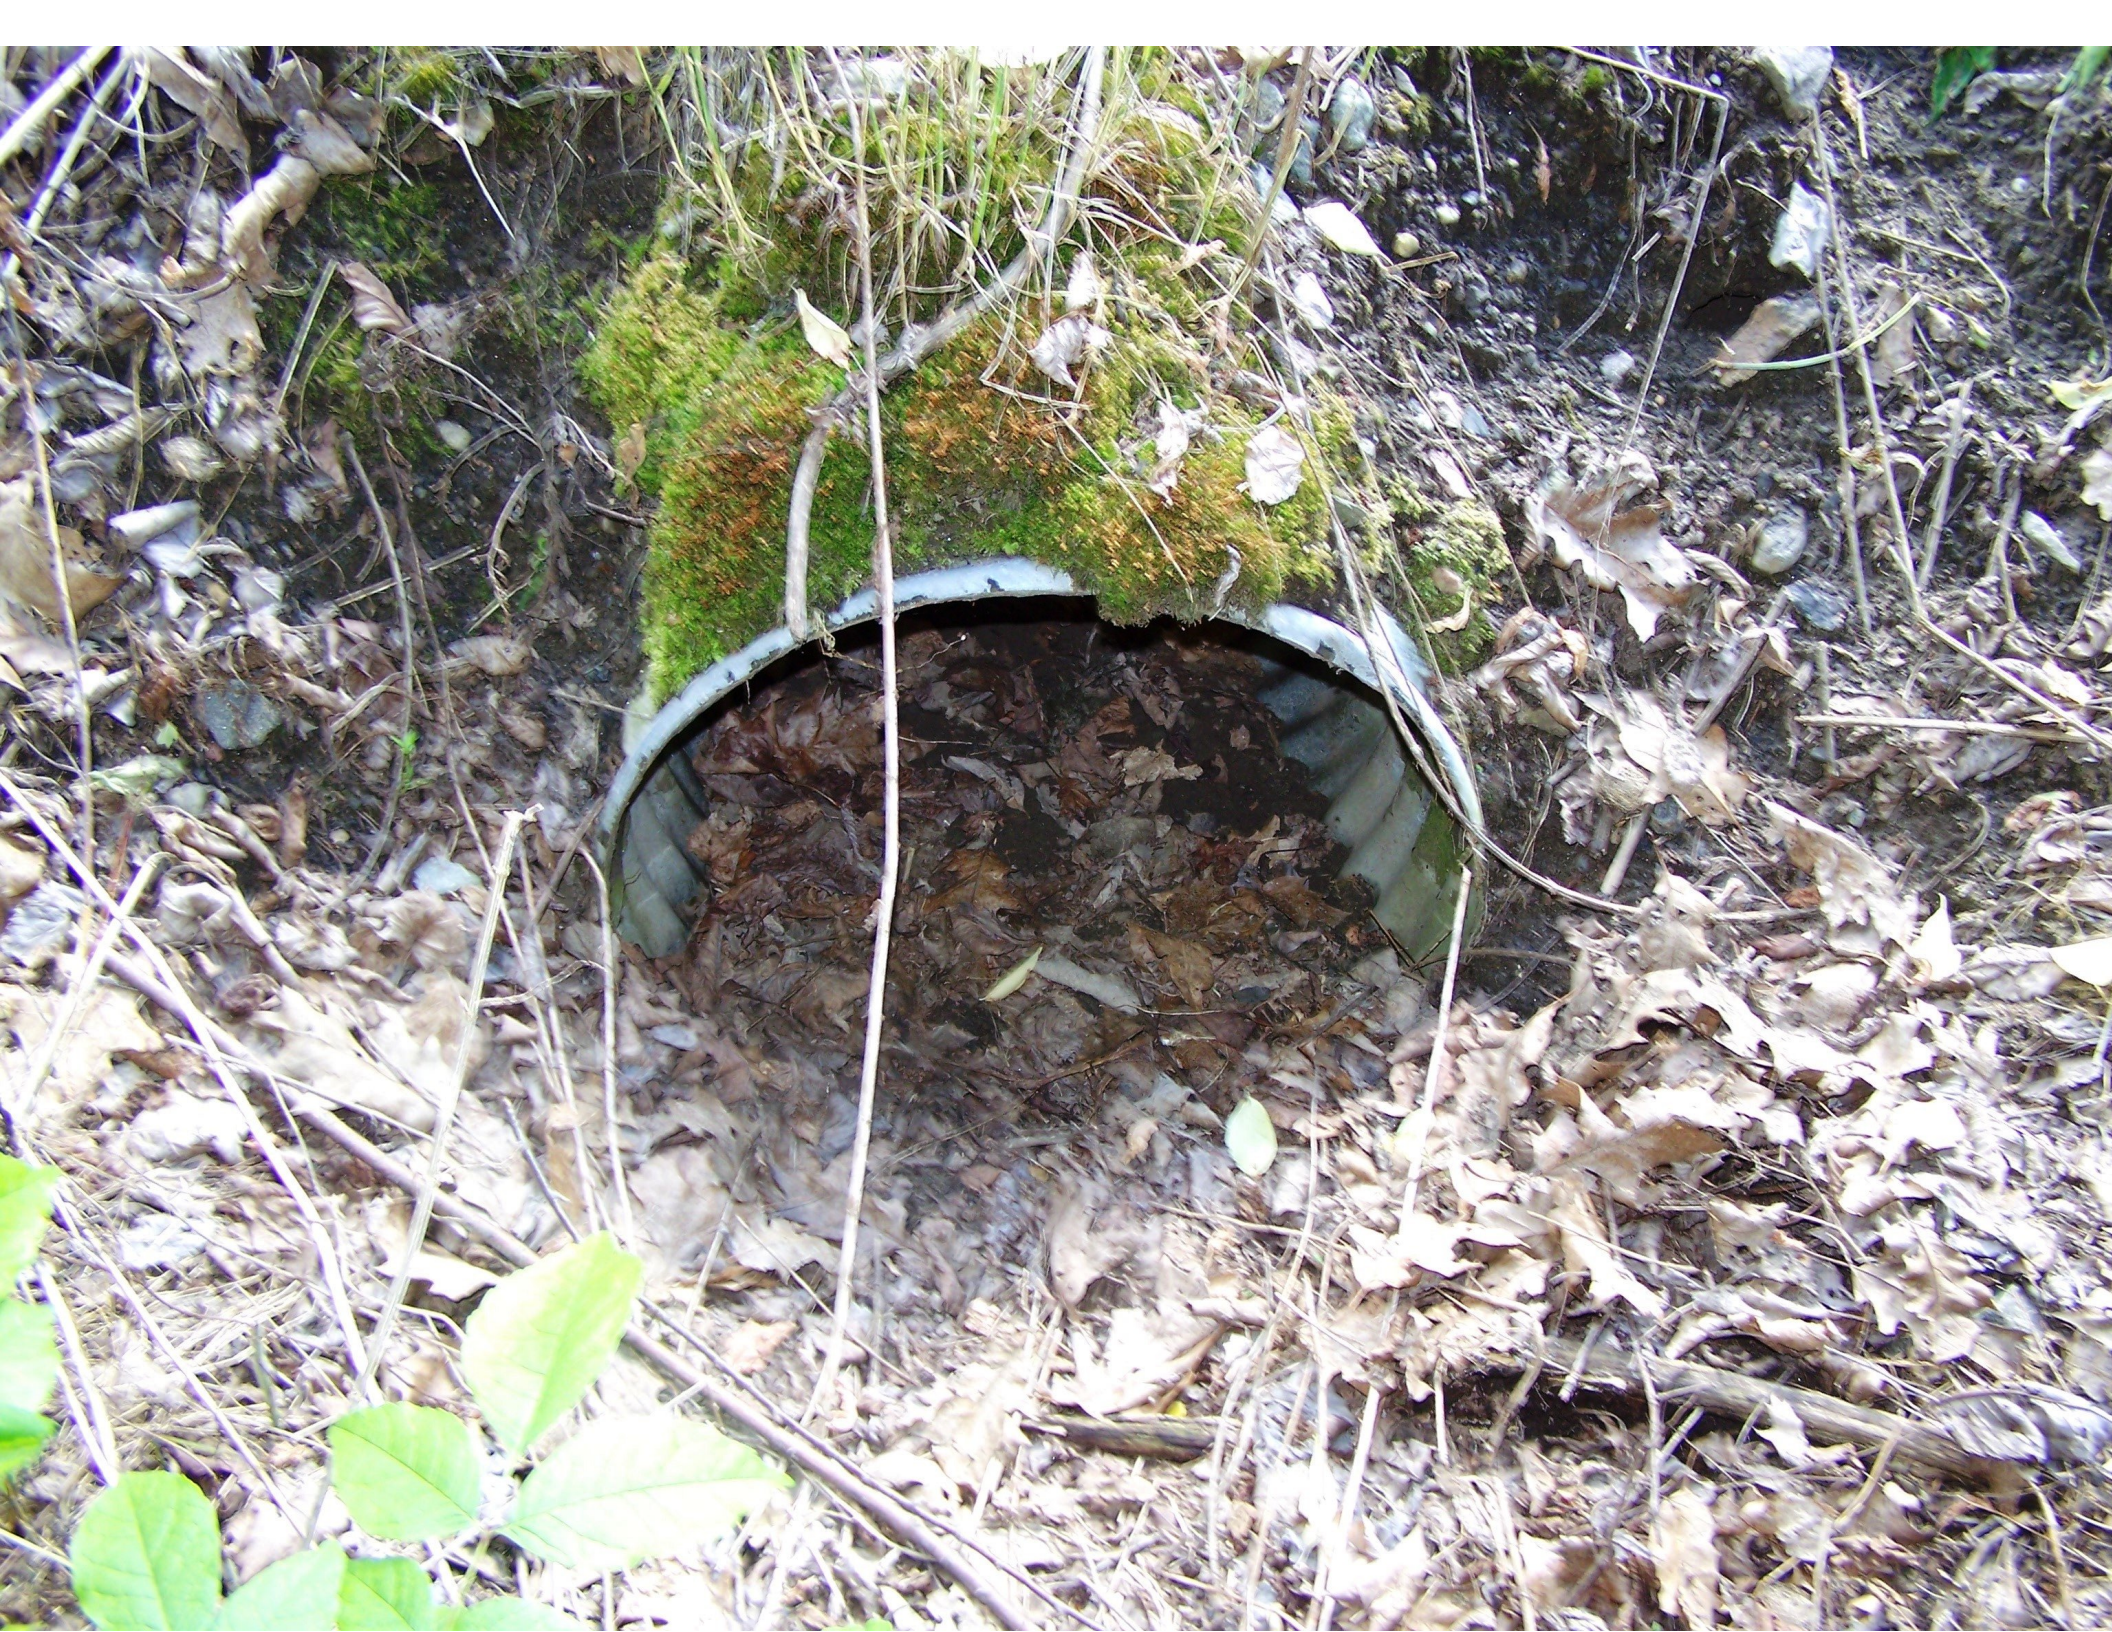
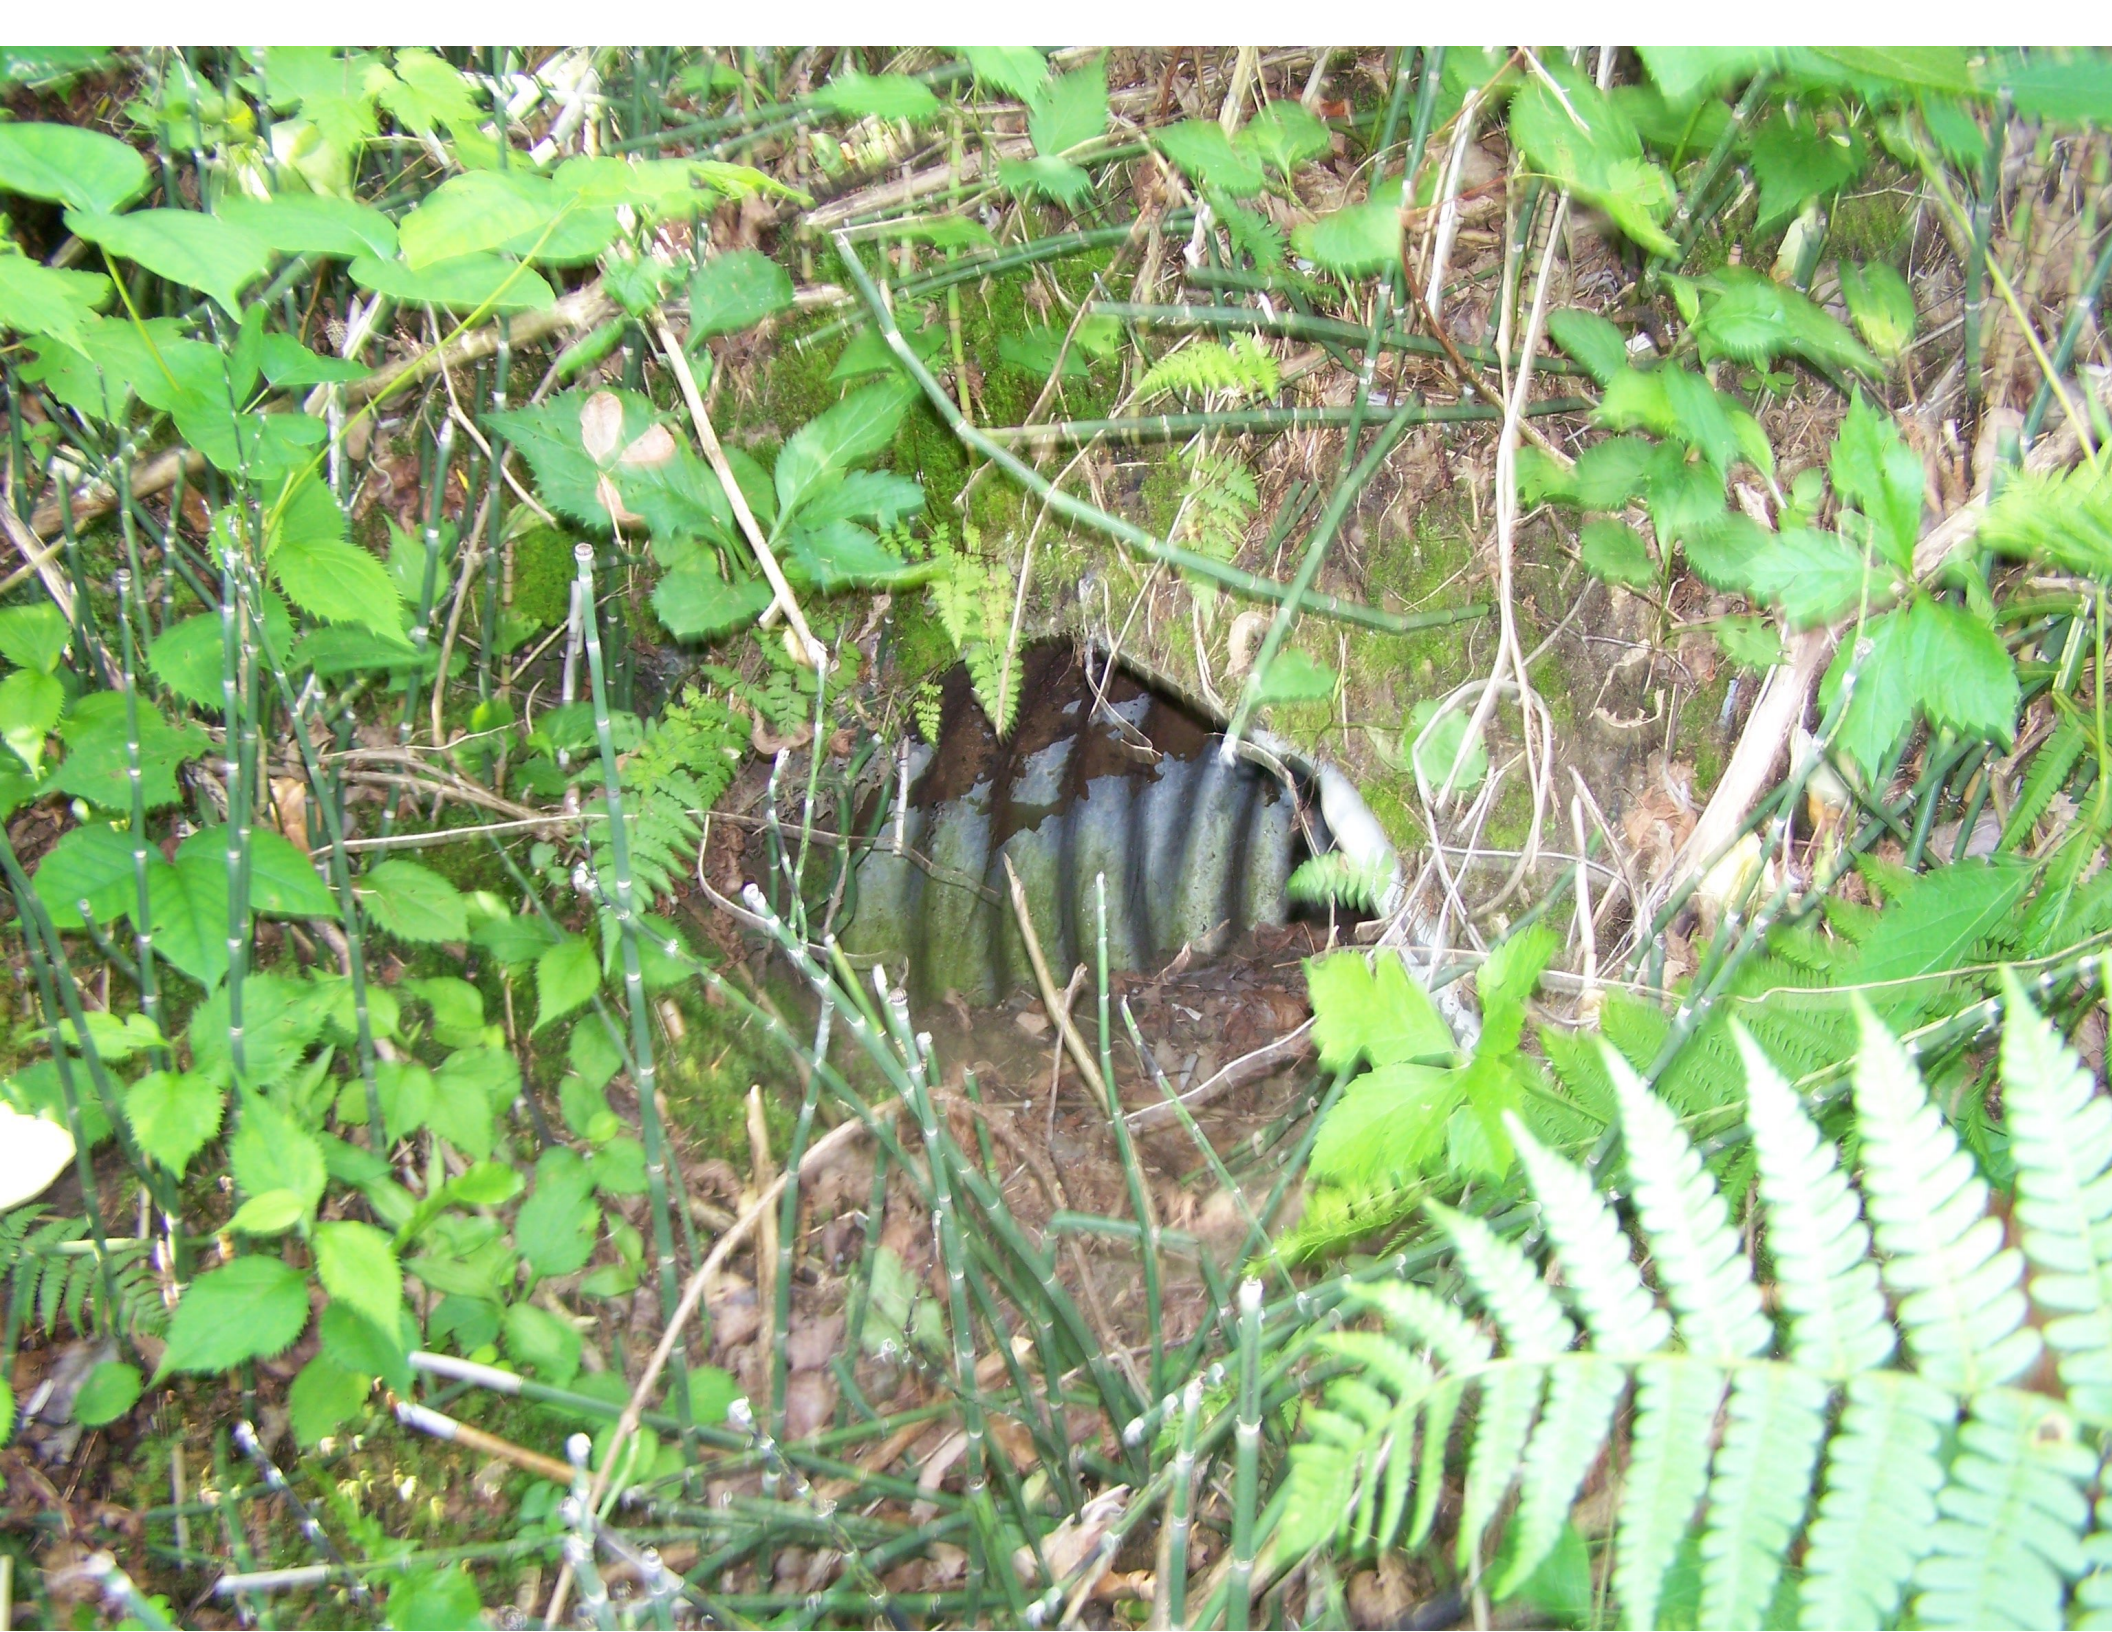
ERODED ON EAST END (OUTLET)
