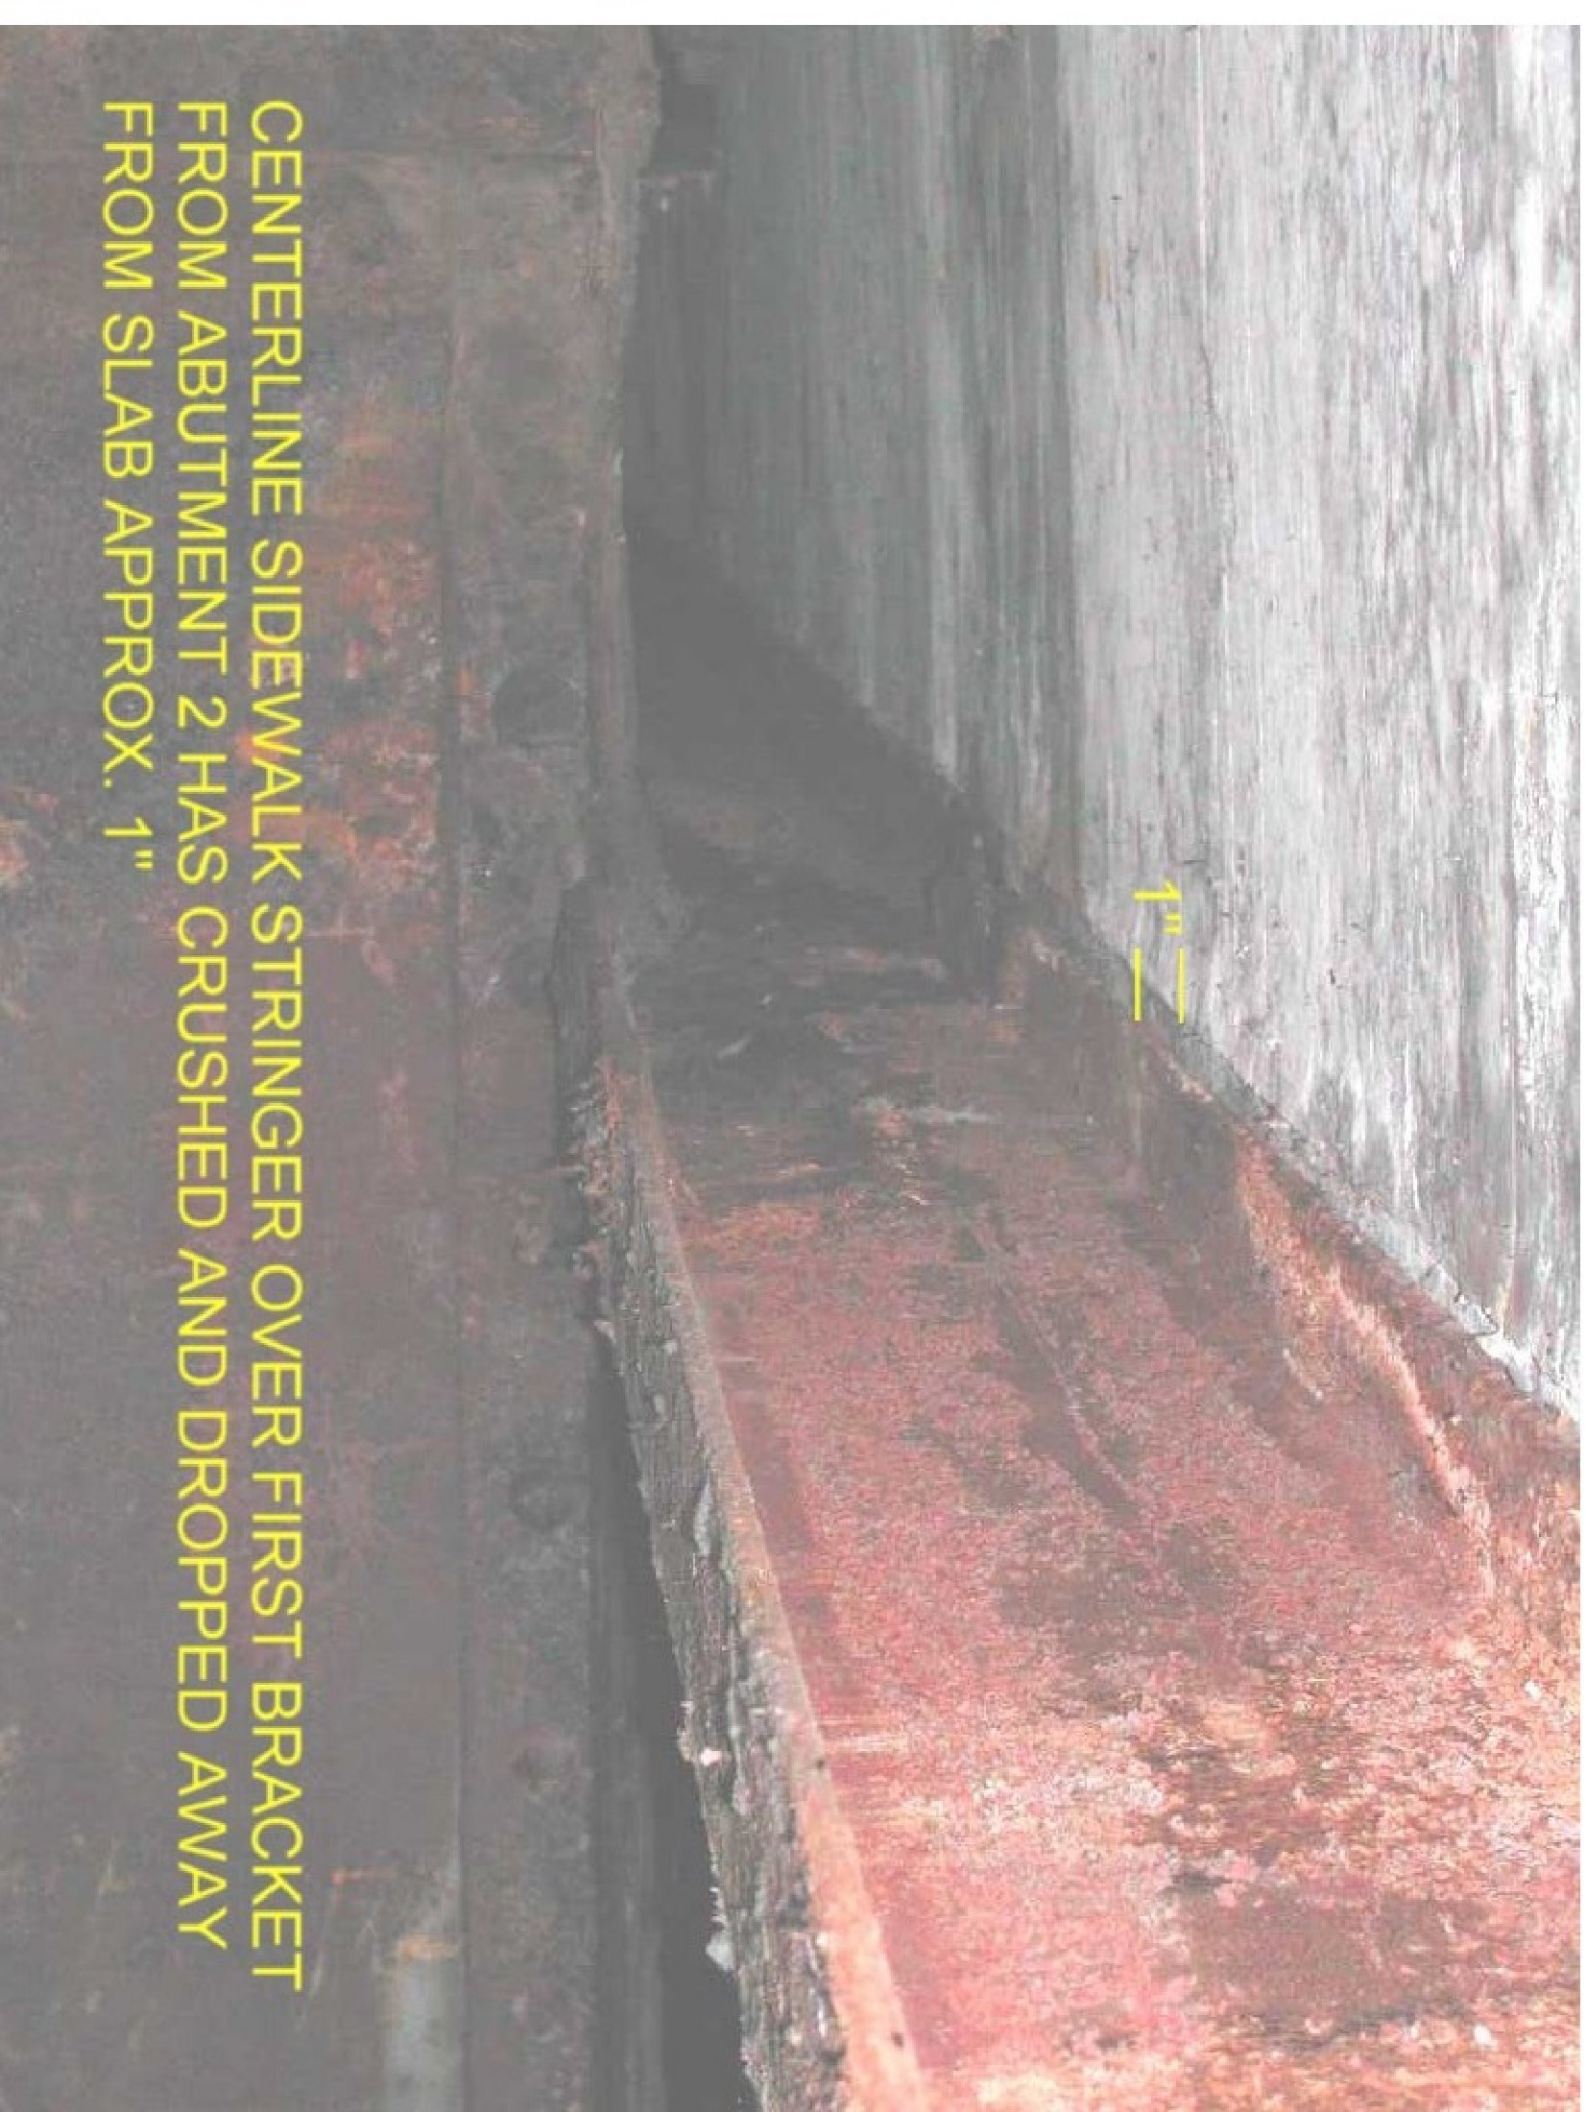
CENTERLINE SIDEWALK STRINGER OVER FIRST BRACKET
FROM ABUTMENT 2 HAS CRUSHED AND DROPPED AWAY
FROM SLAB APPROX. 1"
