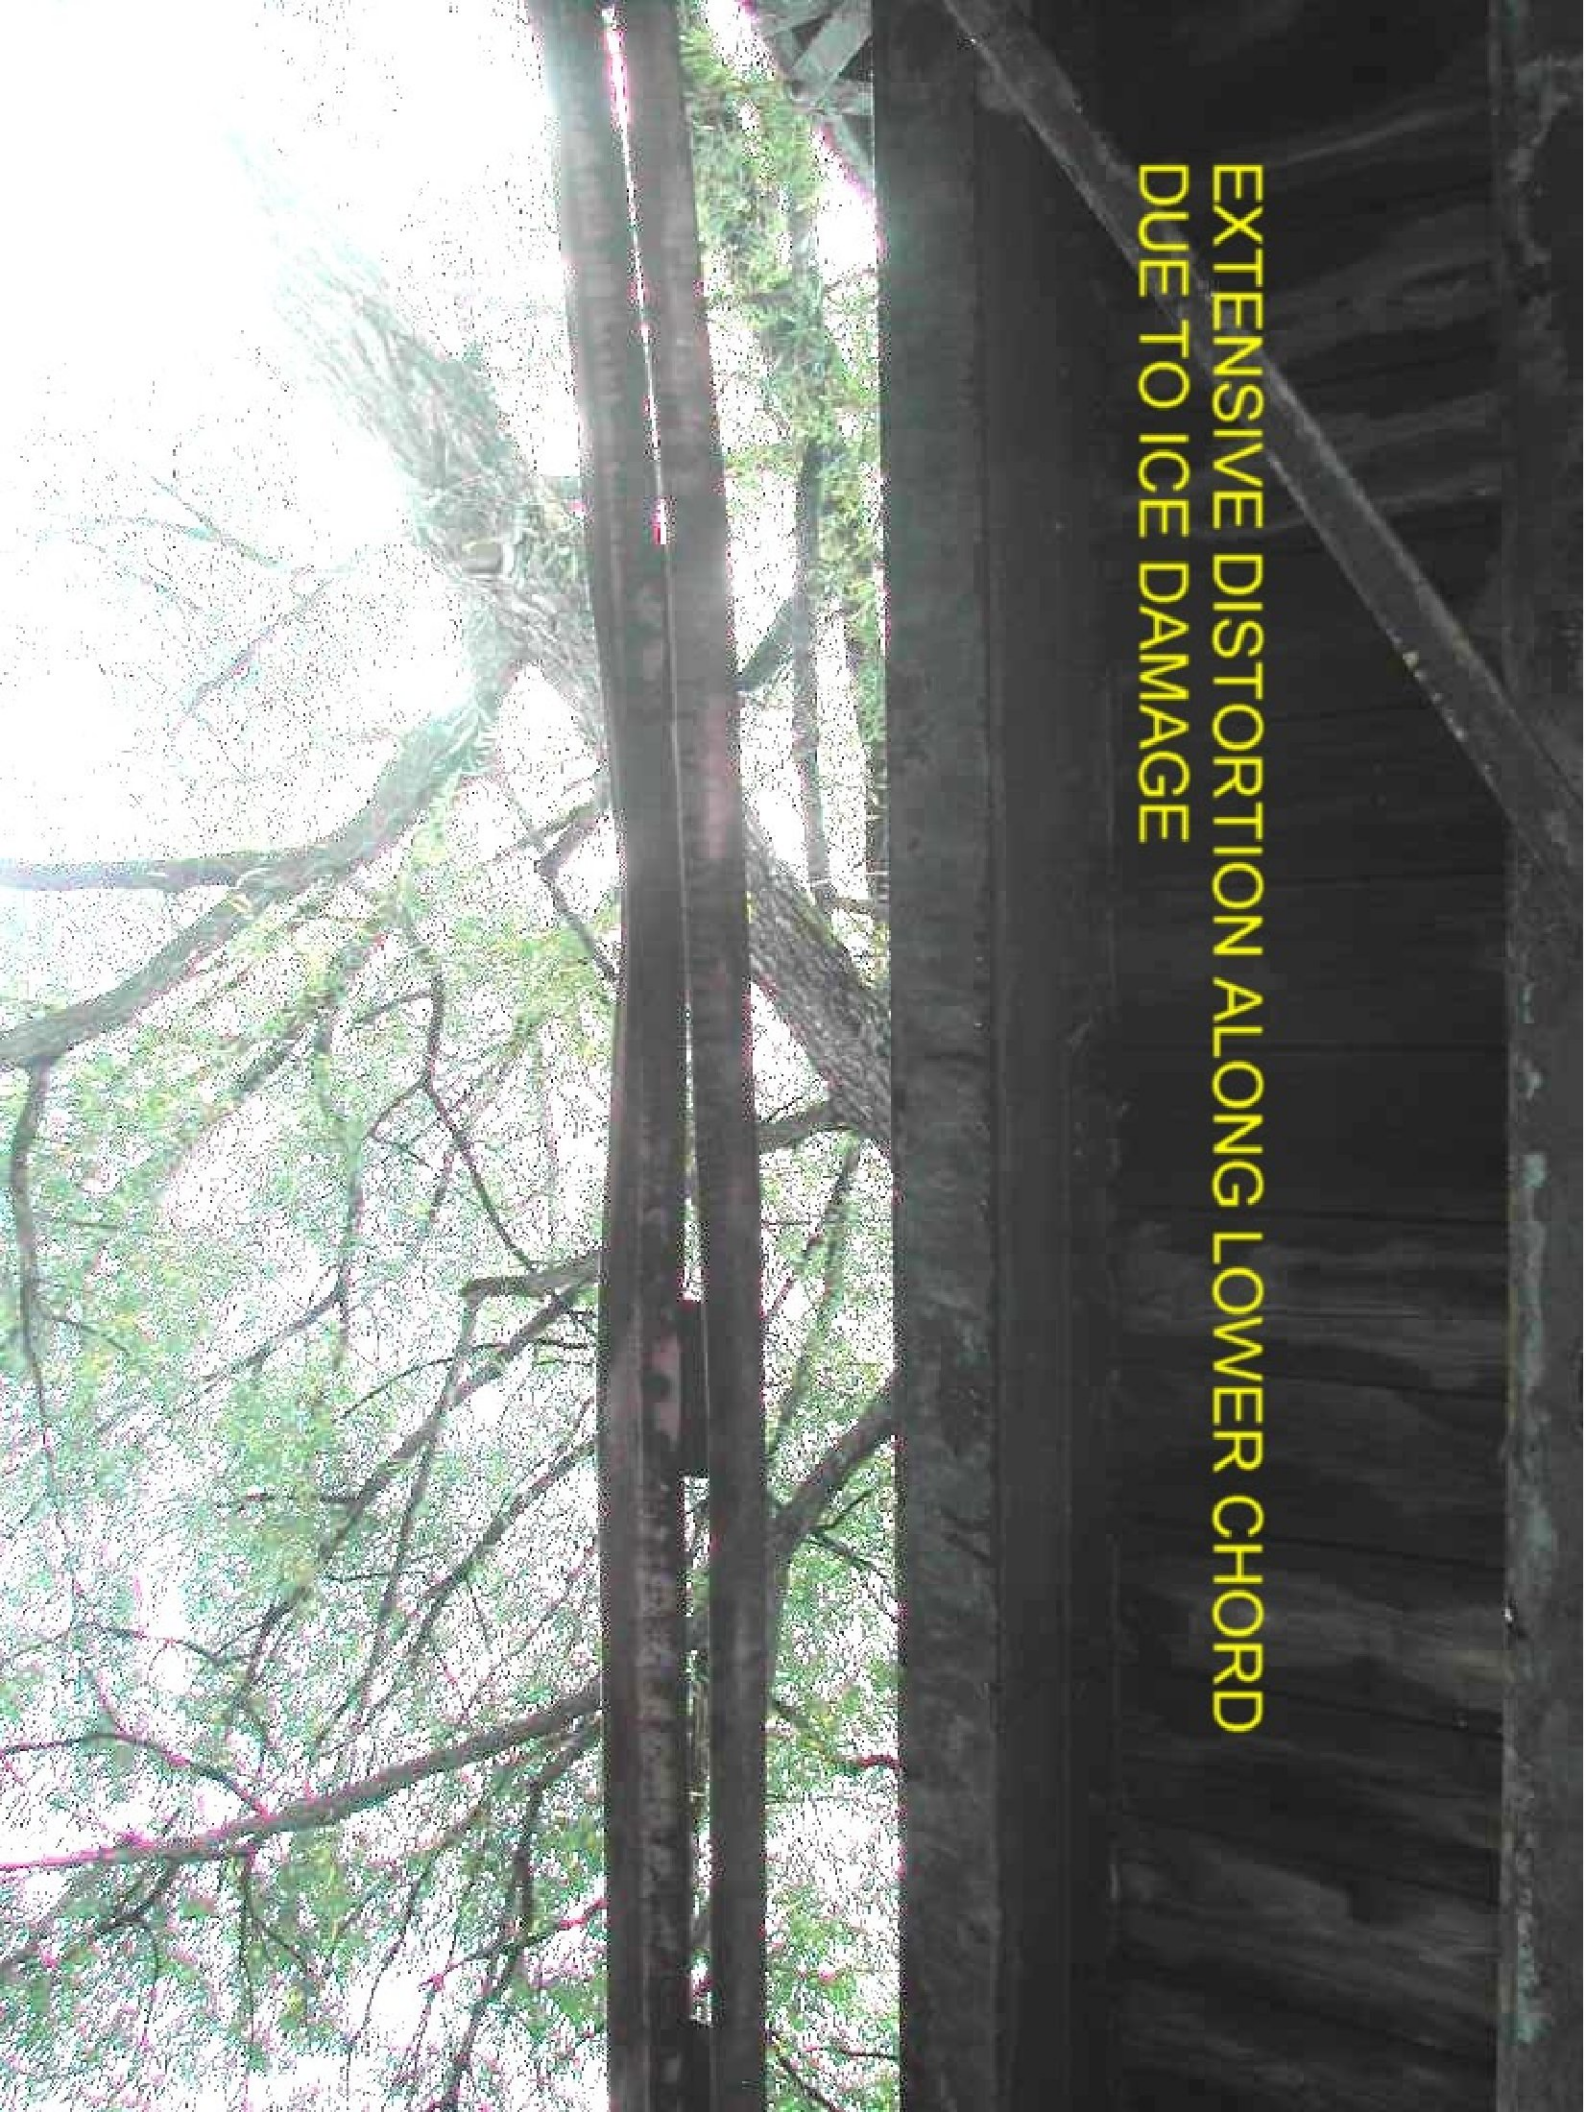
**EXTENSIVE DISTORTION ALONG LOWER CHORD
DUE TO ICE DAMAGE**

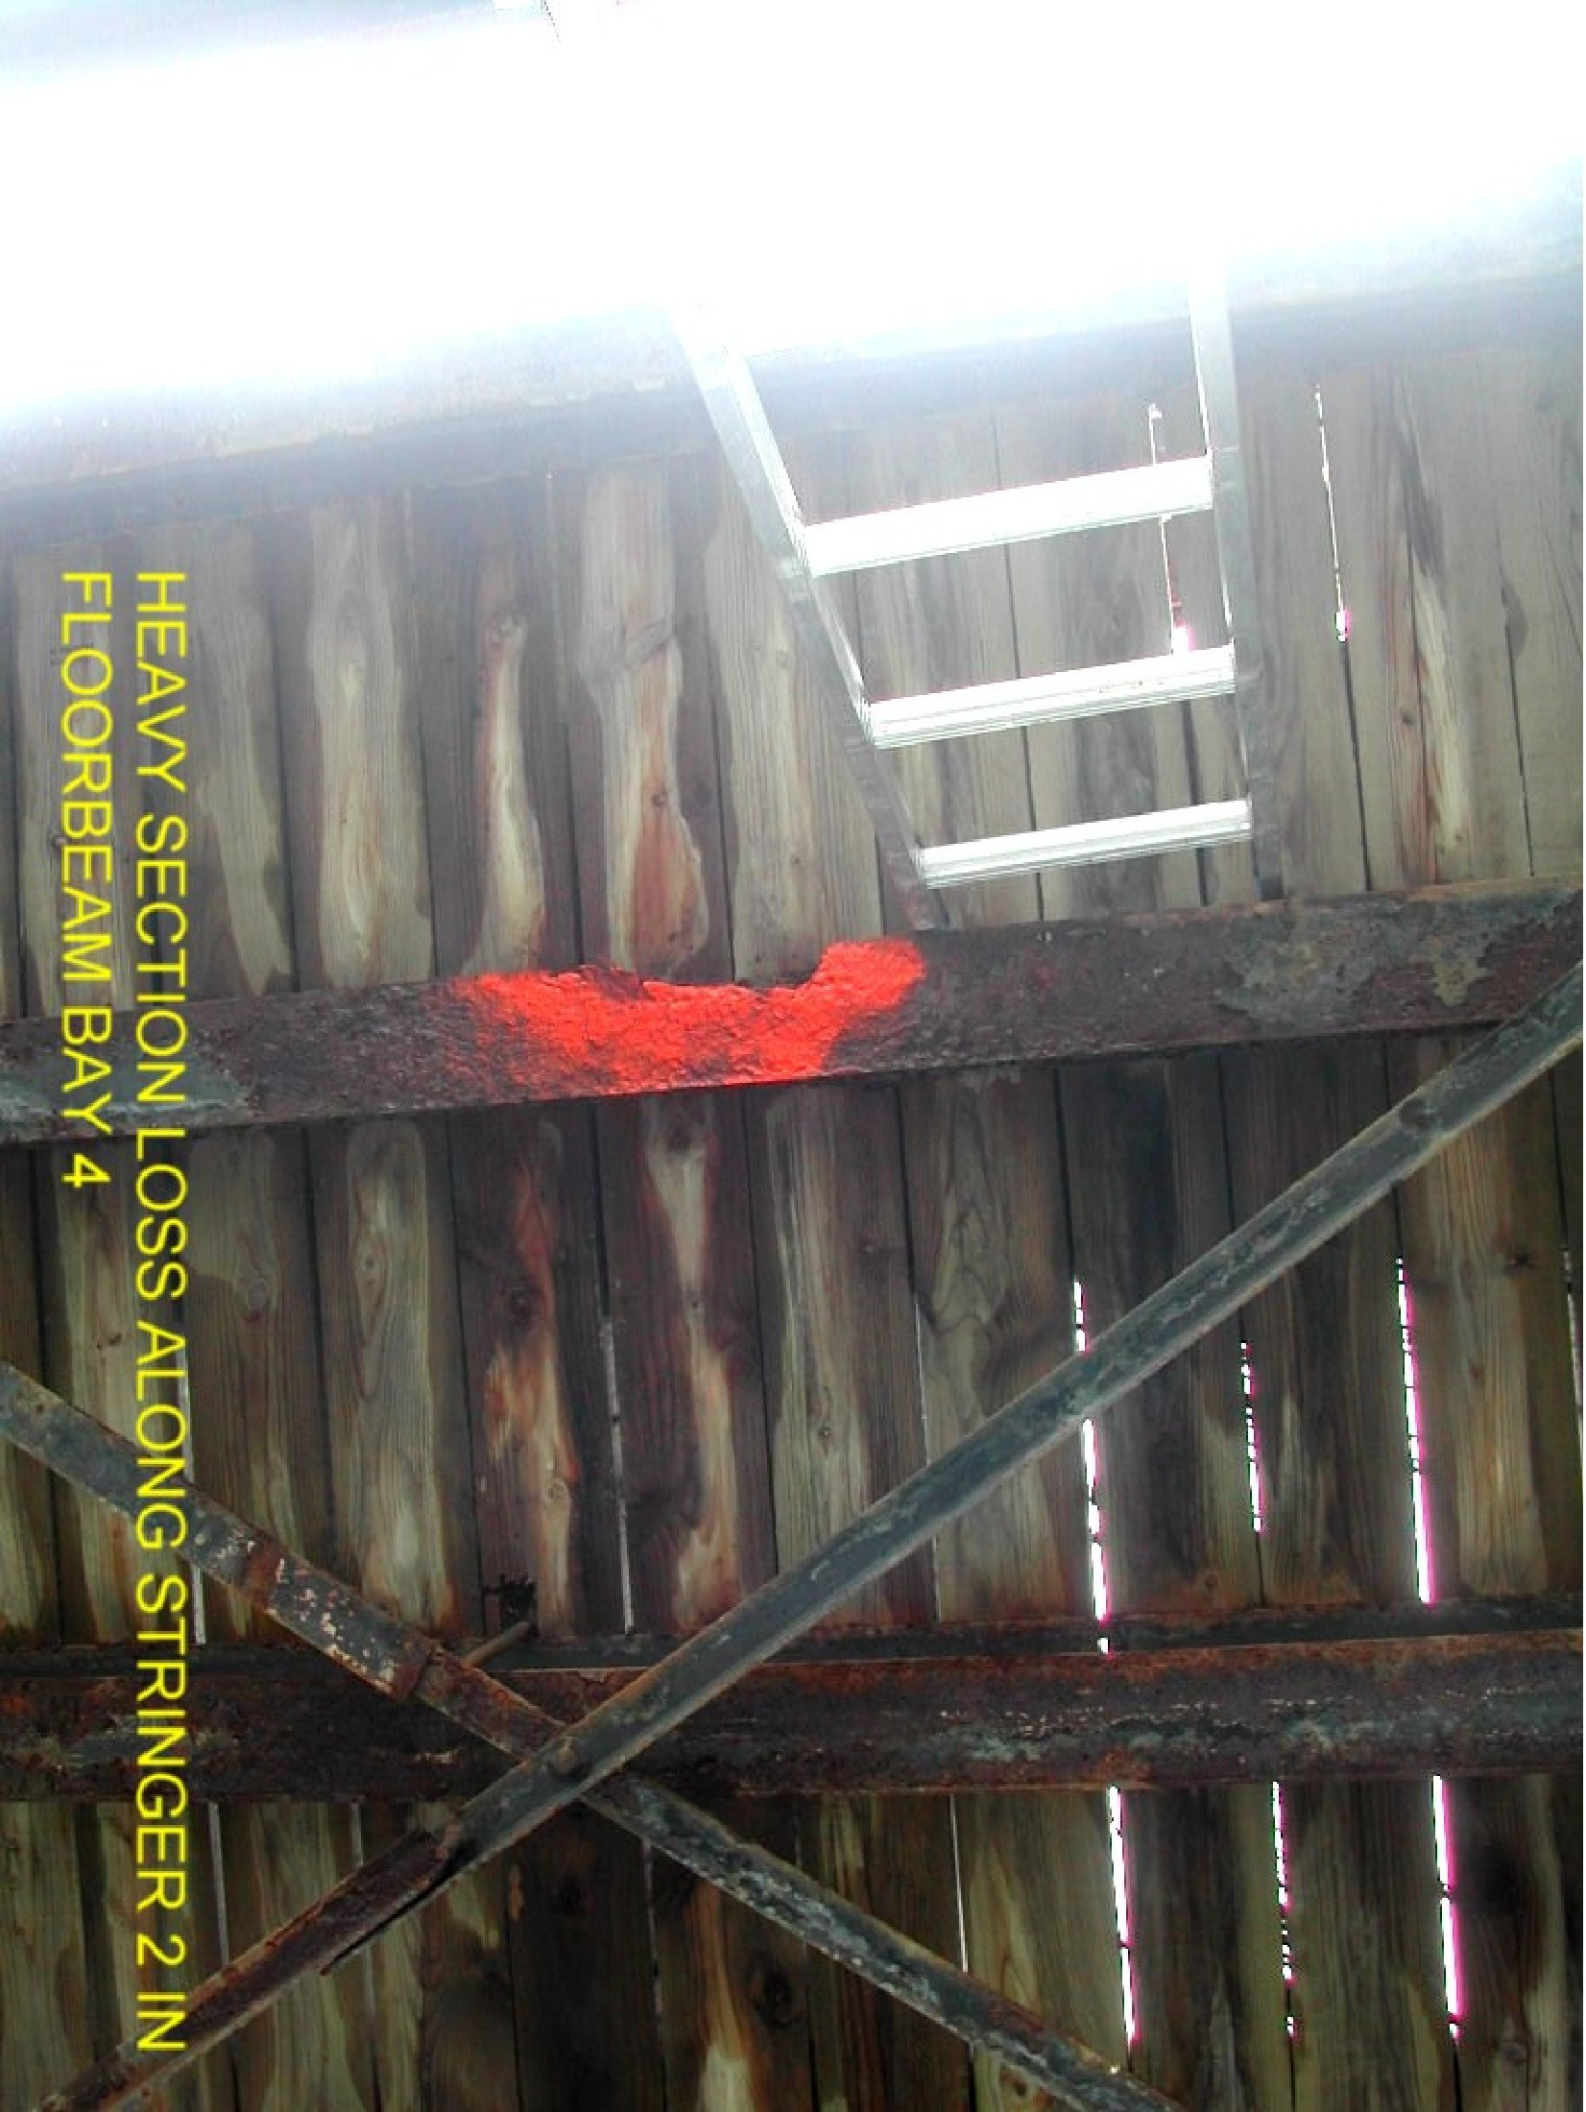
HEAVY SECTION LOSS ALONG STRINGER 2 IN
FLOORBEAM BAY 4

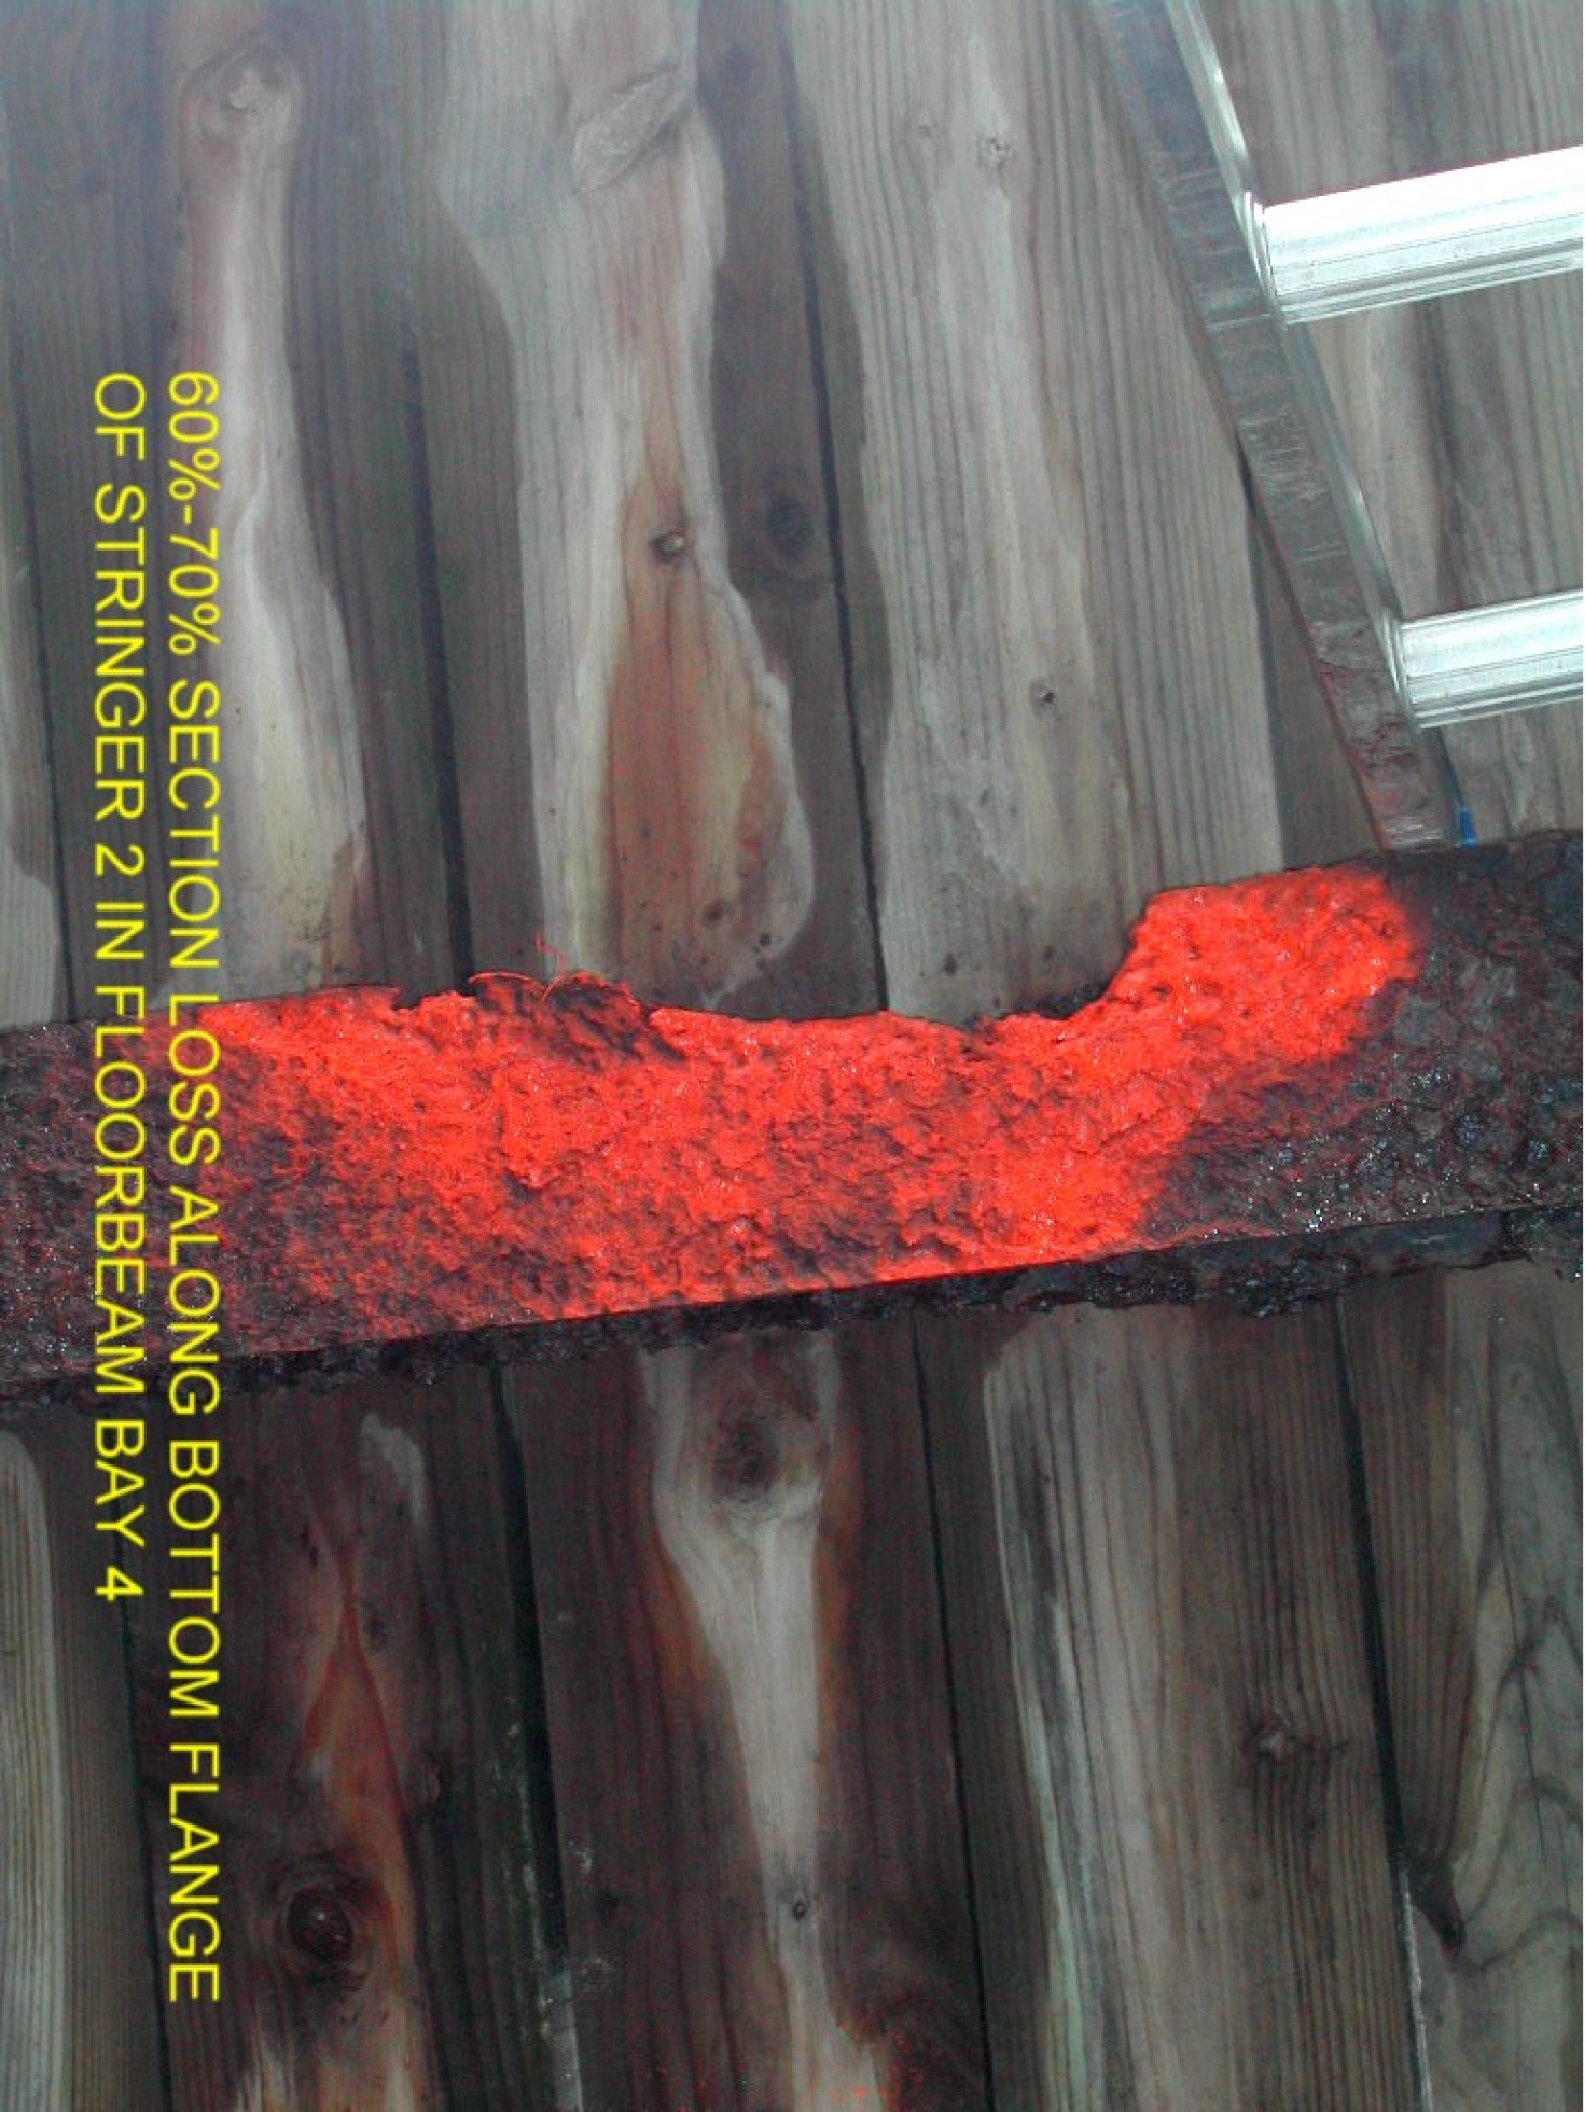
60%-70% SECTION LOSS ALONG BOTTOM FLANGE
OF STRINGER 2 IN FLOORBEAM BAY 4

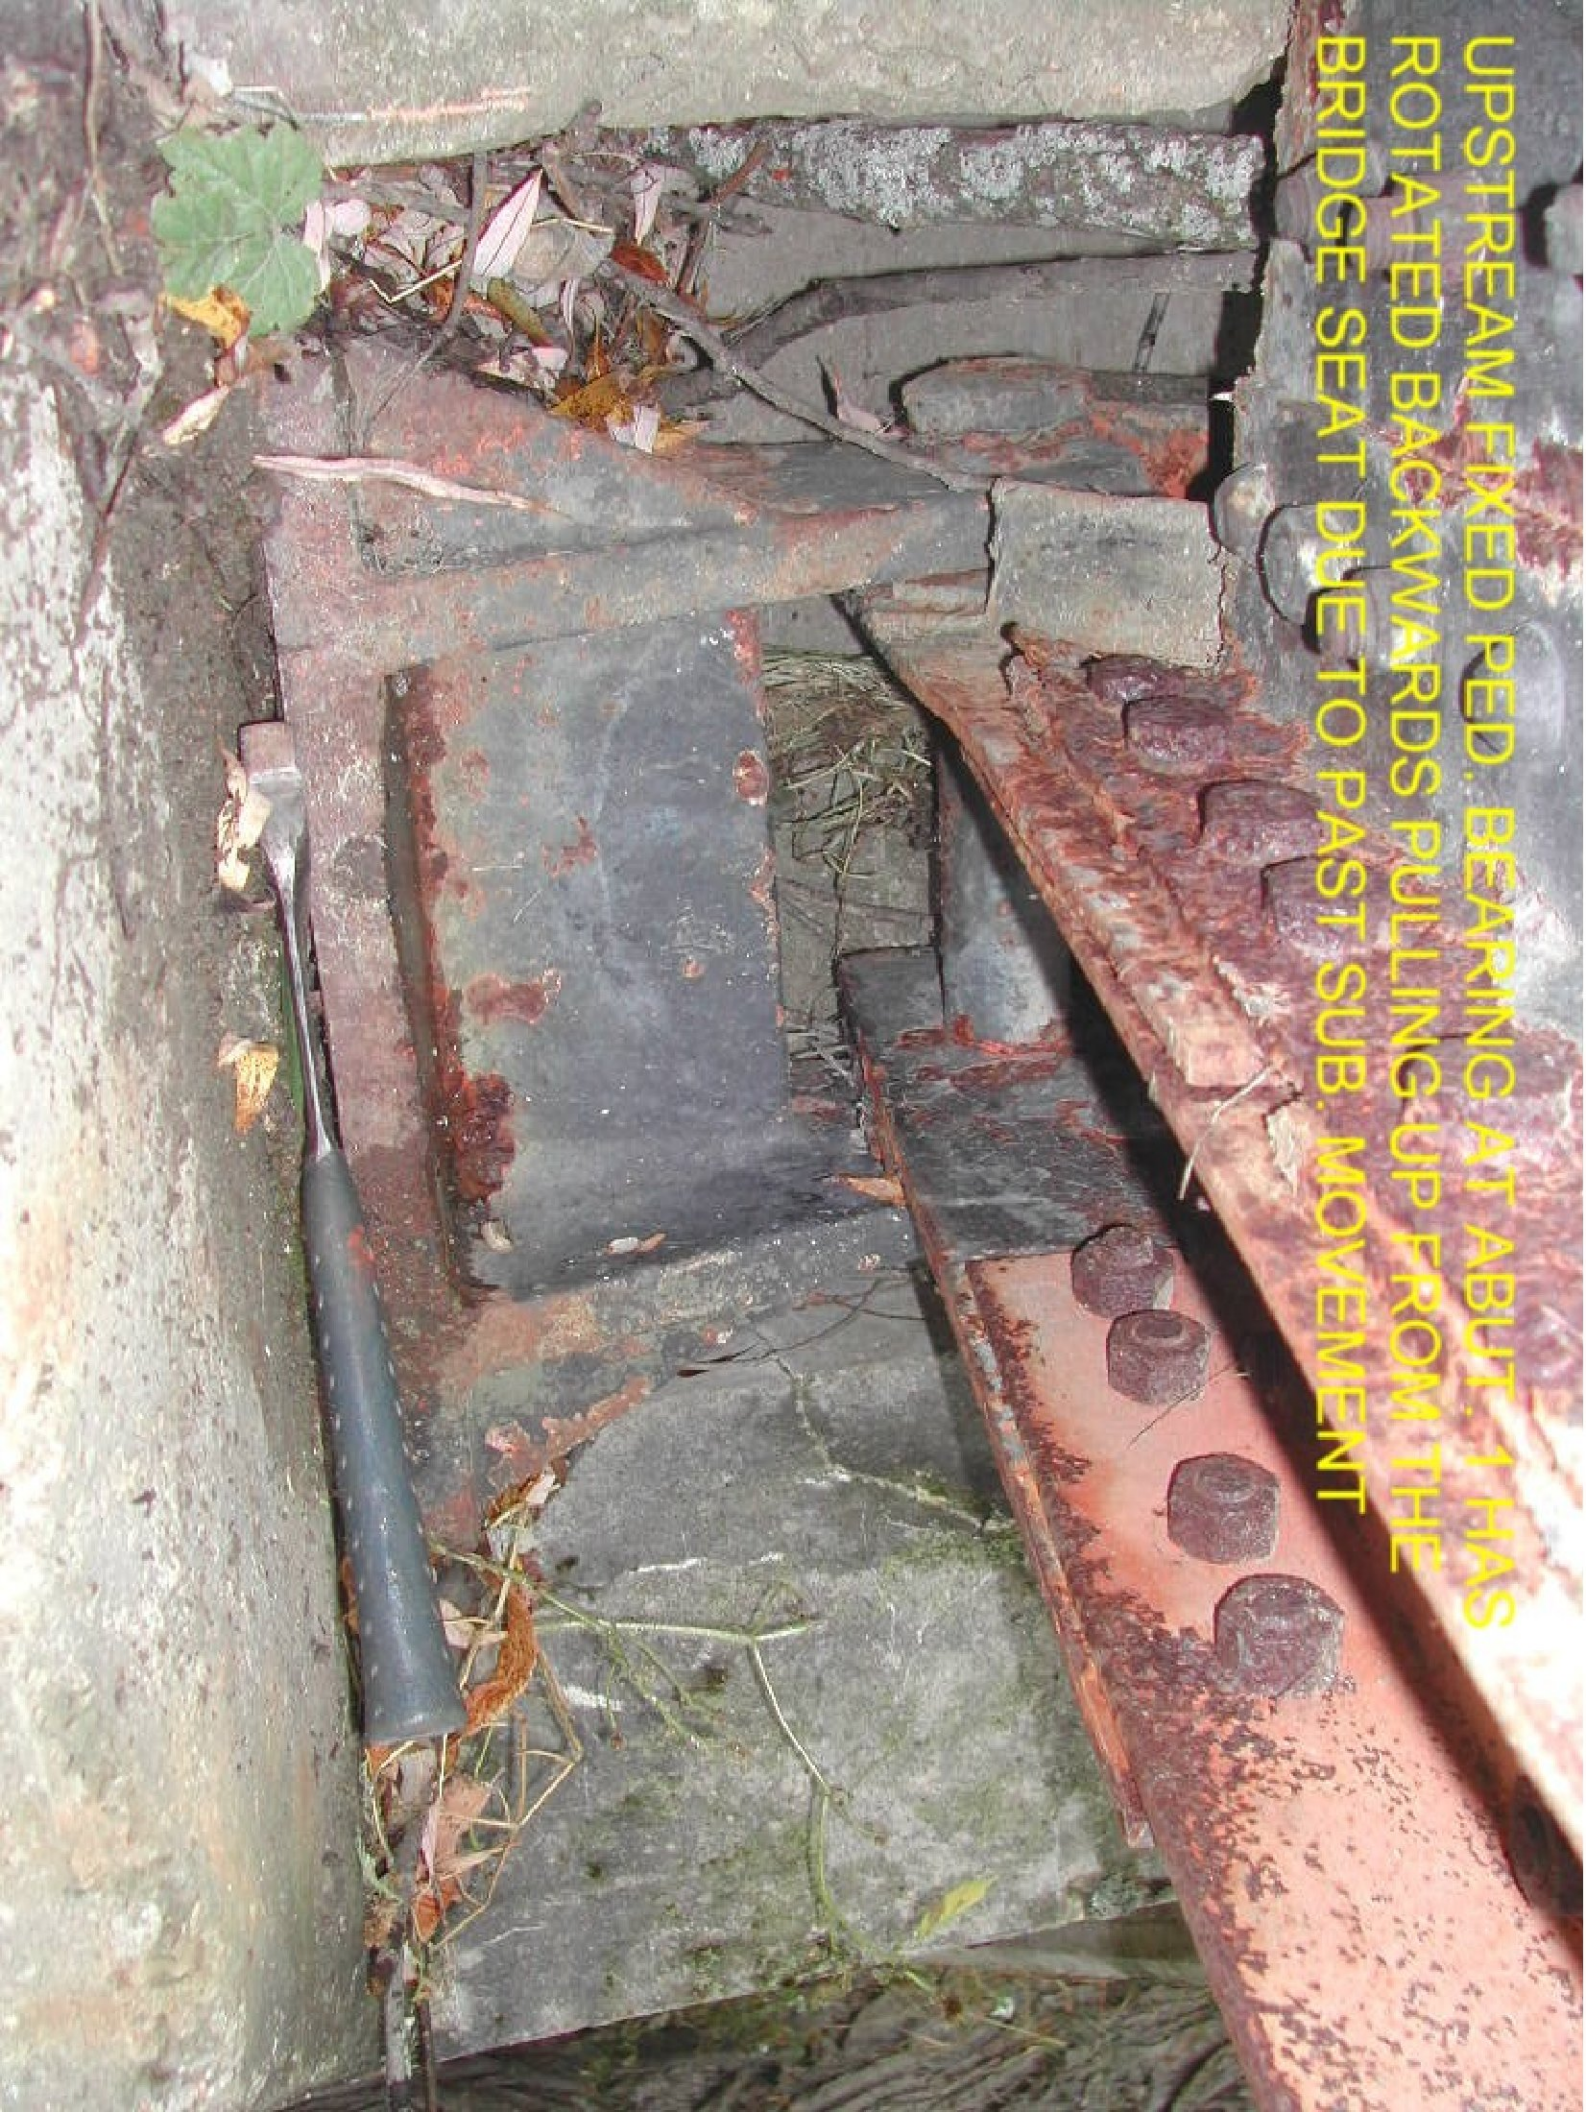
UPSTREAM FIXED PED. BEARING AT ABUT. 1 HAS
ROTATED BACKWARDS PULLING UP FROM THE
BRIDGE SEAT DUE TO PAST SUB. MOVEMENT
