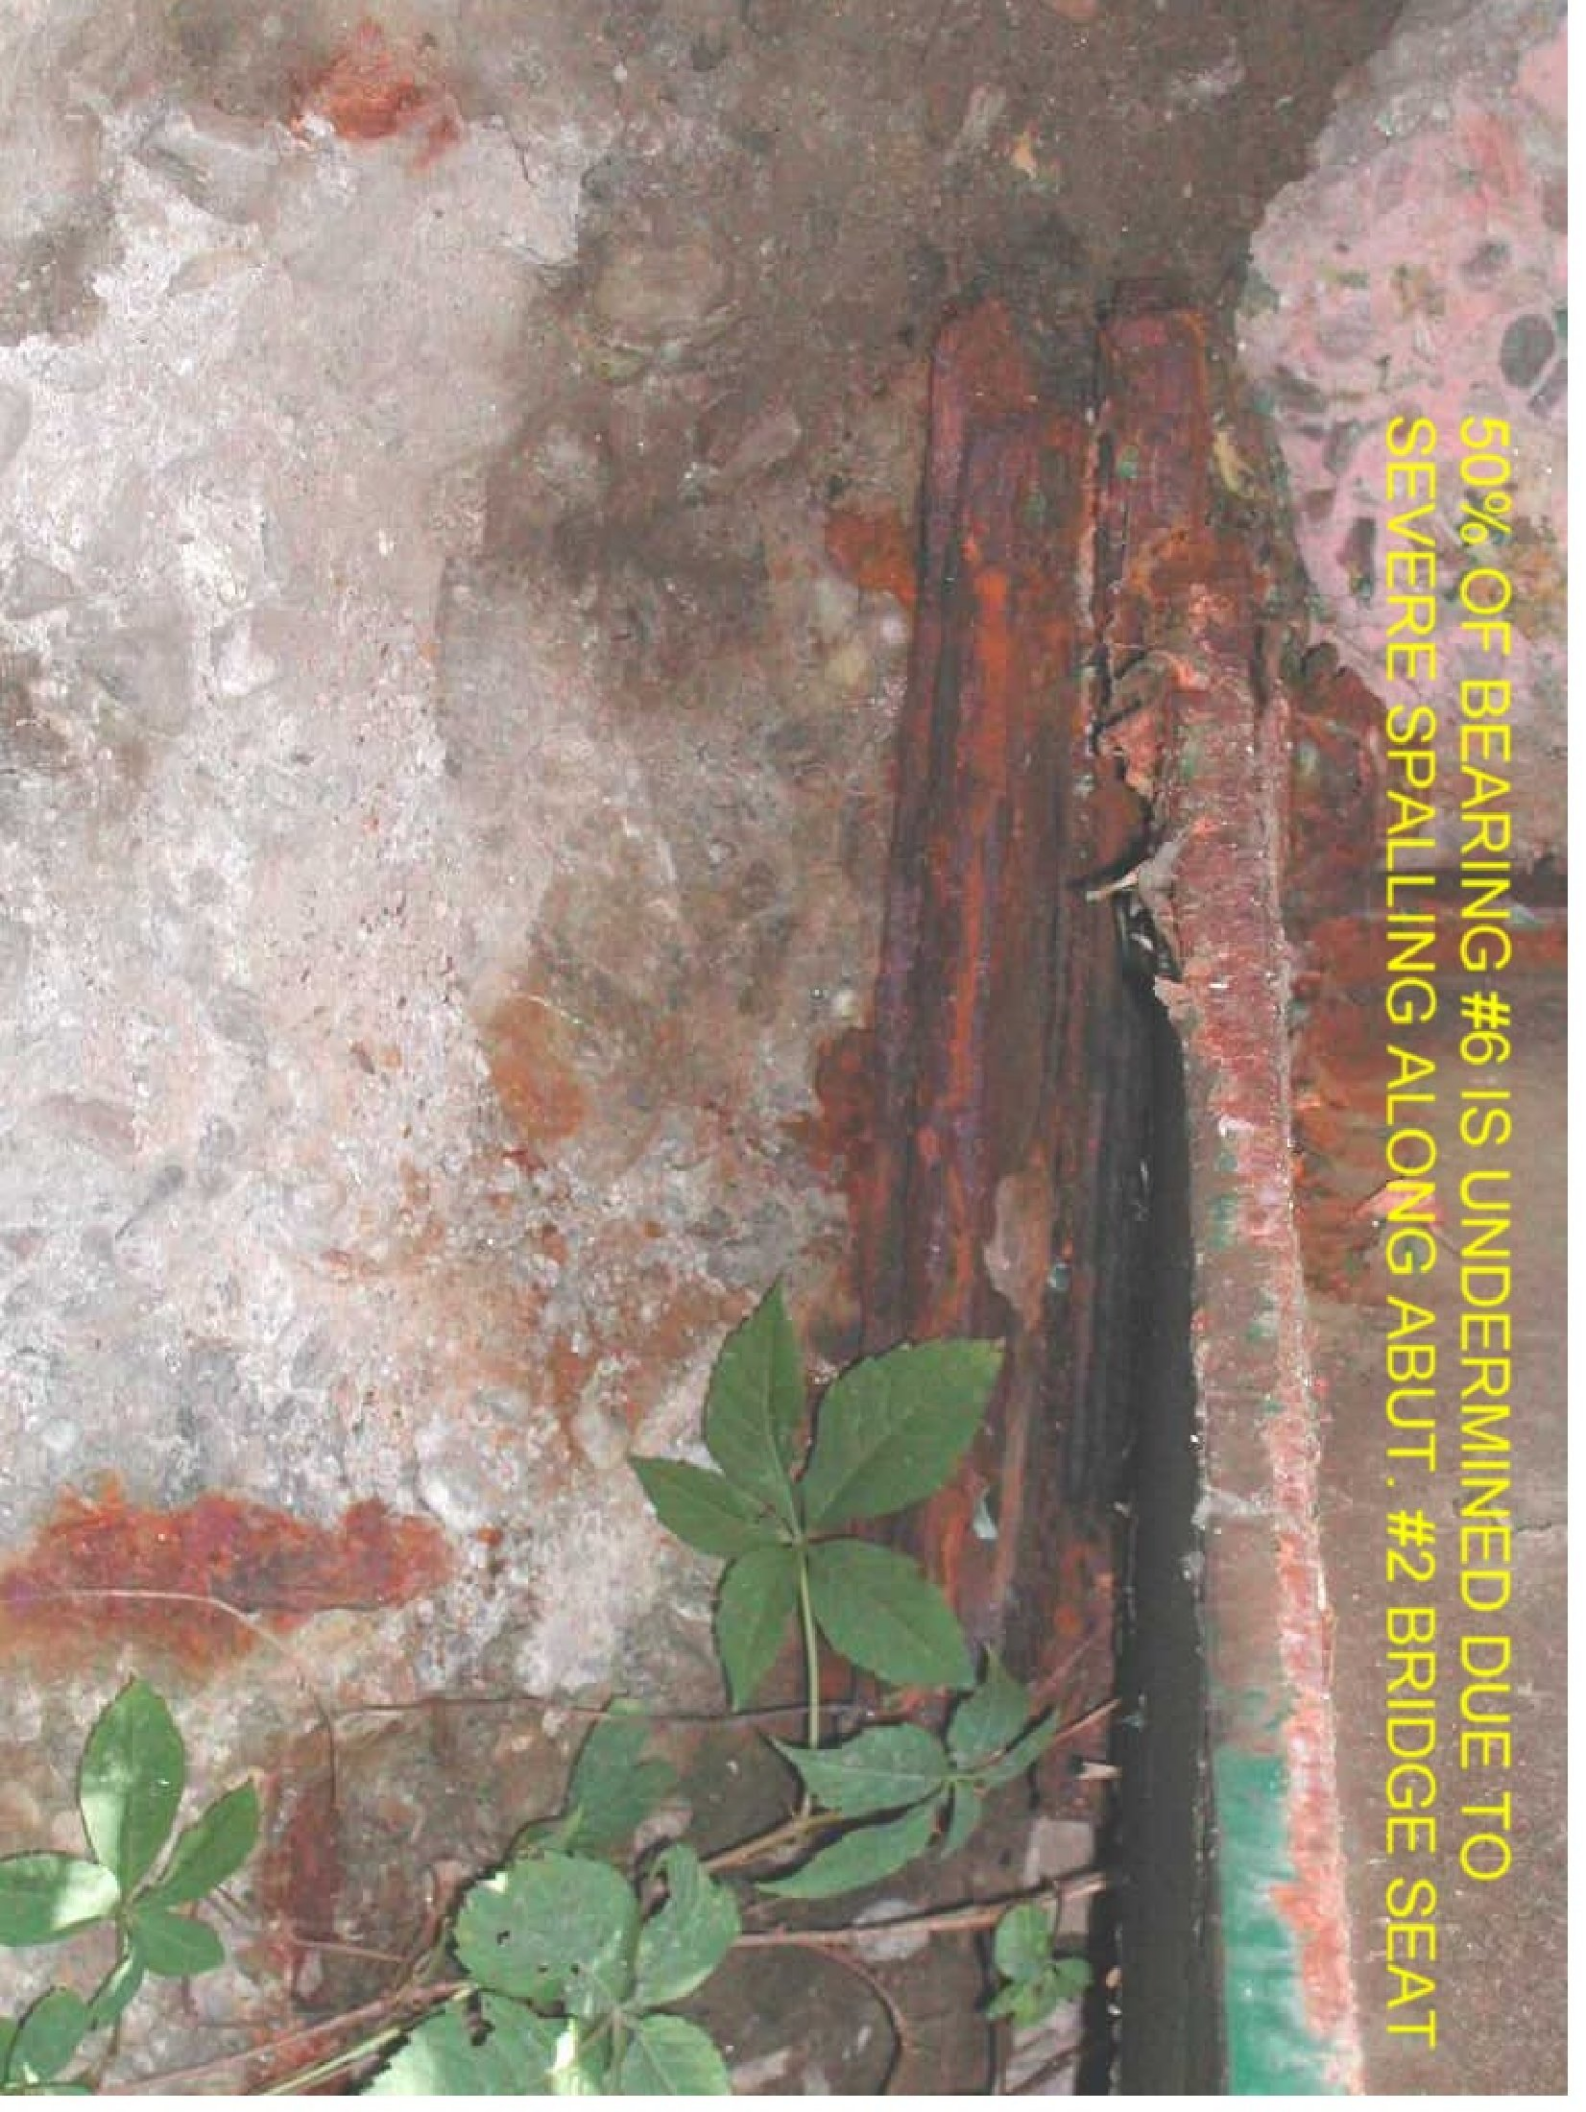
50% OF BEARING #6 IS UNDERMINED DUE TO SEVERE SPALLING ALONG ABOUT. #2 BRIDGE SEAT
