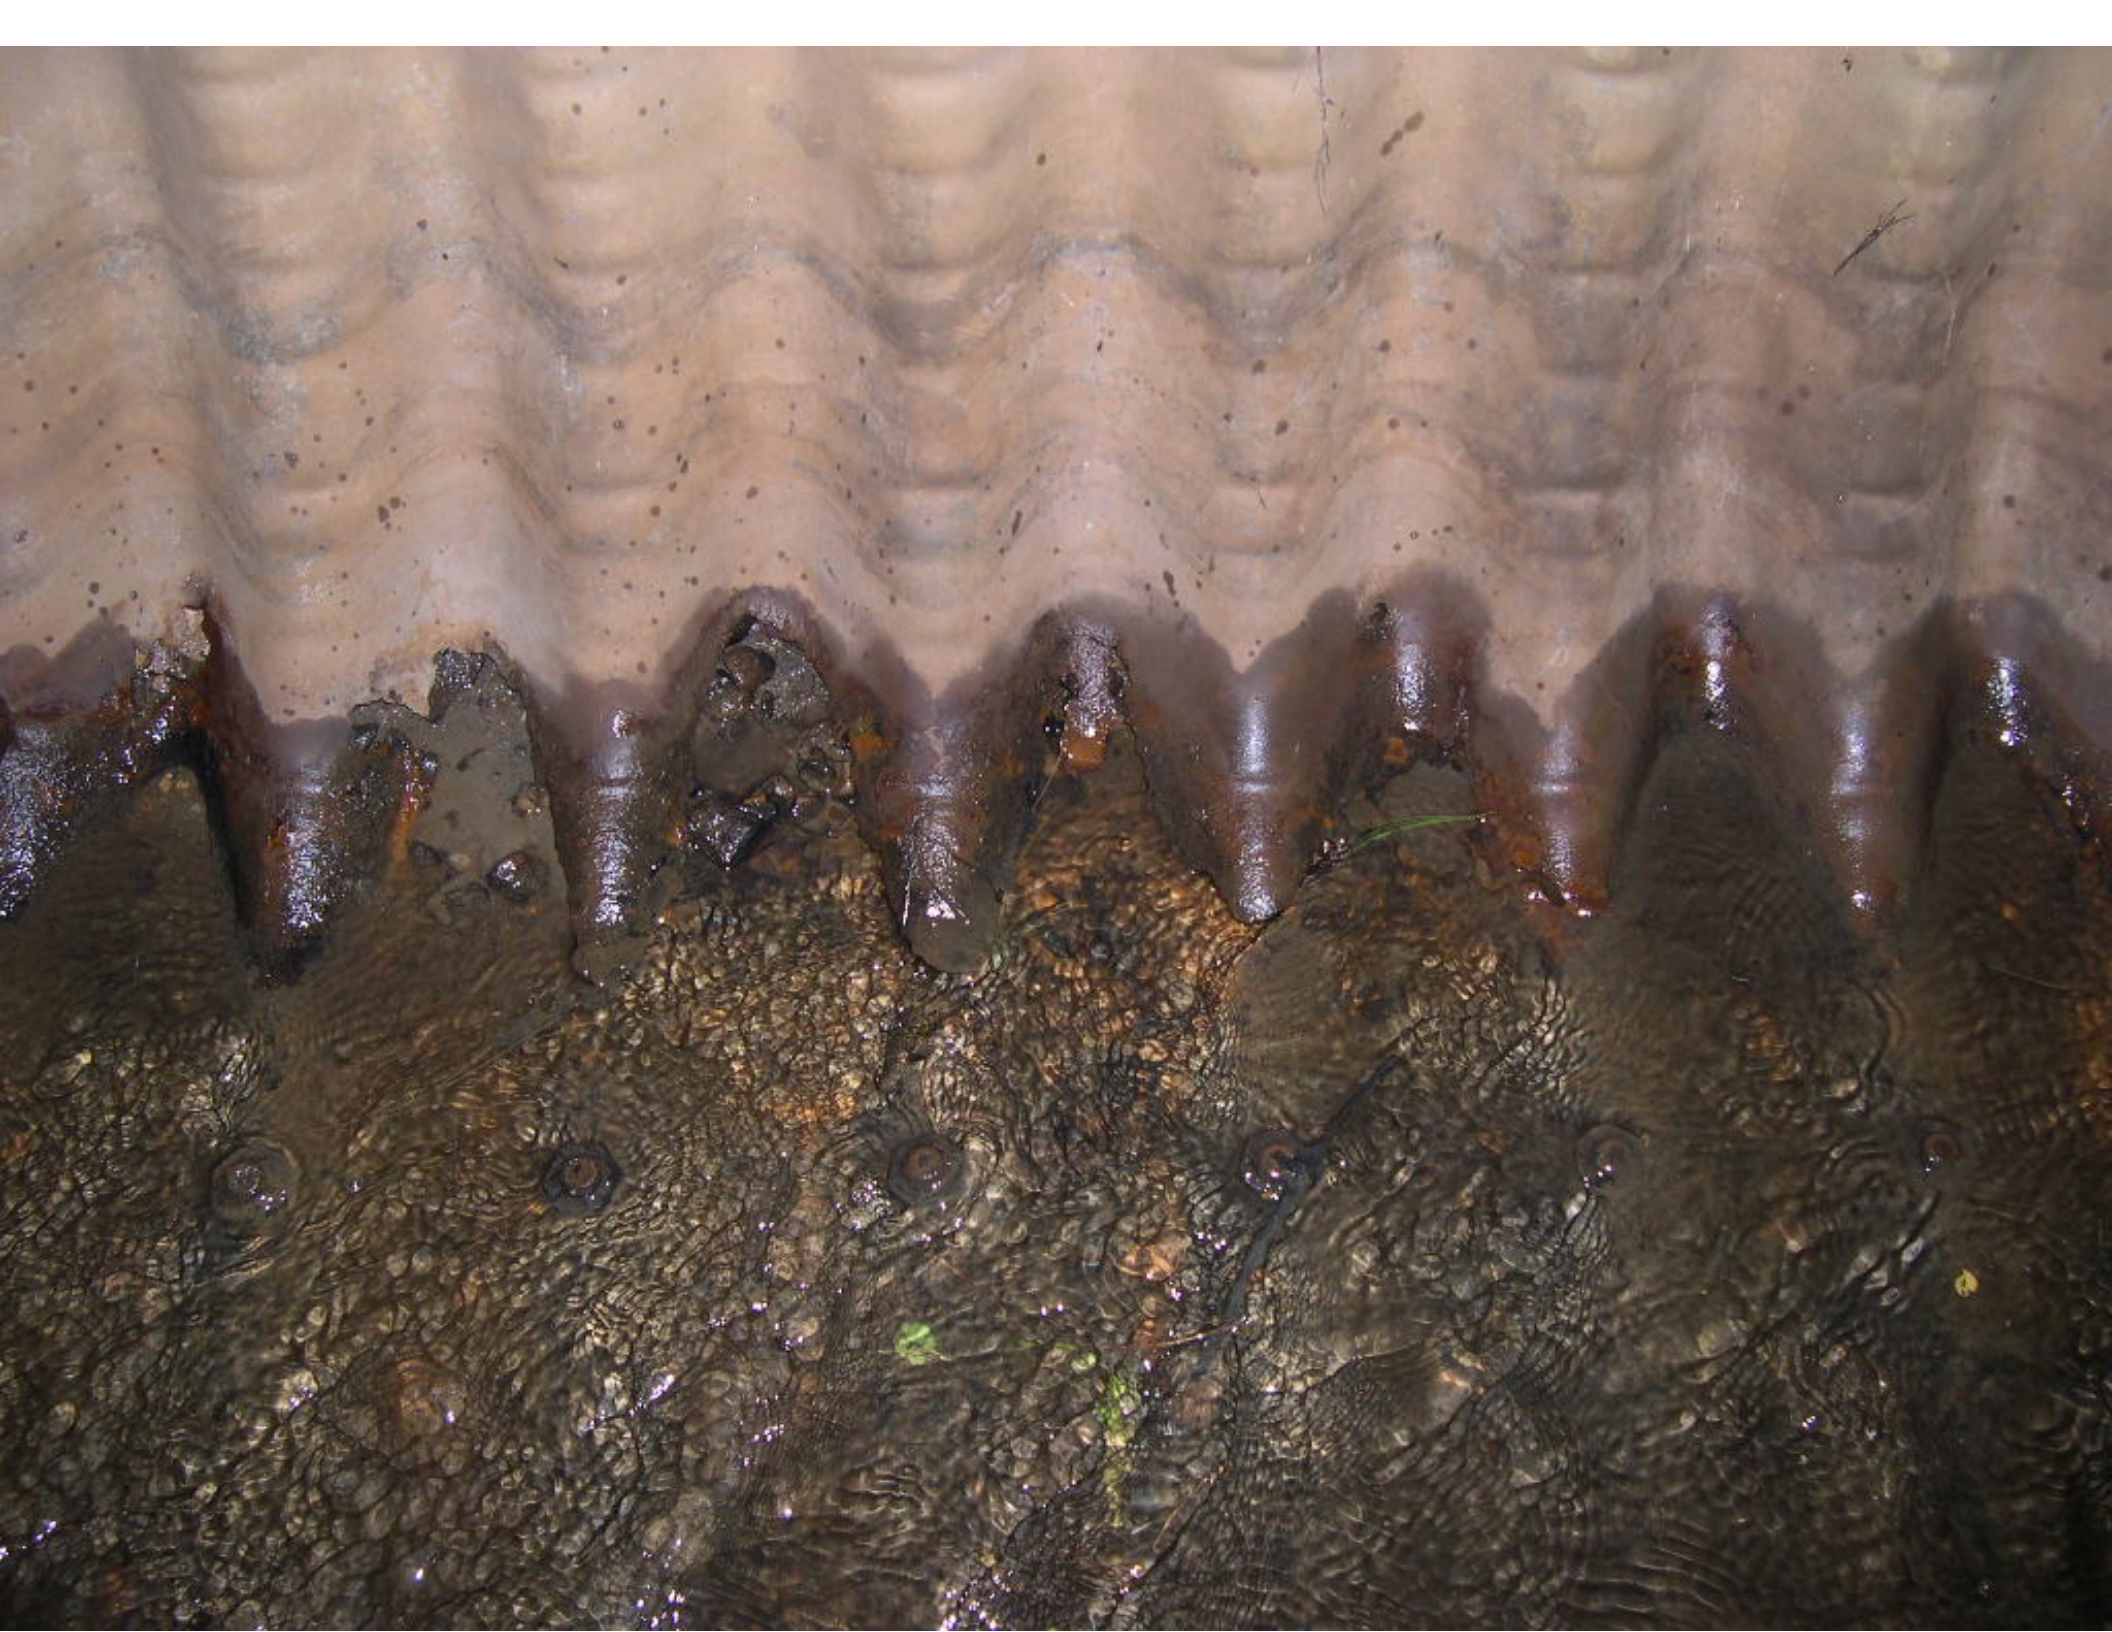
Large hole in side of invert.

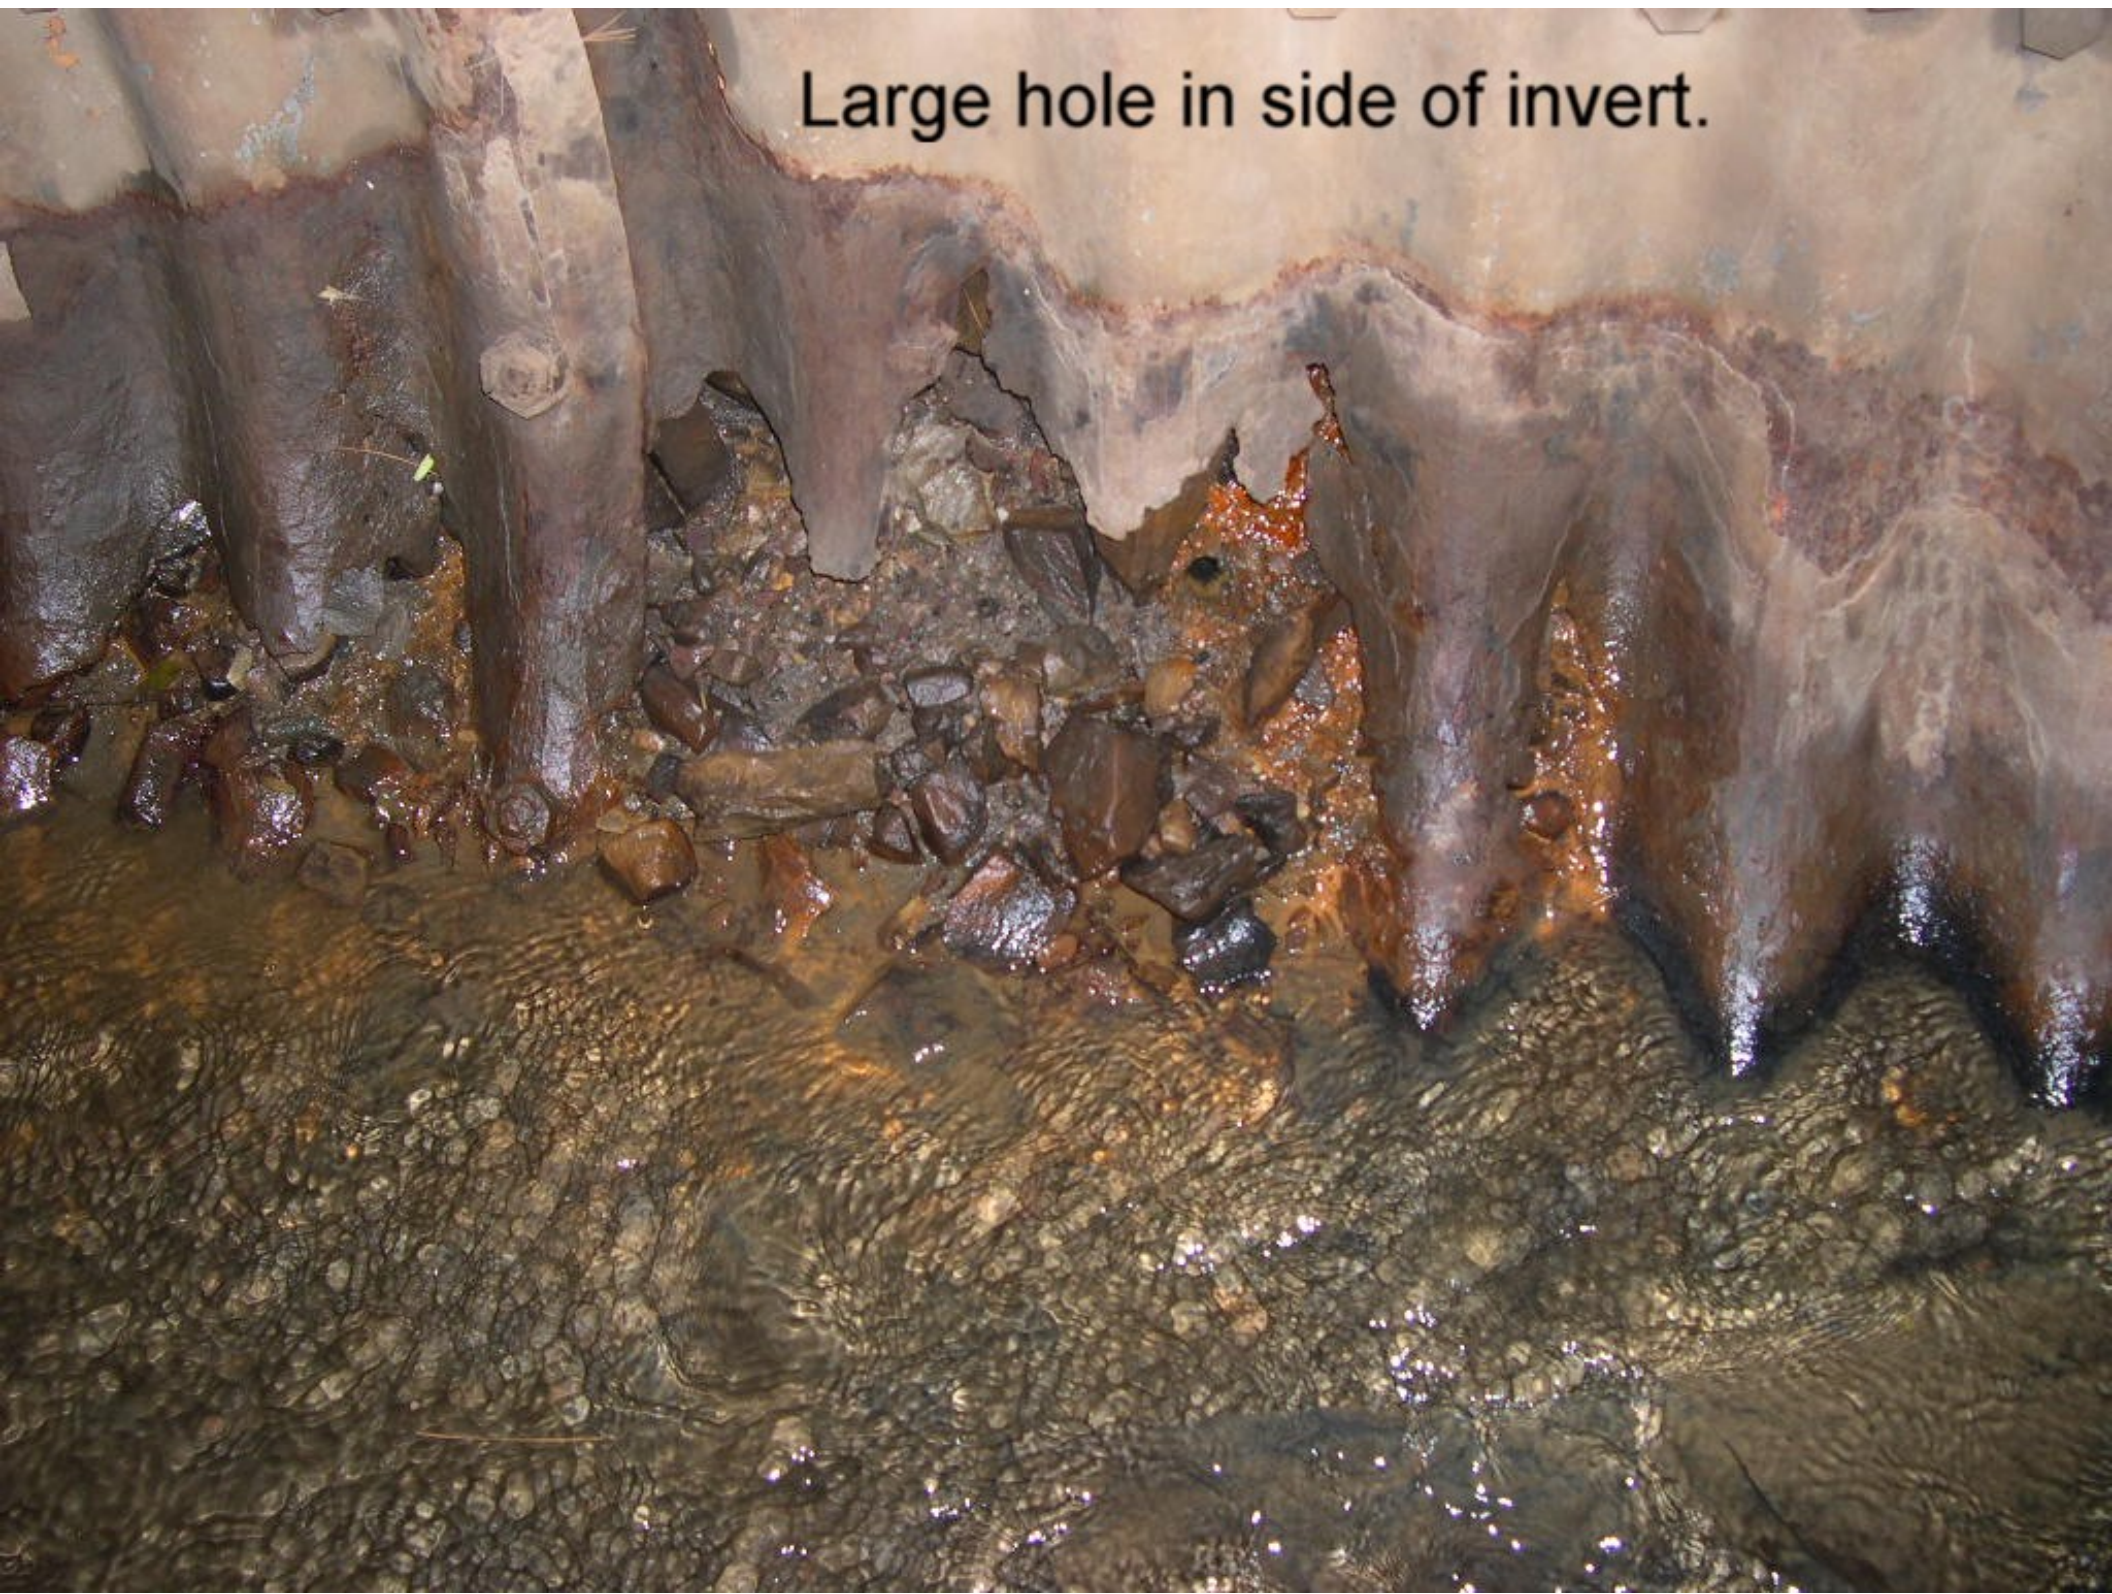
Cracks and small holes and possible crushing.
