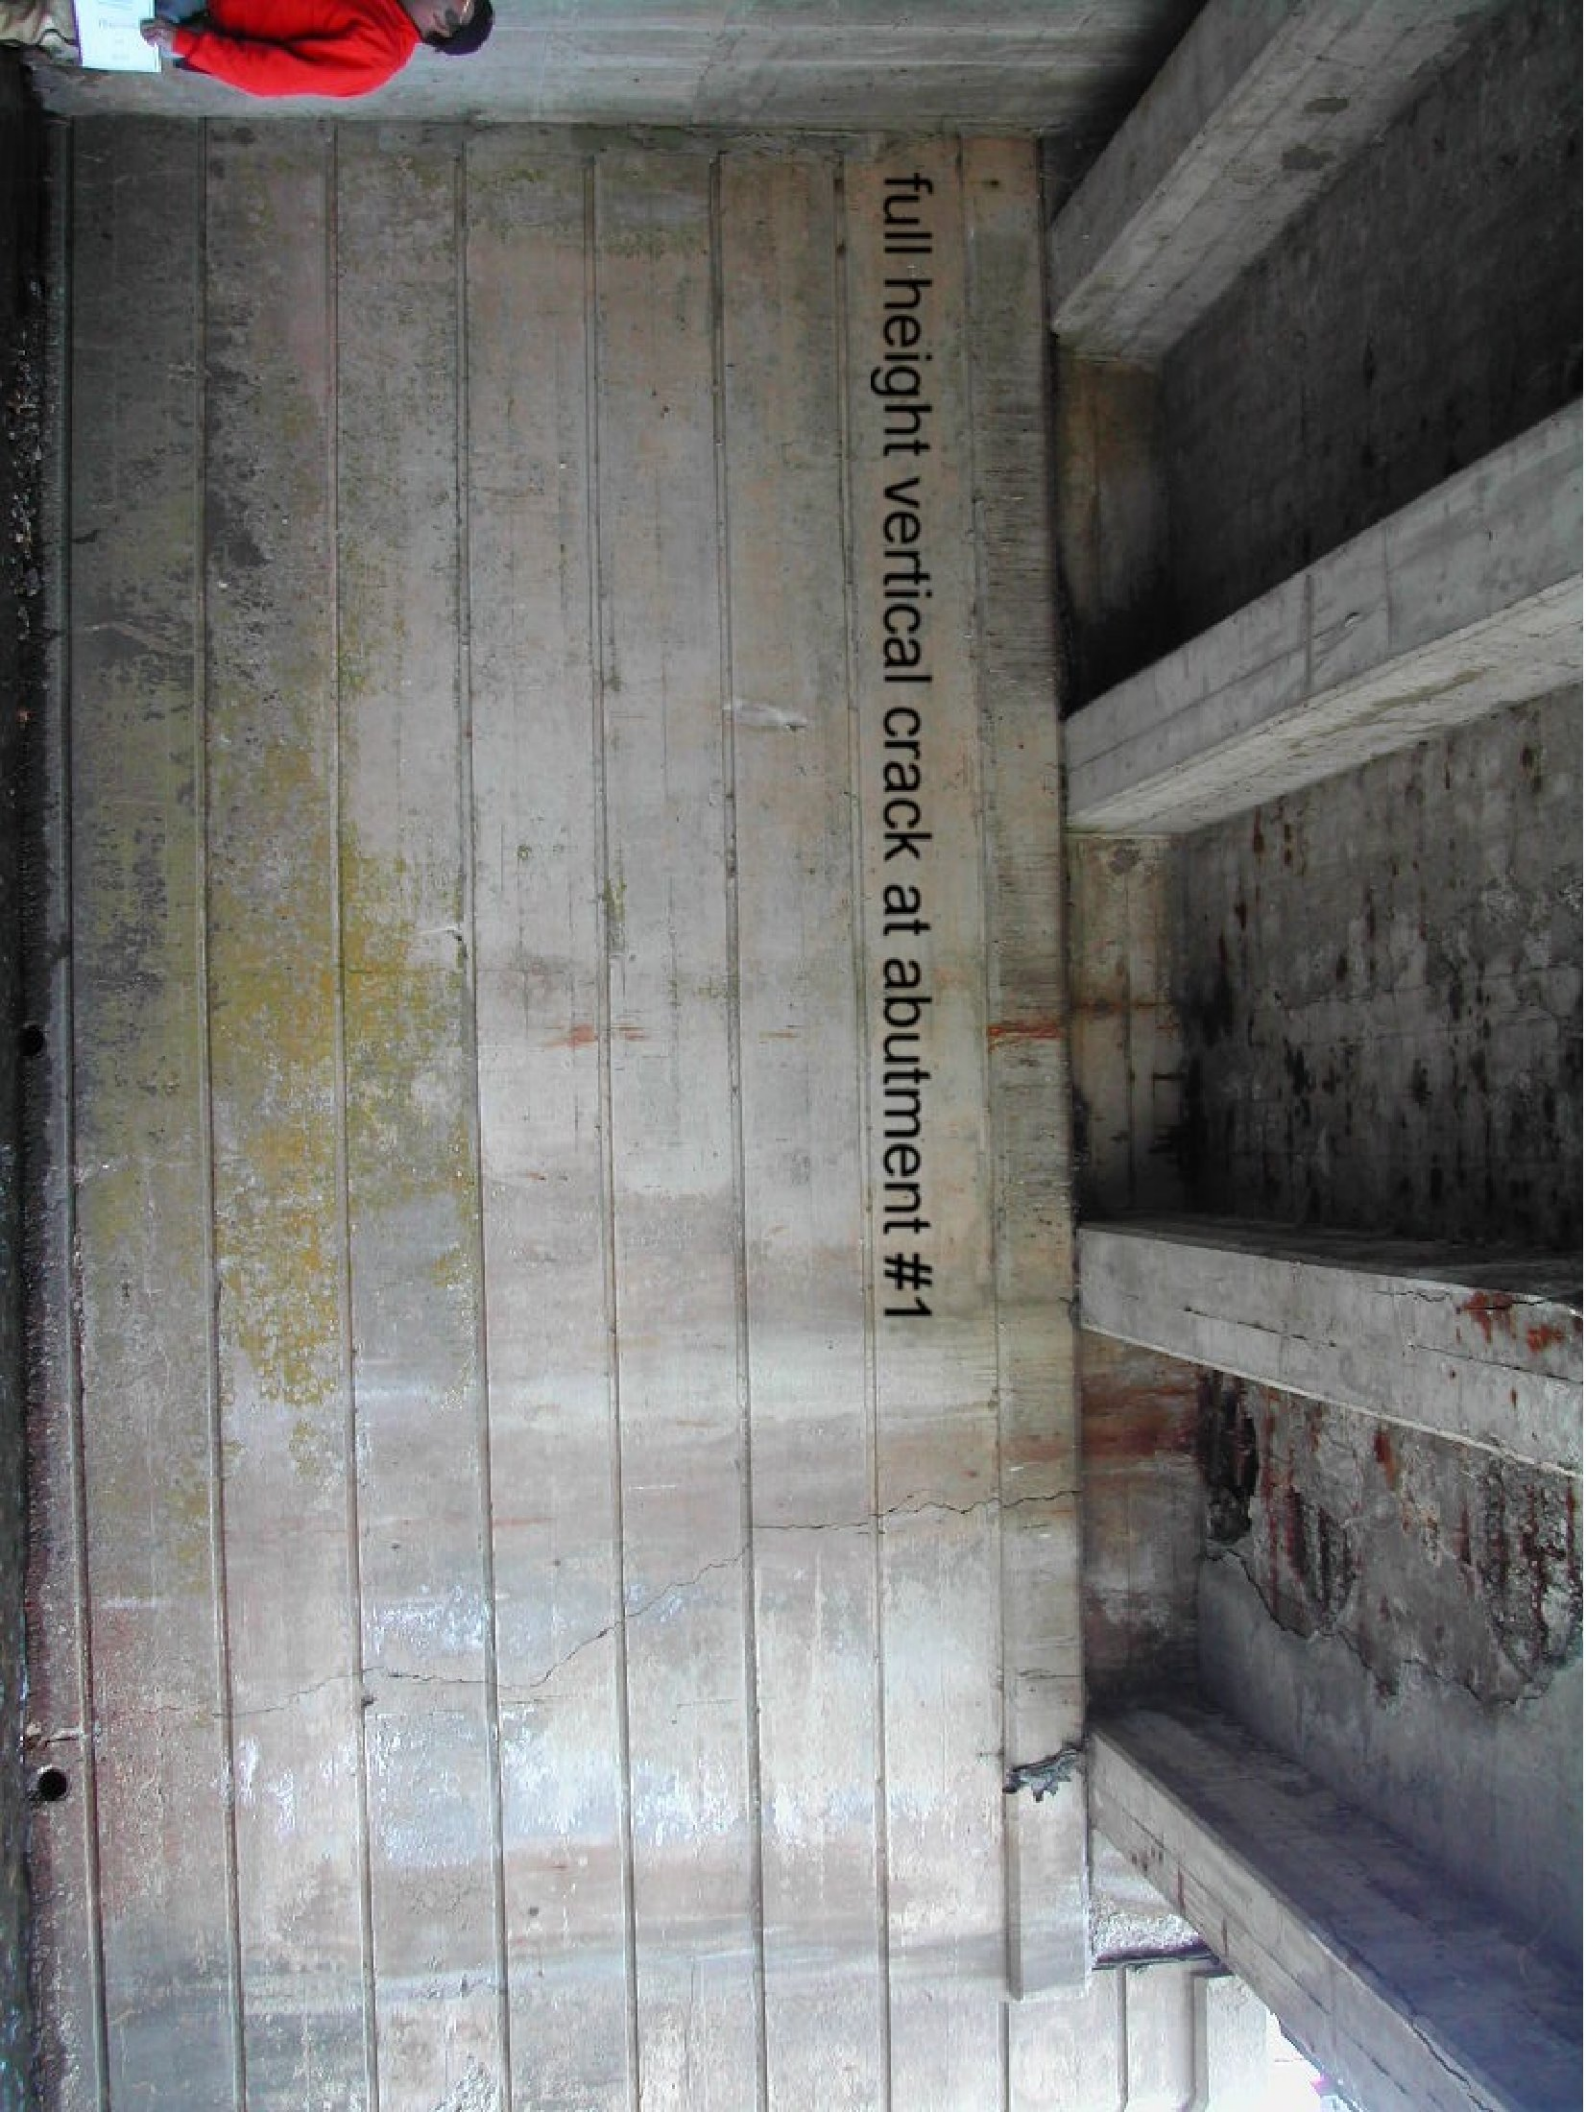
full height vertical crack at abutment #1
