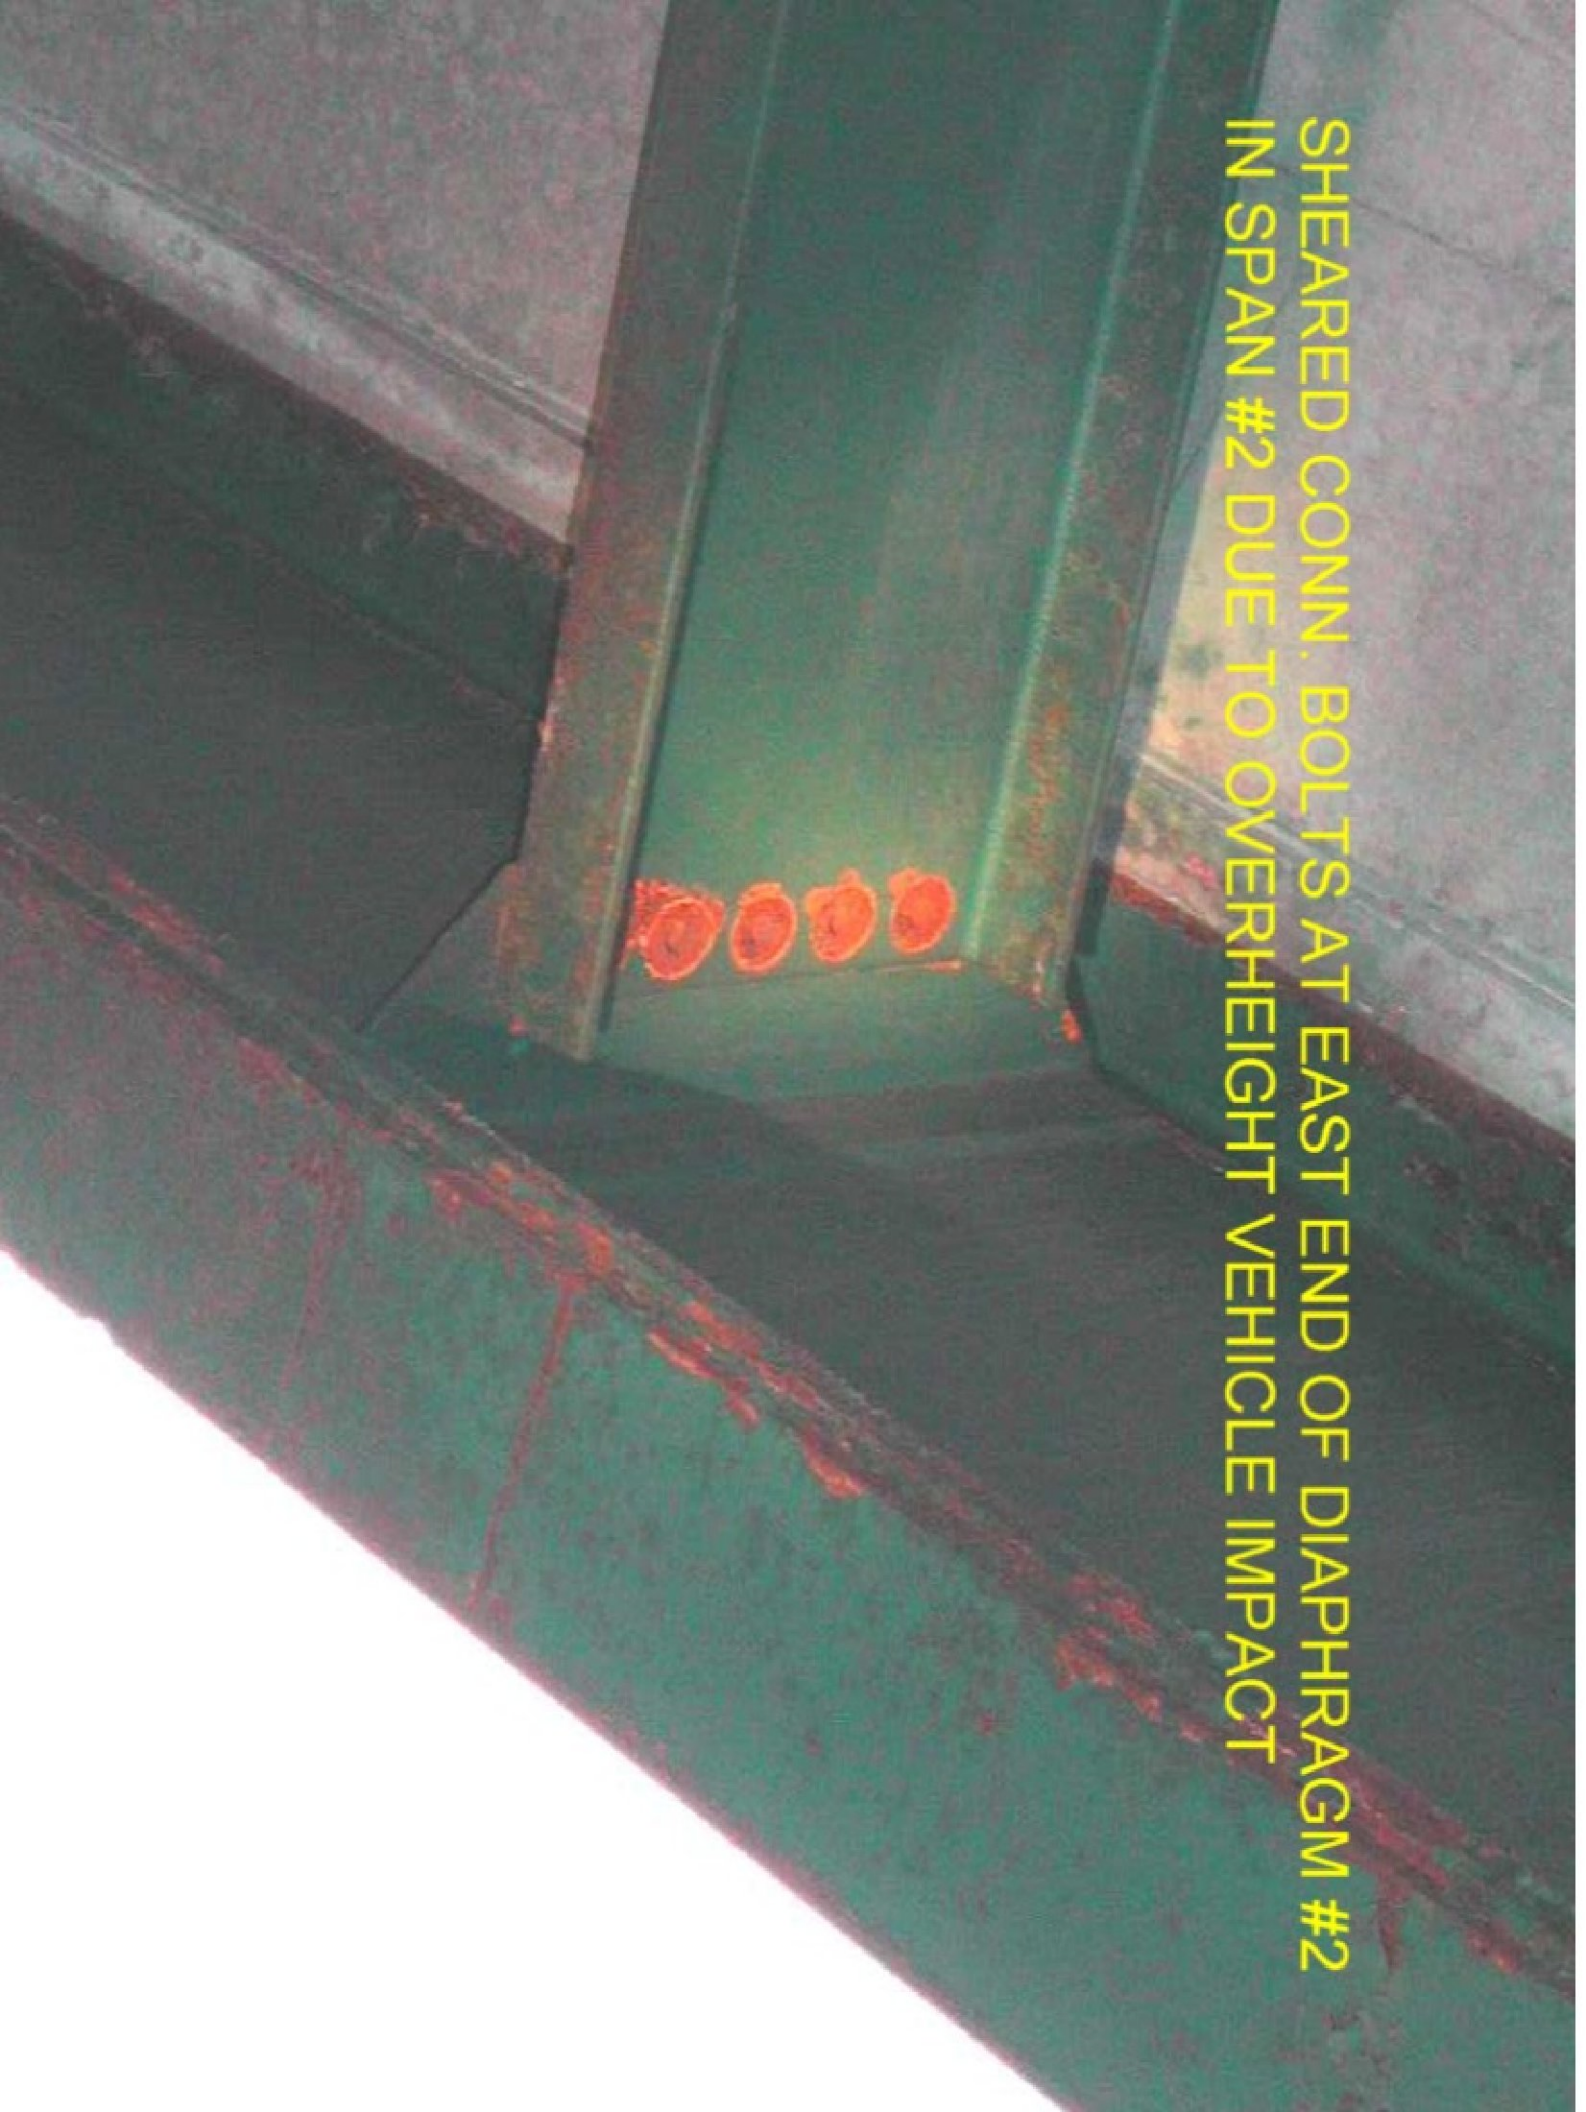
SHEARED CONN. BOLTS AT EAST END OF DIAPHRAGM #2
IN SPAN #2 DUE TO OVERHEIGHT VEHICLE IMPACT
