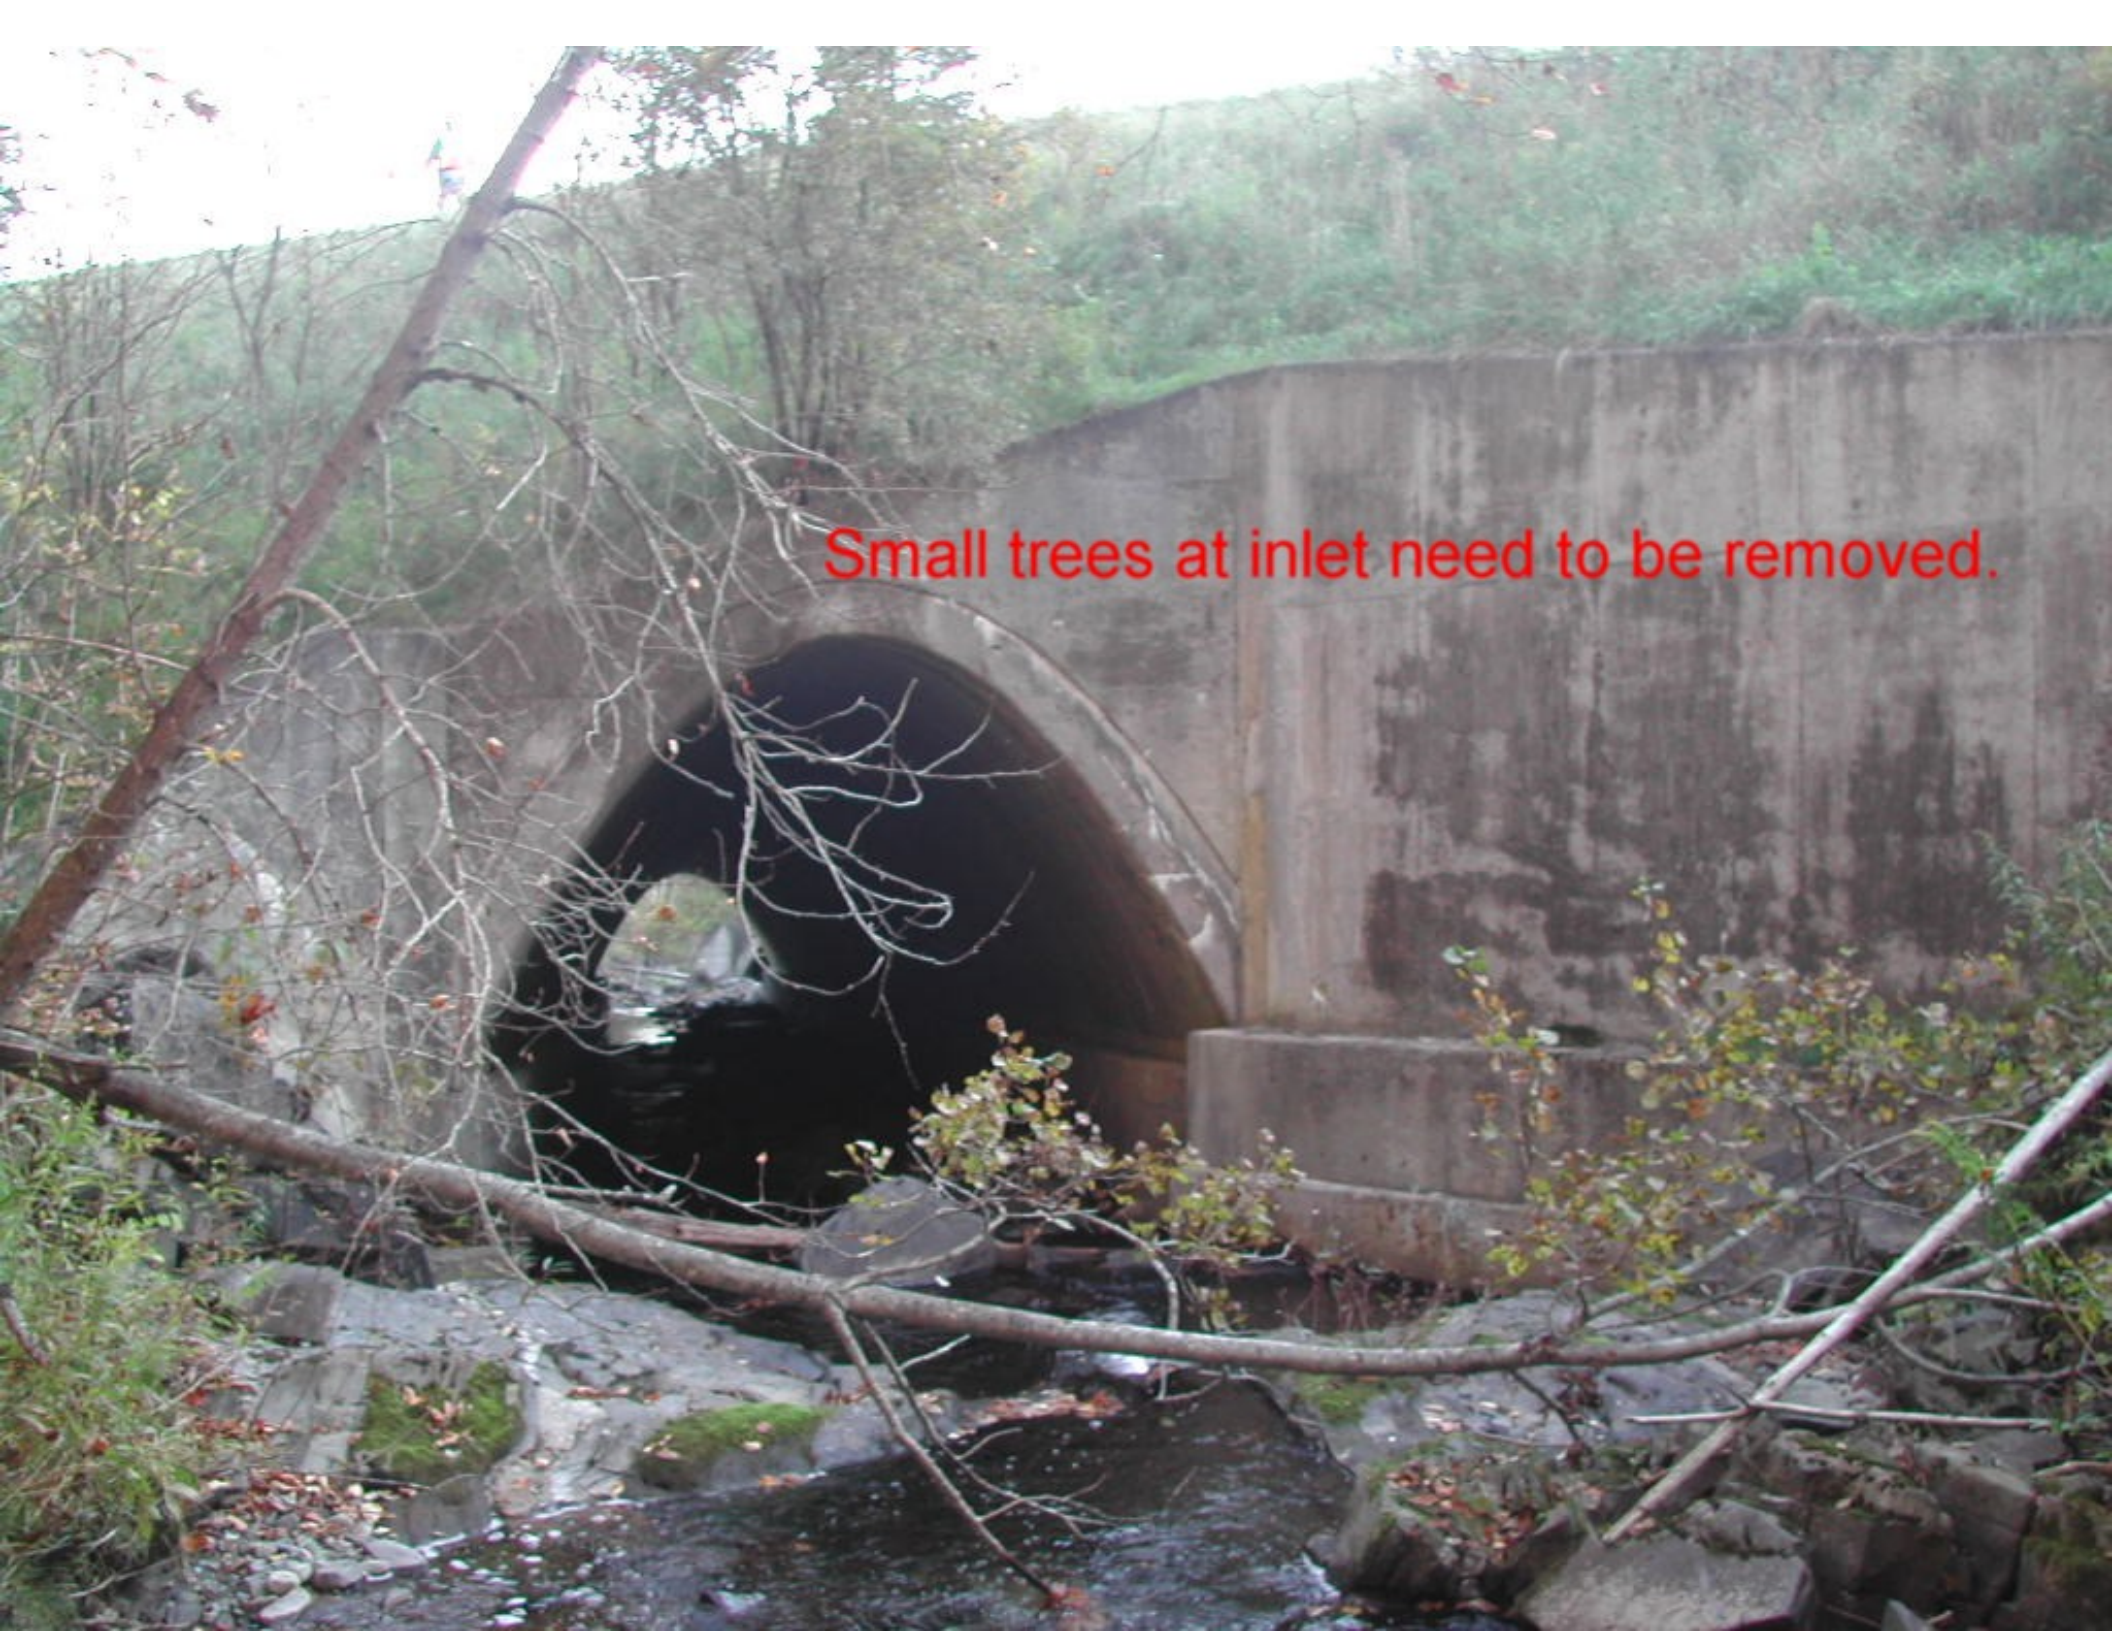
Small trees at inlet need to be removed.
