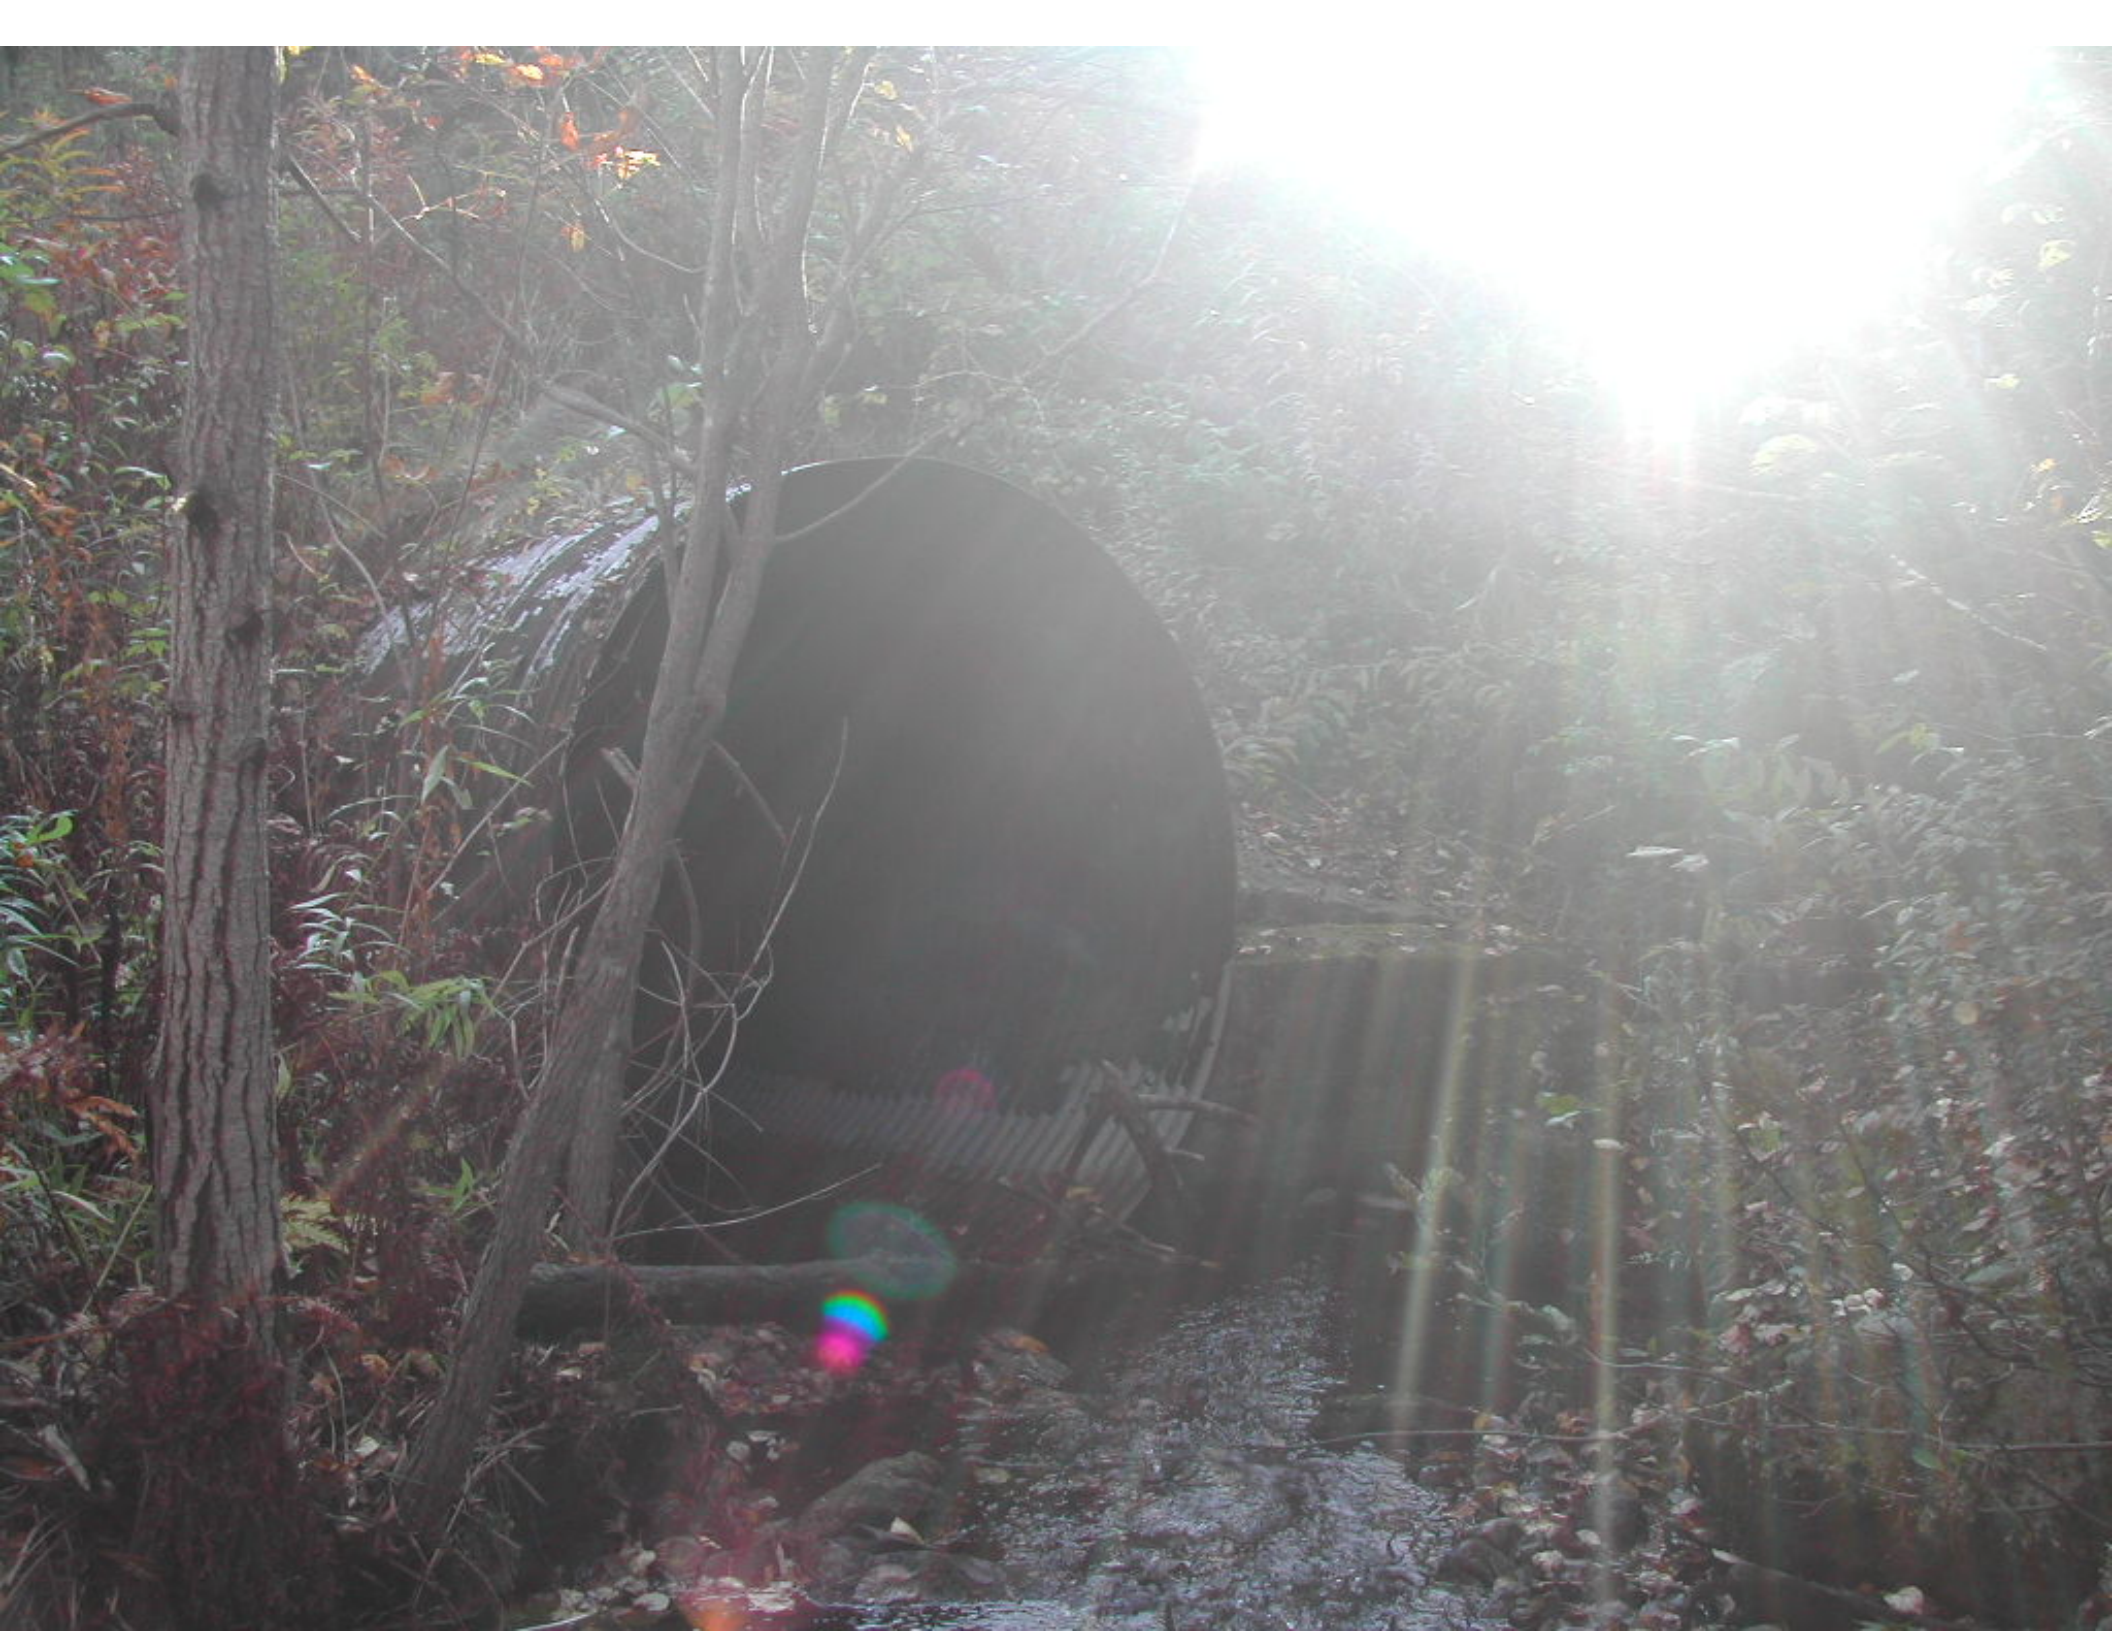
Craddle headwall at outlet should be plumbed and anchored.

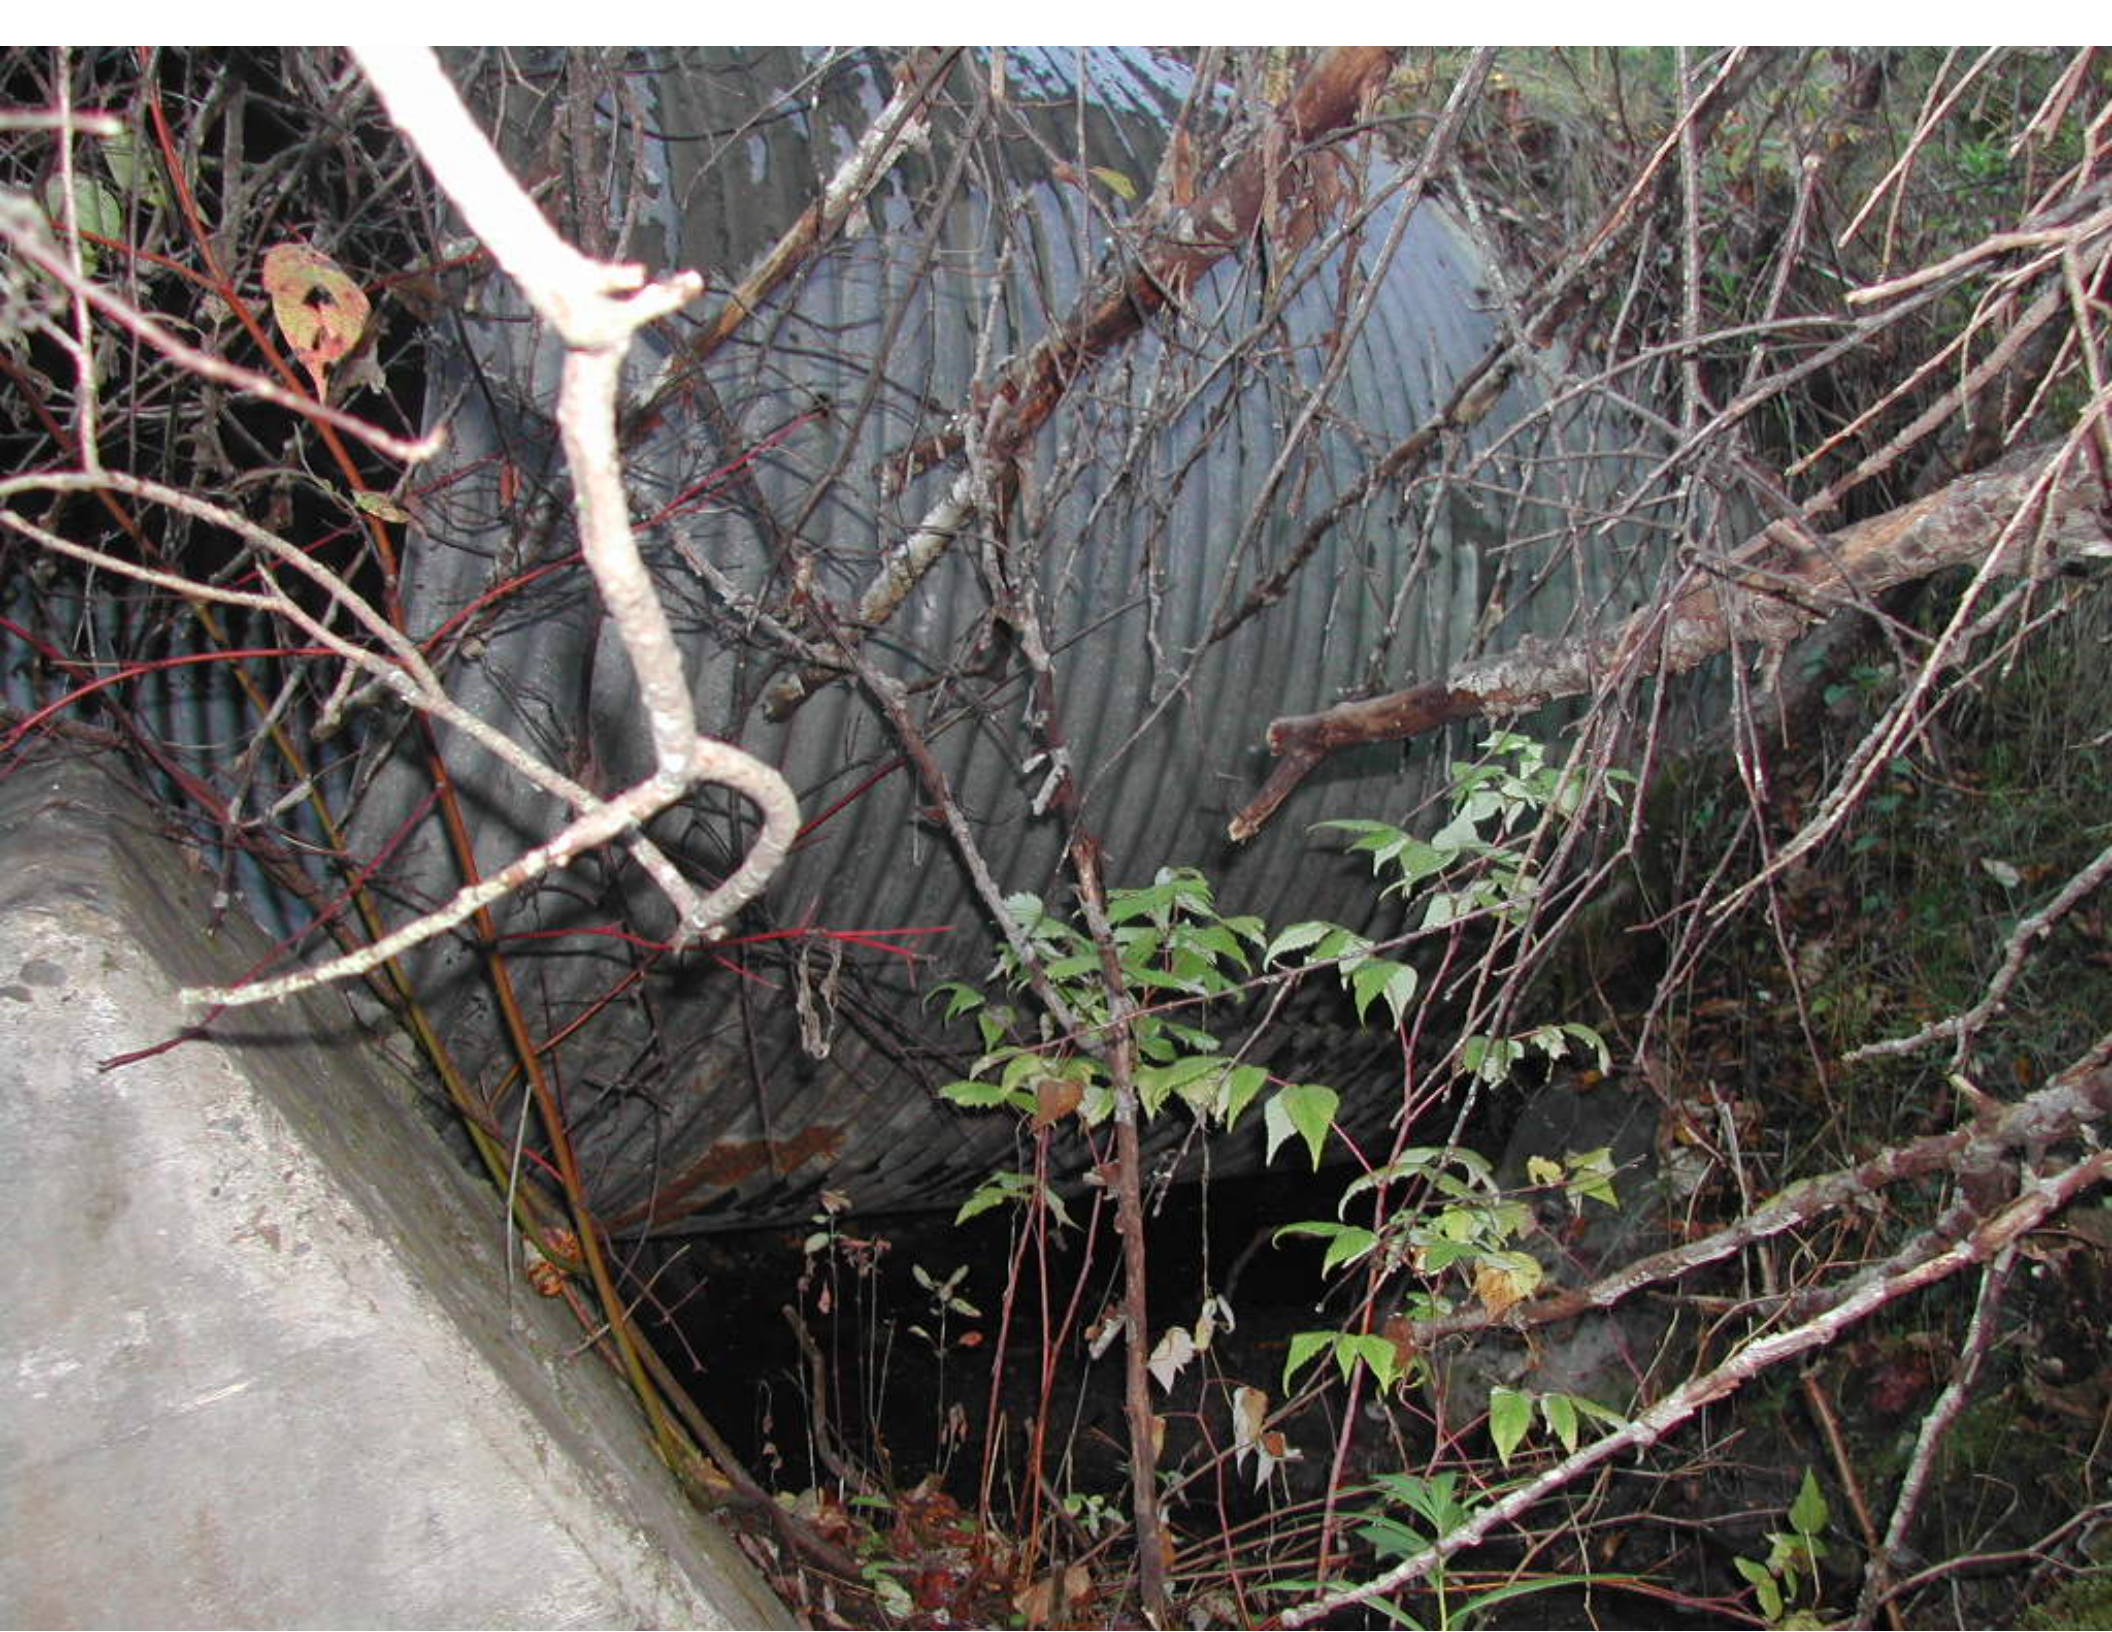
Bank erosion should be repaired.

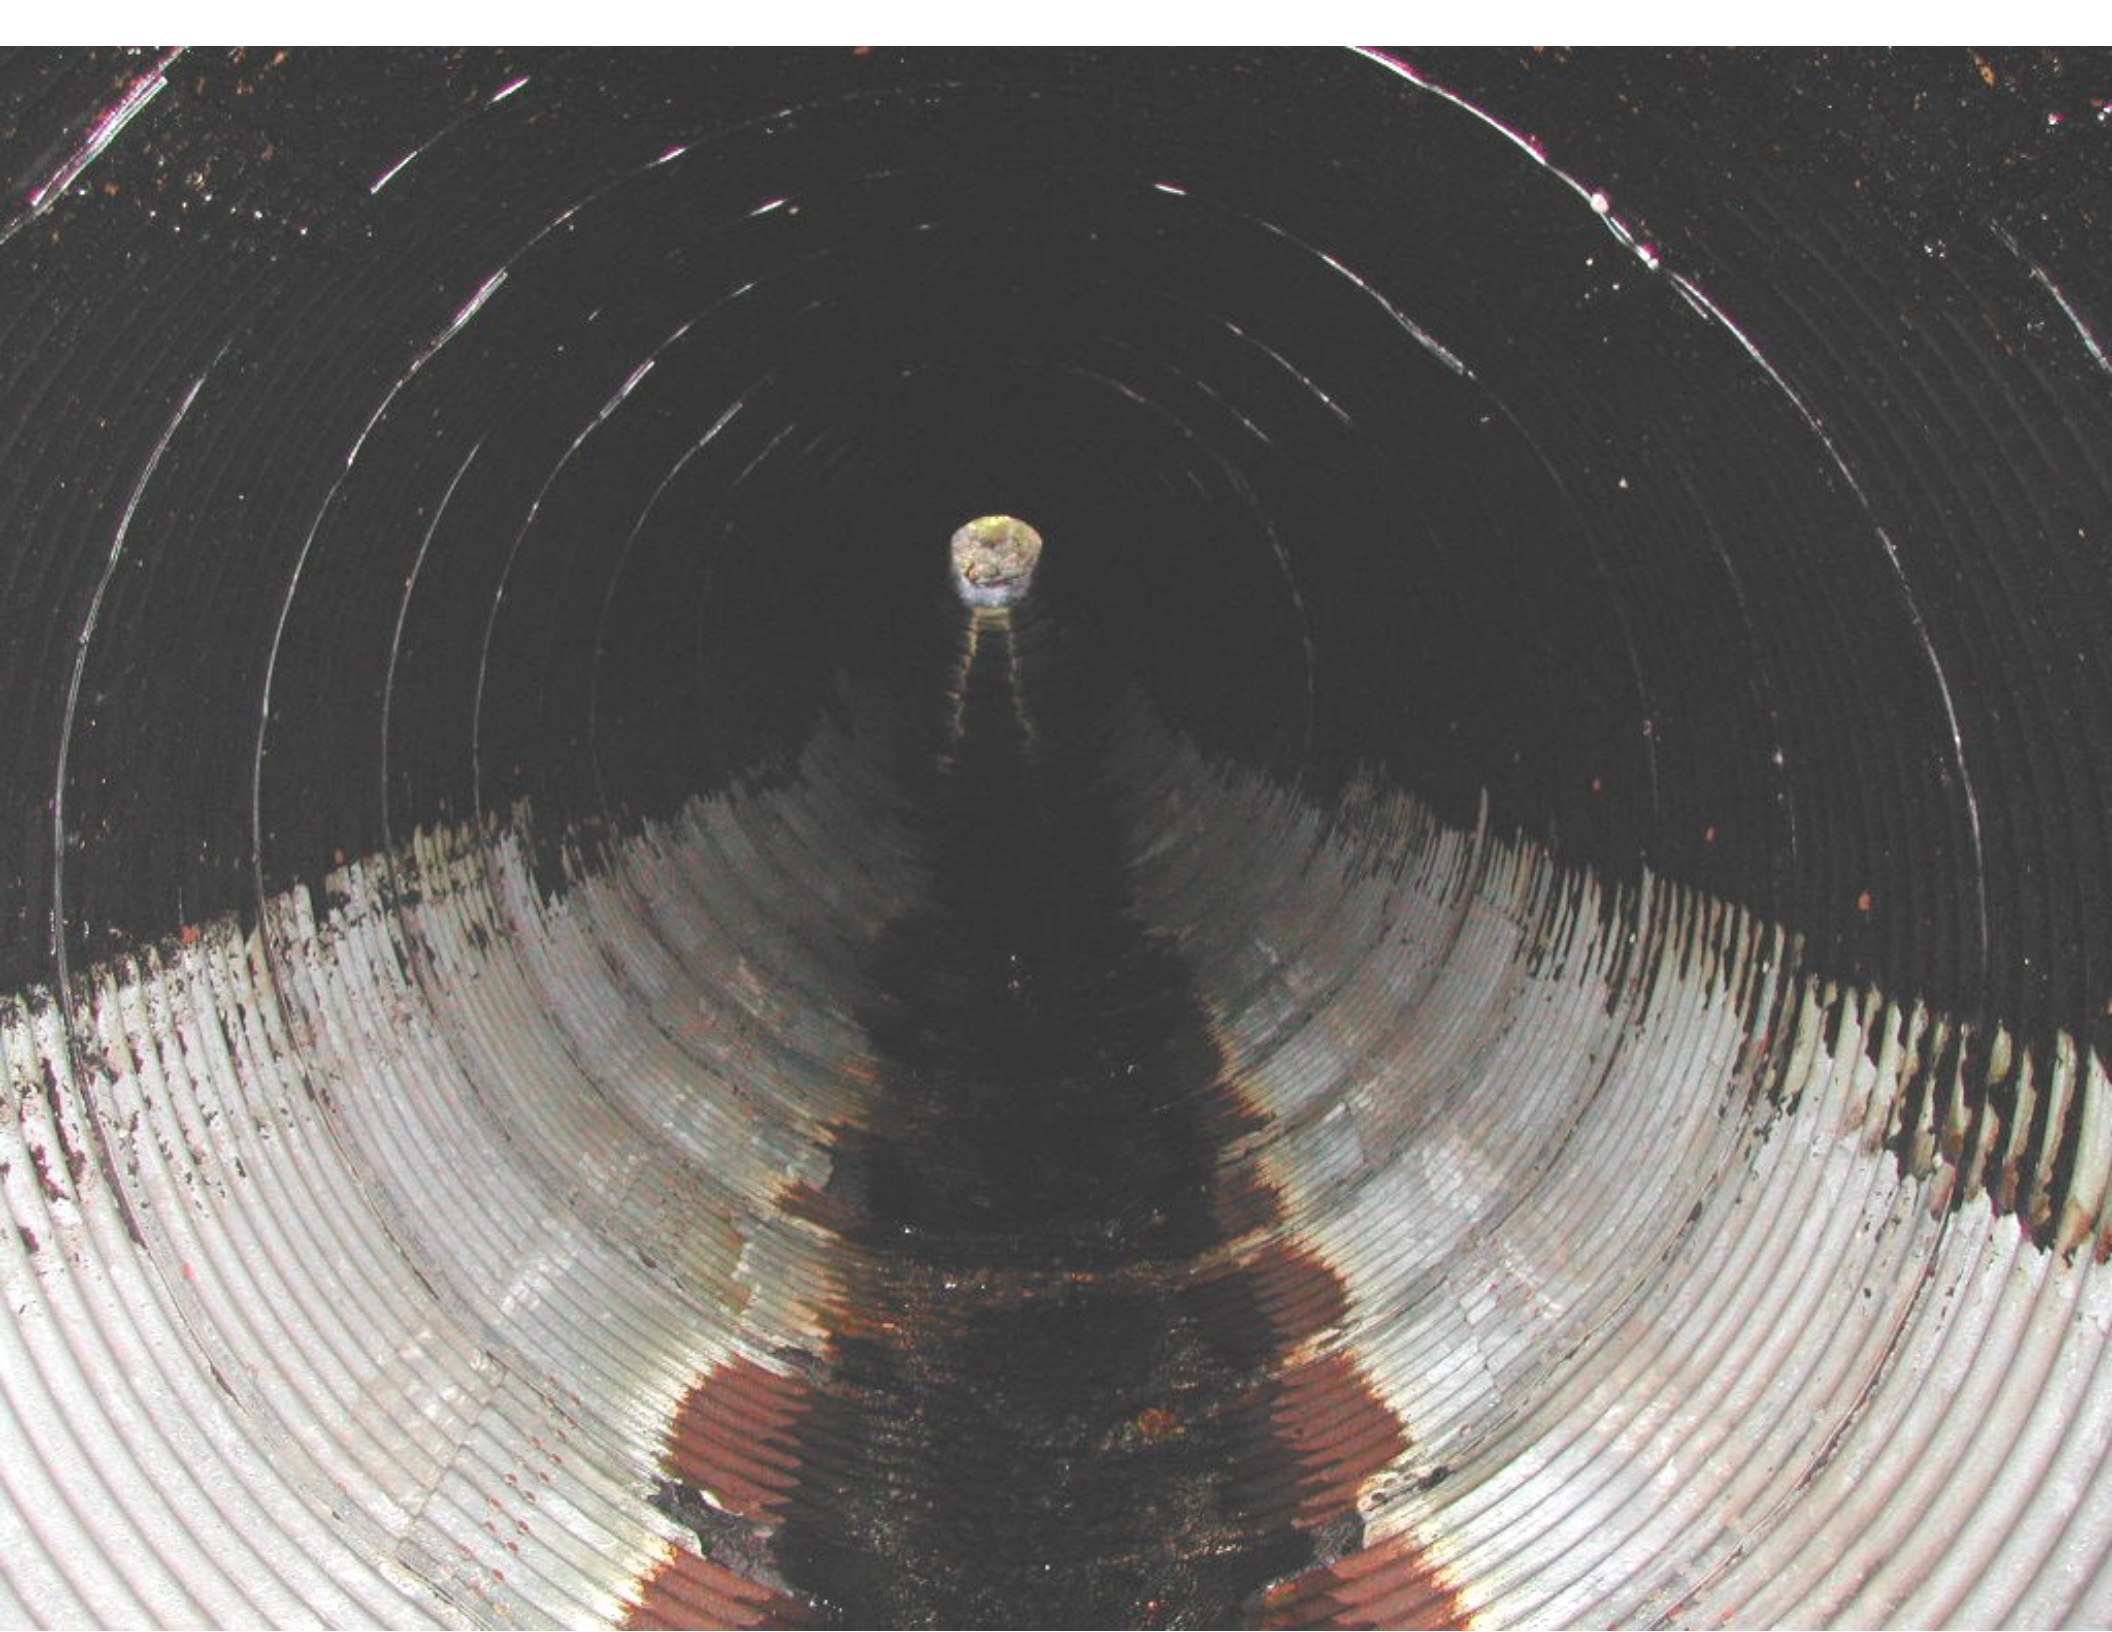
Culvert at inlet end needs to be repaired
and a collar installed.

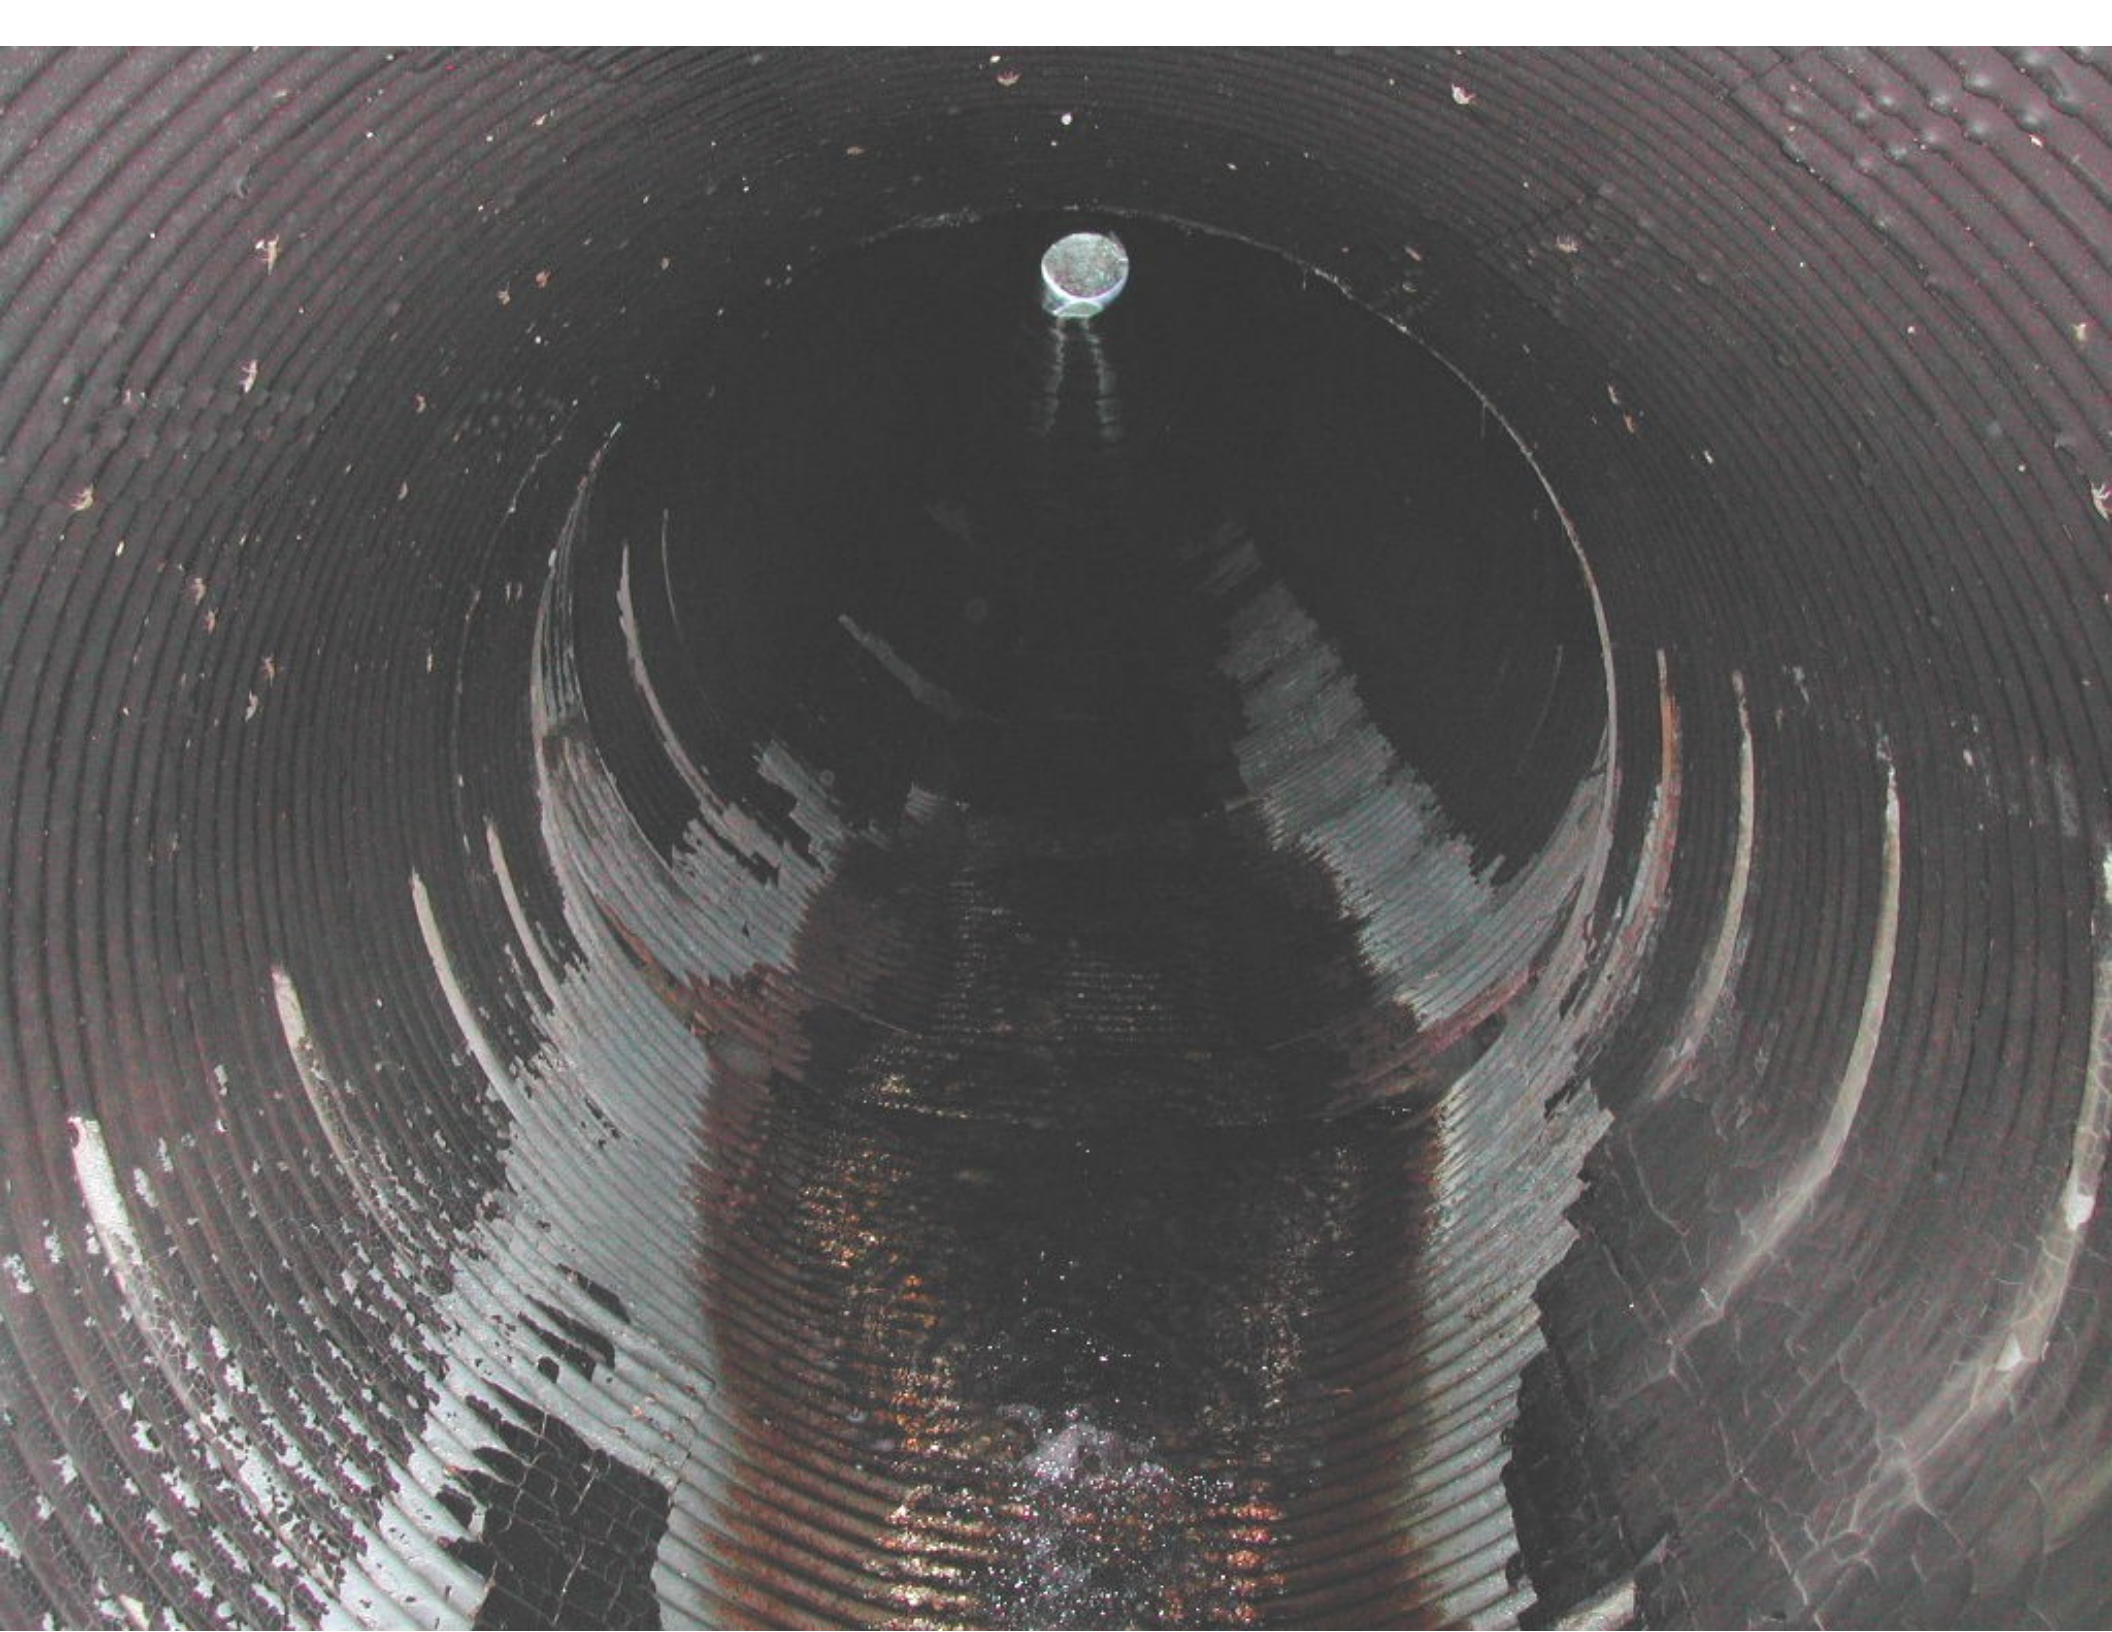
Culvert at outlet needs to be reset and a collar installed
