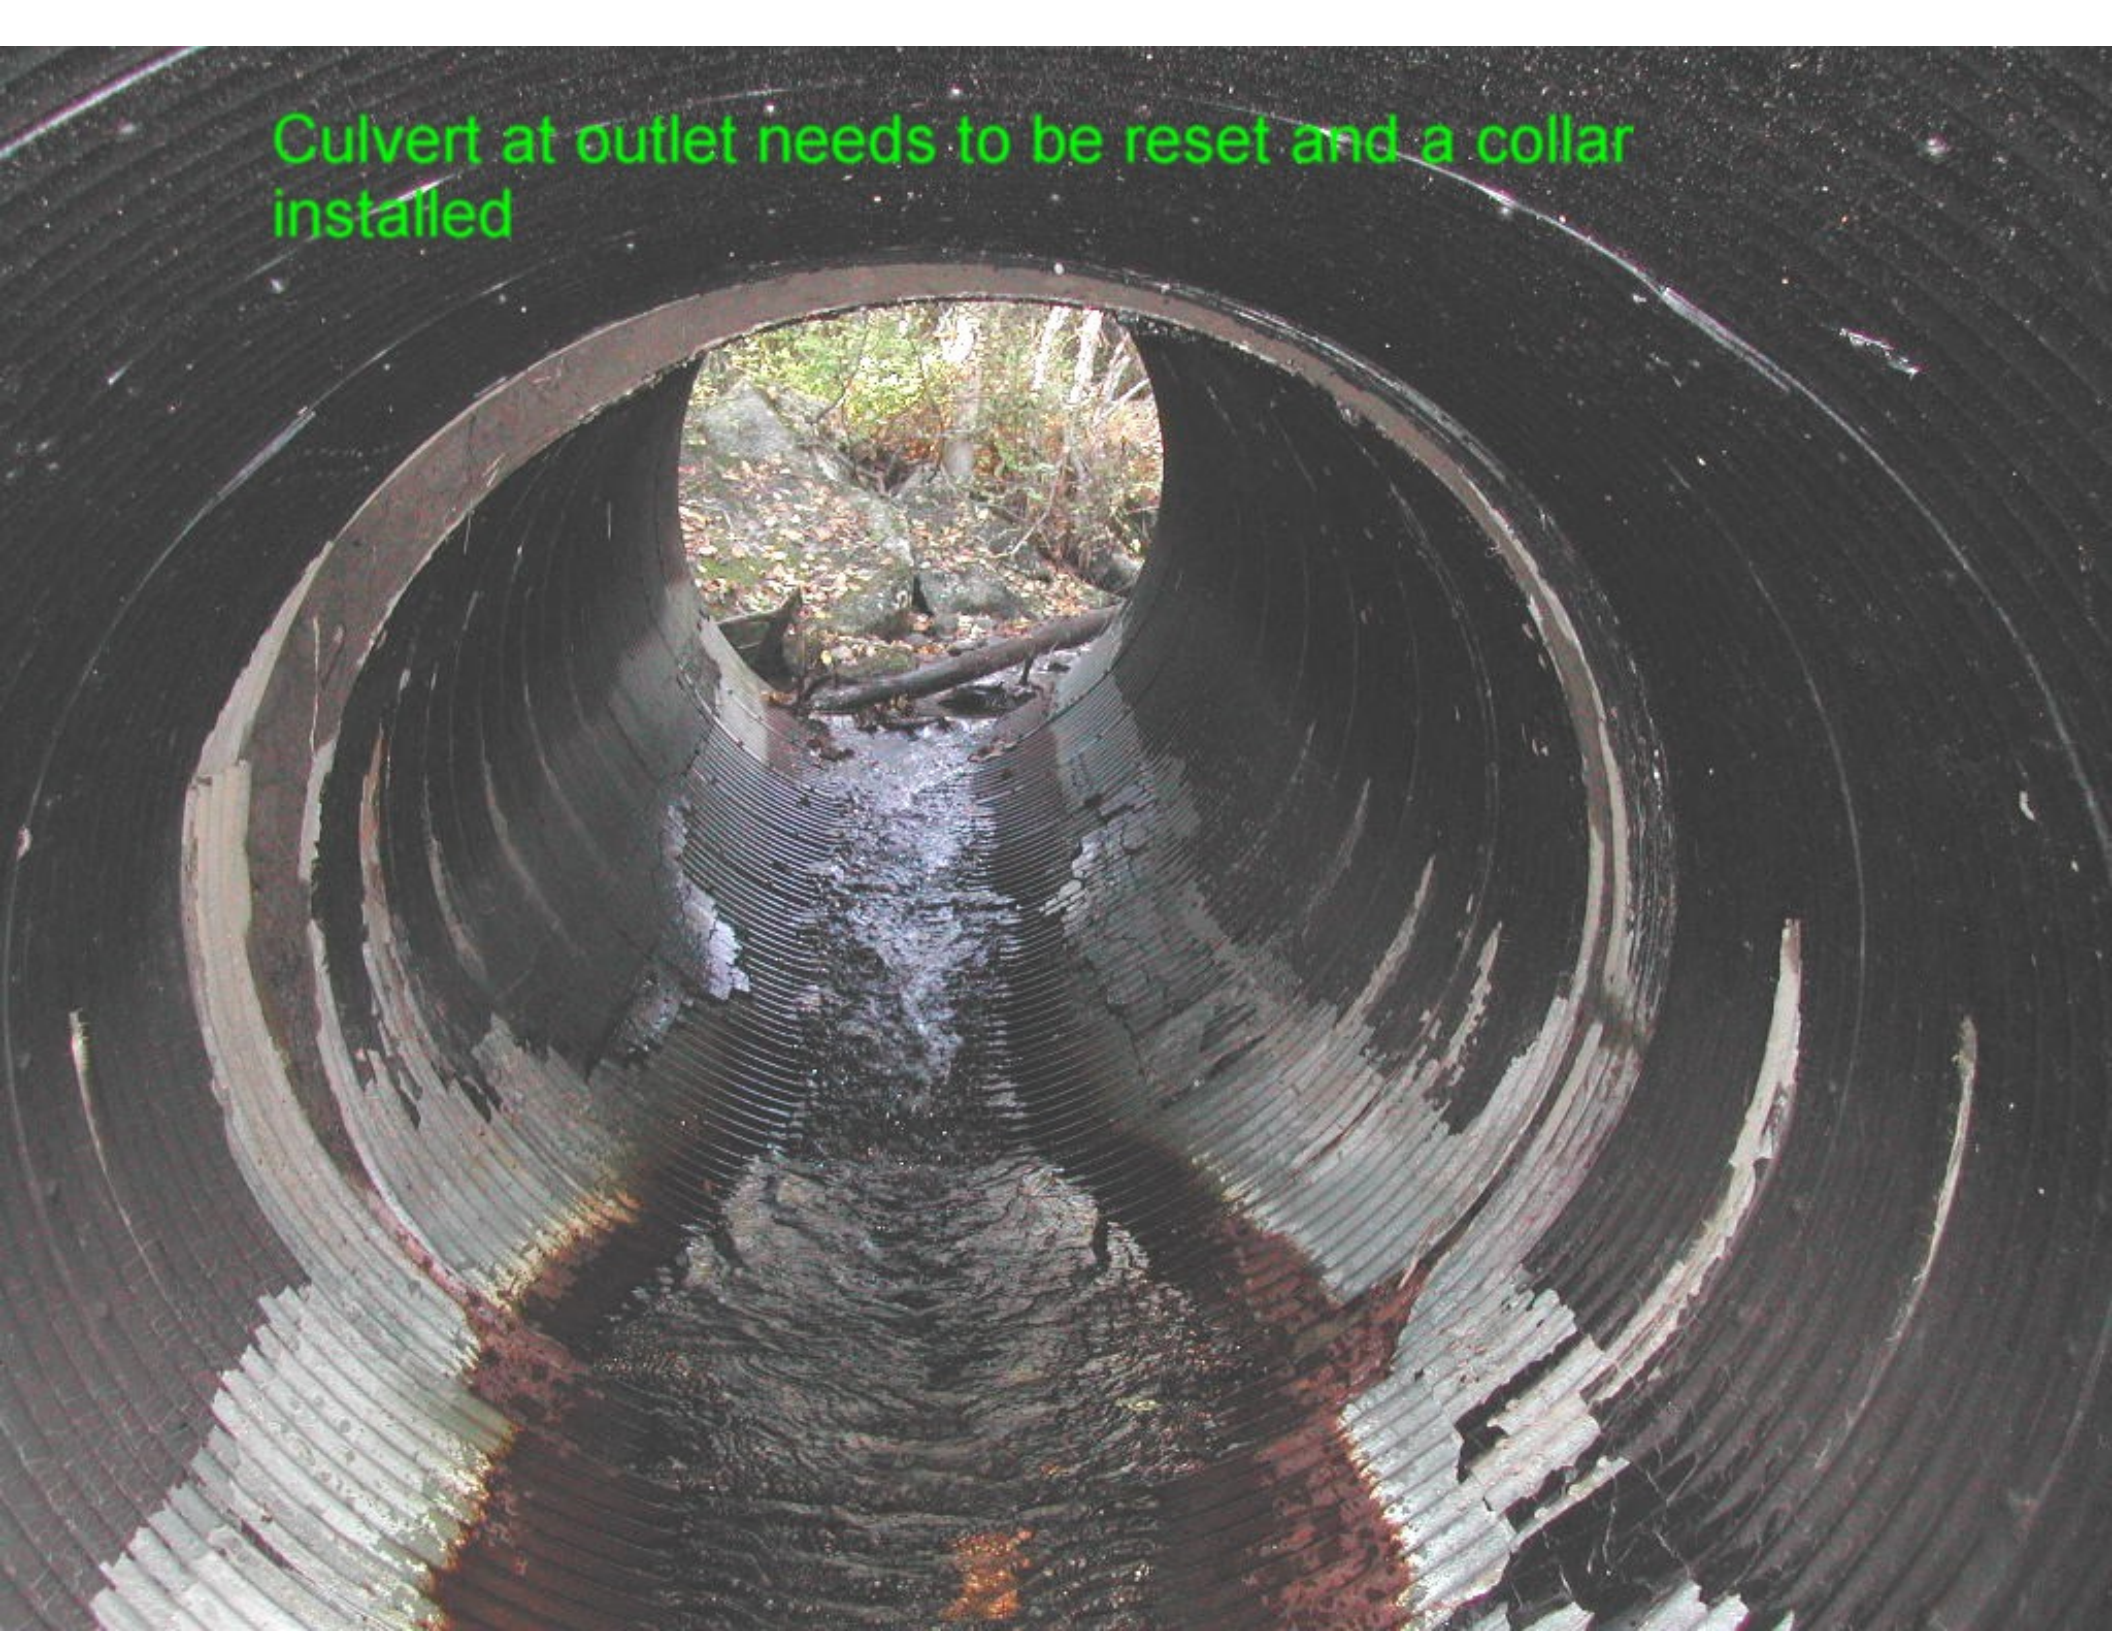
Culvert at outlet needs to be reset and a collar installed
