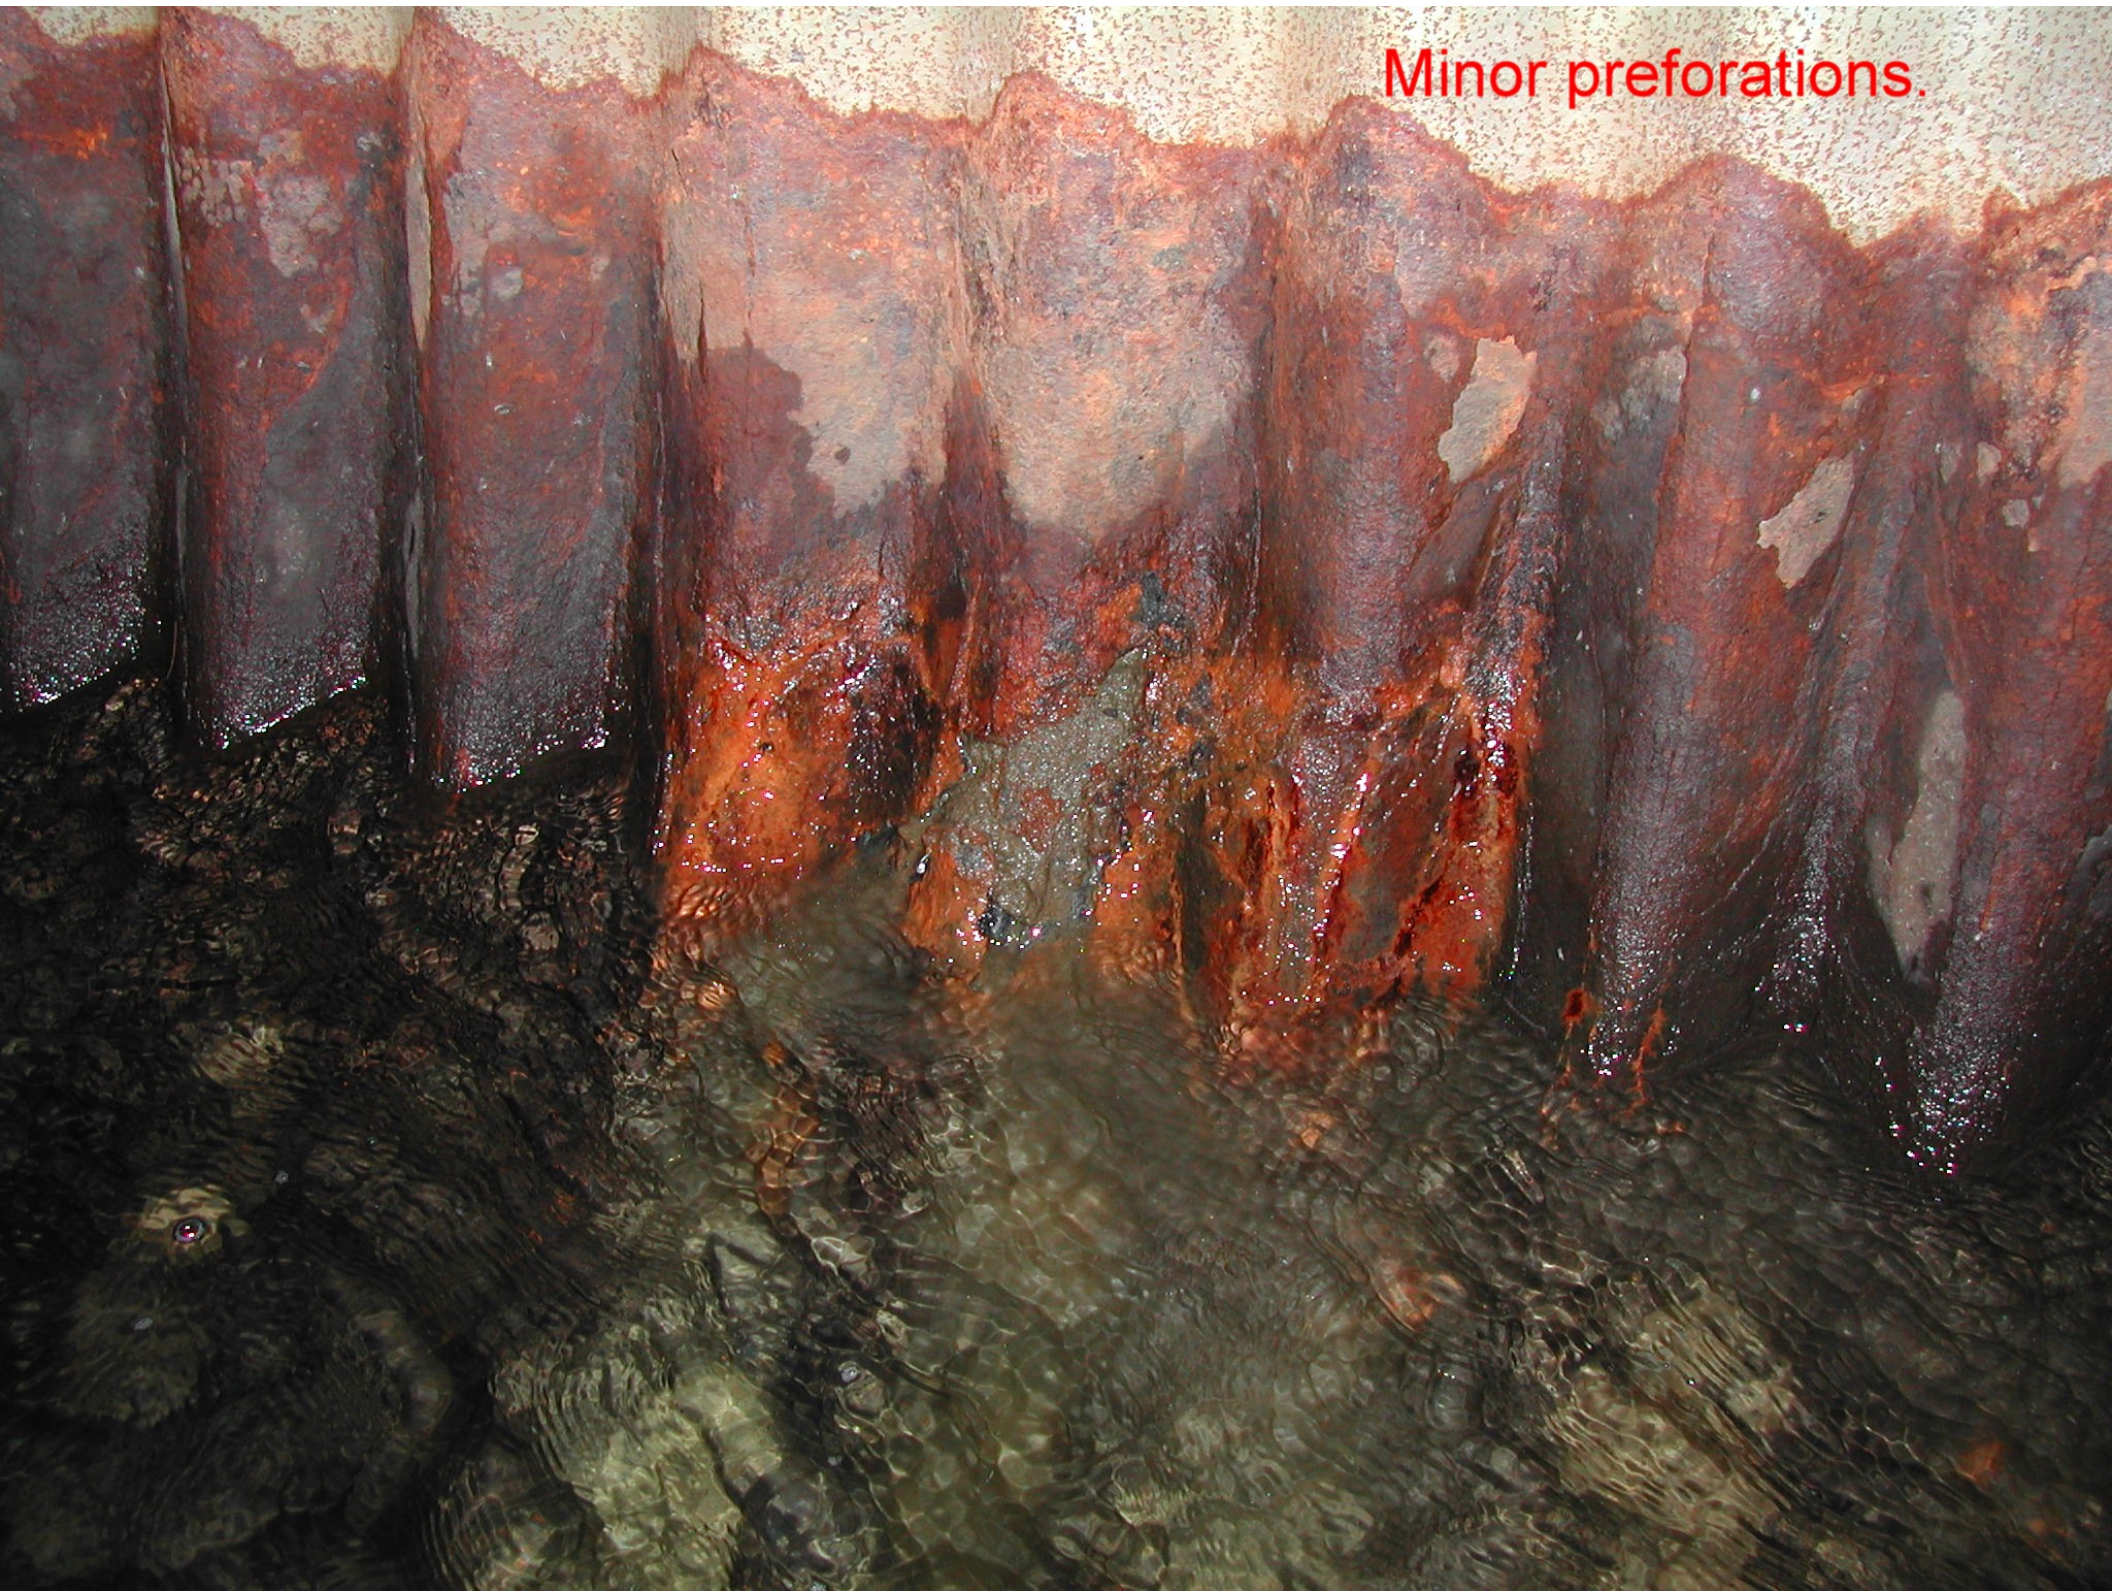
Minor perforations.

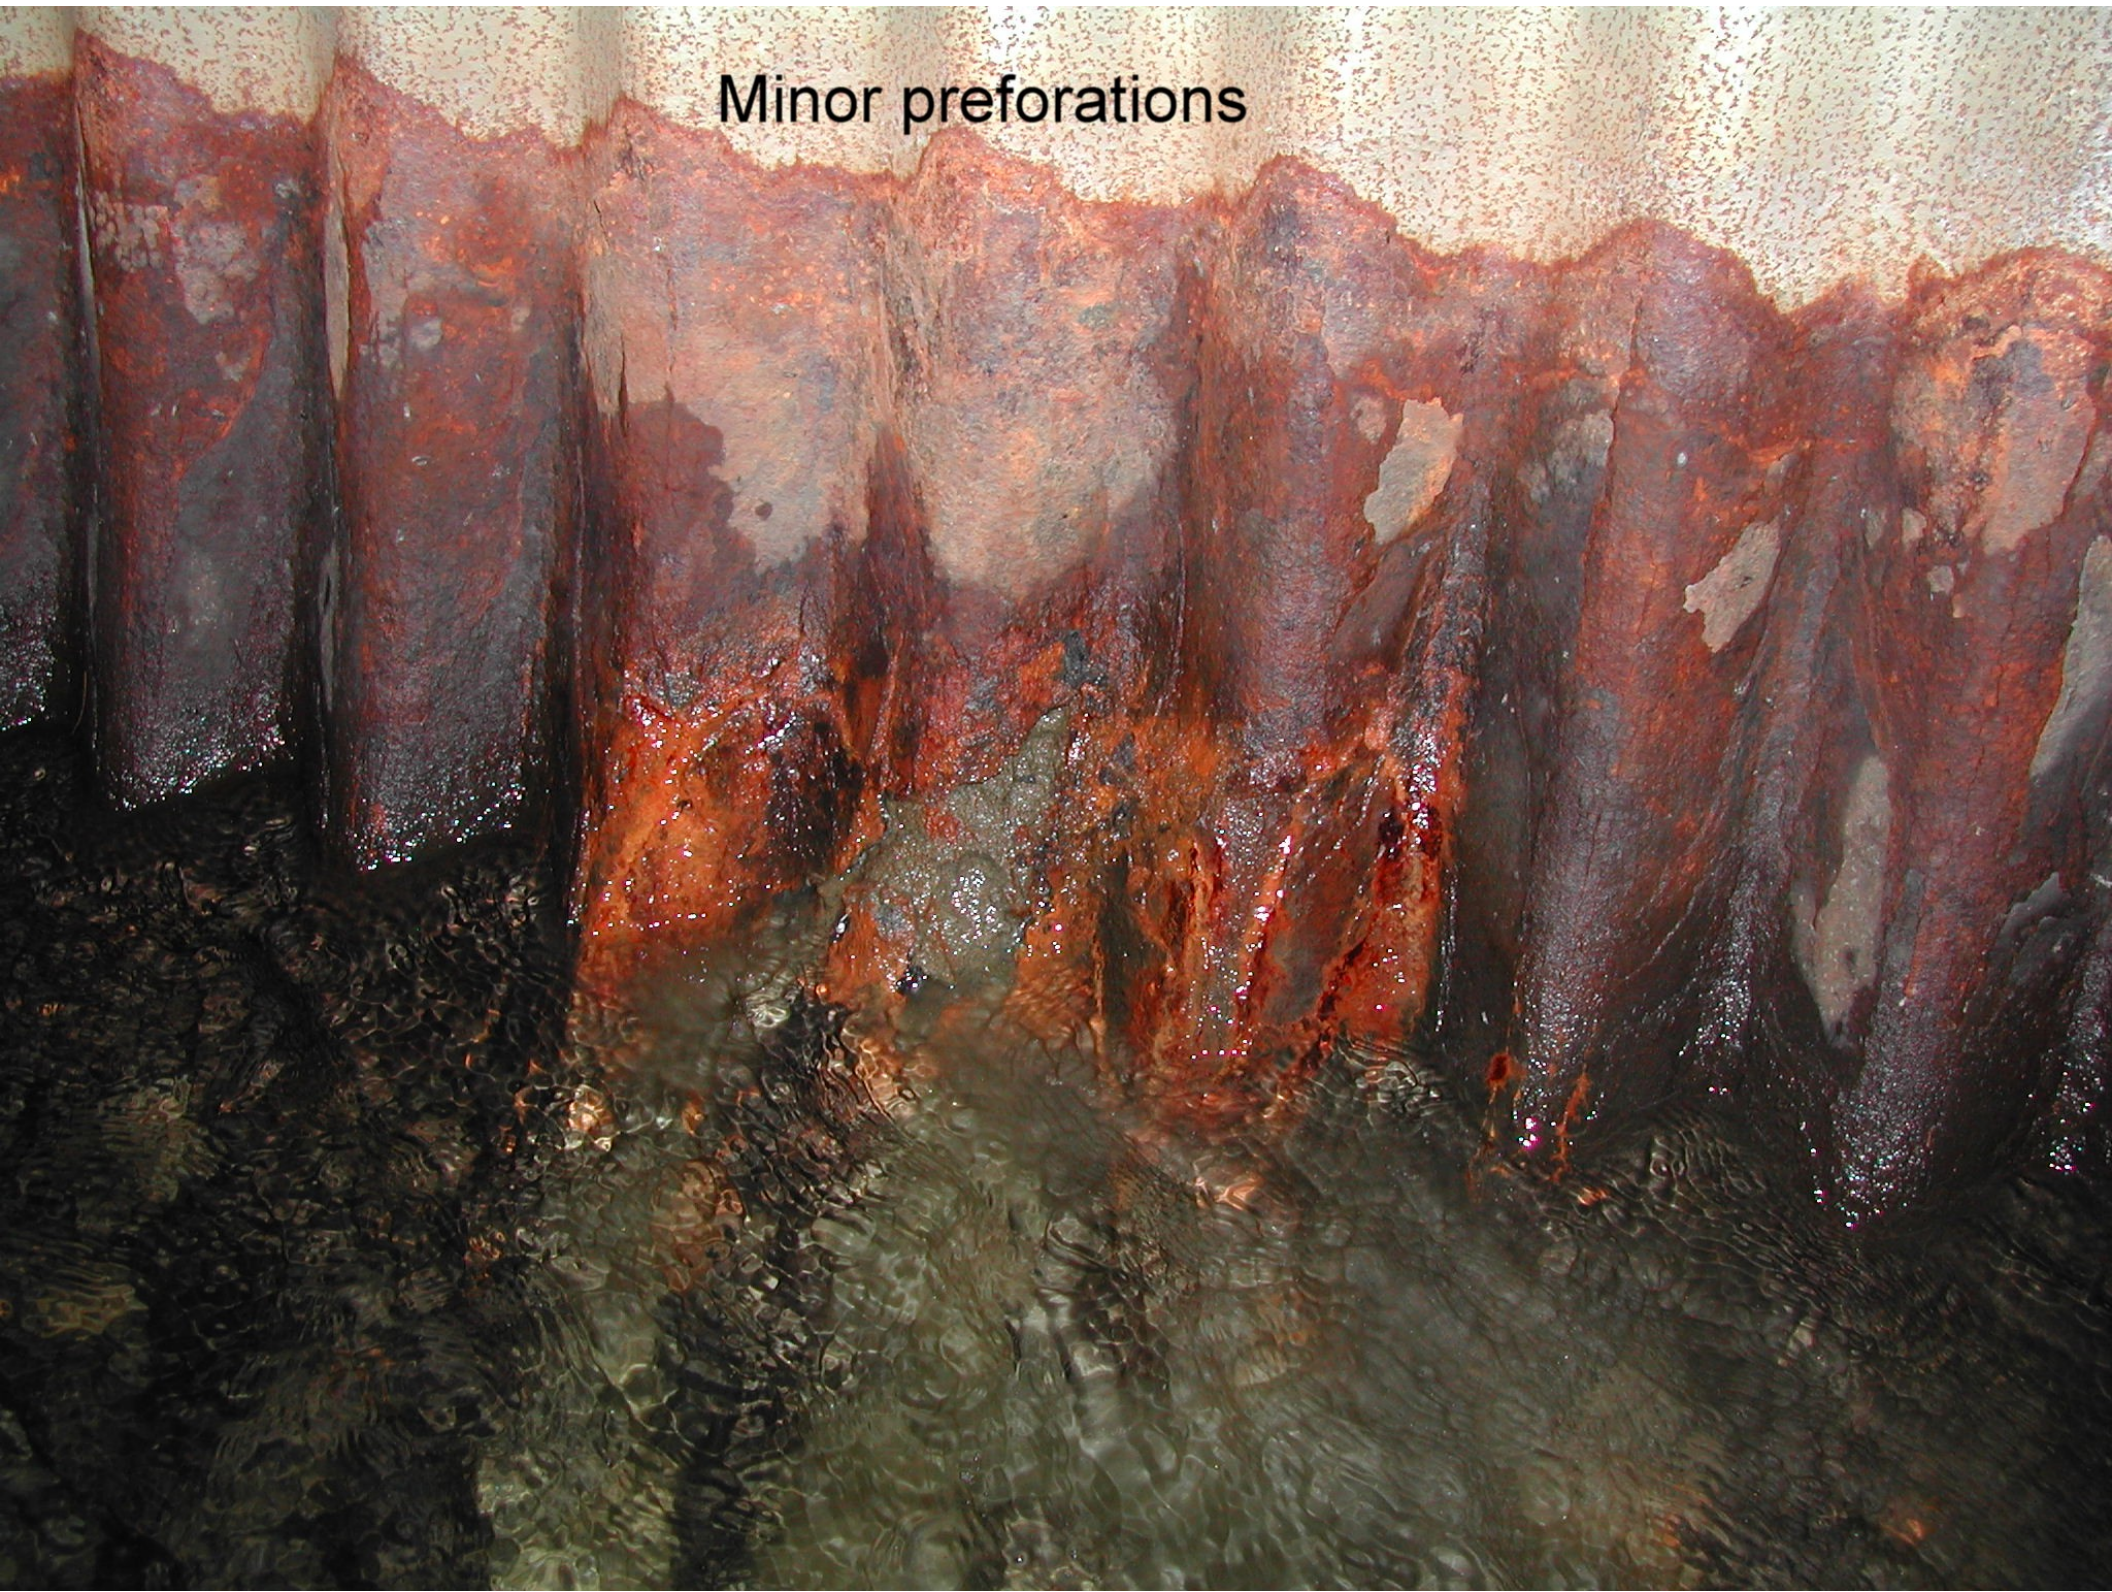
Minor perforations

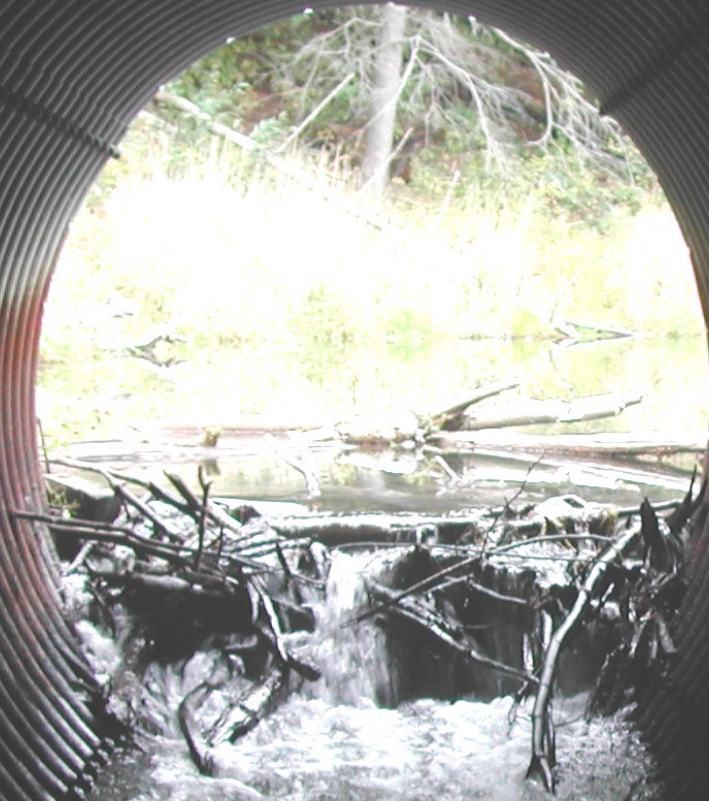
Small beaver dam at inlet end of pipe
