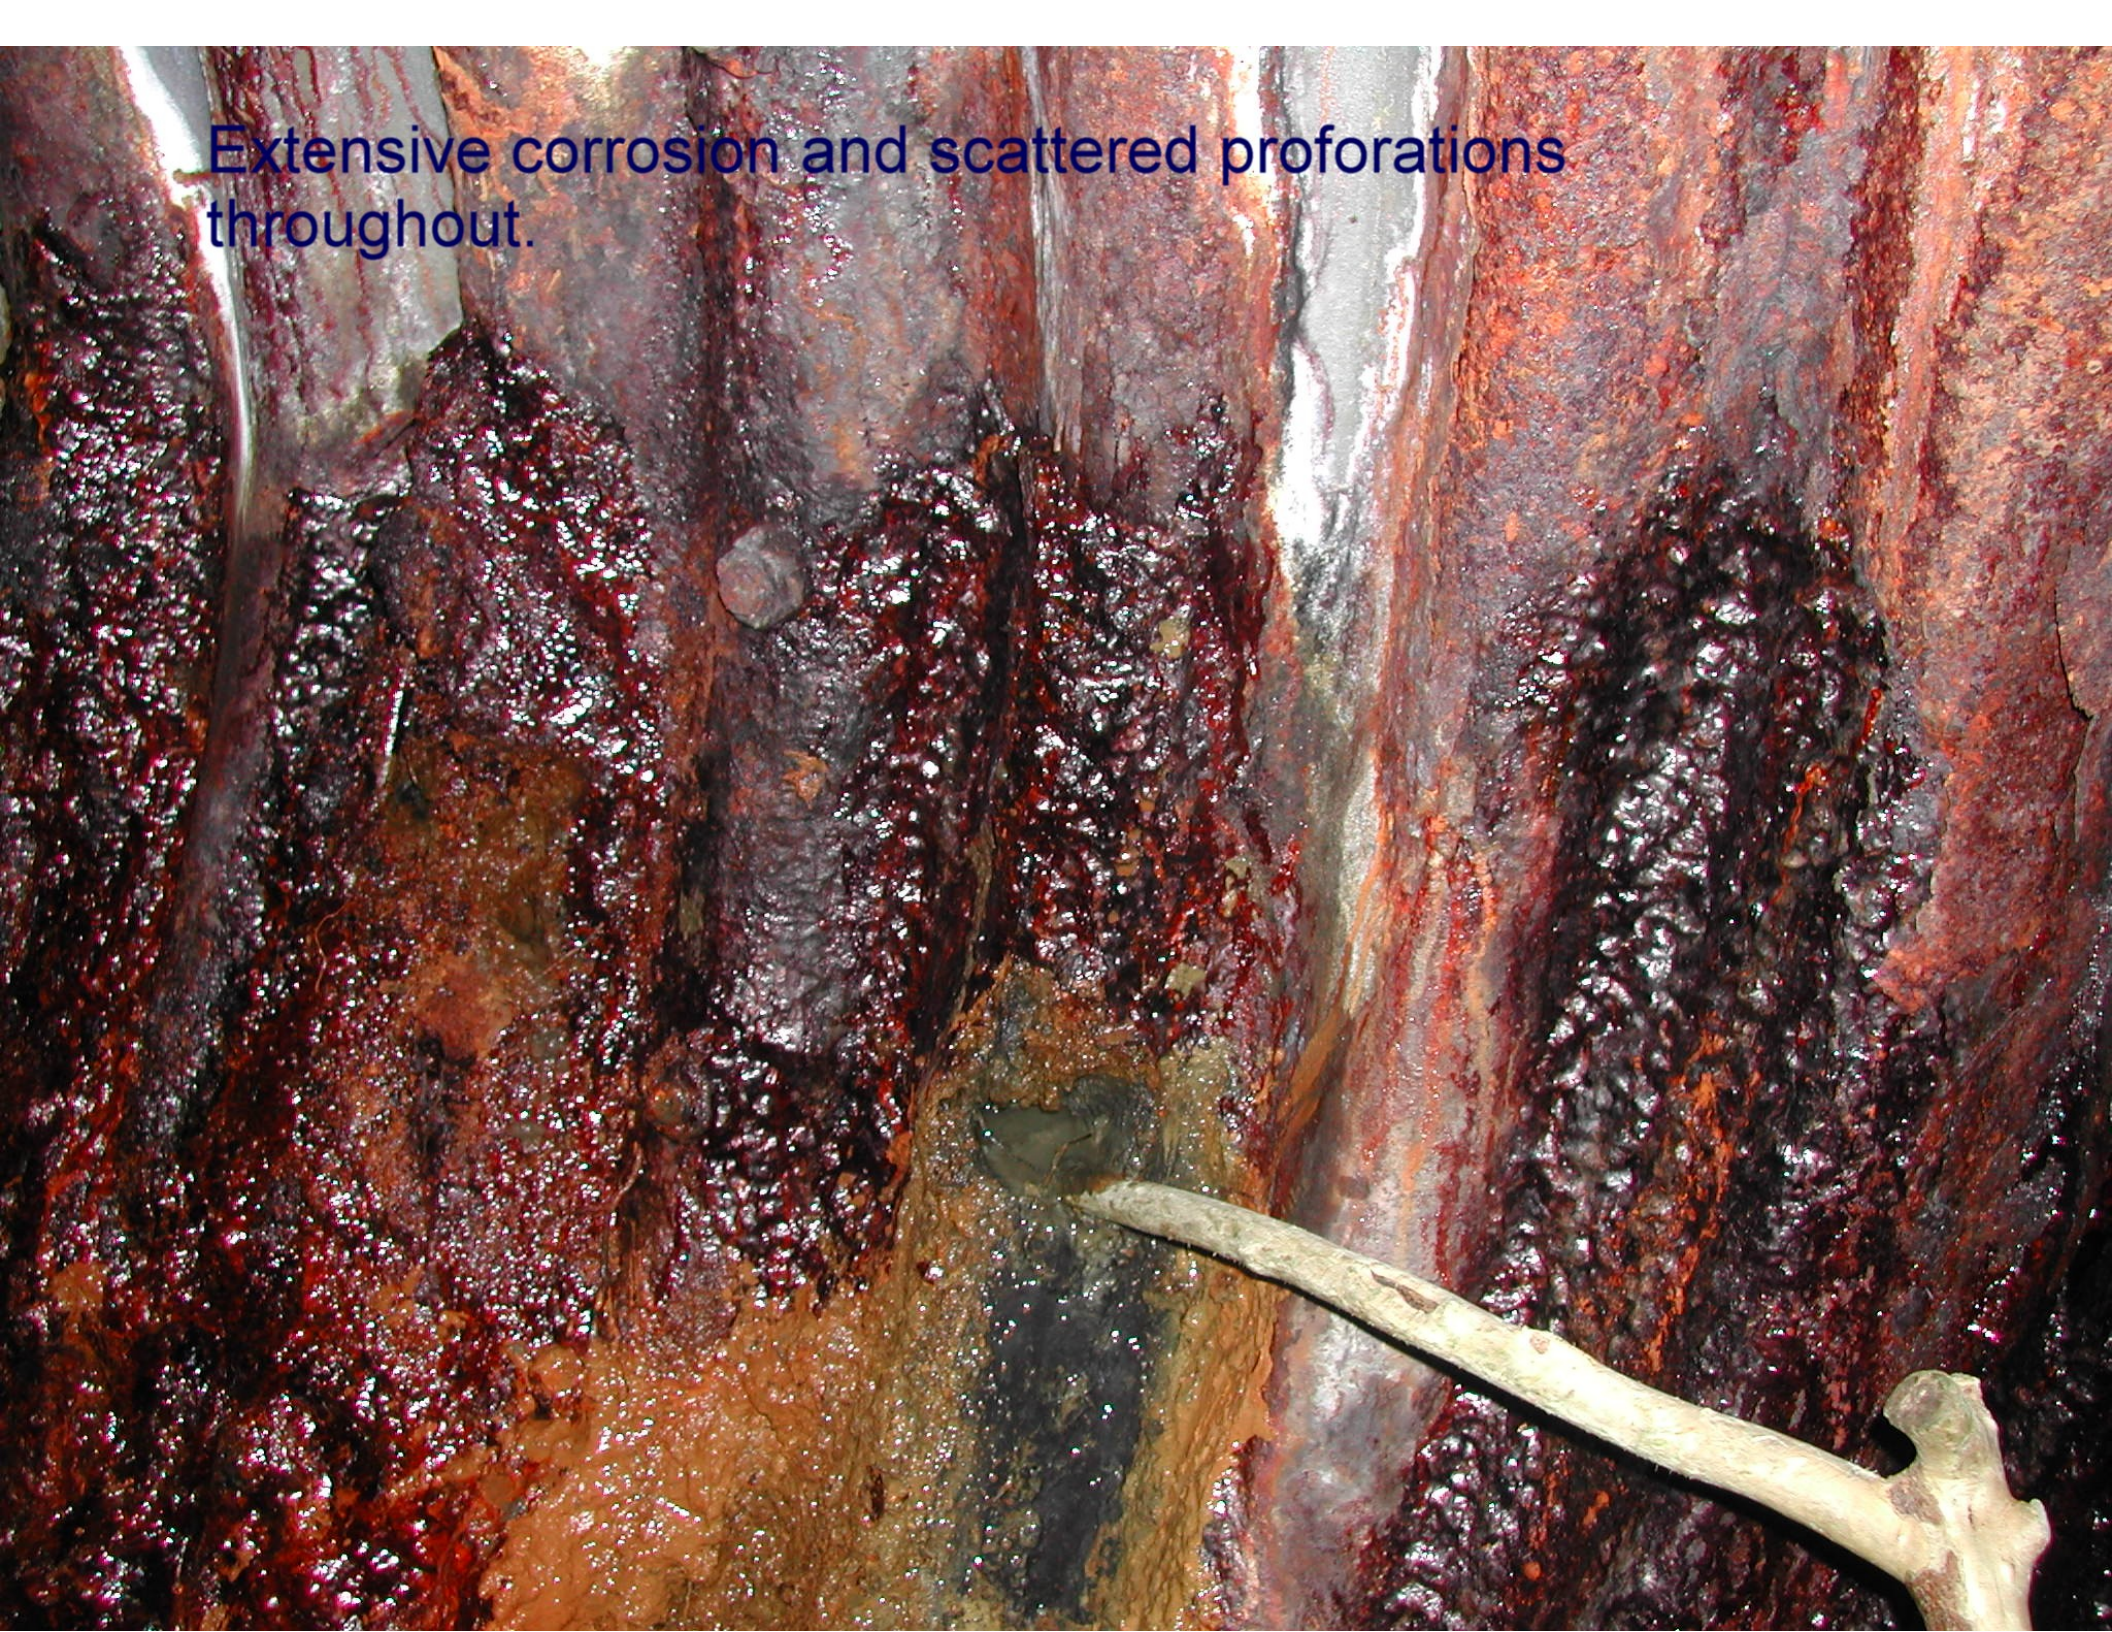
Extensive corrosion and scattered perforations throughout.
