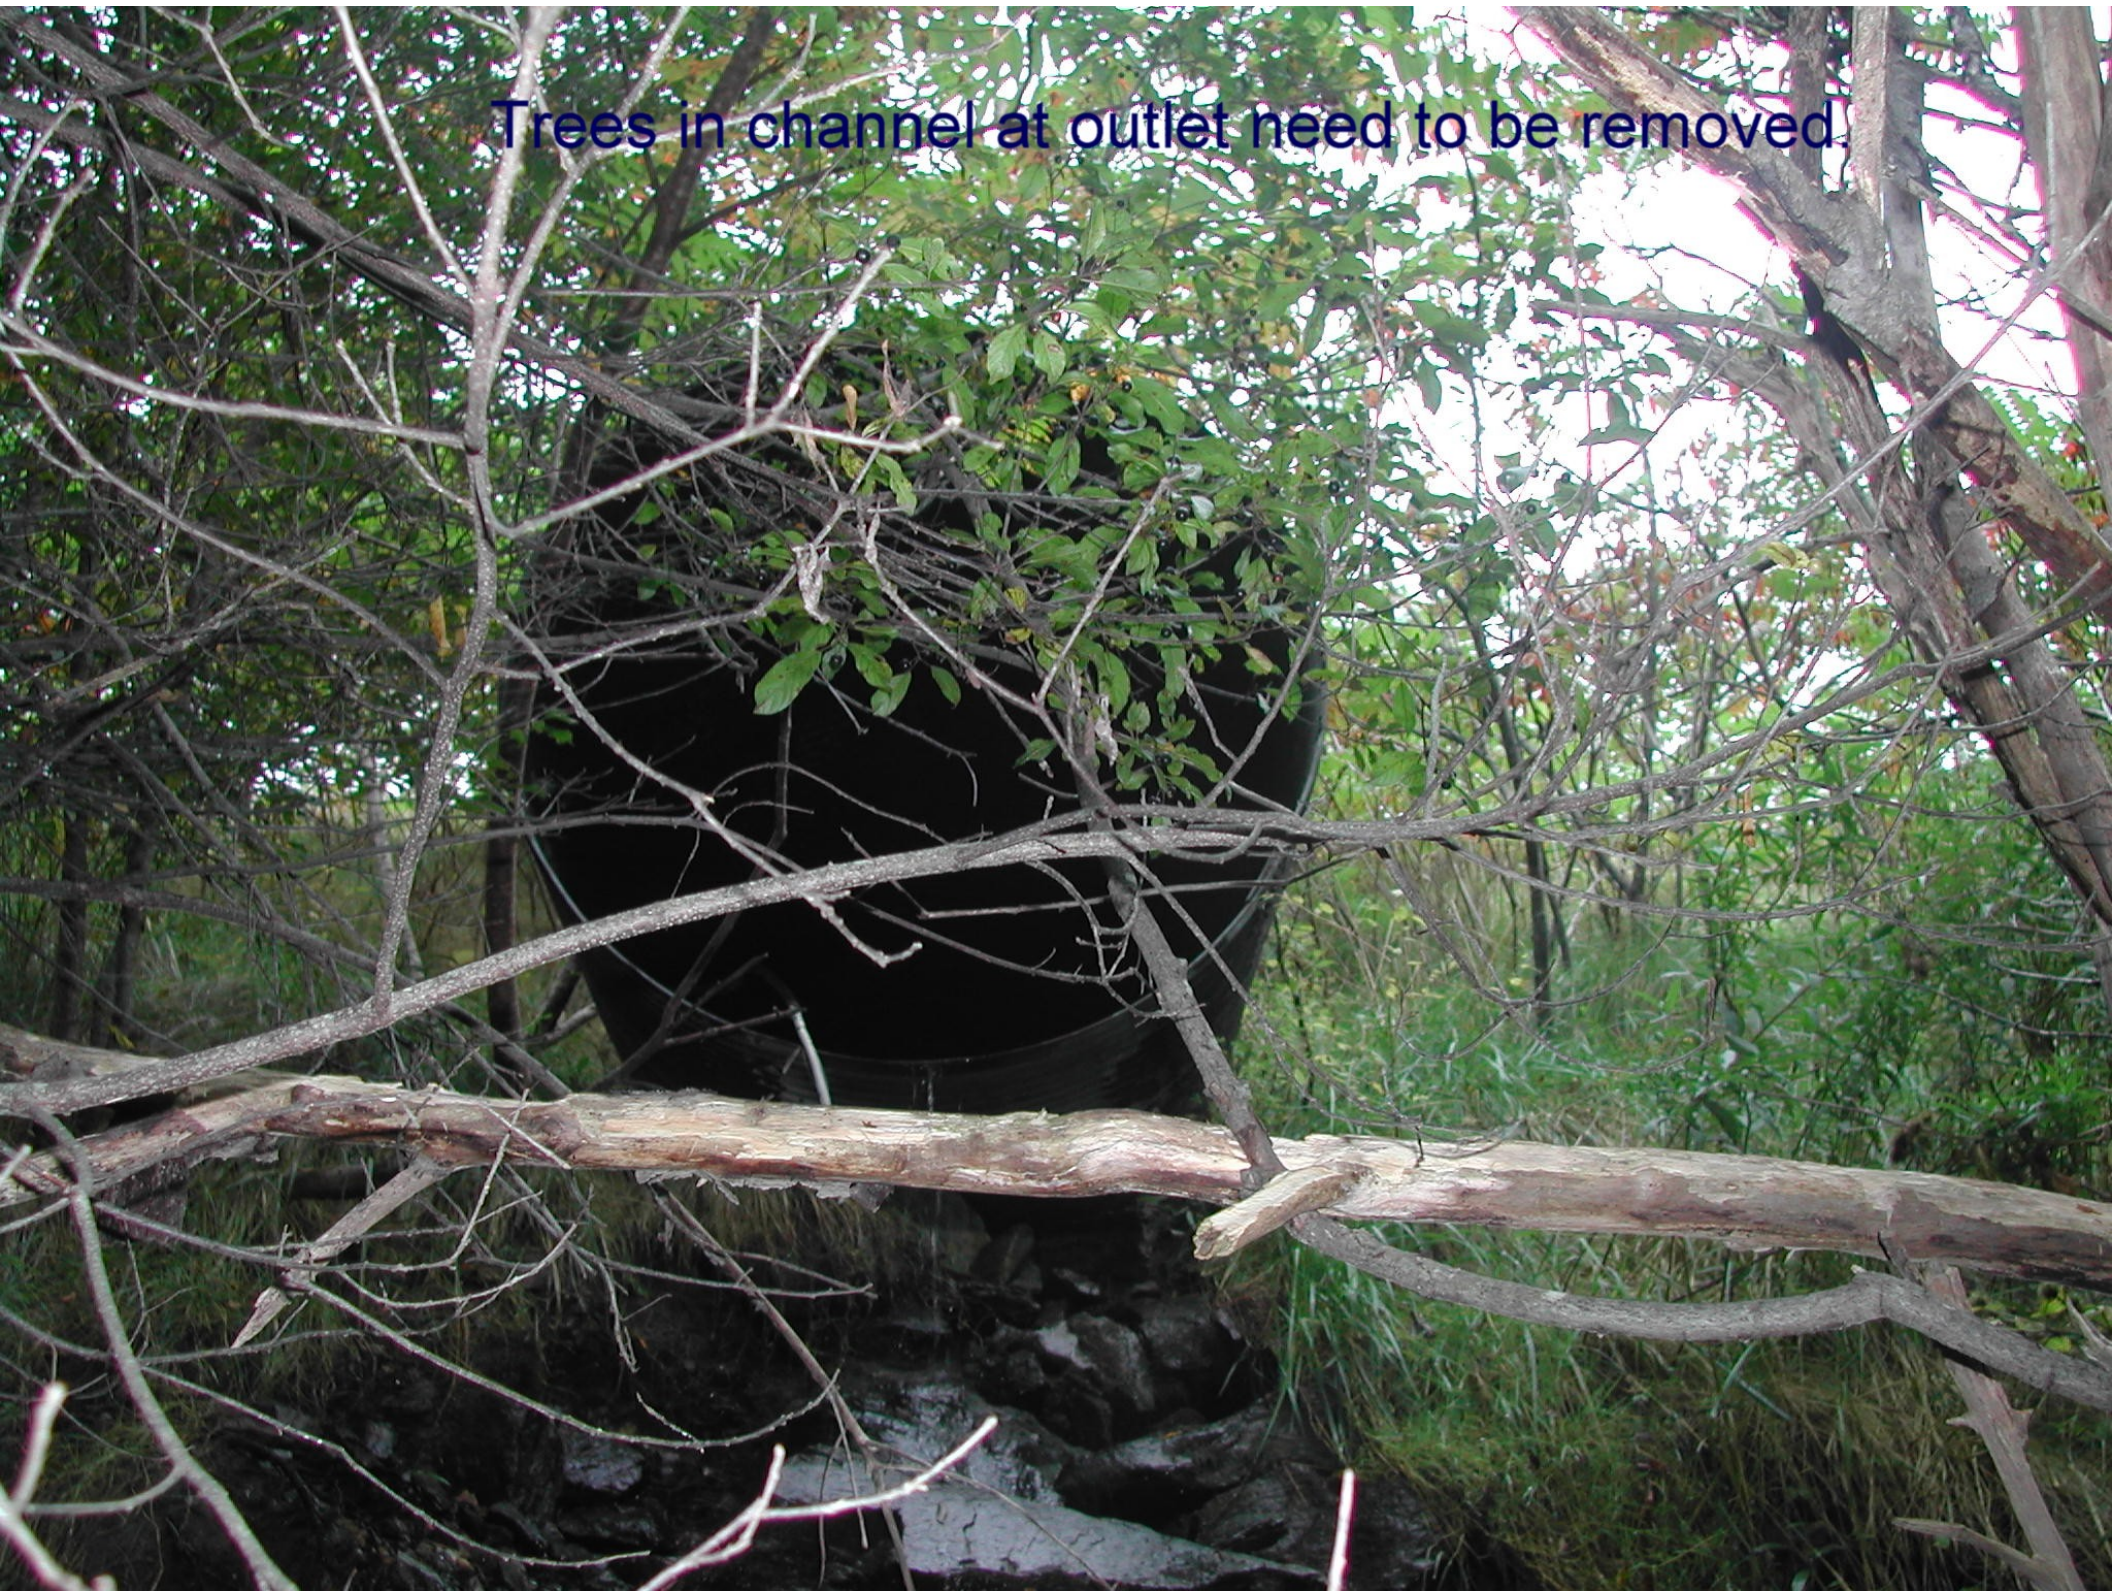
Trees in channel at outlet need to be removed.
