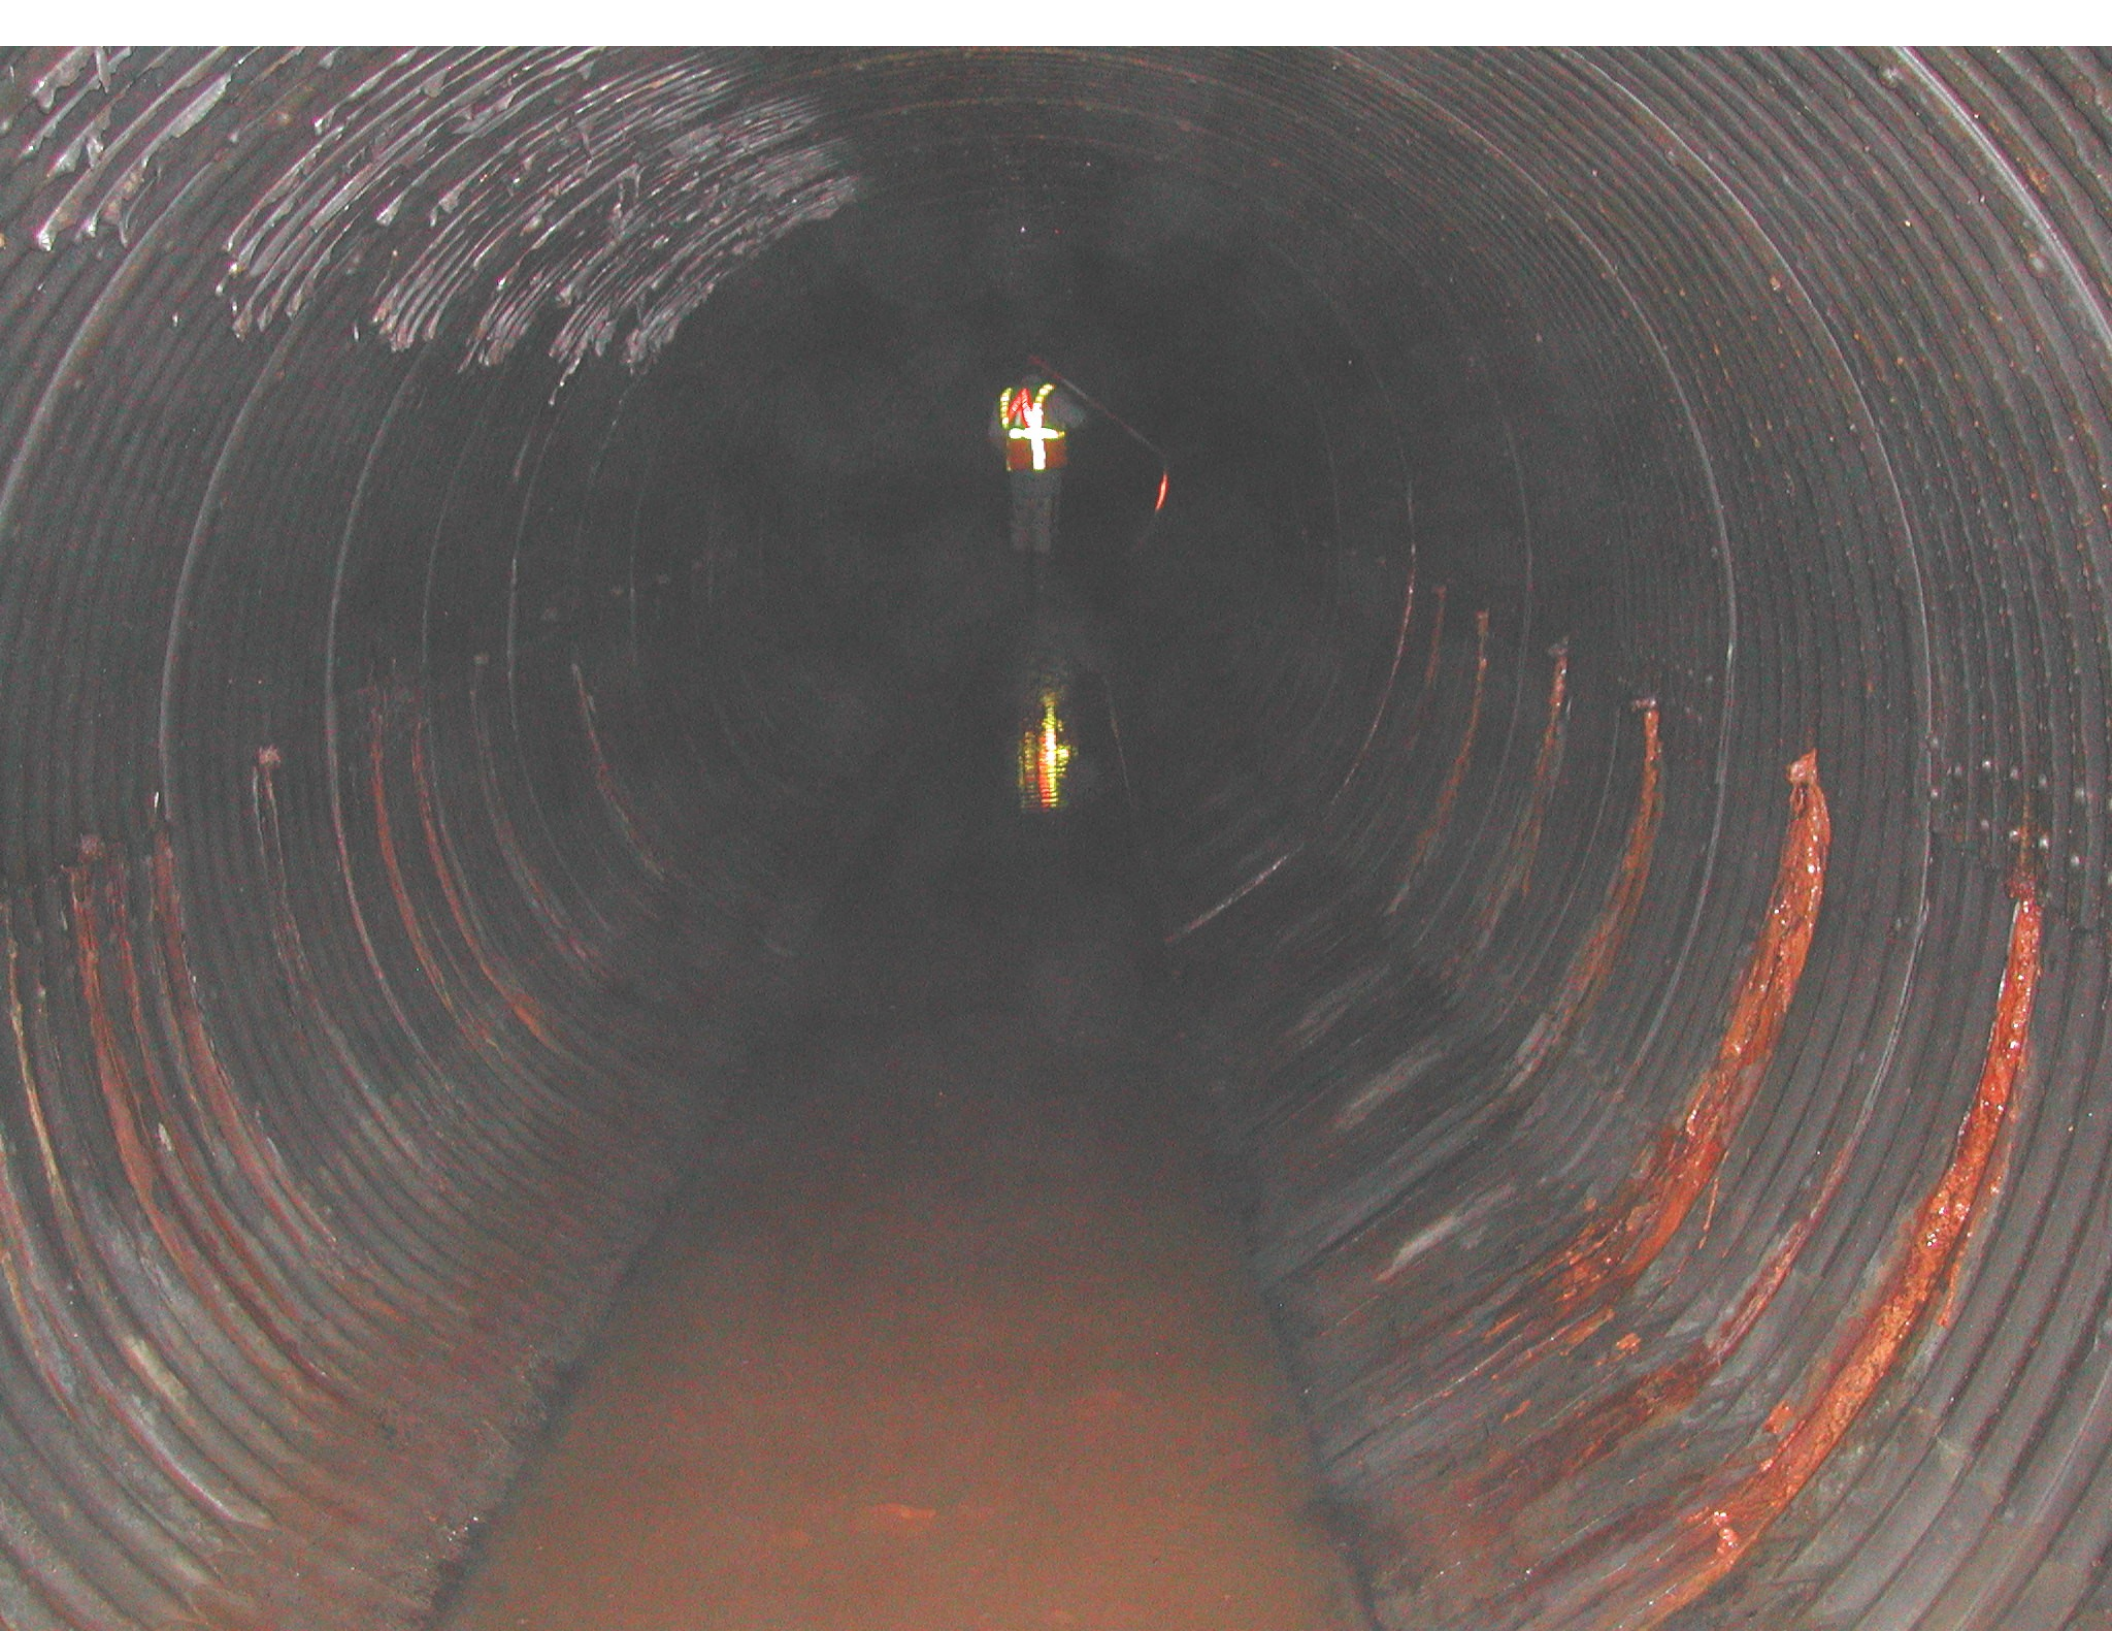
Heavy corrosion throughout pipe.

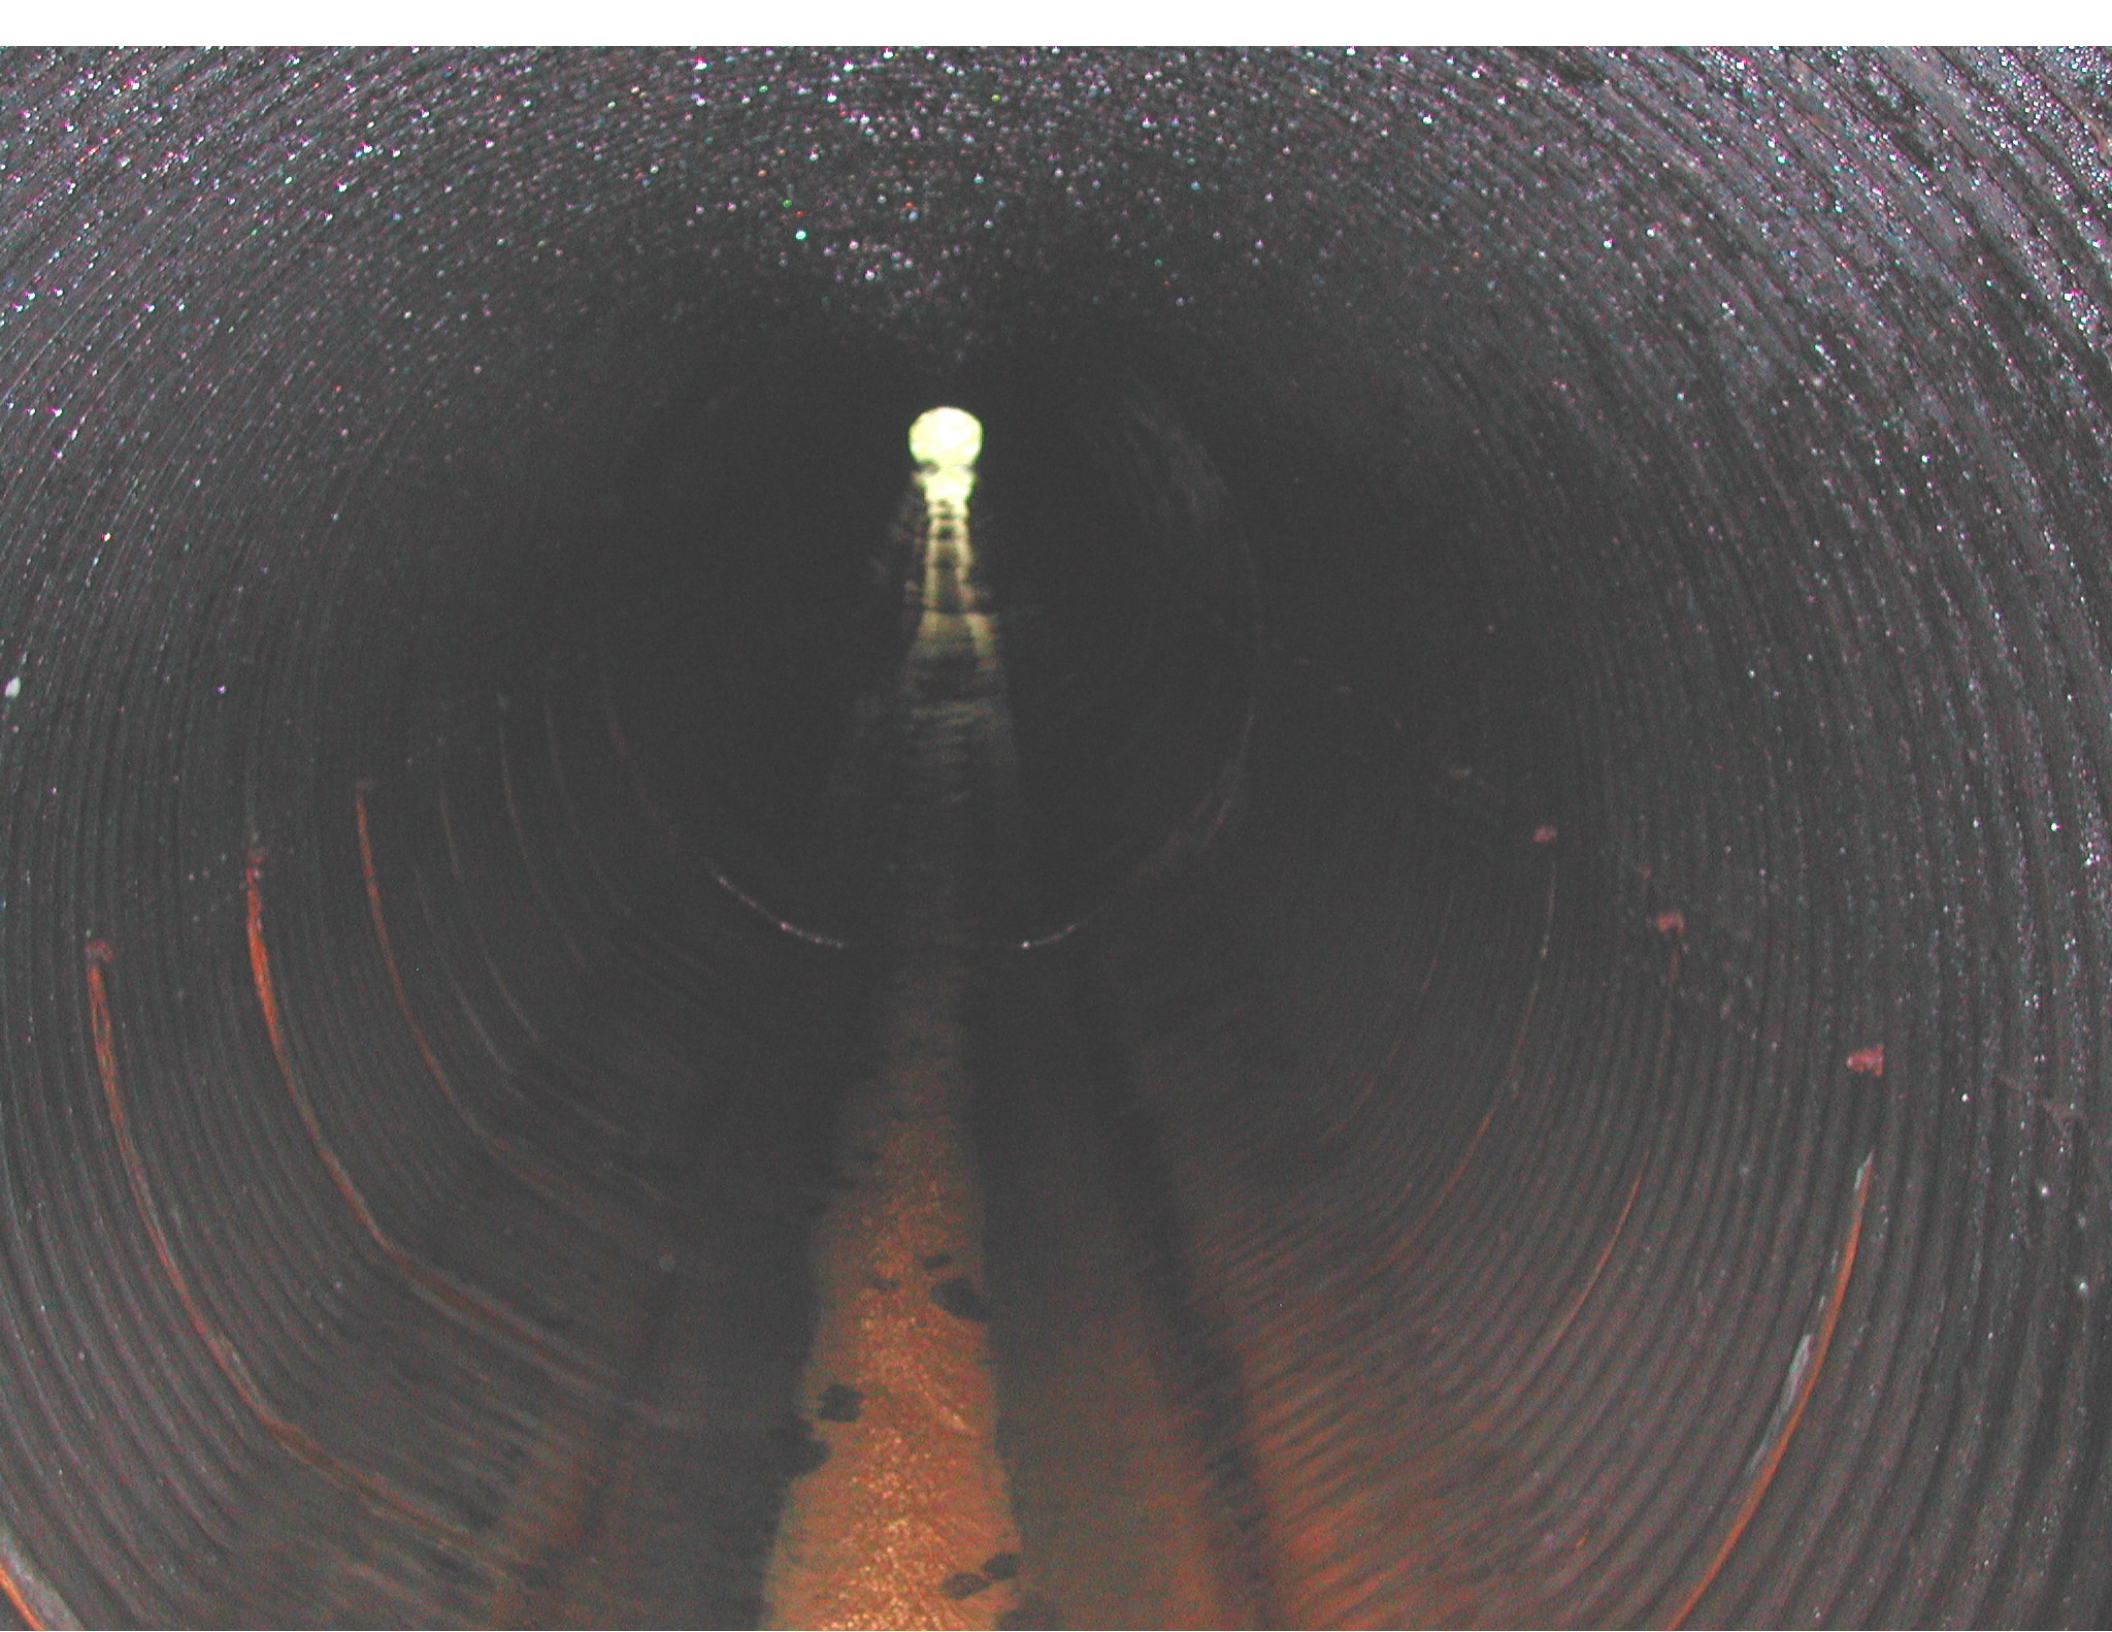
Creddie headwall at inlet should be anchored and erosion repaired.
