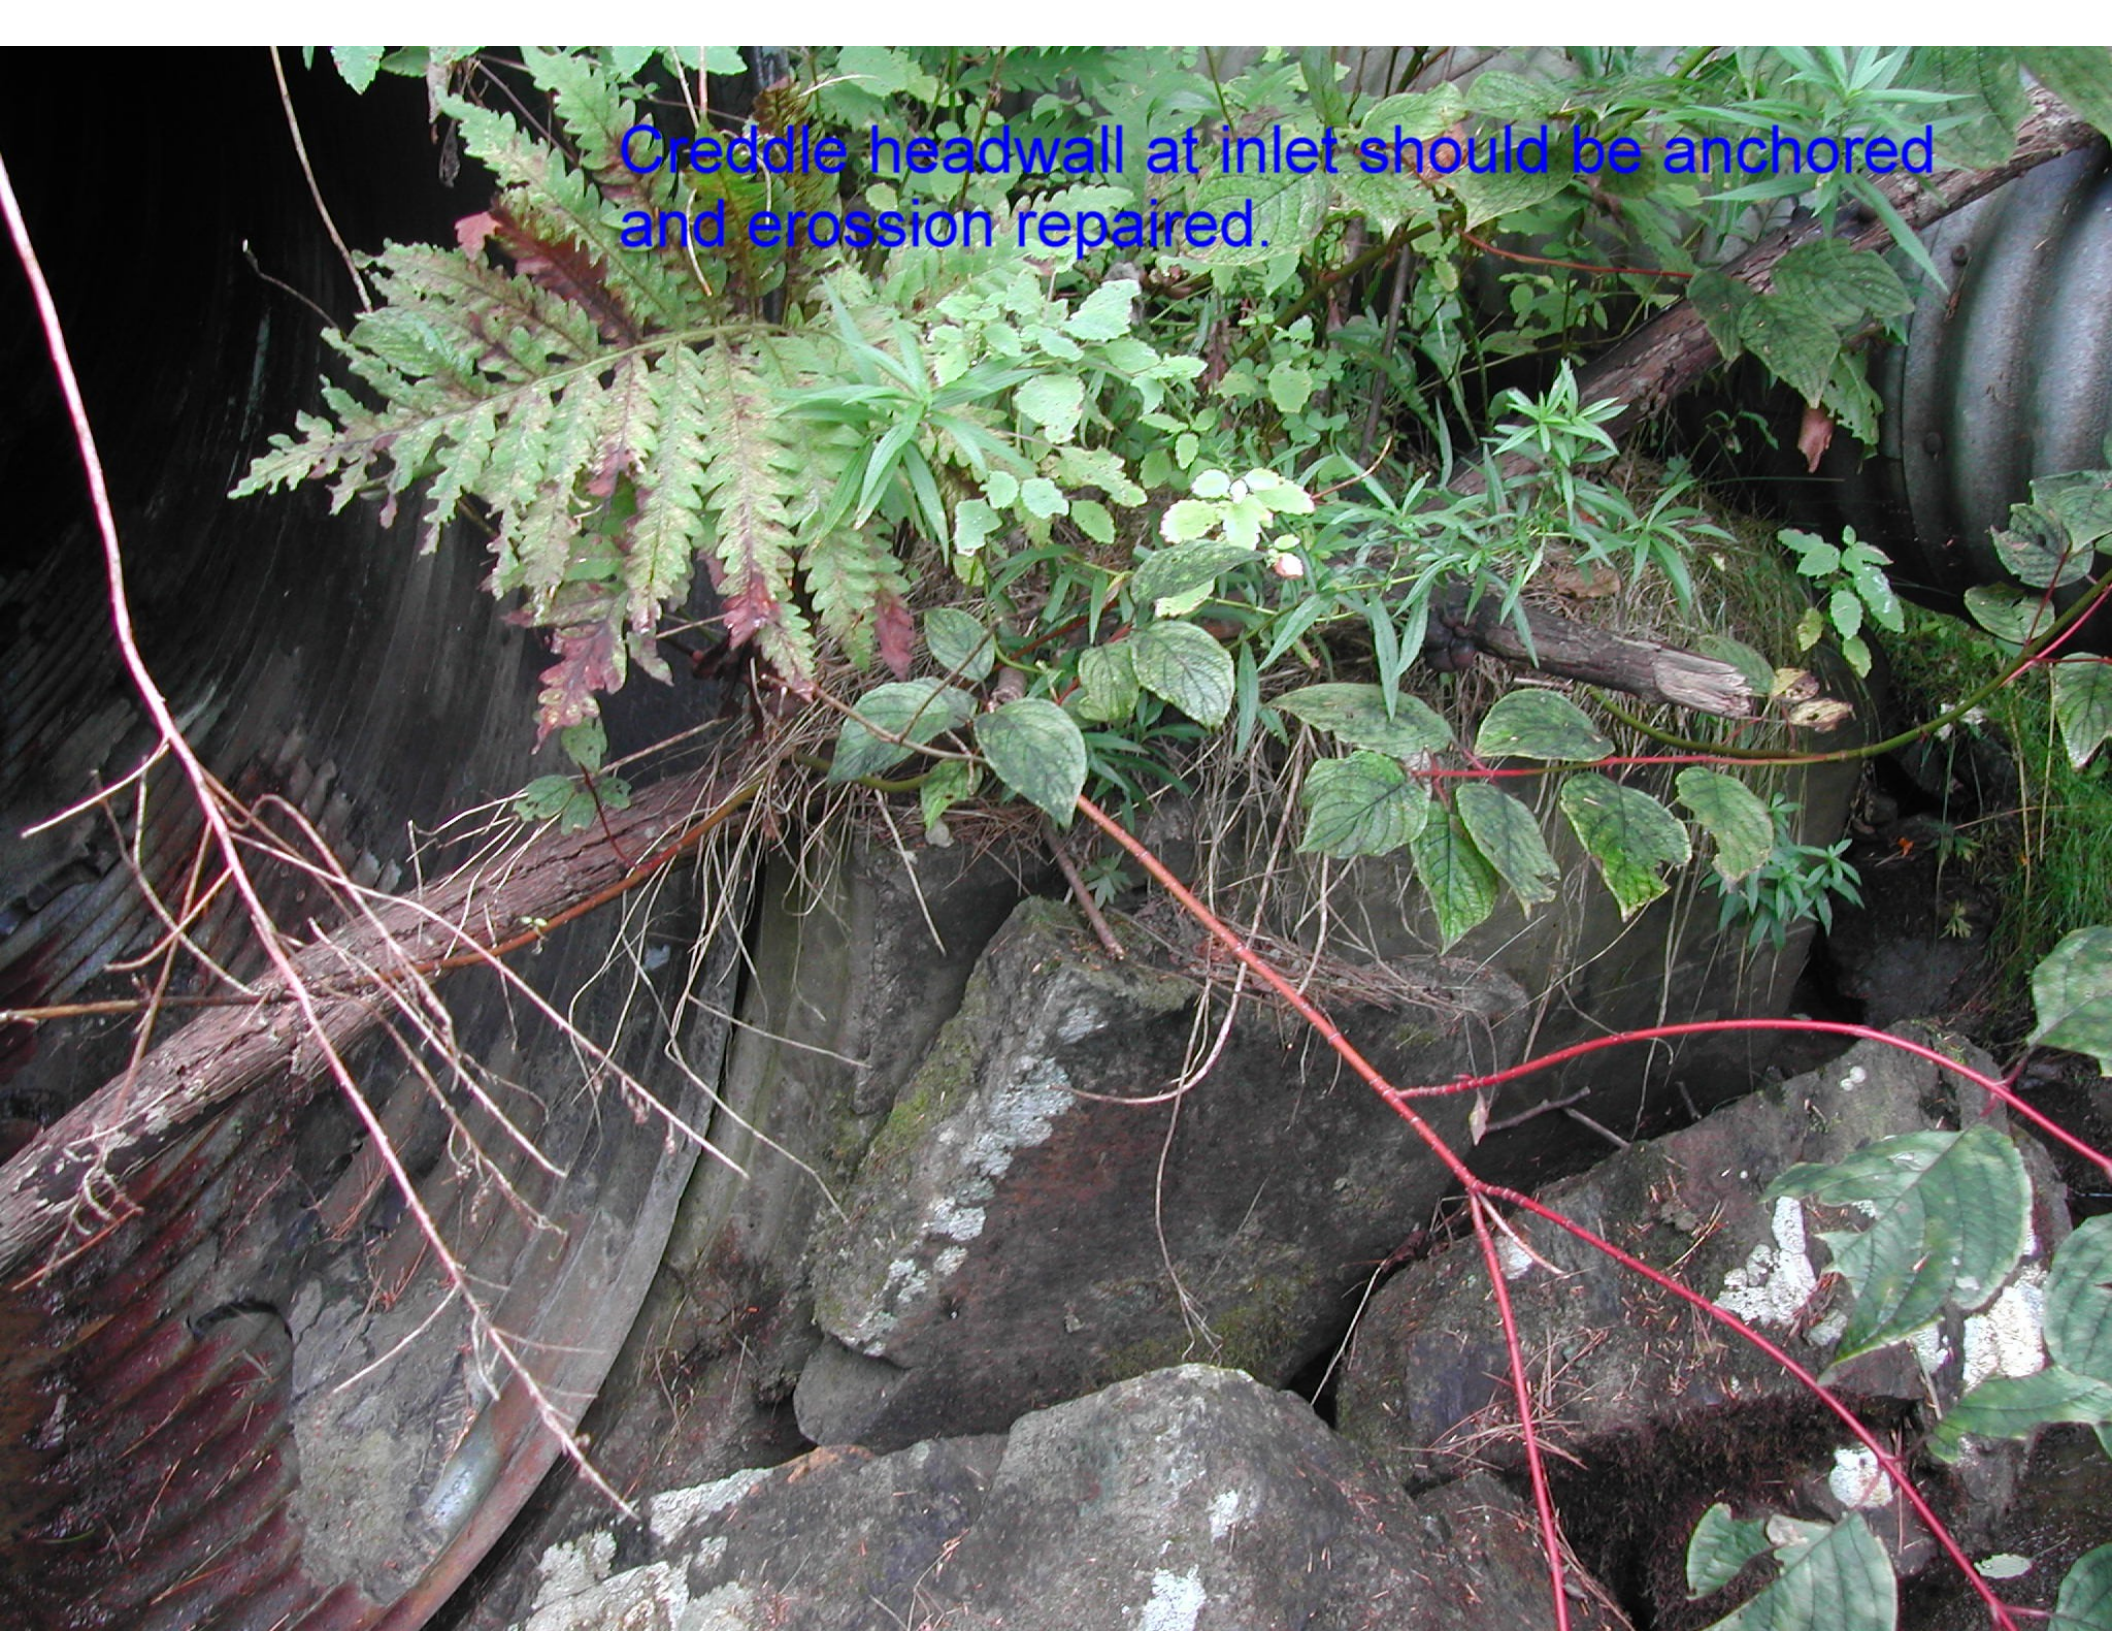
Creddie headwall at inlet should be anchored and erosion repaired.
