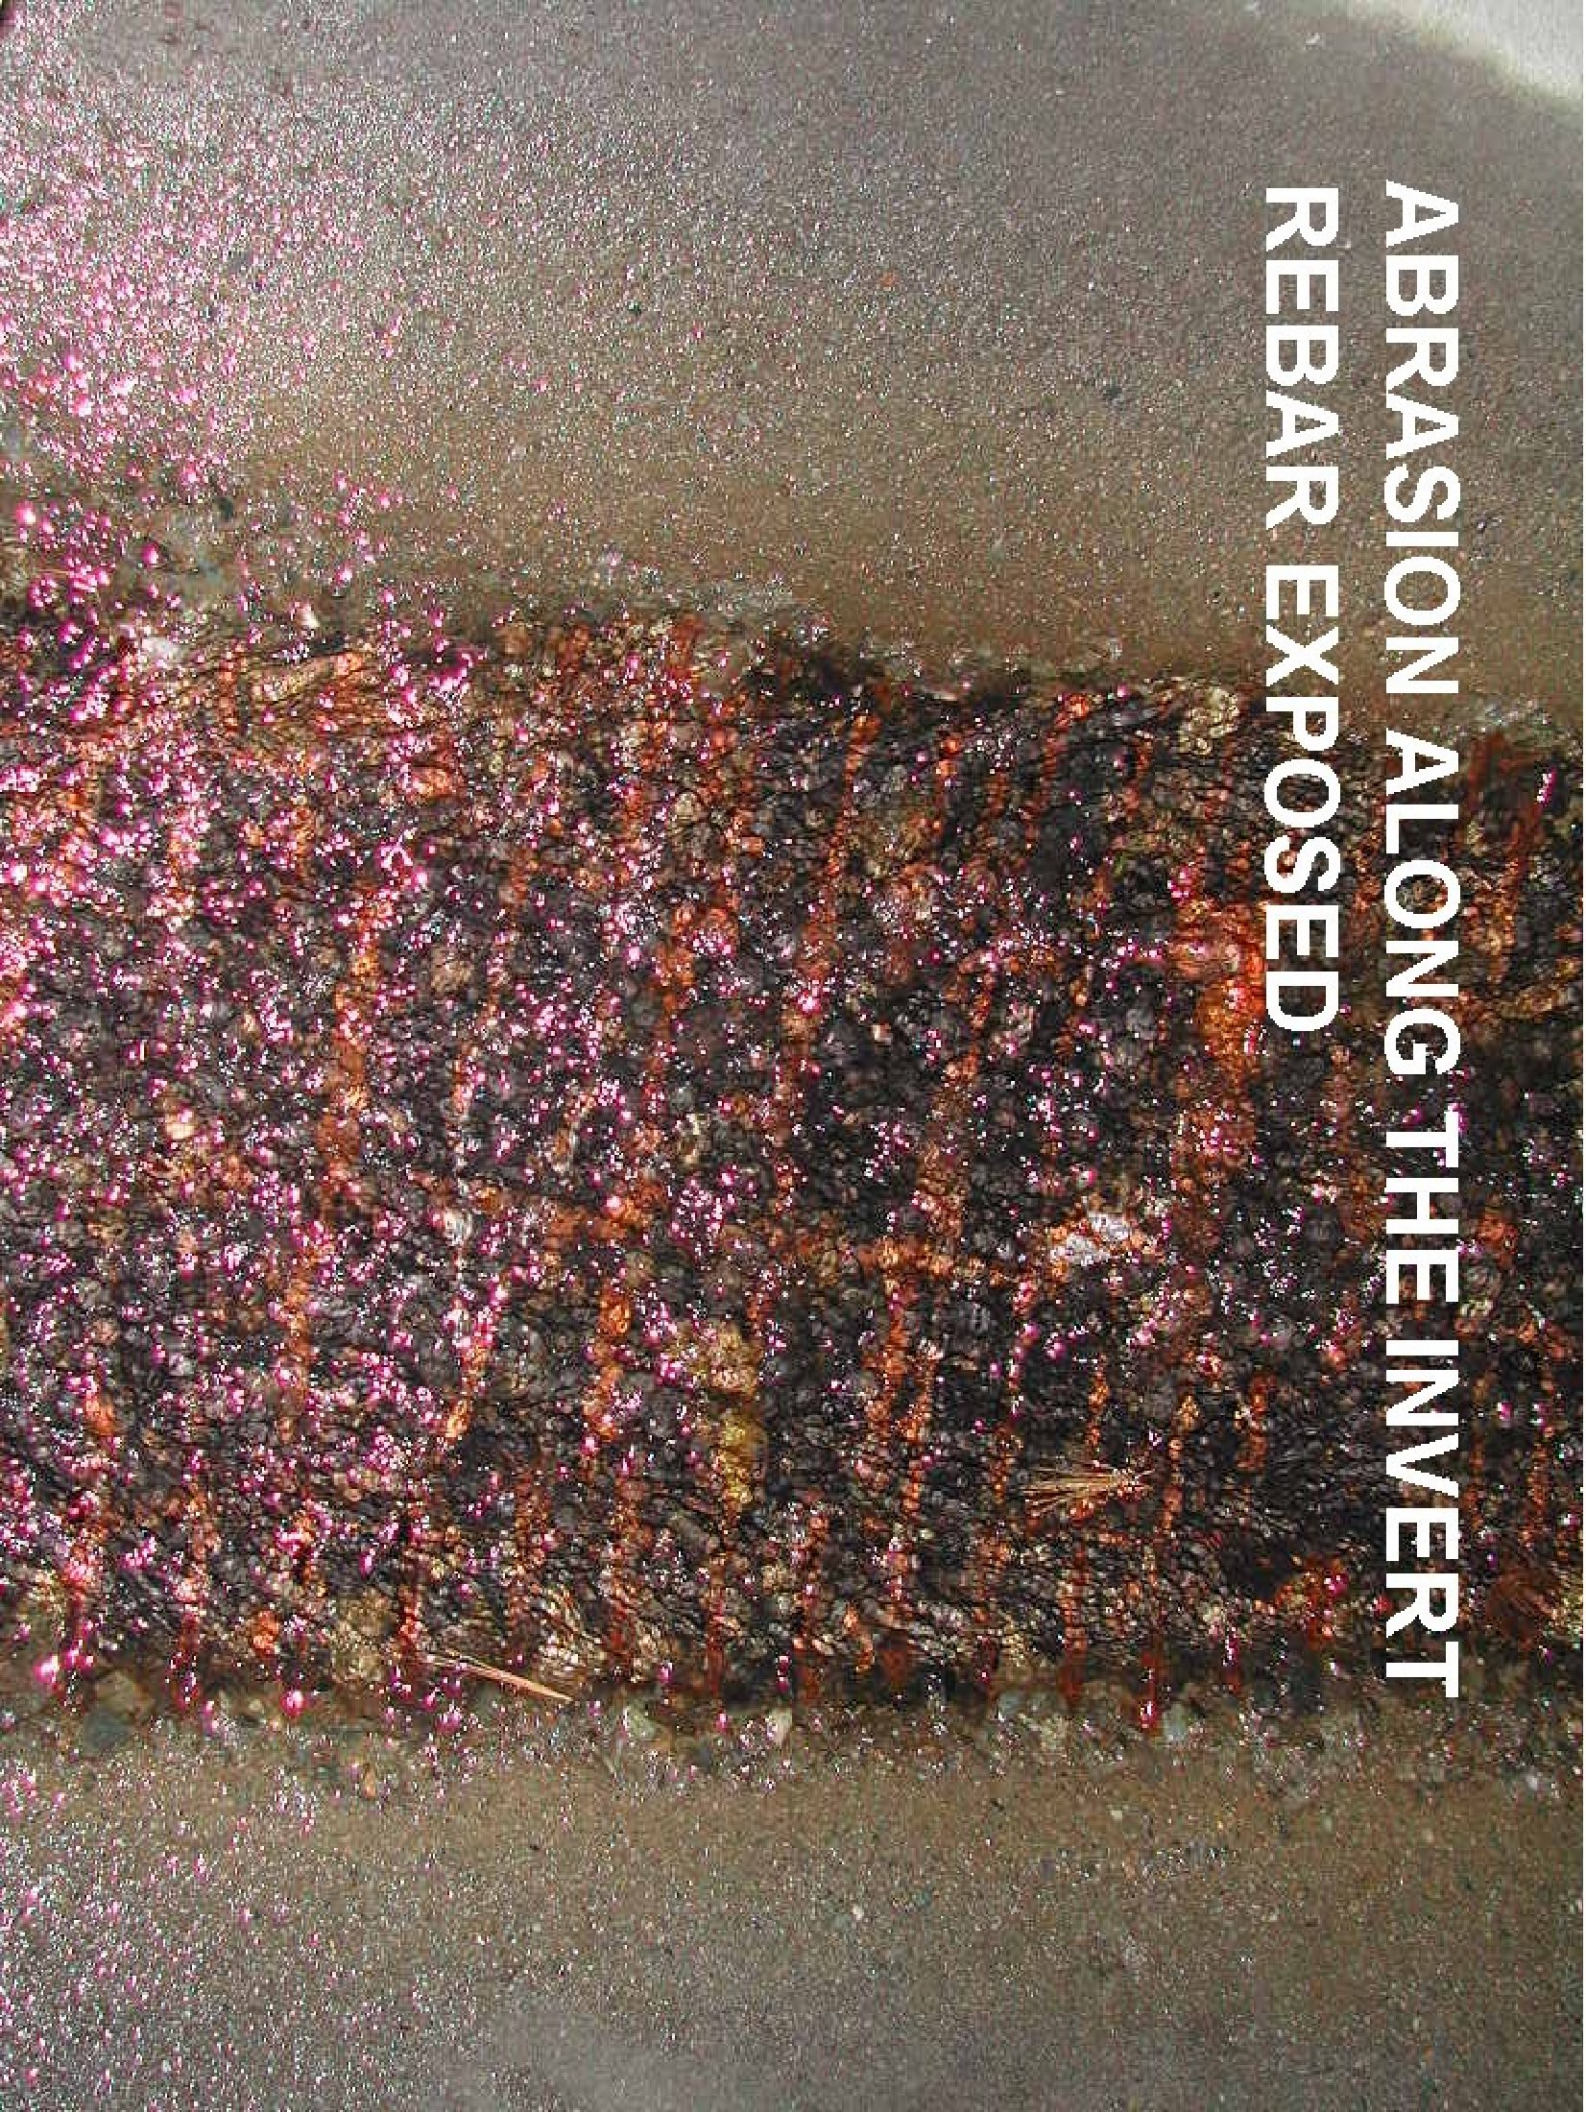
**ABRASION ALONG THE INVERT
REBAR EXPOSED**
