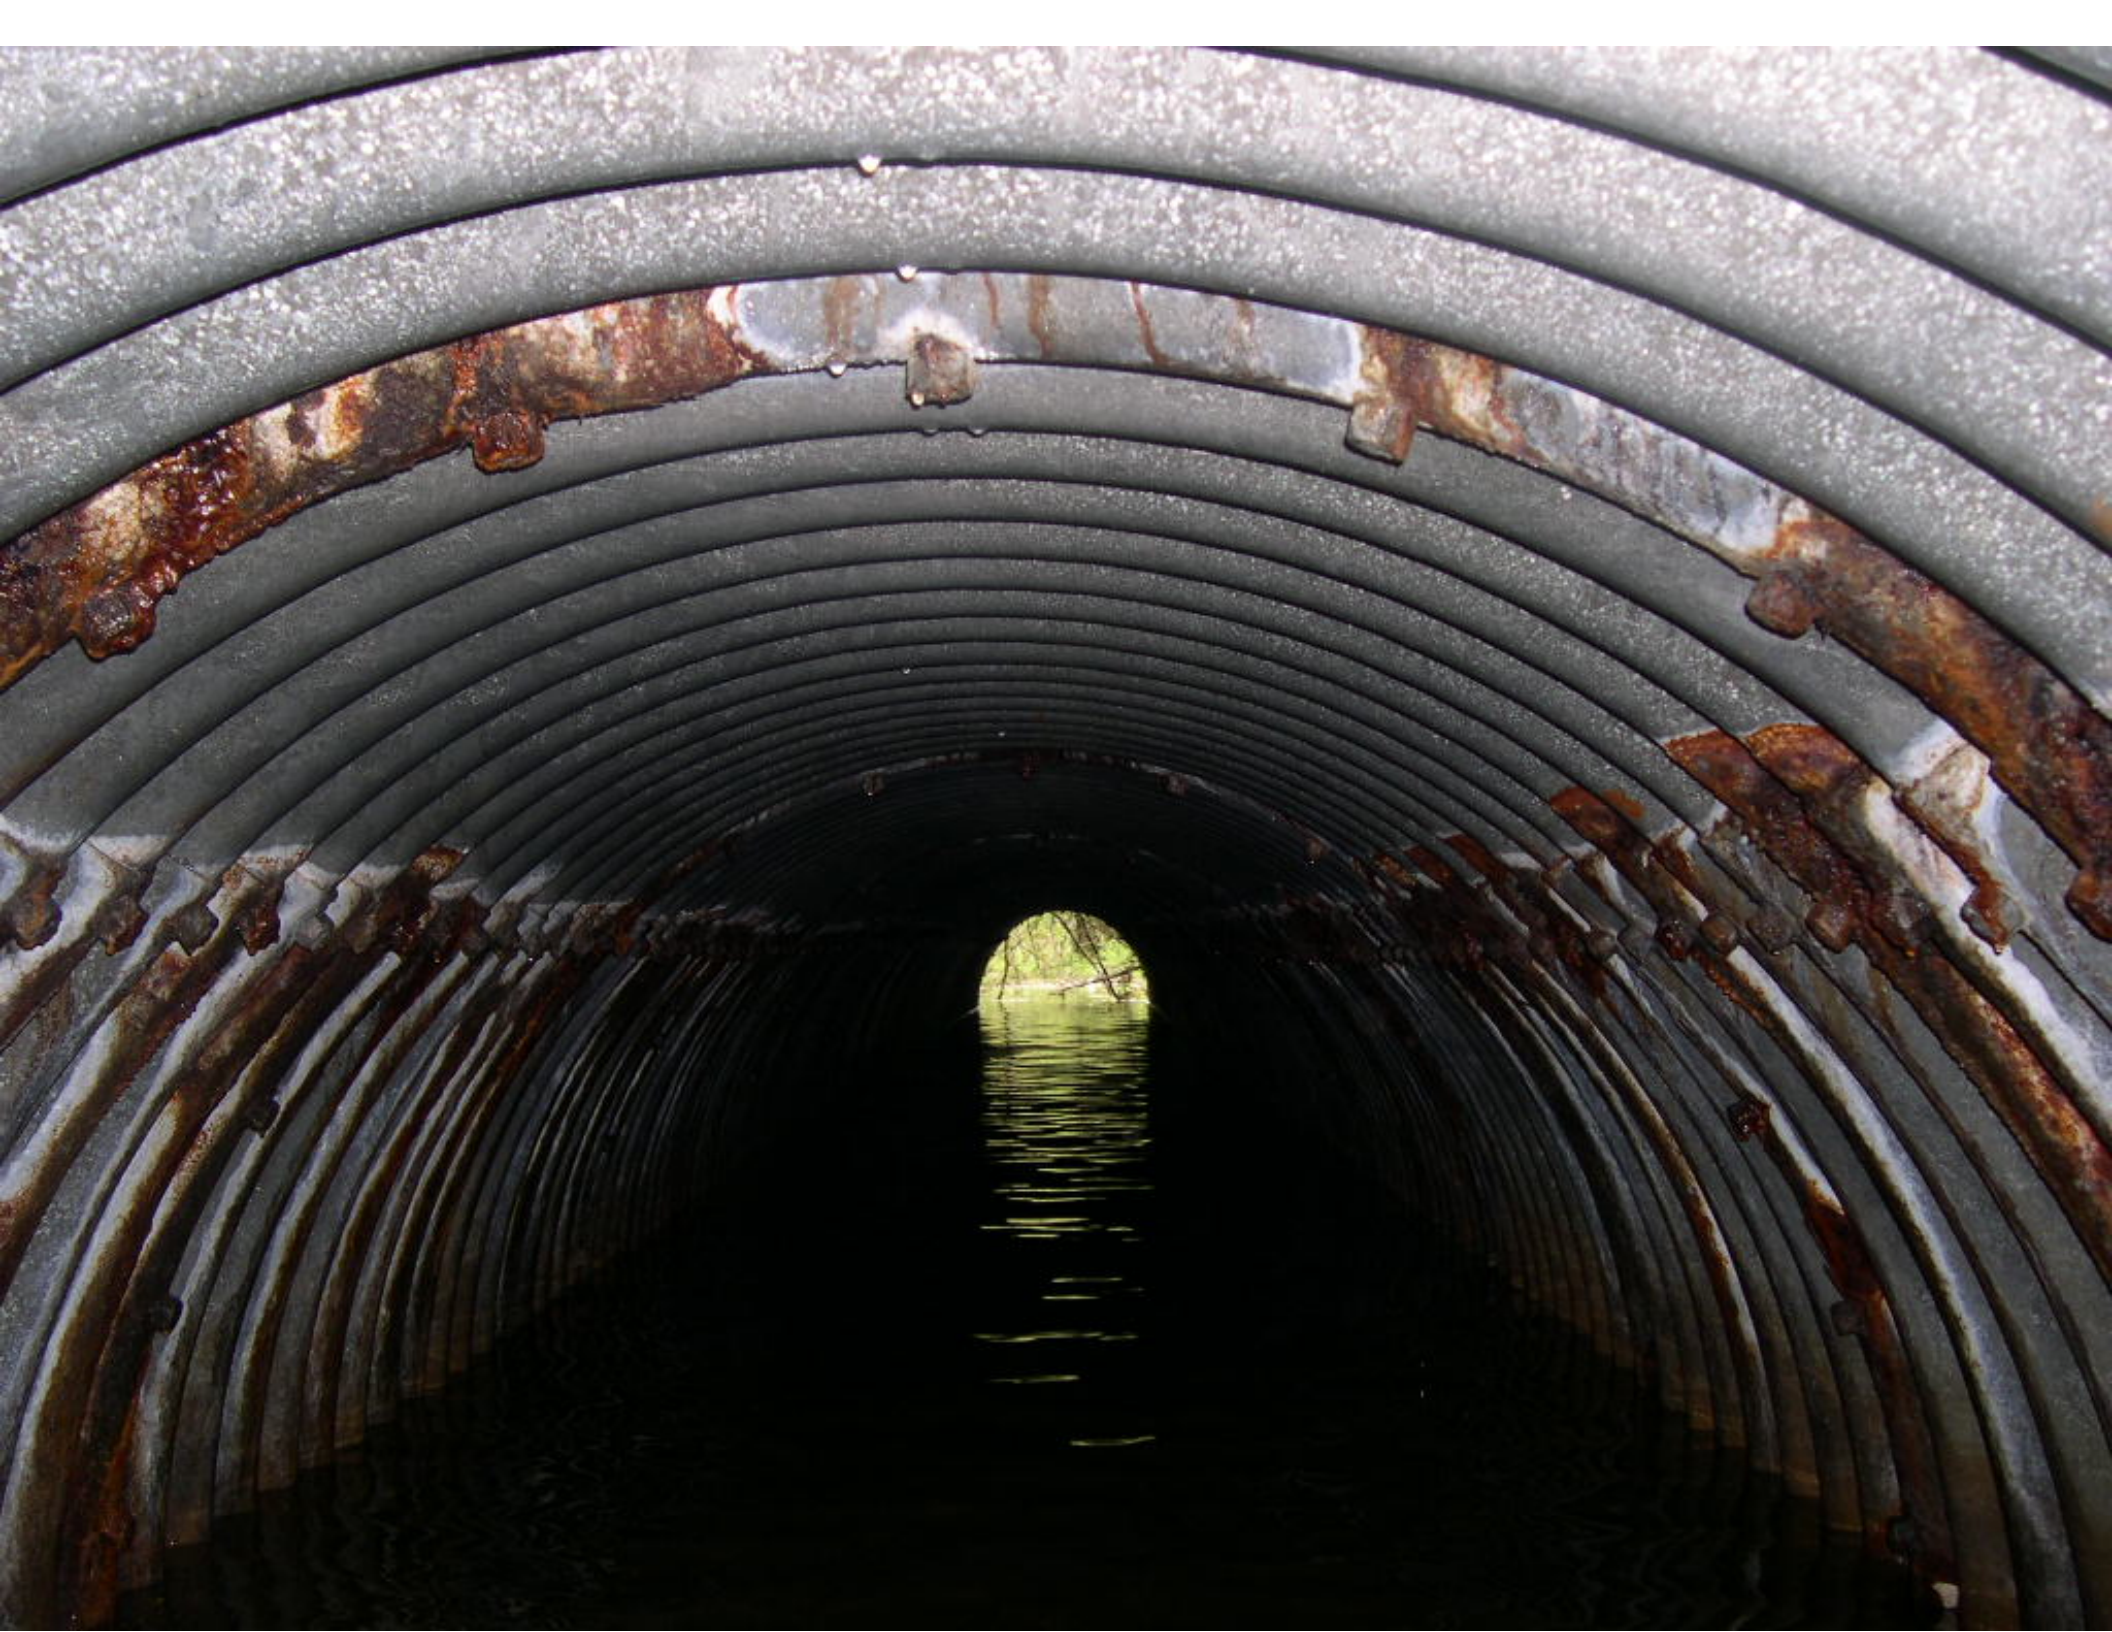
Minor corrosion throughout.
