113

450.  
NEW TANK - BENT. SAG

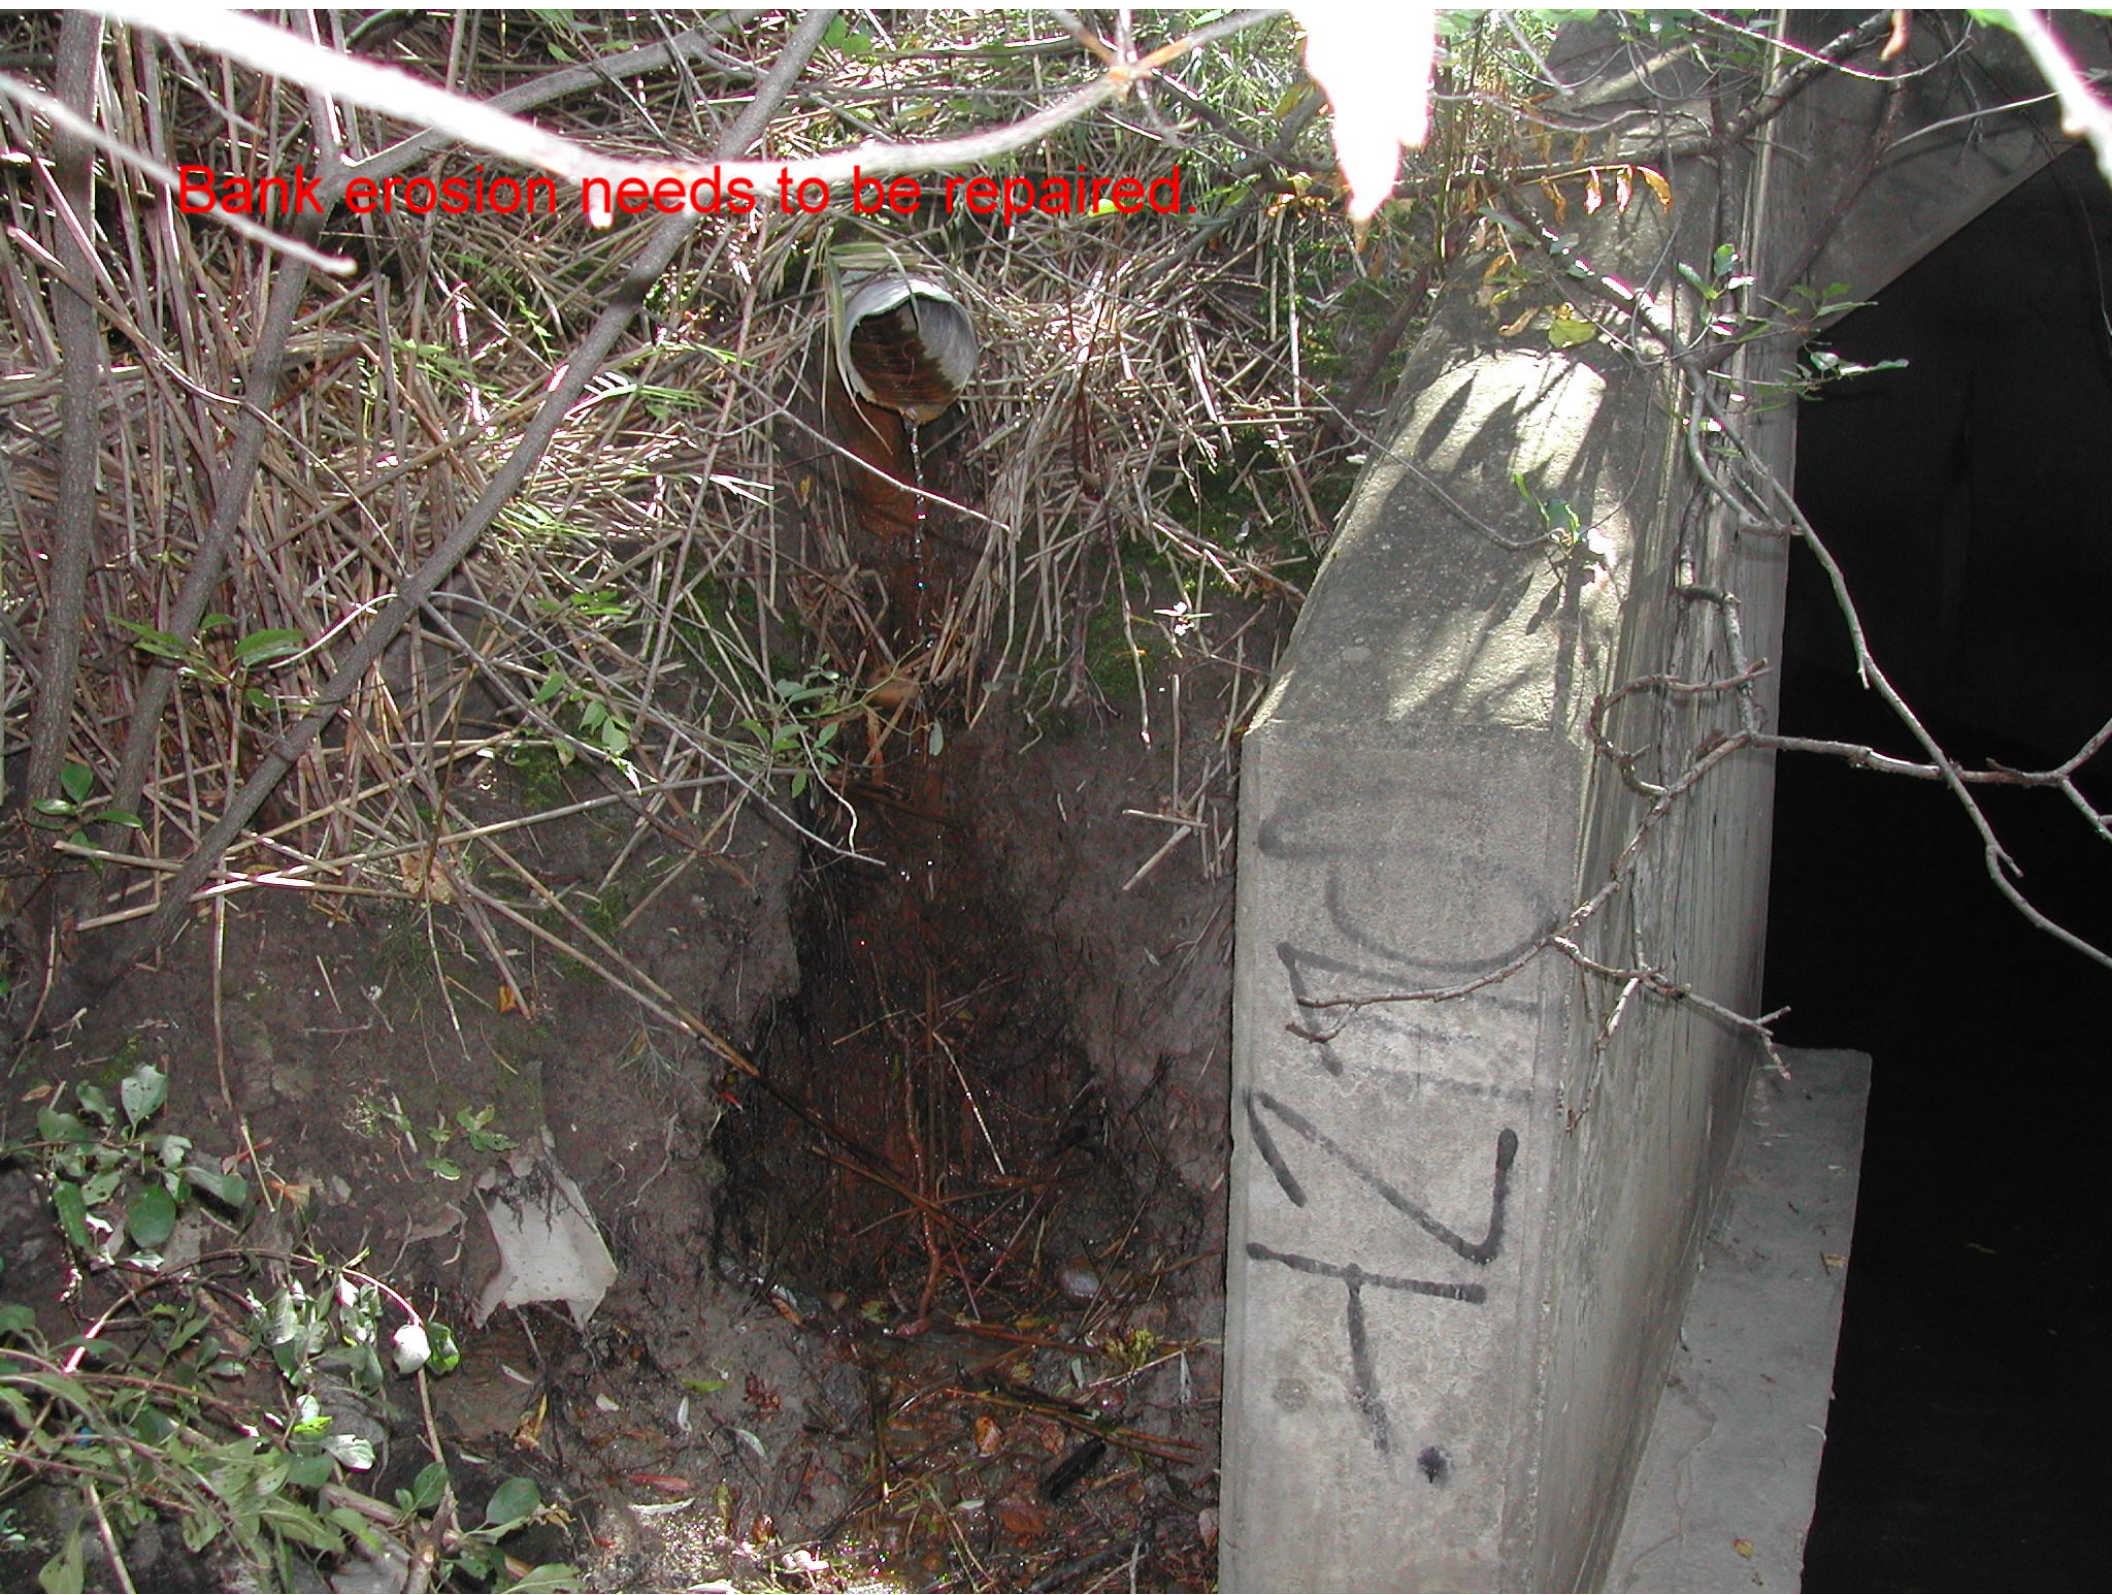
Bank erosion needs to be repaired.

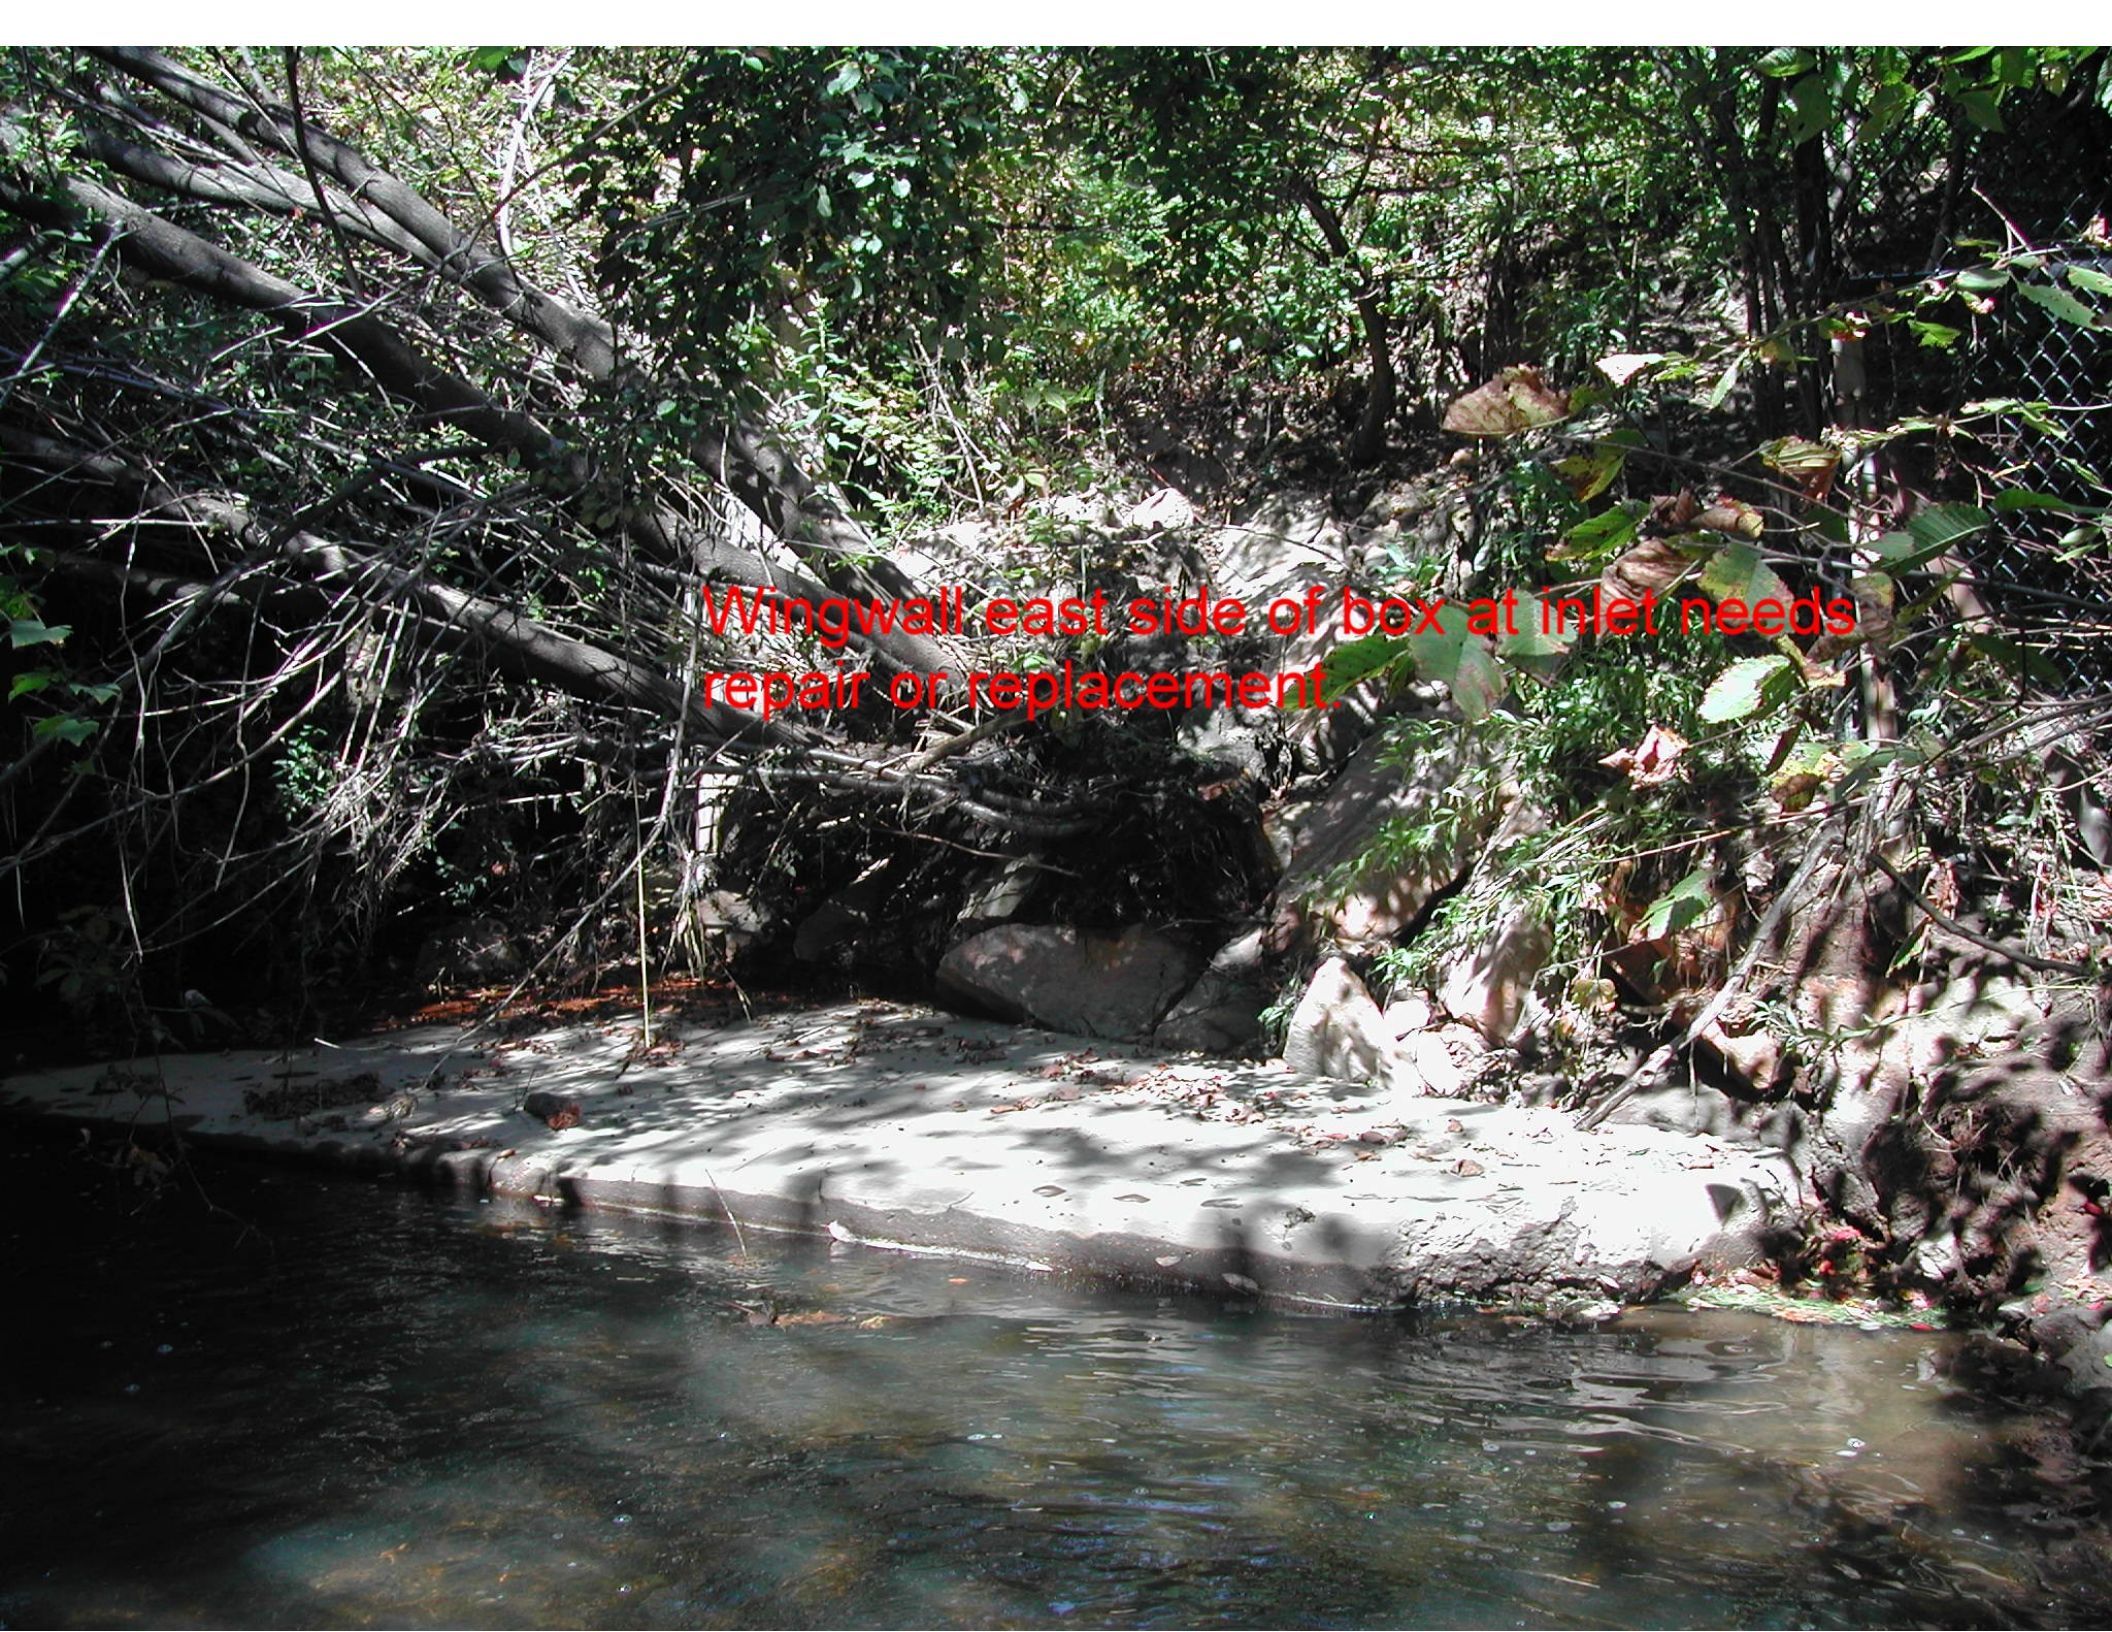
Wingwall east side of box at inlet needs repair or replacement.

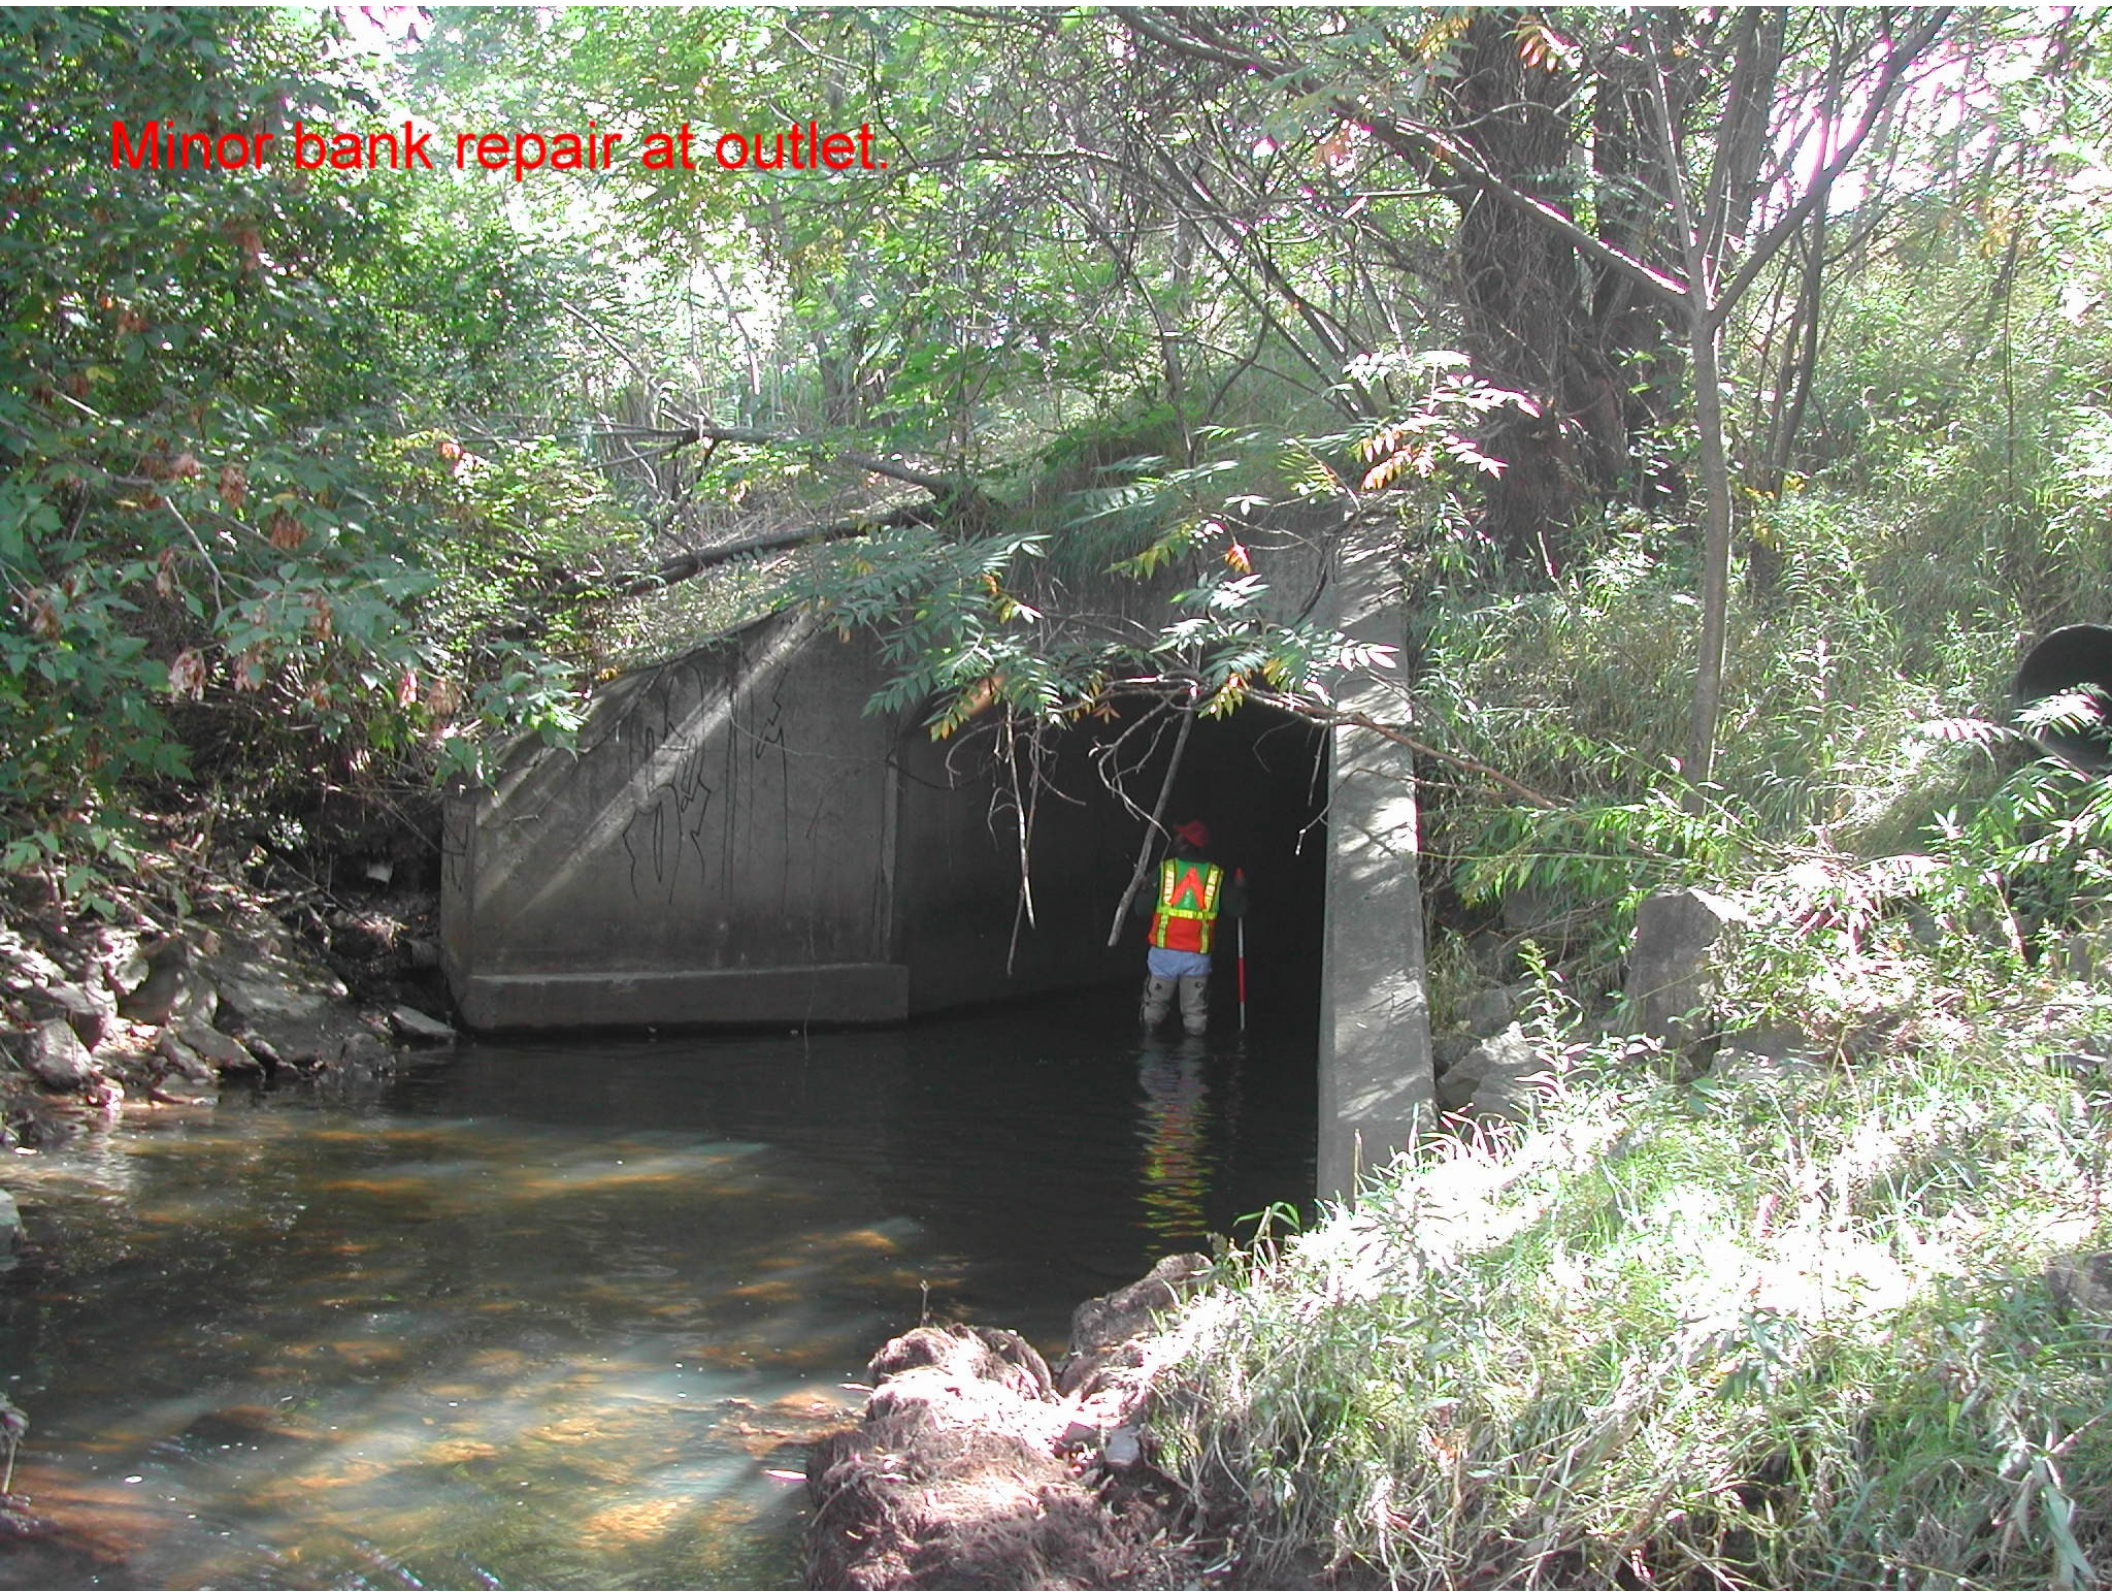
Minor bank repair at outlet.
