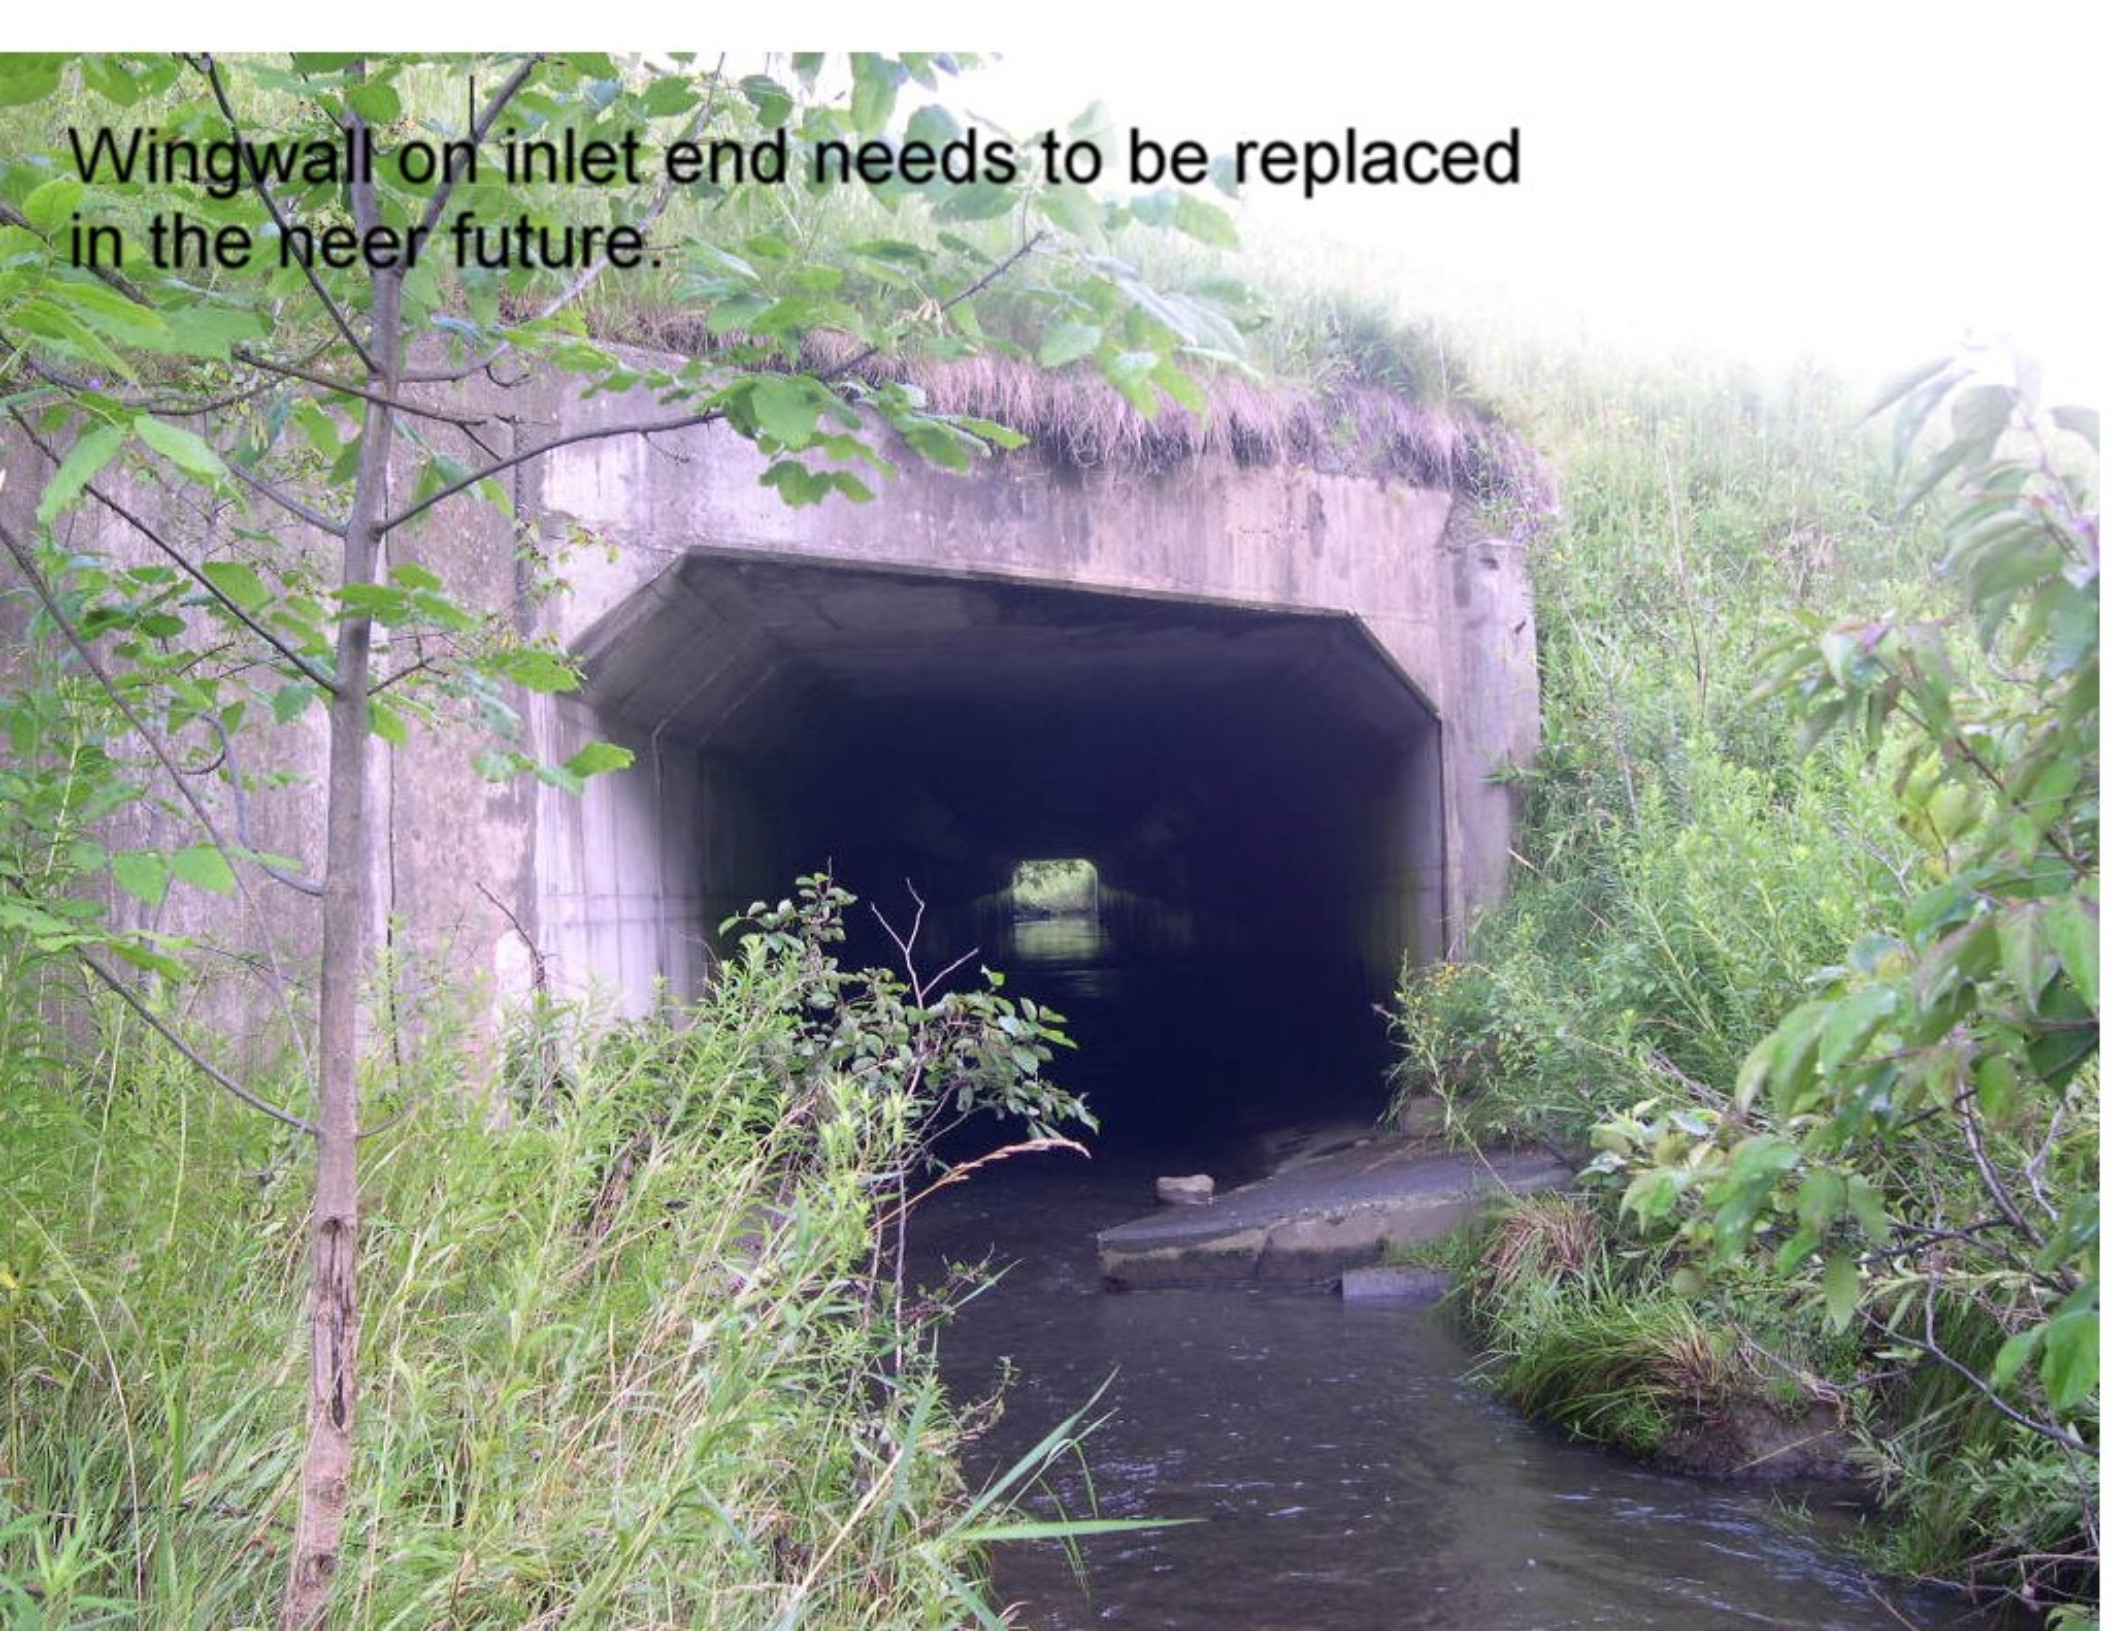
Wingwall on inlet end needs to be replaced in the near future.
