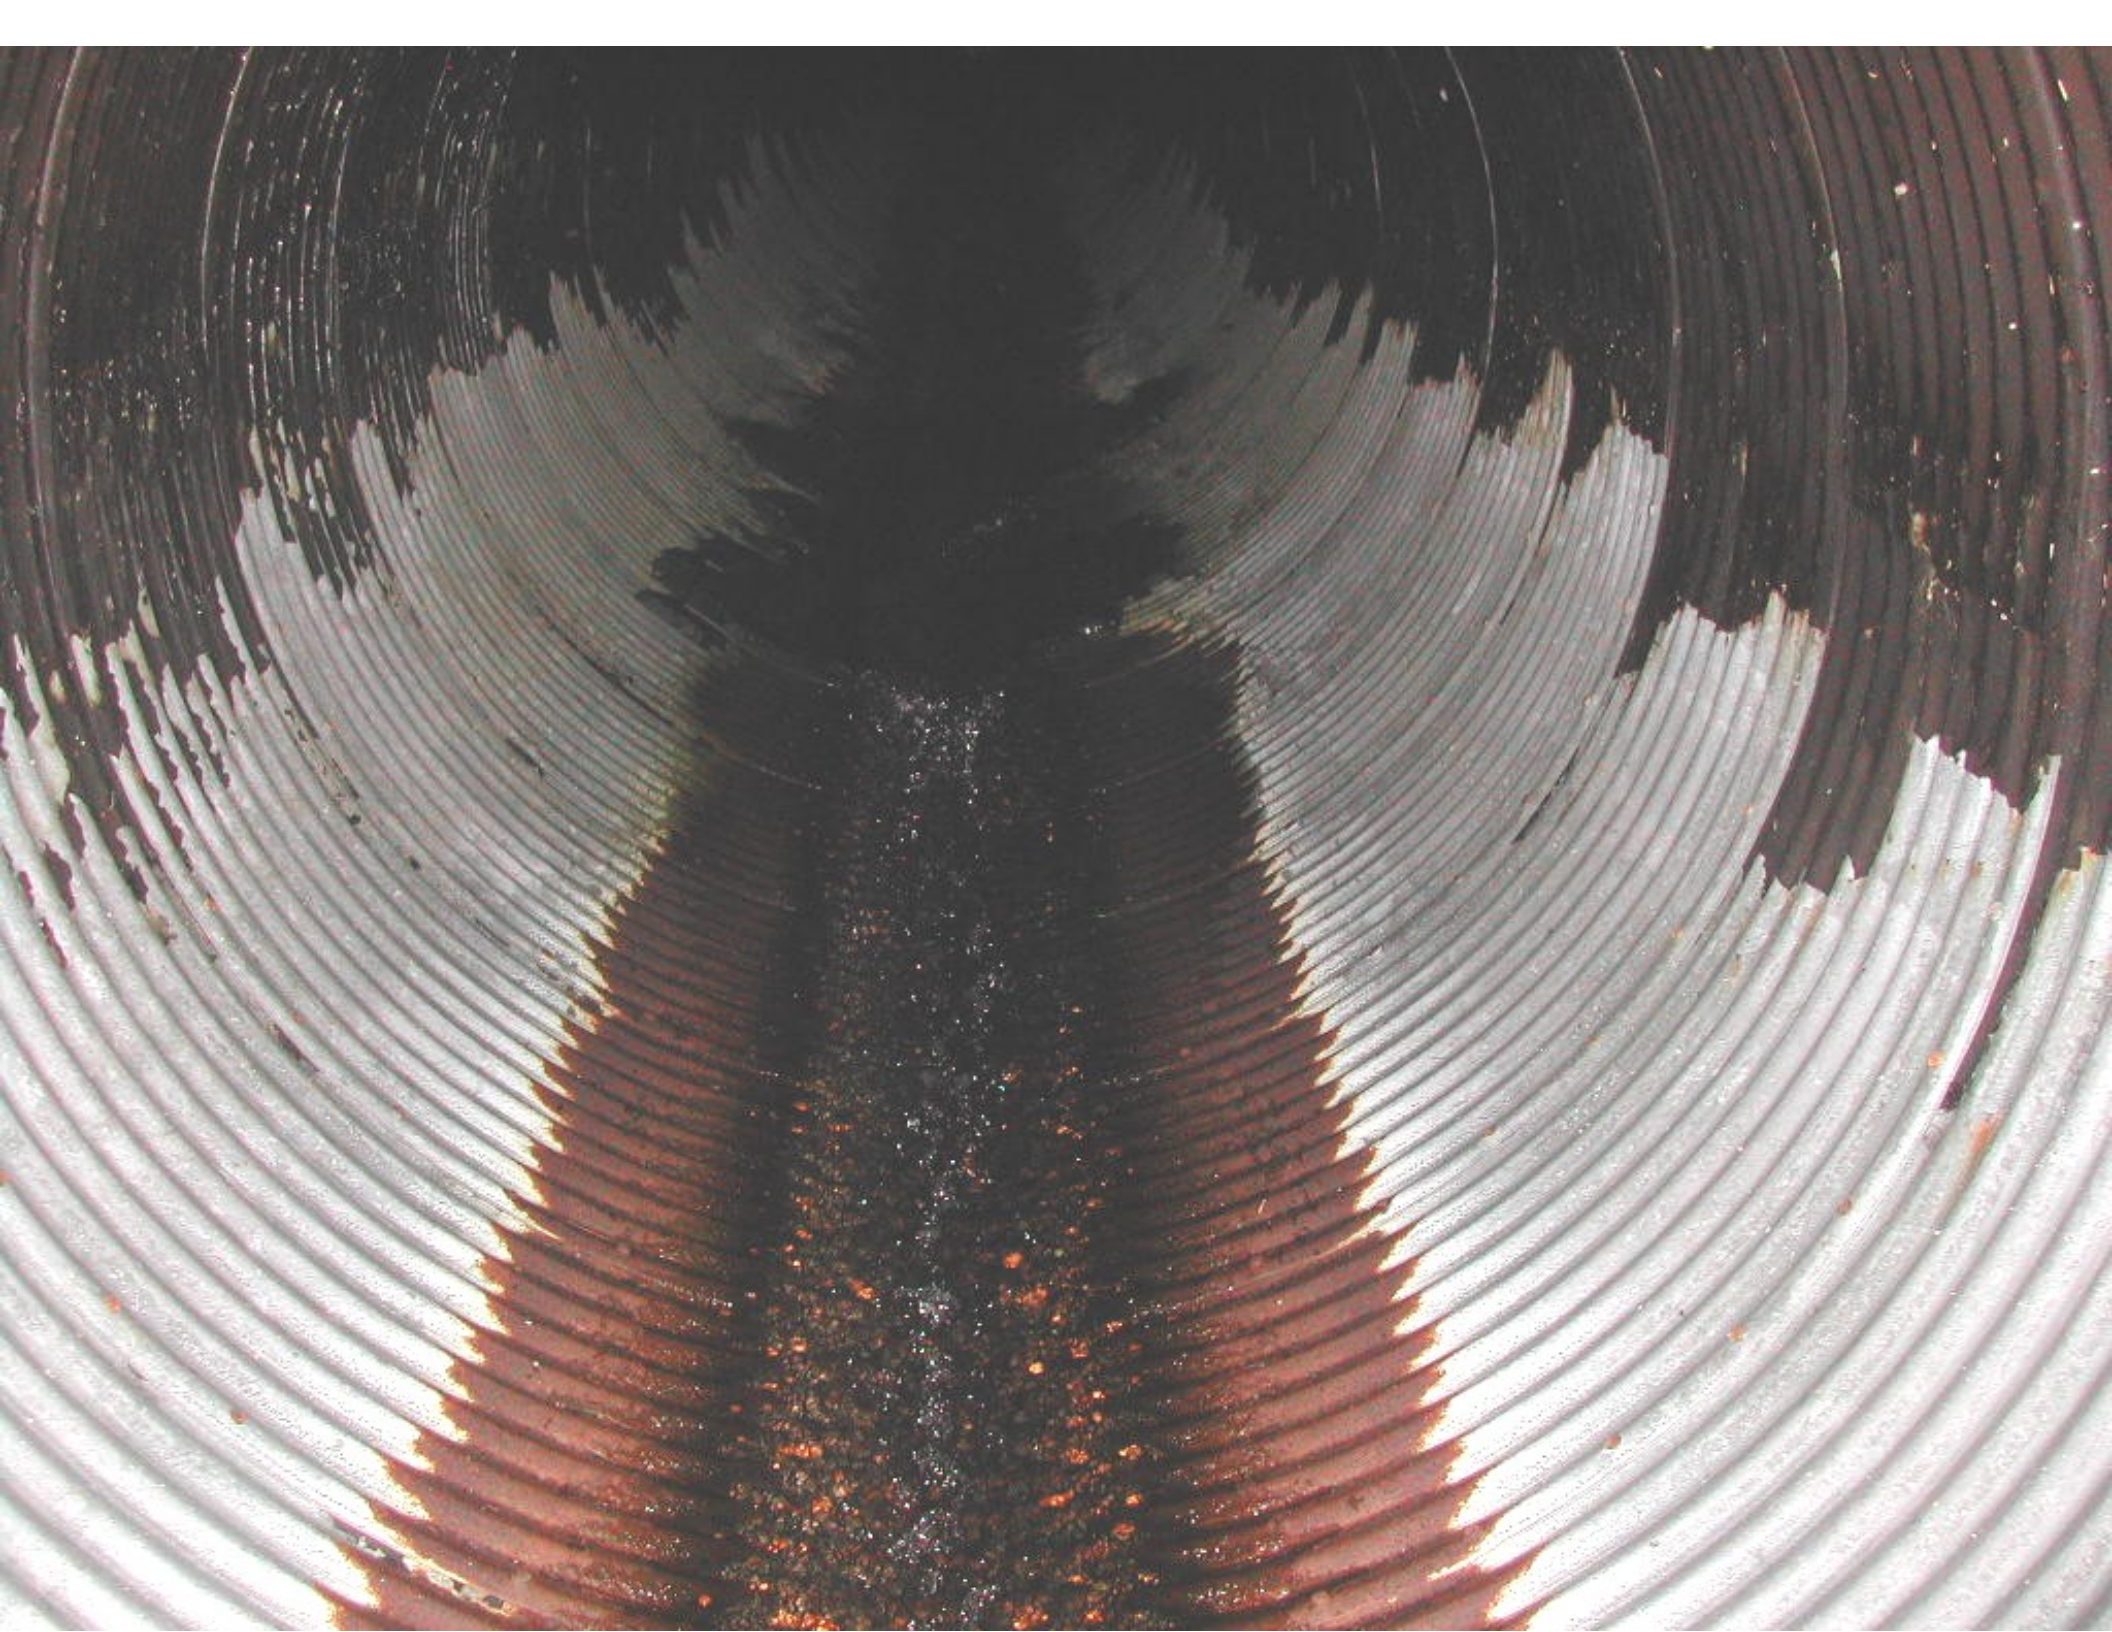
areas of extensive corrosion and scattered perforations
