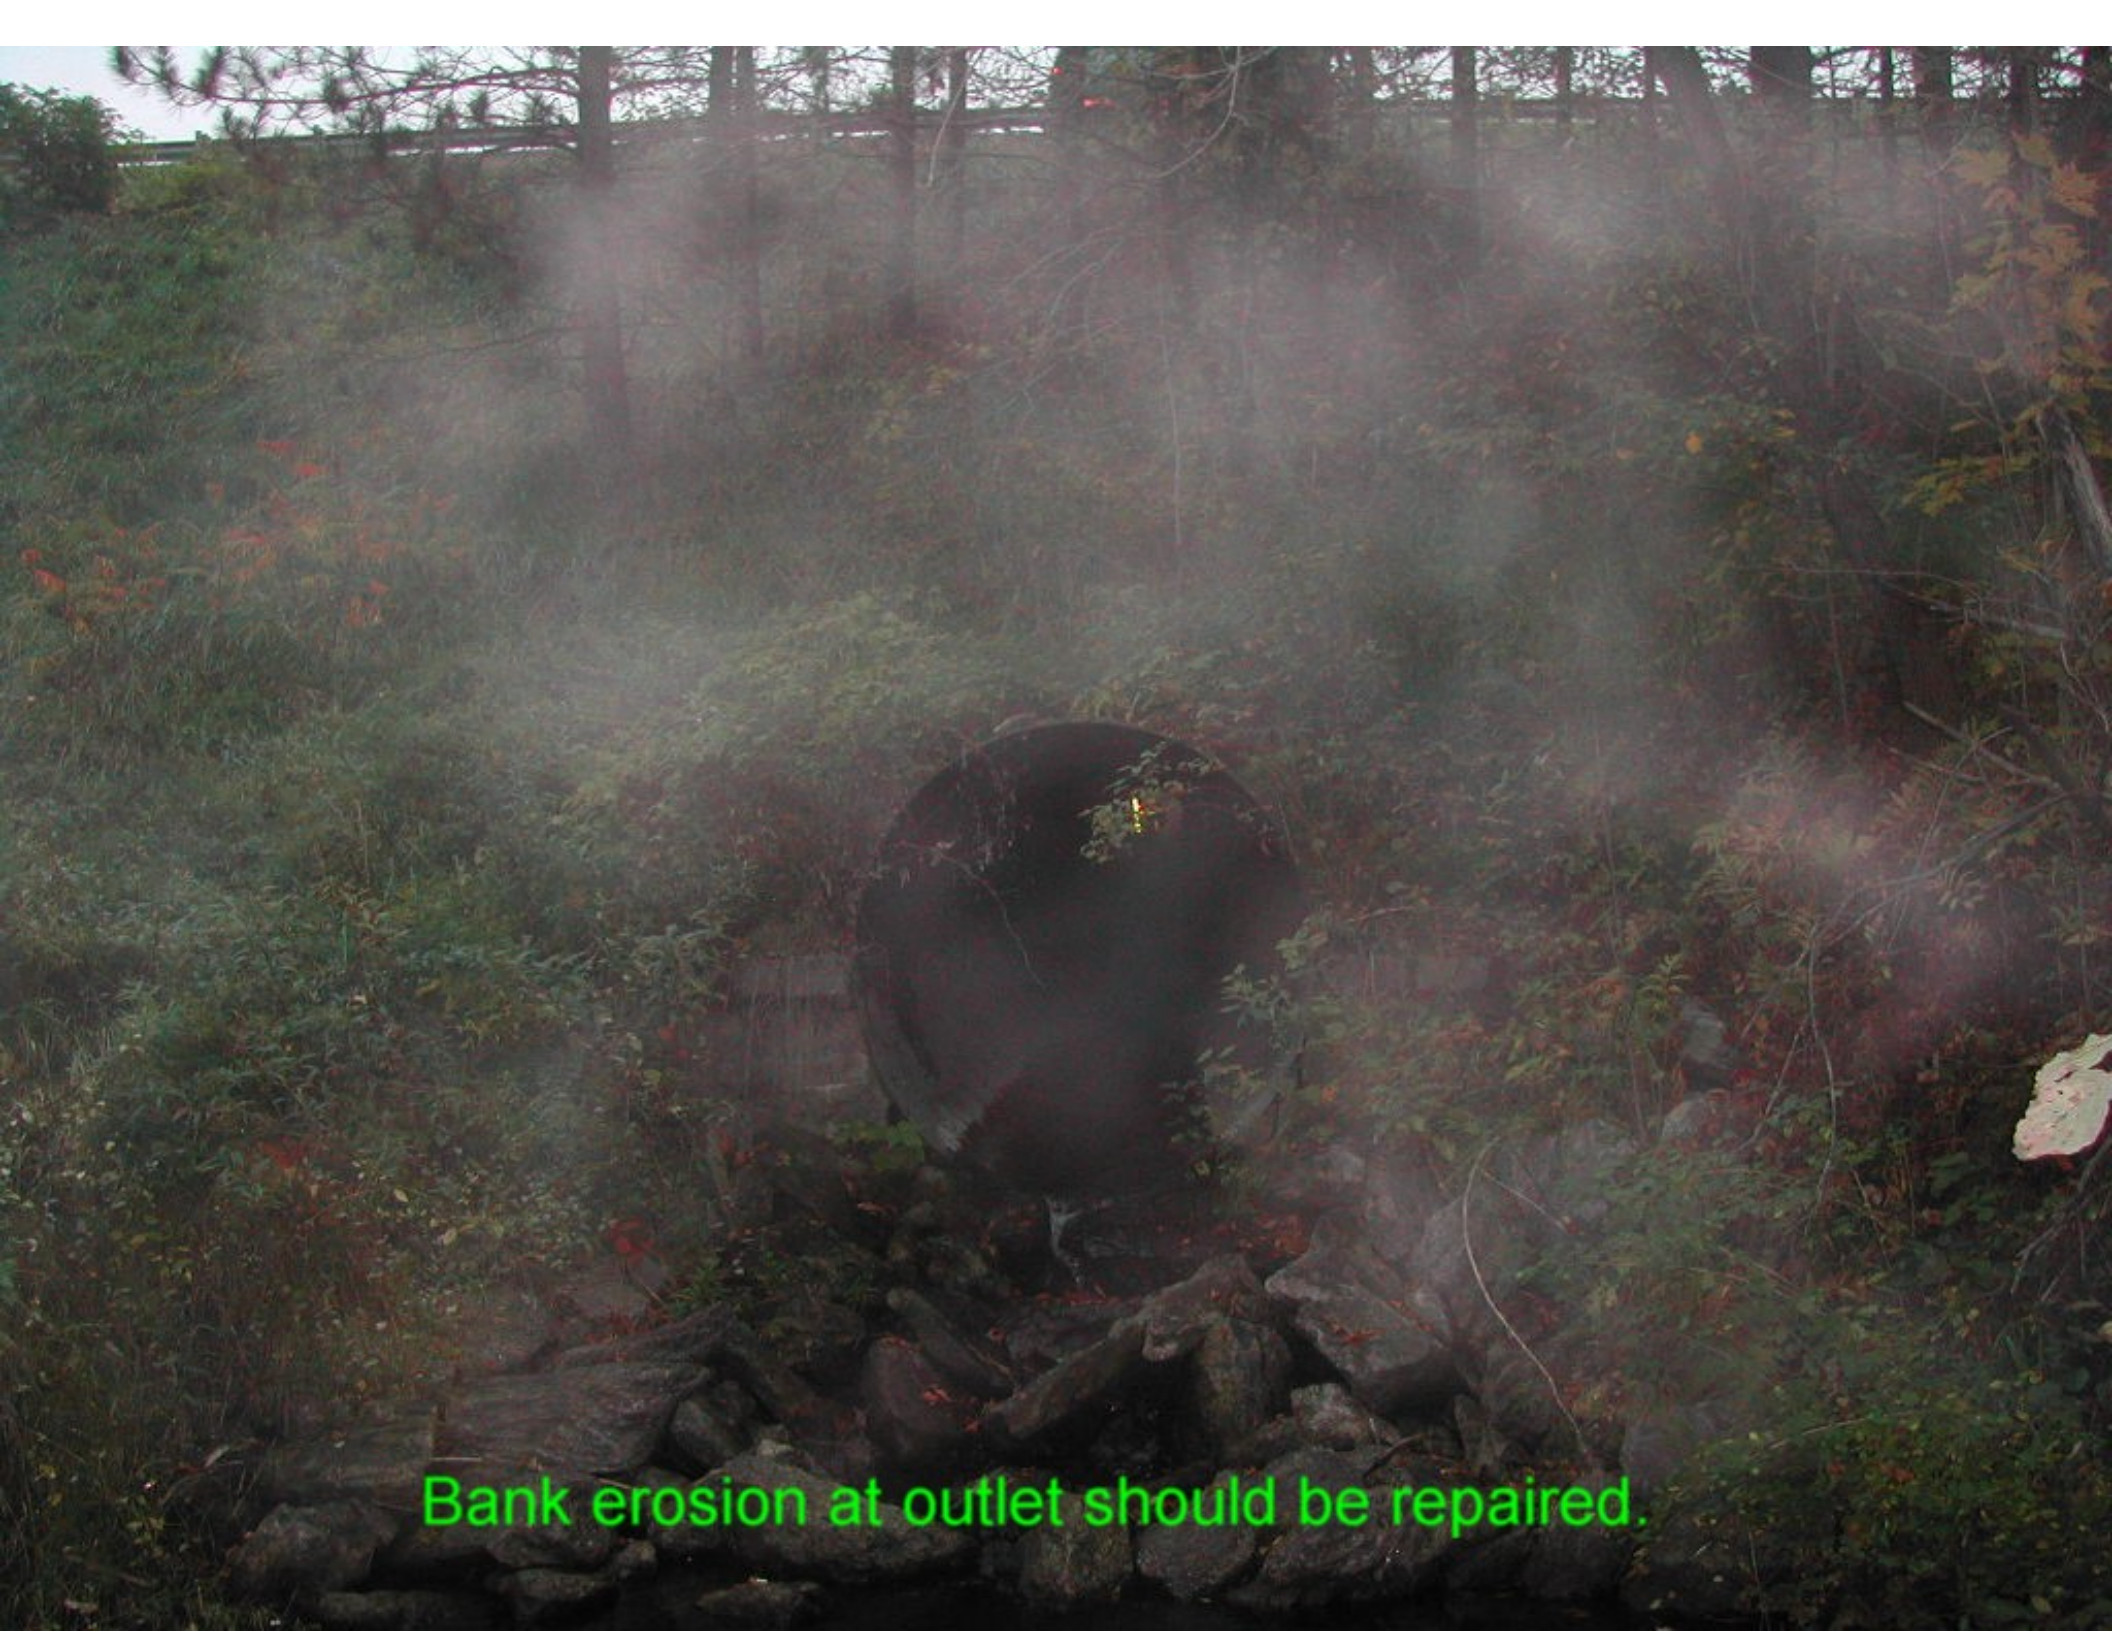
Bank erosion at outlet should be repaired.
