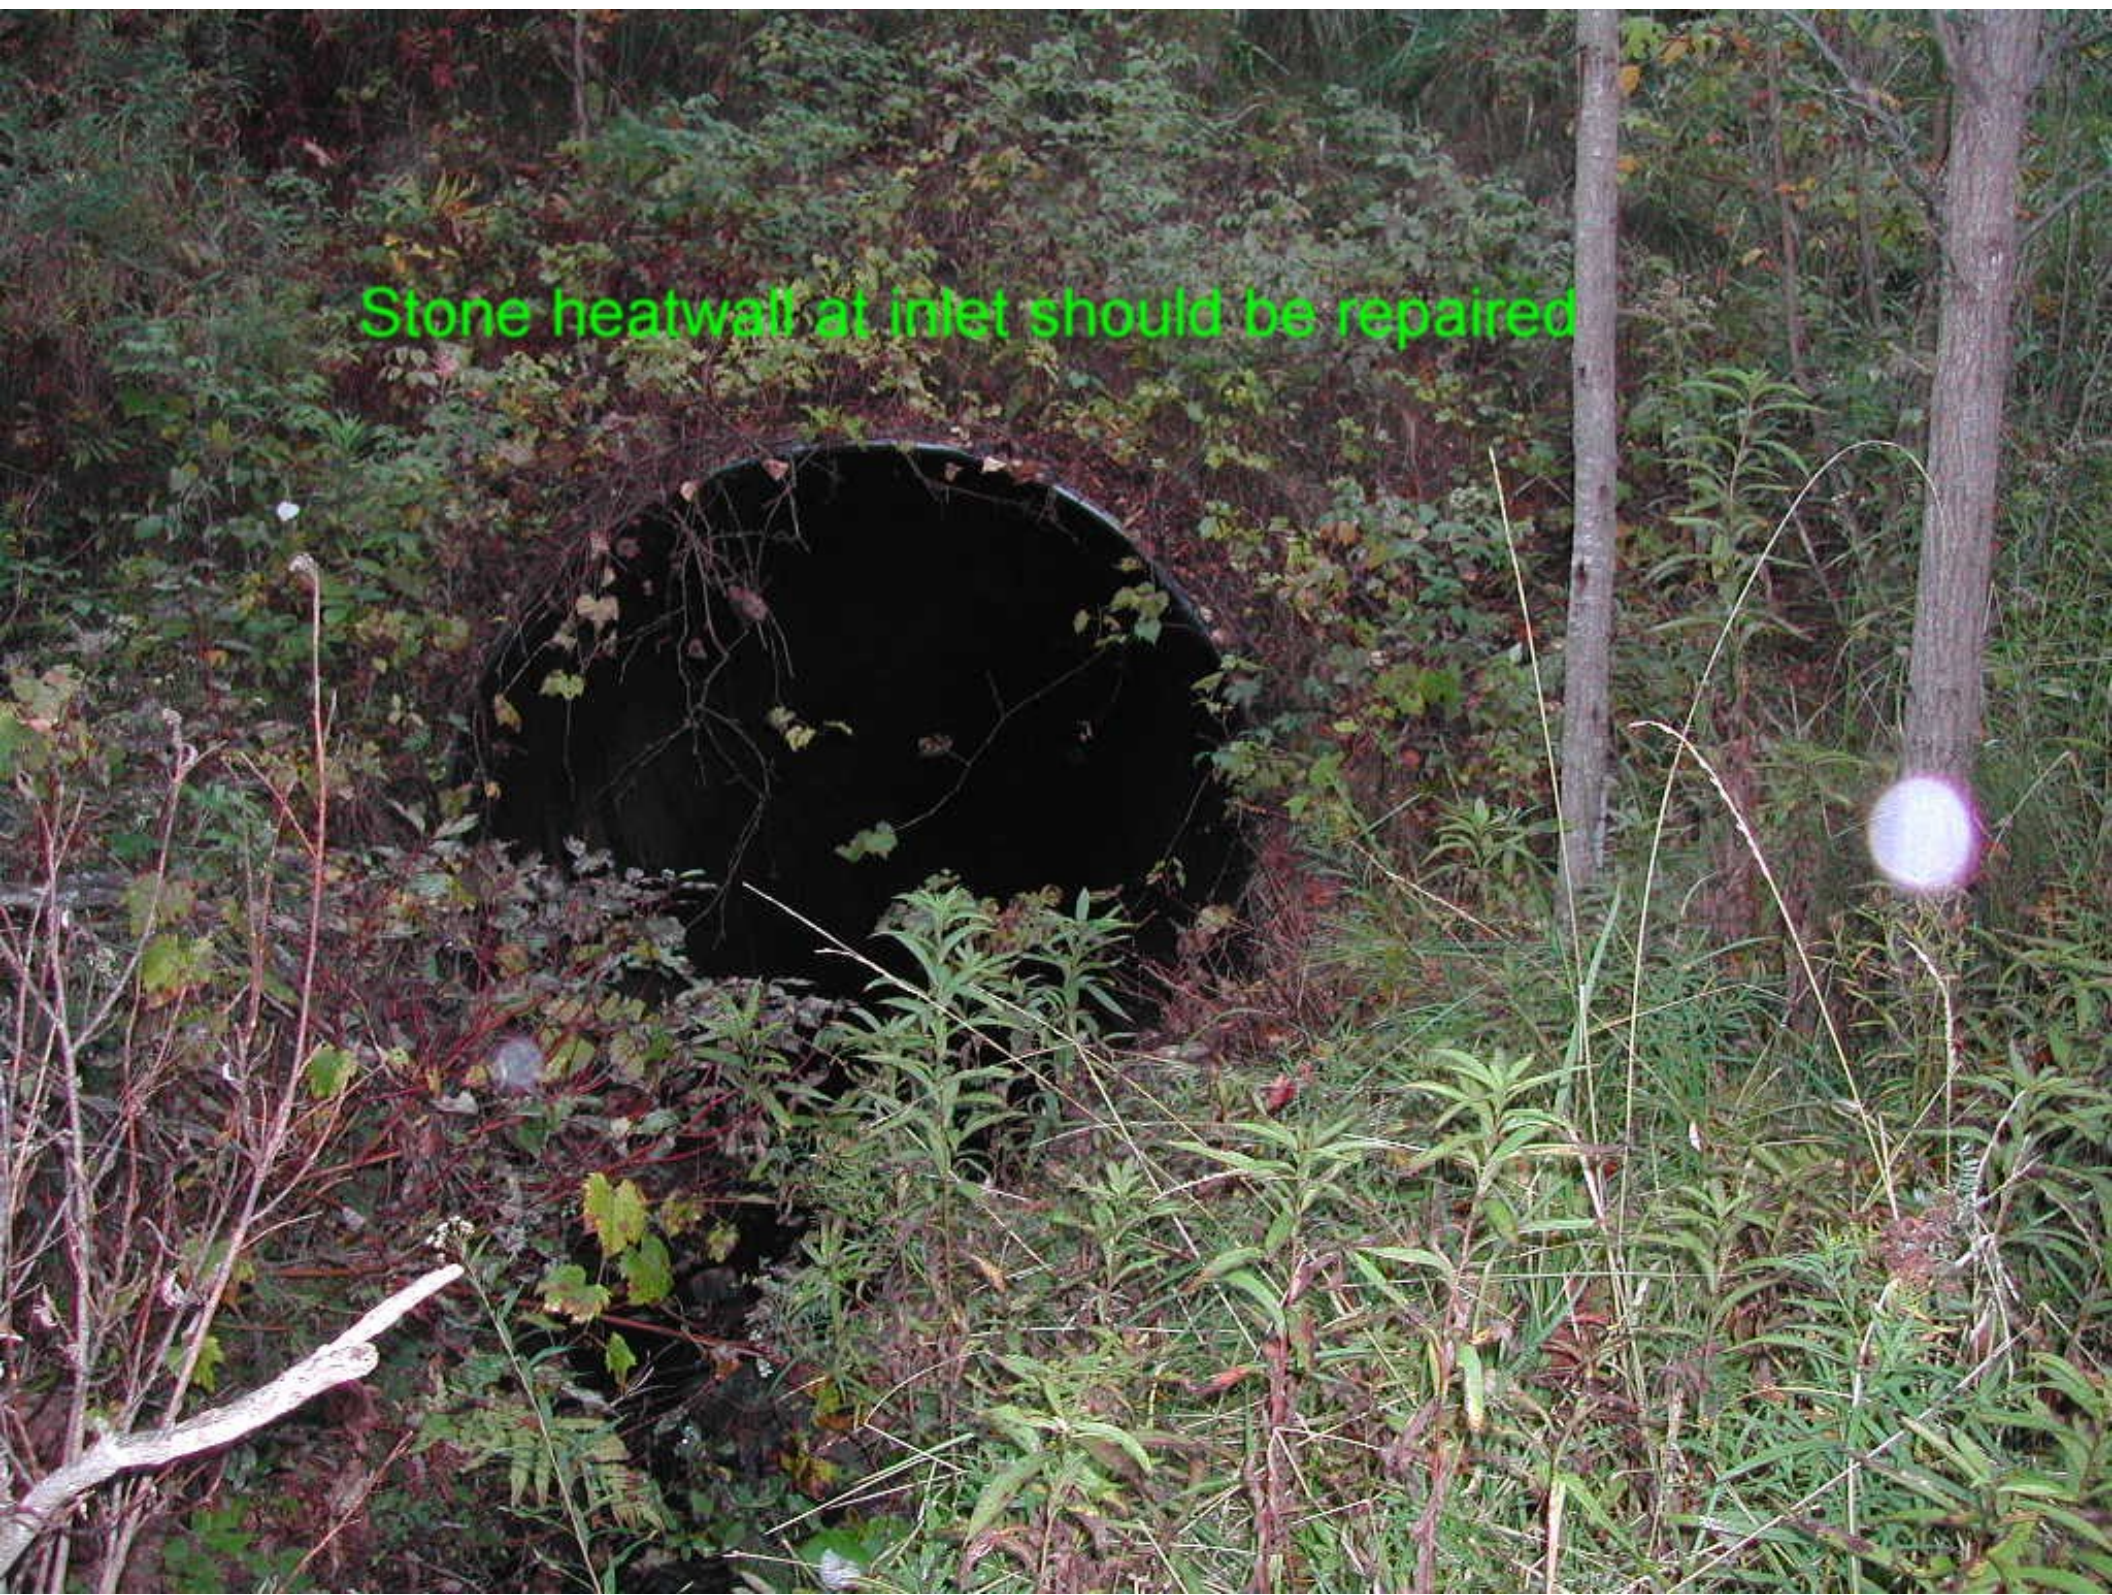
Stone heatwall at inlet should be repaired
