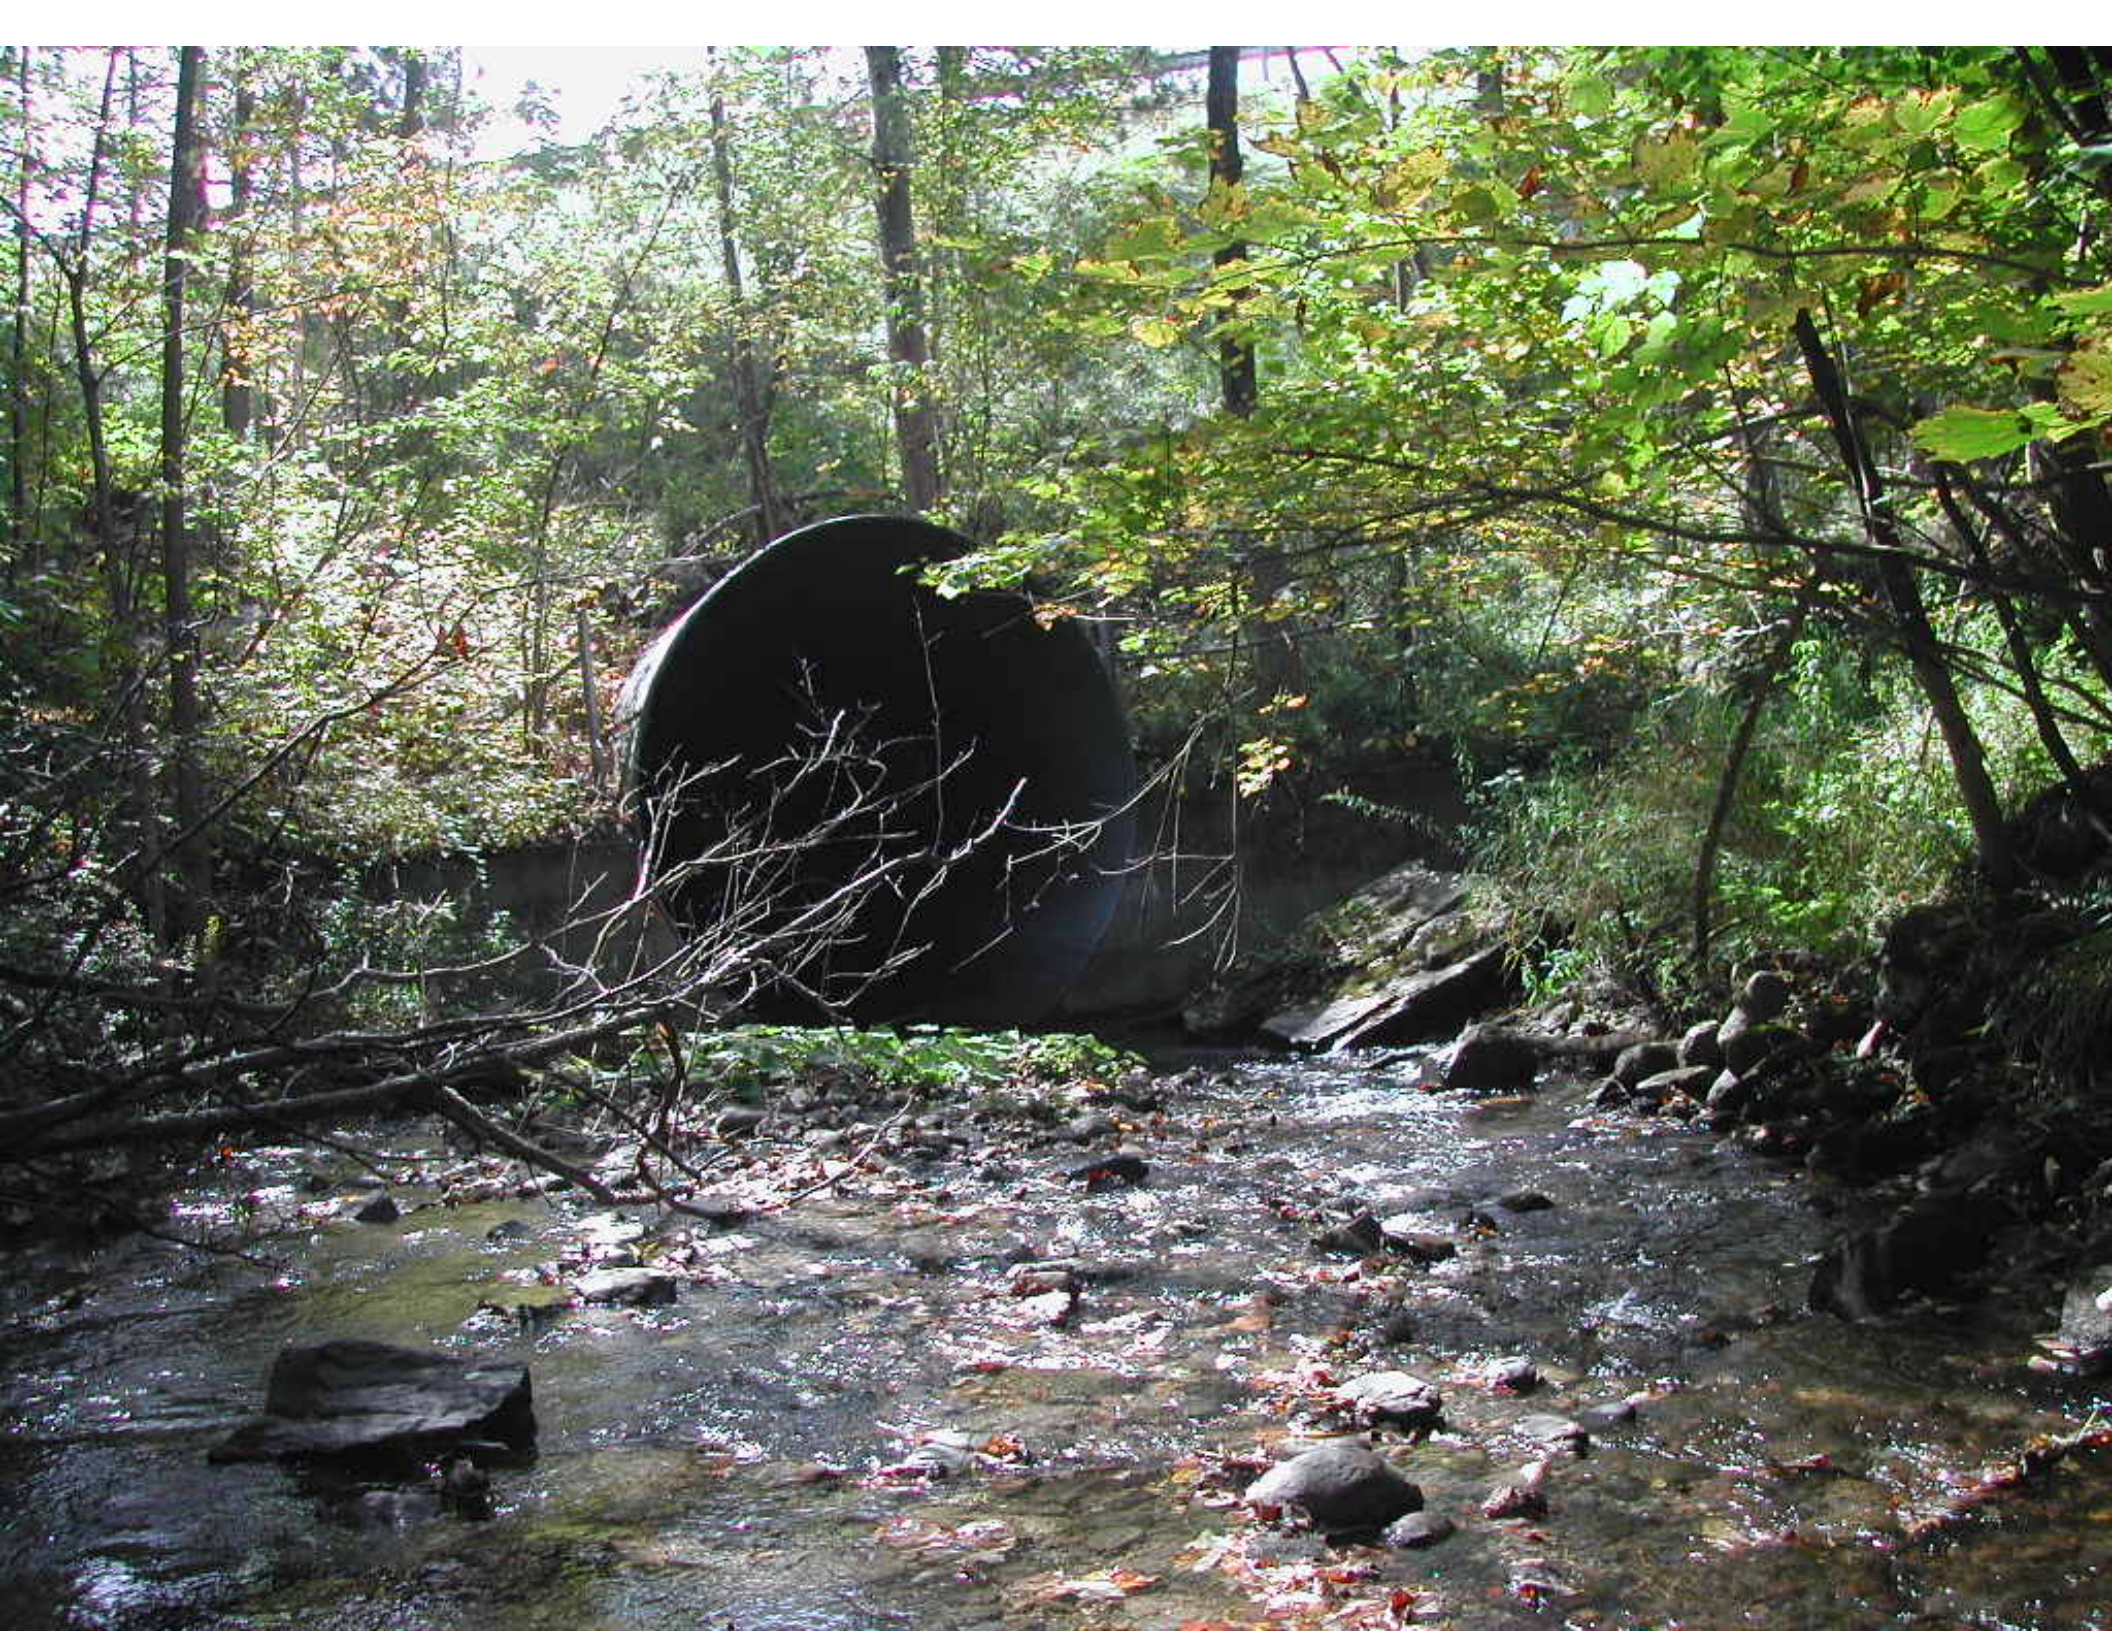
Minor map cracking in cradle headwall.

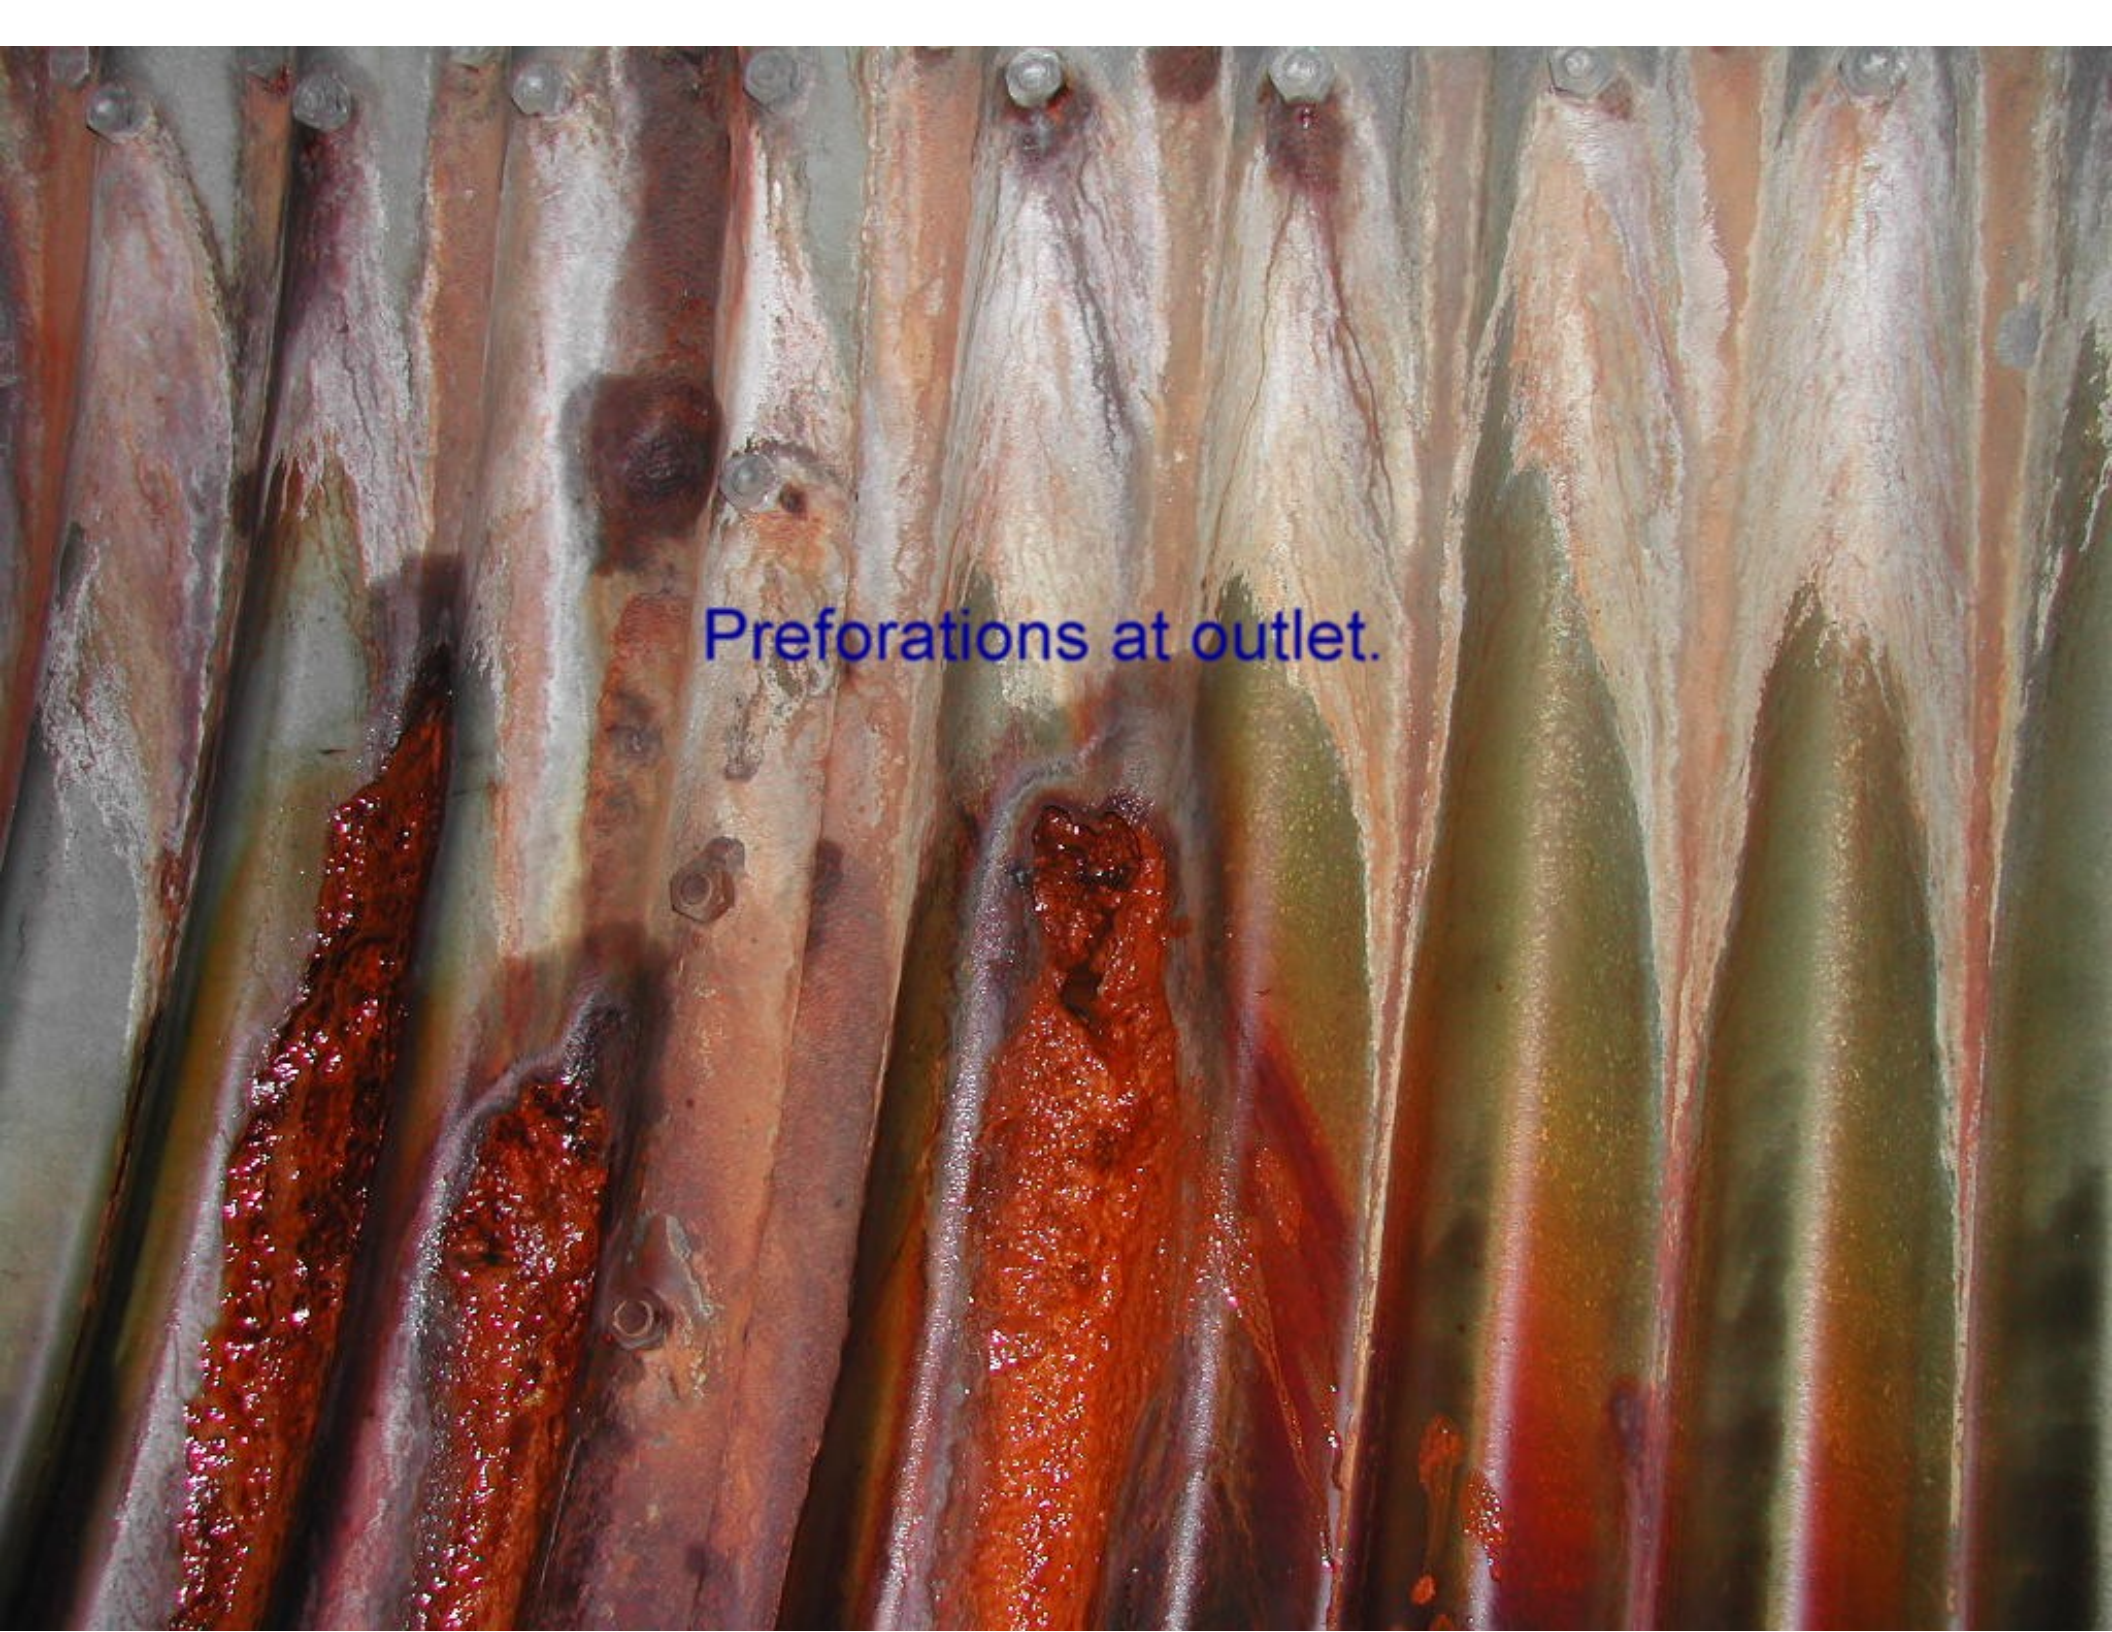
Preforations at outlet.
